DOT/FAA/CT-85/25

# Seat Experiment Results Full-Scale Transport Aircraft Controlled Impact Demonstration

Mark R. Cannon  
Richard E. Zimmermann

Final Report

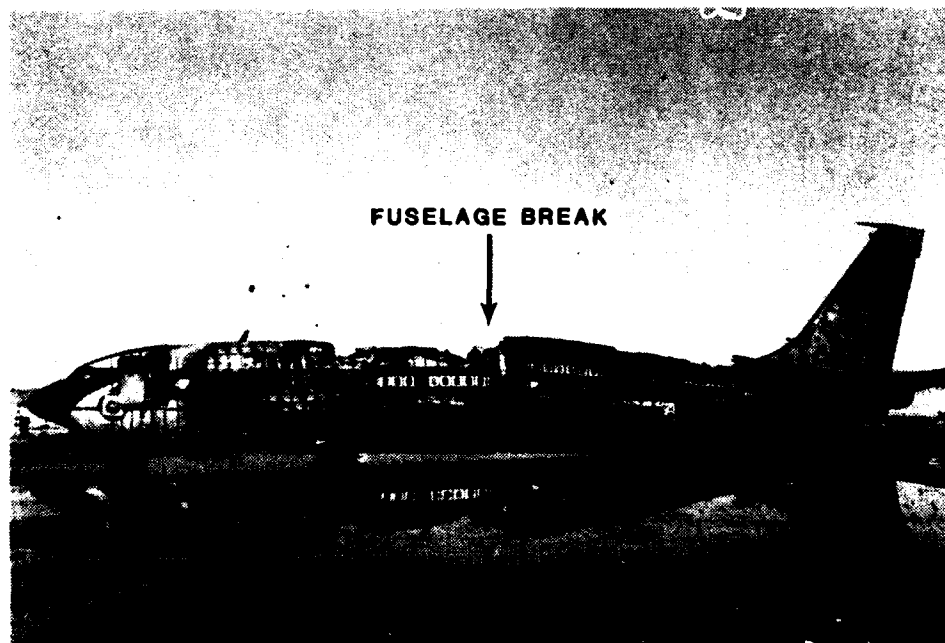
One of the obstacles penetrated the fuselage and weakened it. As the aircraft continued to slide, a fracture occurred at approximately body station 920 (figure 48). The fuselage and floor aft of the break shifted upward (figure 49), and the hub of a landing gear struck the underside of the floor structure (figure 50). The seat located at the floor break was thrown over onto its back, and the seat above the hub impact point had a track fitting dislodged.

Figure 48. Posttest view of aircraft.

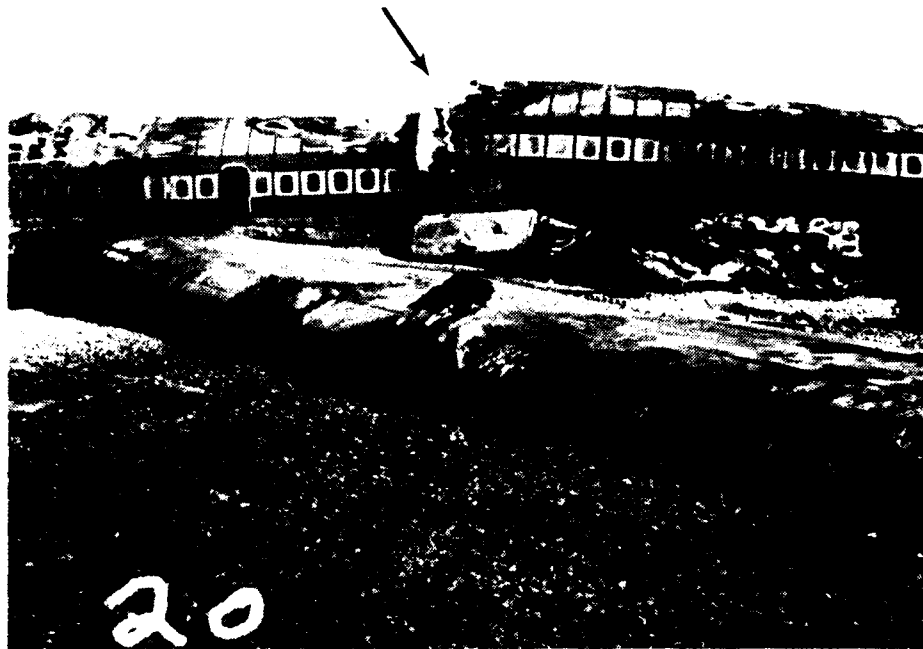
Figure 49. Location of floor break at B.S. 920.

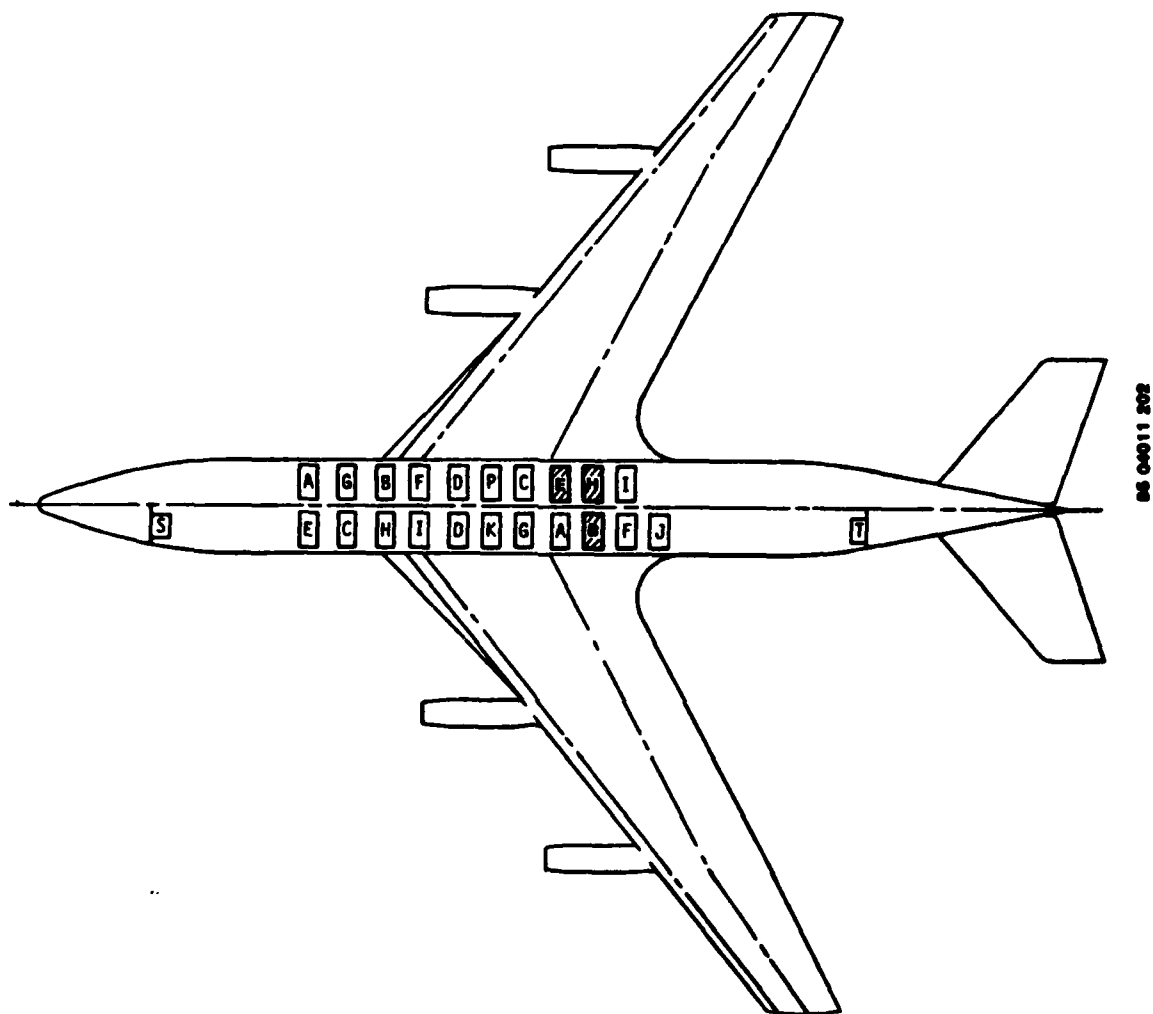
A common occurrence found on three seats was the deformation of the right side of the center seat pan. Figure 53 shows the locations of these seats and figures 54-56 show the seat pans. Onboard films showed the dummies in these seats leaning to the right and bouncing during the obstacle impact and slideout. The accelerometers from seats H/R and B/L indicated peak vertical accelerations of 40 G with 10-msec durations.

Figure 53. Locations of seats with seat pan deformation.

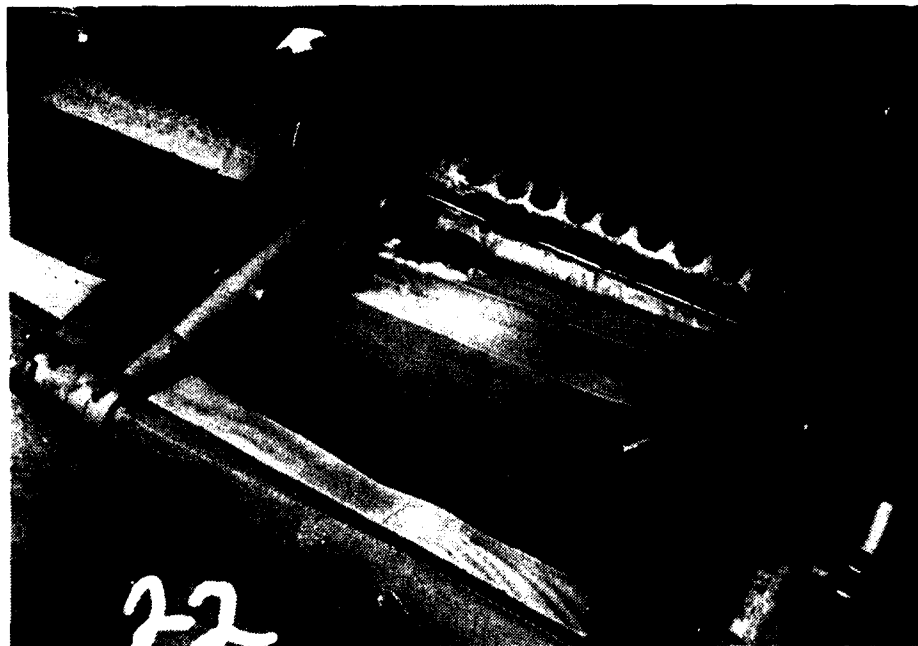
Figure 54. Seat pan deformation of seat E/R.

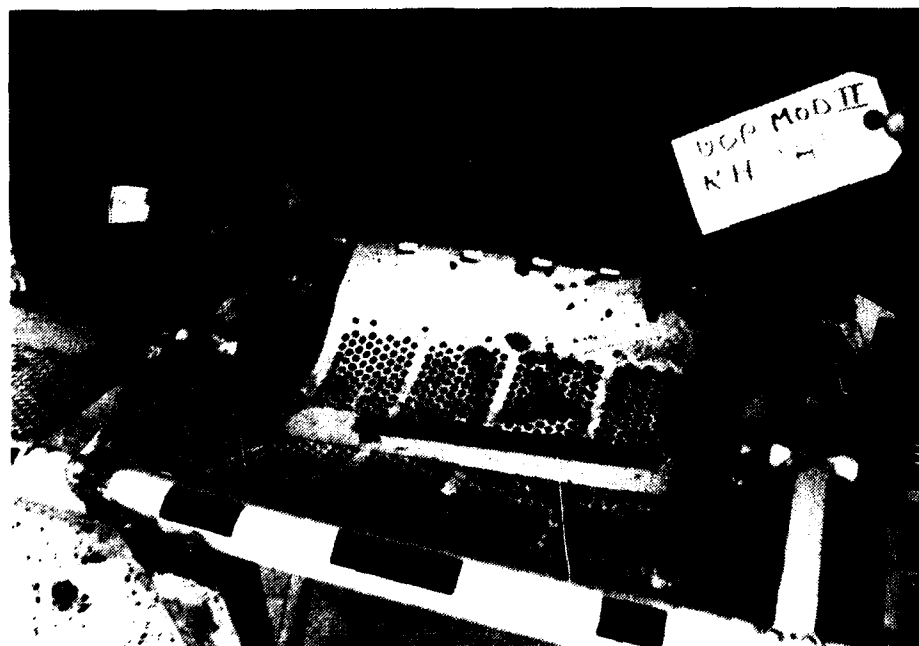
Figure 55. Seat pan deformation of seat H/R.

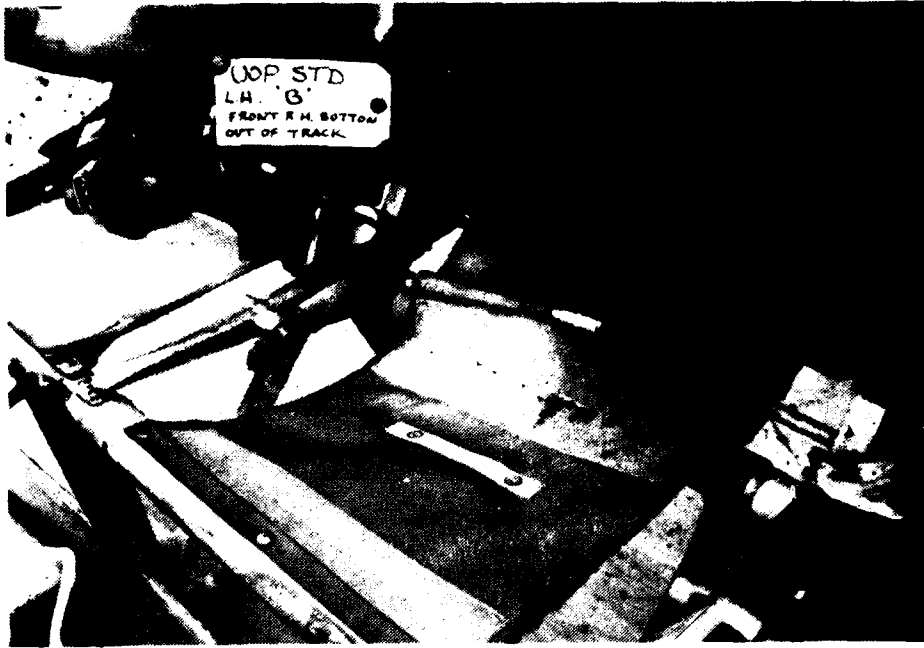
Figure 56. Seat pan deformation of seat B/L.

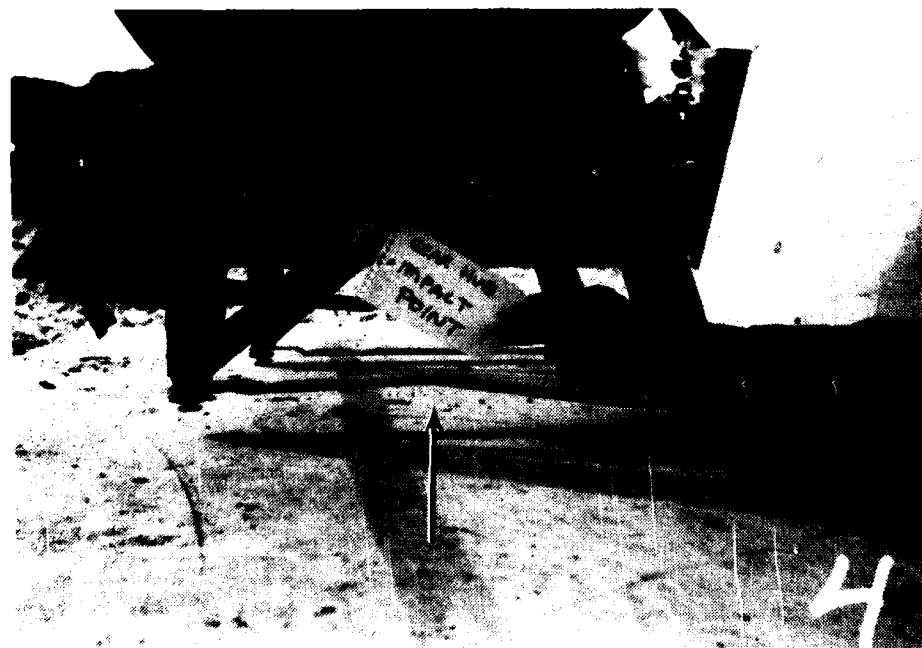
SEAT B/L. During the obstacle impact, a landing gear hub struck the underside of the floor structure directly beneath the outboard track cover bar that connects the front and rear seat legs. The floor broke and assumed the shape of an inverted V. Since the track cover bar was lying flush over the floor track, it also assumed the same shape (figure 75). The deformation of the floor also caused the outboard front track fitting to come loose from the floor track (figure 76), leaving the seat supported by three legs.

Figure 75. Location of gear hub impact point beneath seat B/L.

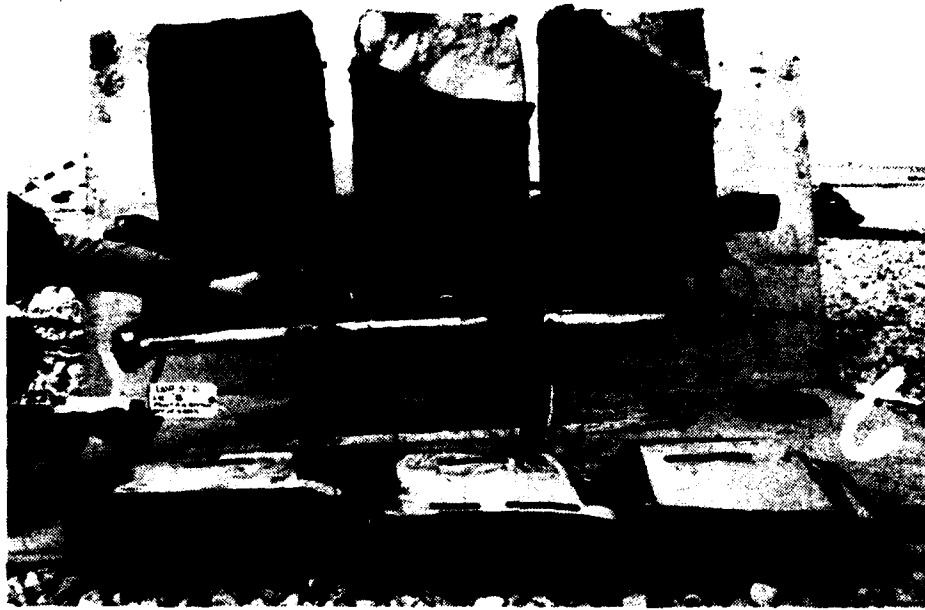
The front seat pan tube was deformed downward at both window and aisle seat positions (figure 79) and the rear seat pan tube was similarly deformed at the aisle seat position (figure 80). Since the fire had discolored the tubes at these locations, the deformations can be attributed to the heat softening the metal.

Figure 79. Deformed front seat pan tube of seat B/L.

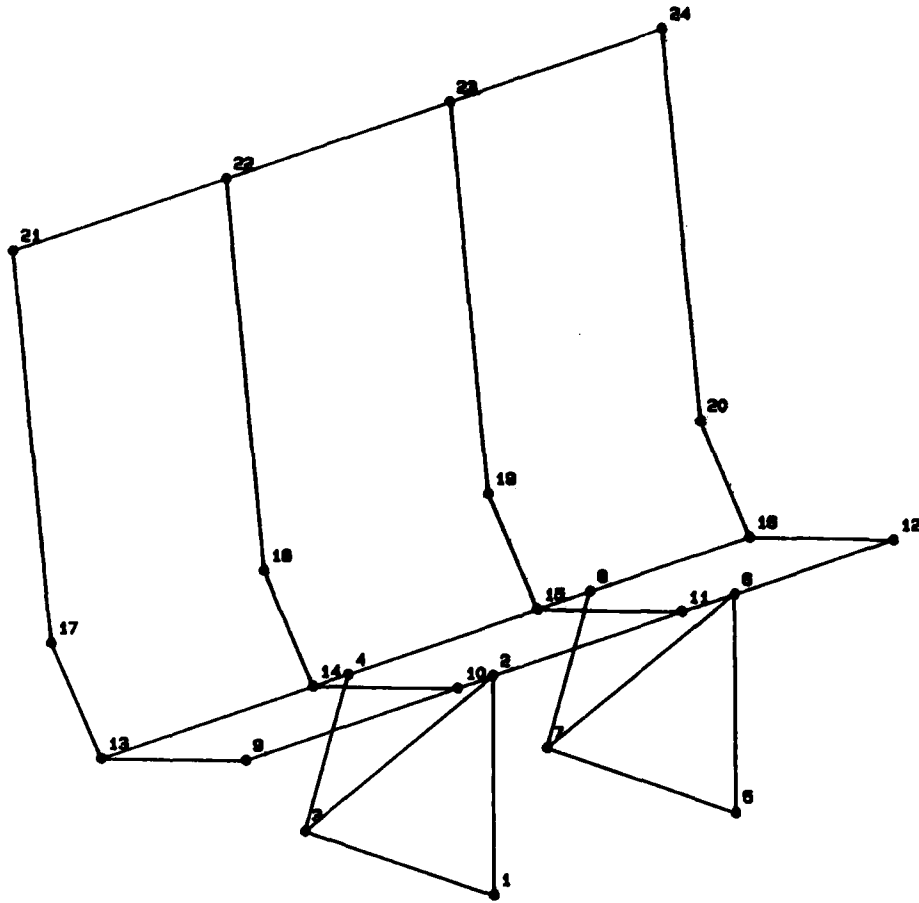
Program SOM-TA simulations of the Weberlite 4000 seat (A/R) indicate that the impact did not produce any significant seat deformations. The internal loads predicted for the beam elements used to model the seat structure were all below those that will cause structural failures.

Figure F-7. Weberlite 4000 seat (A/R) finite element model.

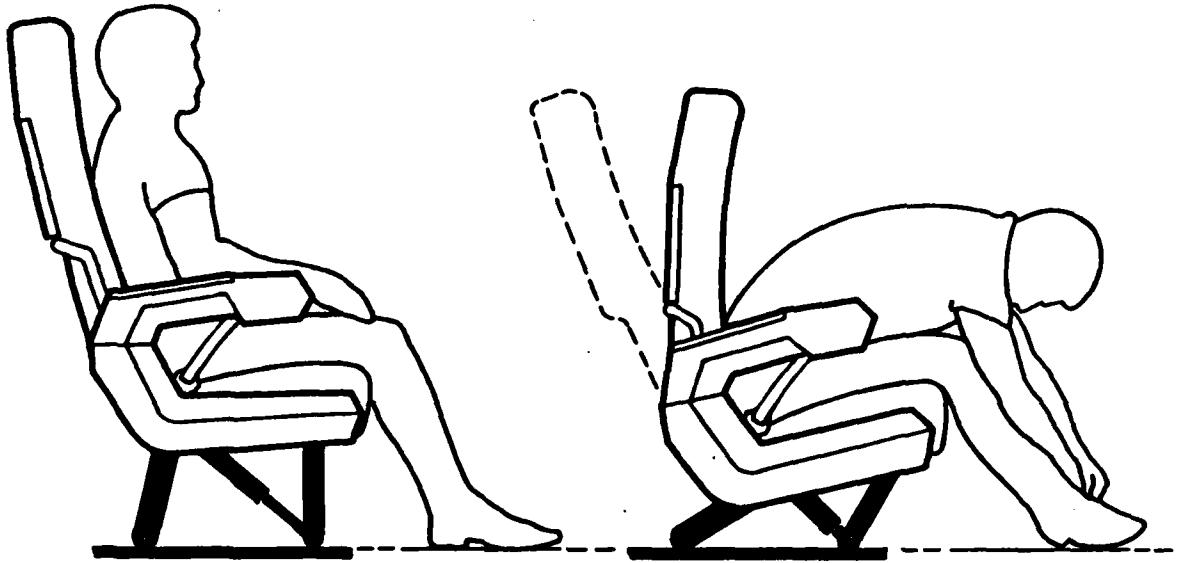
The UOP 901 seat modeled was a modified version of the standard production design. The production design was modified to include a compressive energy absorber as shown in figure F-8. The seat track fittings were also replaced by track fittings of Simula Inc. design (figure F-9). These fittings were locked in both the front and rear legs and also provided moment release about the pitch and roll axes.

Figure F-8. Modified UOP 901 seat (F/L) before and after stroking of the diagonal compressive energy absorbers.

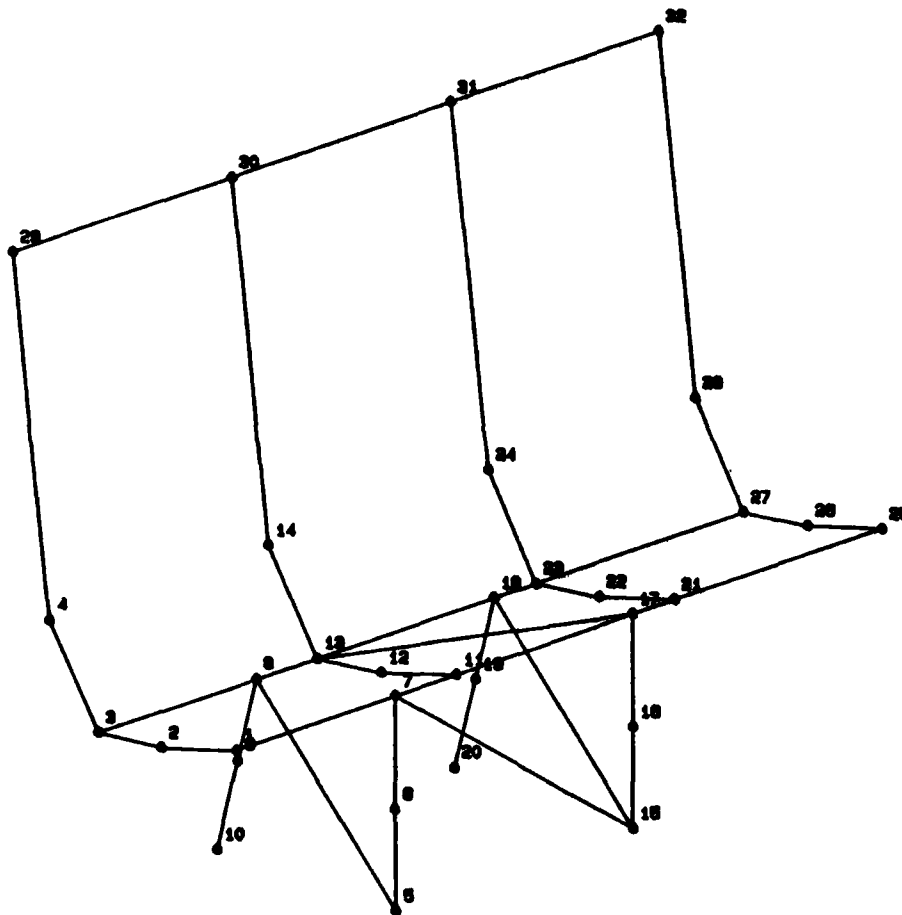
Program SOM-TA simulations of the modified UOP 901 seat (F/C) and the CID test data indicate that the impact did not produce any significant seat deformations. The internal loads for the beam elements used to model the seat structure were all below those that will cause any structural failures.

Figure F-10. Modified UOP 901 seat (F/L) finite element model.

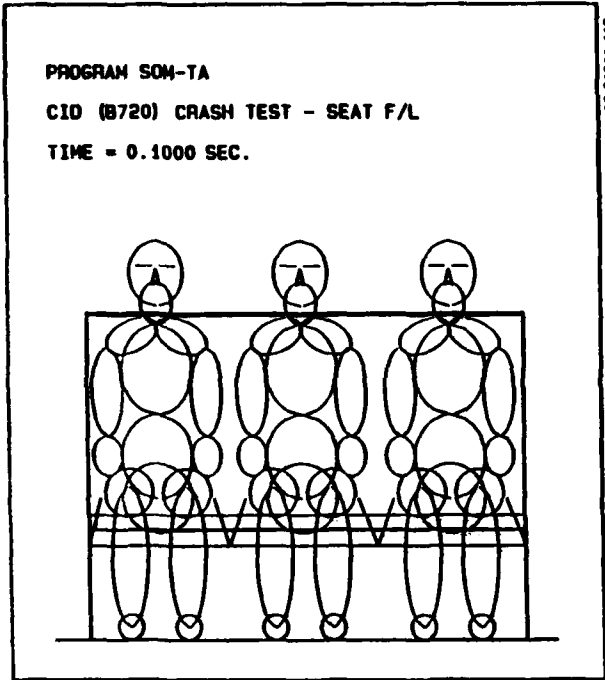
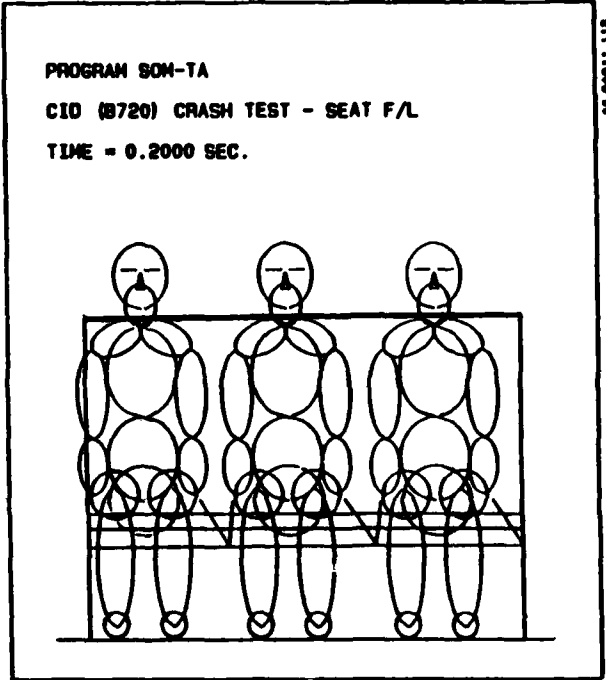
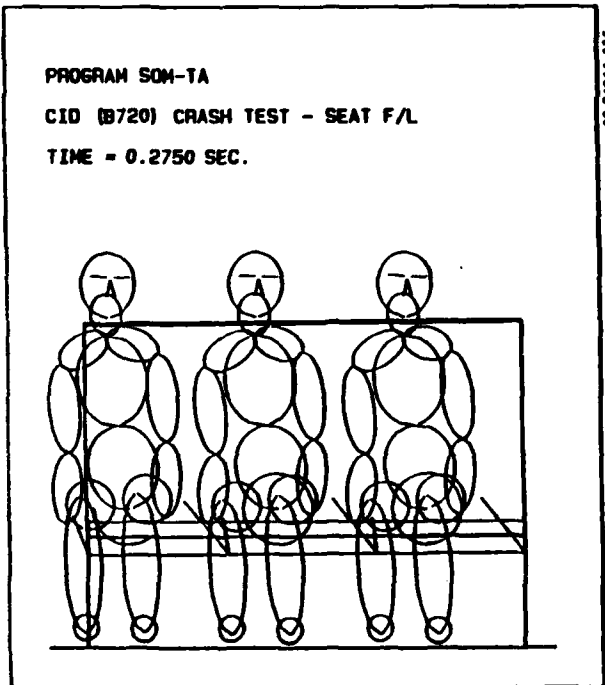
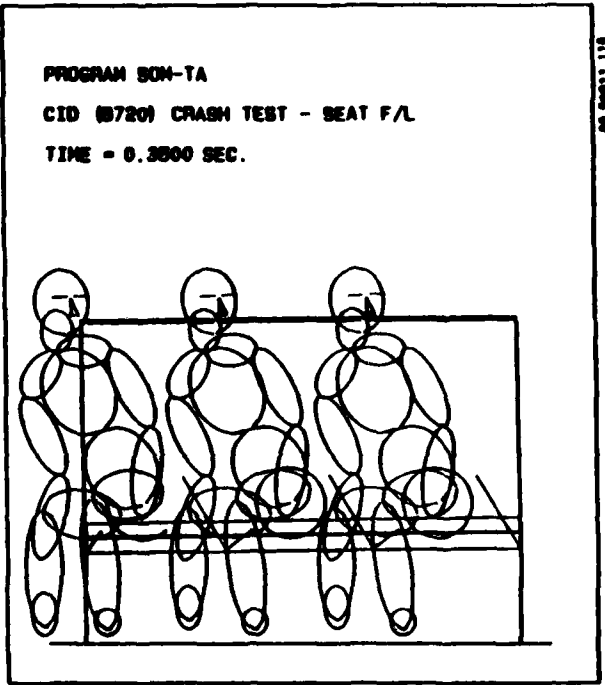
Figure F-36. Modified UOP 901 seat (F/L), Program SOM-TA predicted occupant response (front view).

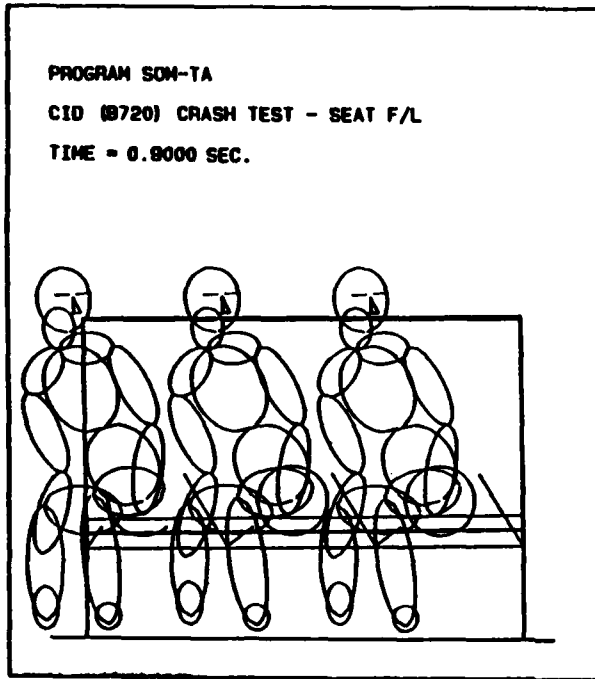
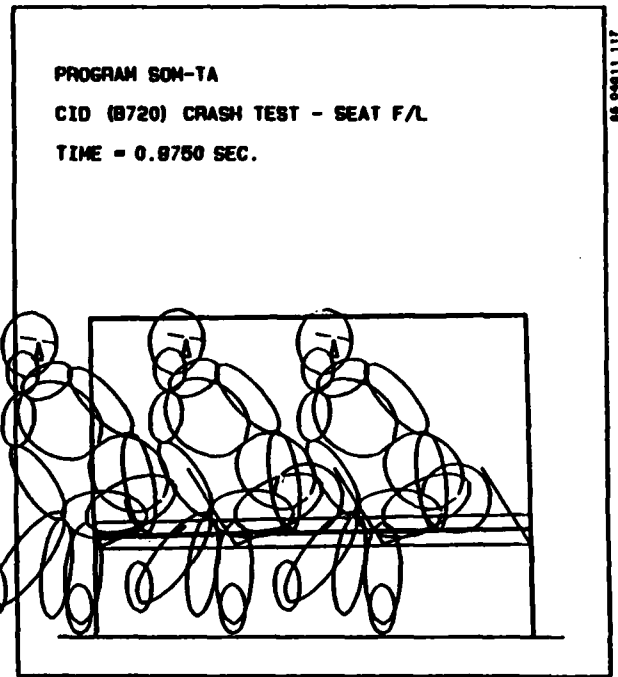
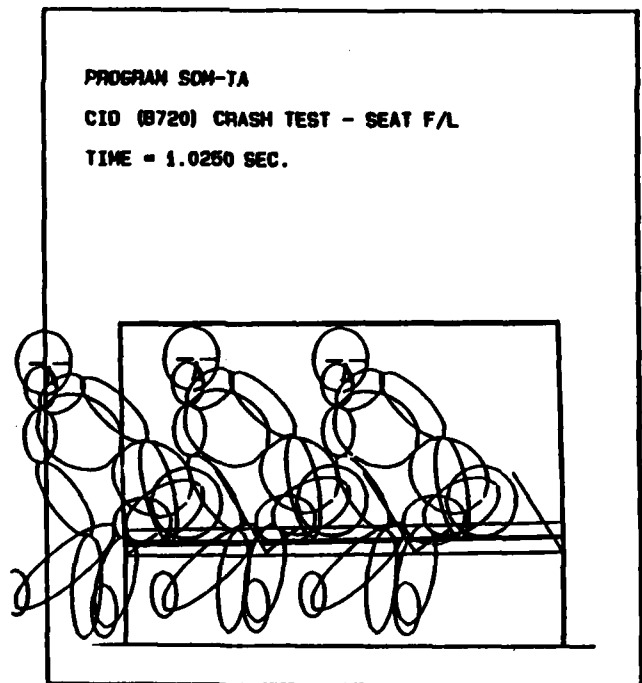
Figure F-36 (contd). Modified UOP 901 seat (F/L), Program SOM-TA predicted occupant response (front view).
