US Army Corps  
of Engineers

REPAIR, EVALUATION, MAINTENANCE, AND  
REHABILITATION RESEARCH PROGRAM

TECHNICAL REPORT REMR-C.T-3

GEOTECHNICAL ASPECTS OF ROCK EROSION  
IN EMERGENCY SPILLWAY CHANNELS

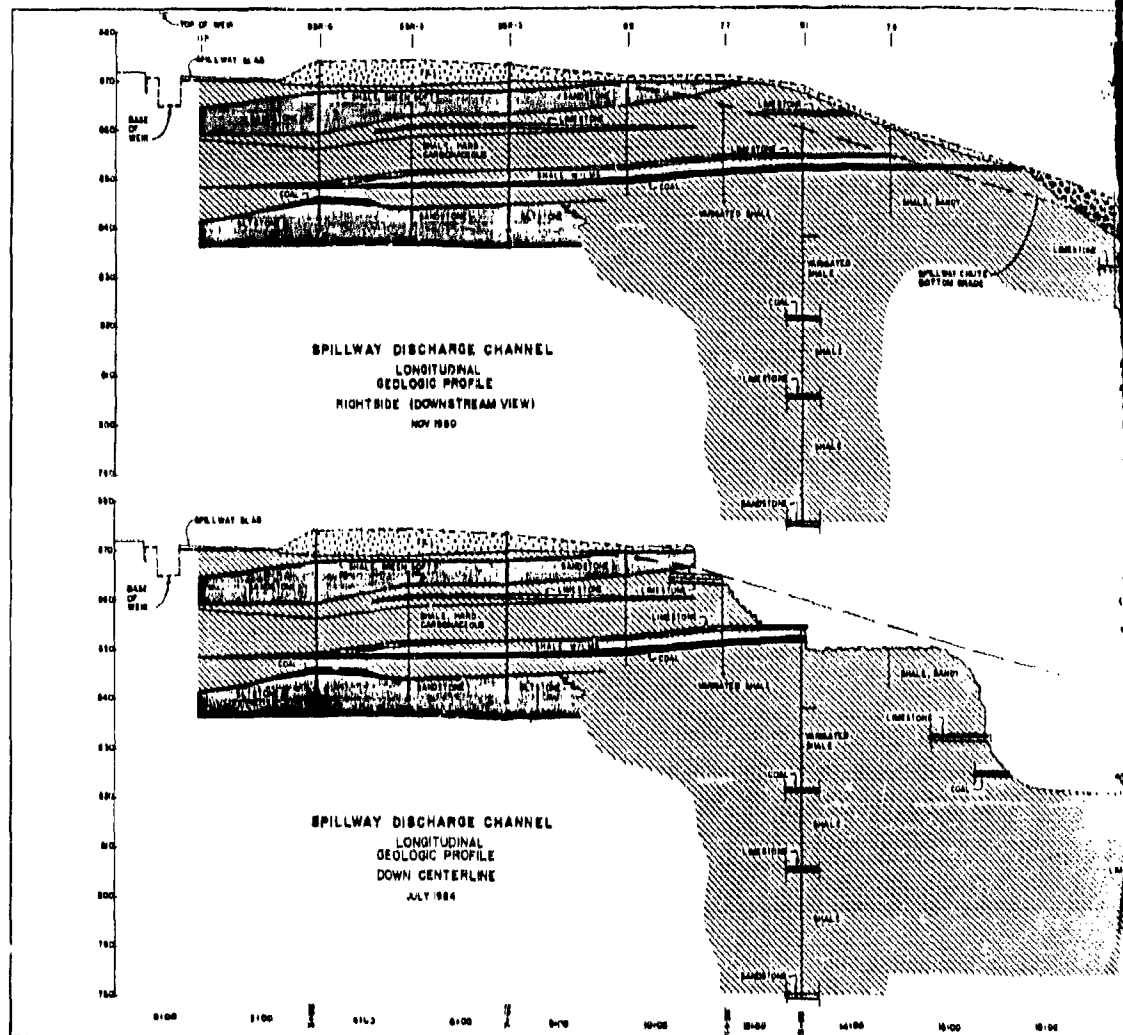
Figure 7. Saylorville emergency spillway discharge (down centerline) before and after

23. Emergency spillway overflow, which peaked at 17,000 cfs on 22 June 1984, produced the rock erosion predicted by the District's studies of 1981-82. District personnel observed the flow and erosion during the event as well as examined the before and after flood longitudinal geologic profiles (see Figure 7), and sections comparing preflood and postflood topography at twelve locations in the channel (Figures 10-12) revealed the following:

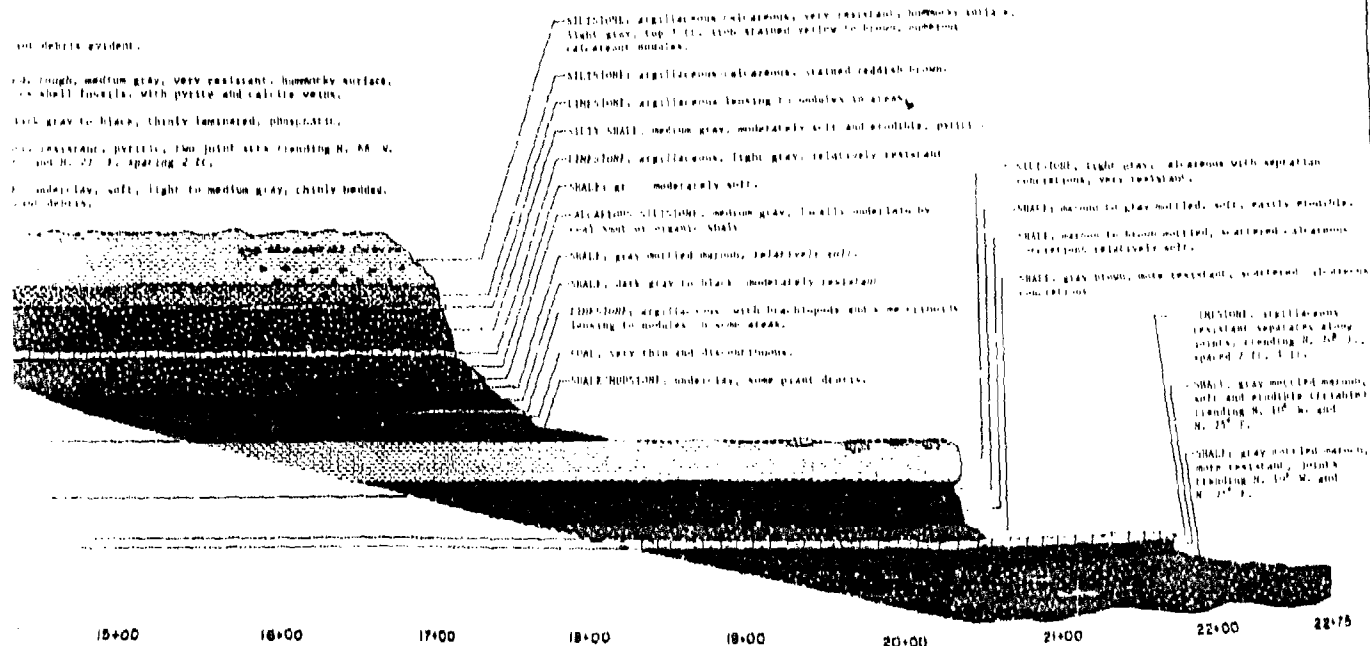
stratigraphy and lithologies underlying the lower portion of Saylorville Dam emergency spillway discharge channel

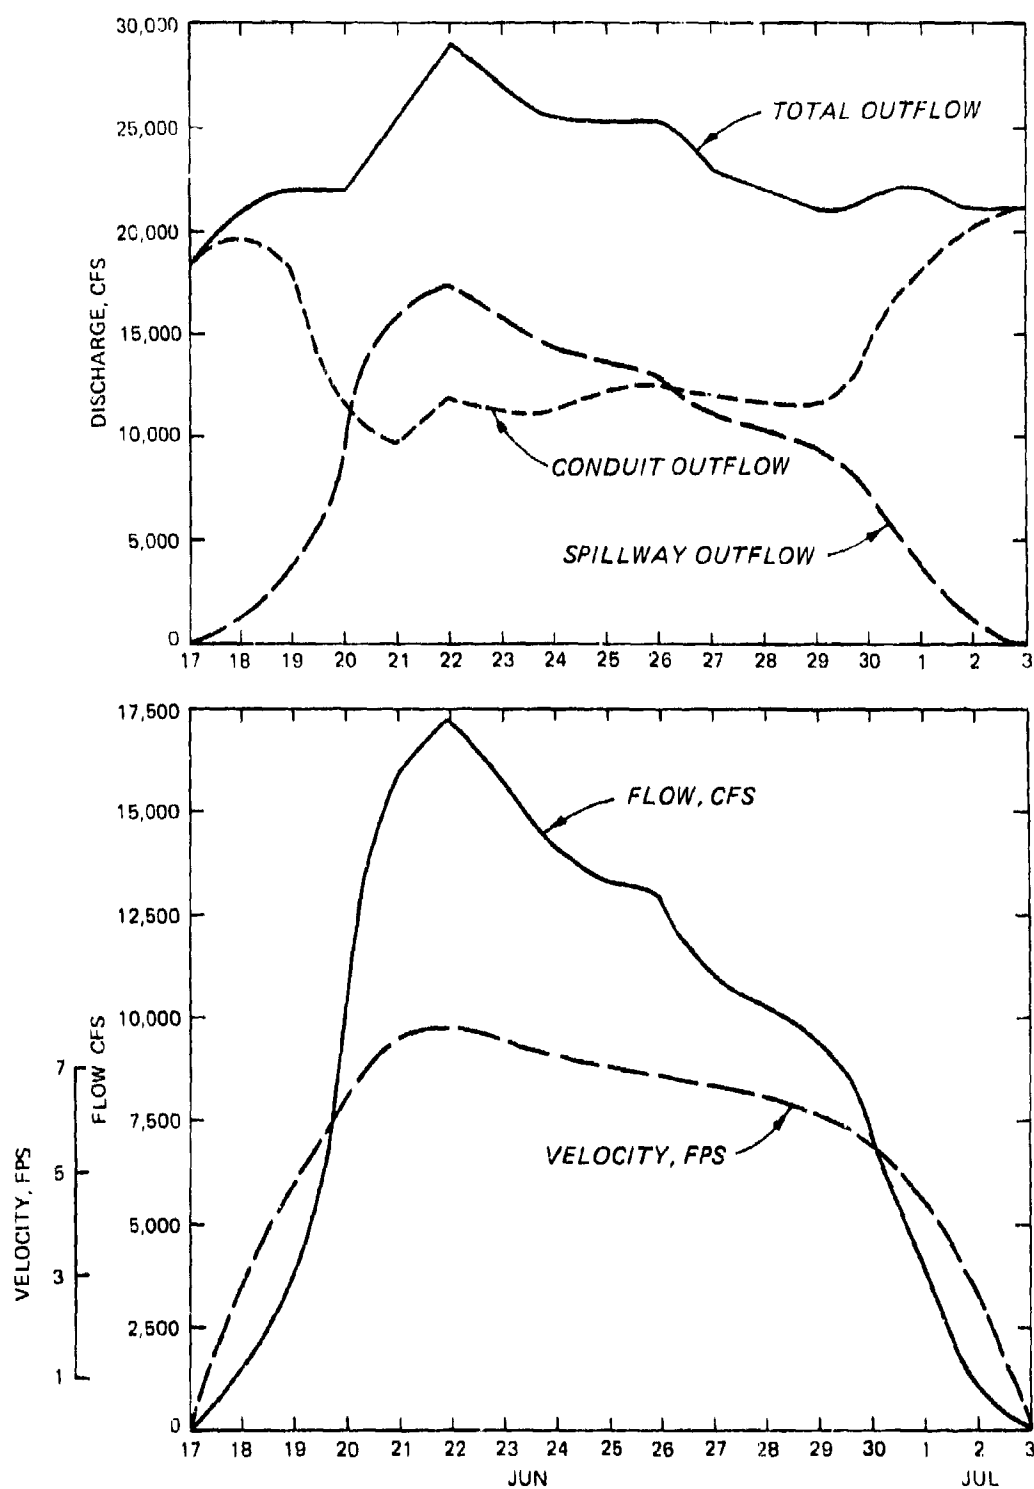
Figure 9. Saylorville spillway, outflow and velocity (at sta 7+00) versus duration of 1984 overflow event

21. Overflow event. District hydrologists estimate the events producing spillway flow were sustained high flows amounting to a 100-year volume flood along with flows peaking at a 10-year flow frequency. Peak flow (17,000 cfs) and velocities (approximately 7.5 fps) on the upper spillway channel occurred on 22 June, 4-1/2 days after the overflow commenced (Figure 9). At maximum flow, water moved over the weir crest under a head of 5.2 ft. According to the NCR report (US Army Engineer District, Rock Island 1984), total outflows from Saylorville Reservoir were regulated by adjusting the releases from the outlet conduit, and erosion occurred essentially as predicted. The estimated erosion, for flows greater than 20,000 cfs, still remains a prediction with little observed experience.

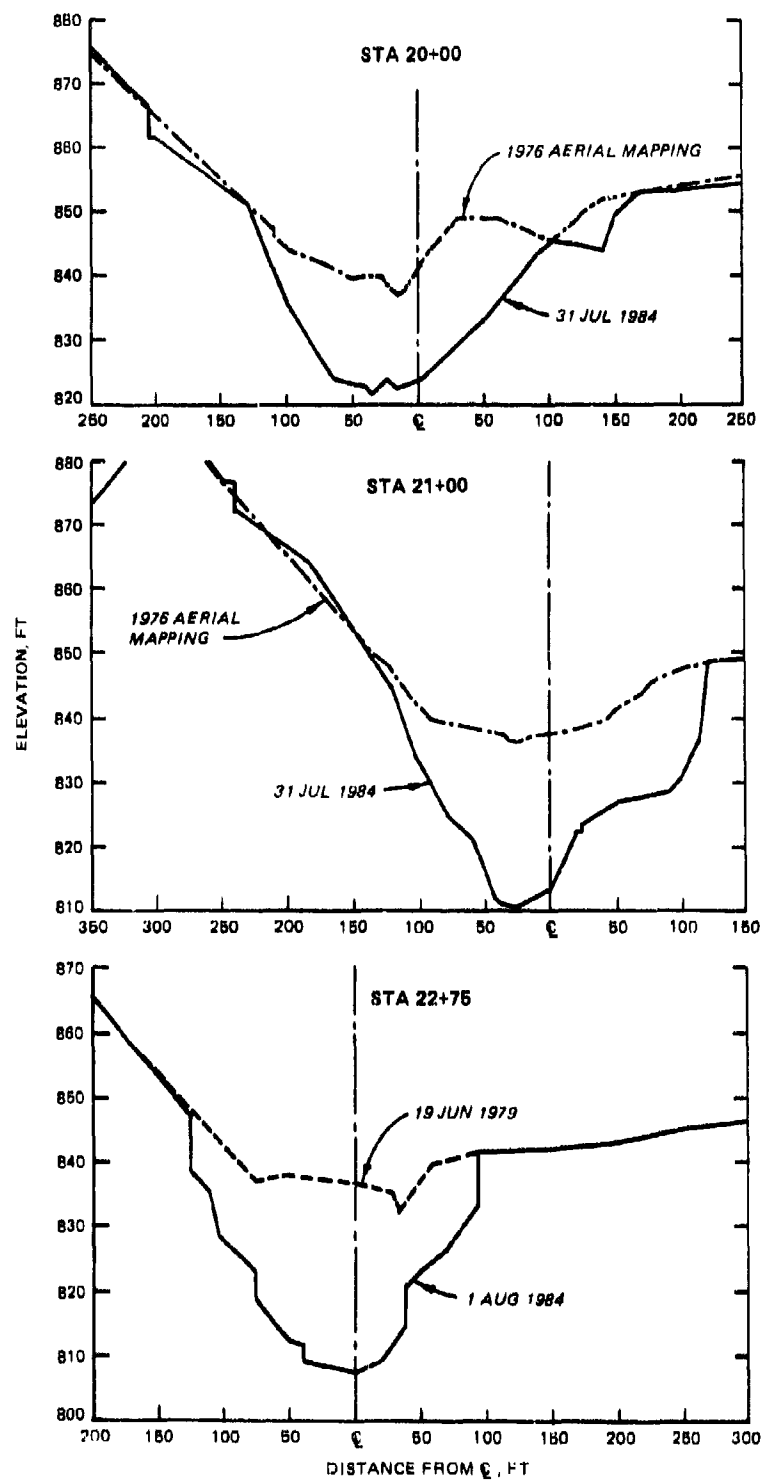
Figure 11. Saylorville emergency spillway discharge channel, cross sections showing preflood and postflood topography

(knickpoint\*) in the preflood channel. Downstream from this position, the flow velocity increased and, by the third day, the turbulent white-water flow created falls between sta 10+90 and sta 11+50. Estimates by District personnel of the turbulent flow velocity below the falls area were in the 20- to 25-fps range.

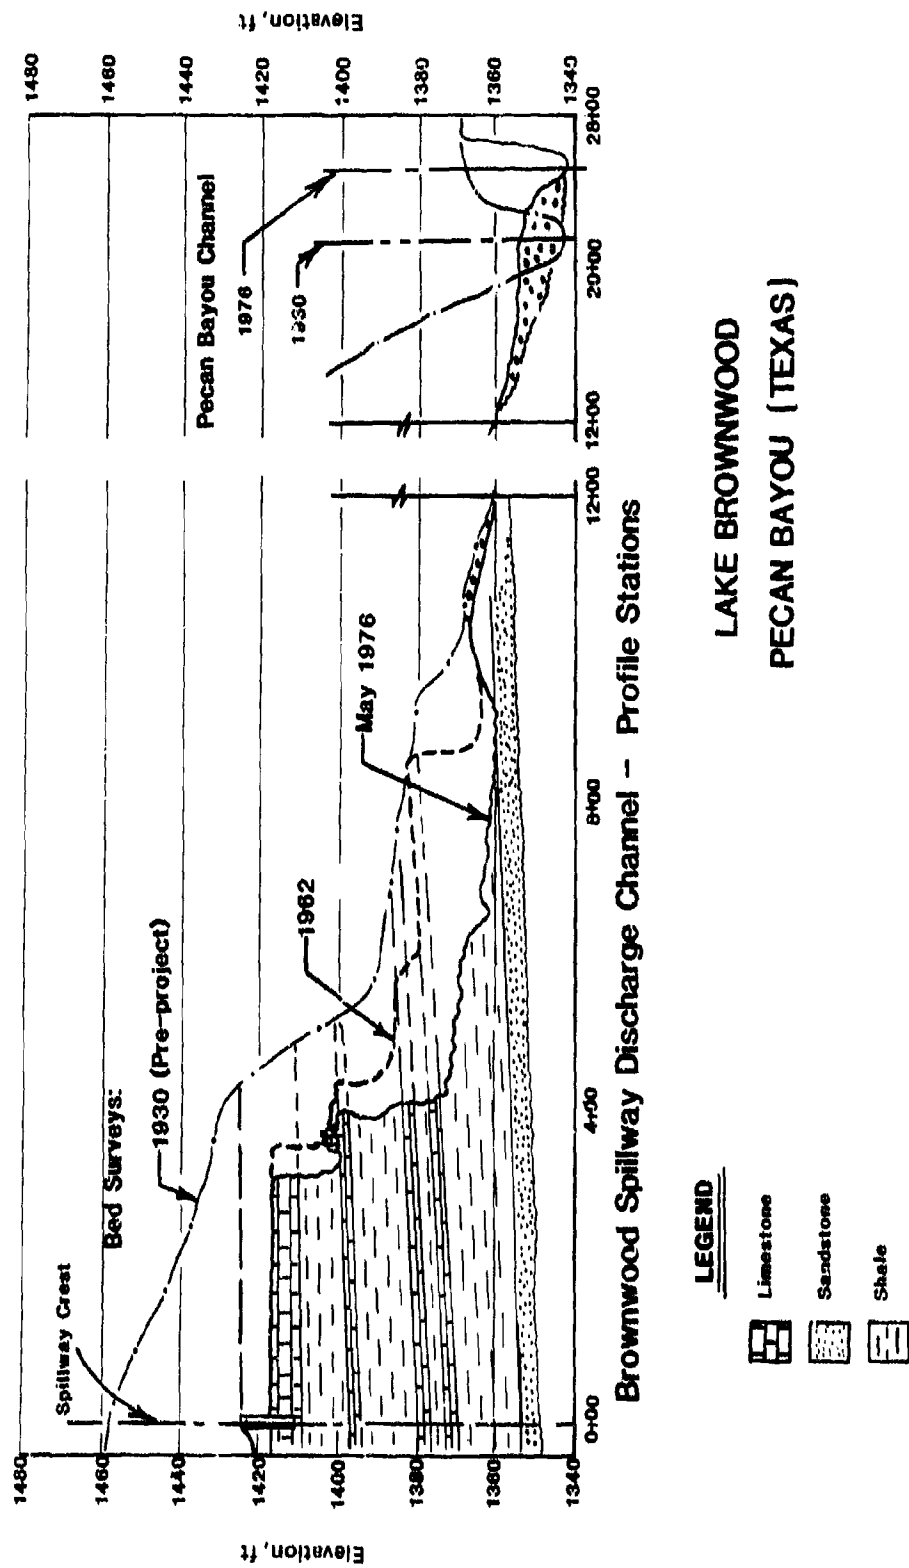
Figure 20. Lake Brownwood Dam. Emergency spillway discharge channel profiles

36. Spillway overflows and erosion. Considerable erosion of the spillway discharge channel occurred during a flood in July 1932 when the spillway was in construction and the reservoir was undergoing impoundment. Although this event was not large (13,000 cfs at the Brownwood Gage), it reportedly caused the most damage to the channel. As is well illustrated in the channel-bed surveys shown in Figure 20, successive overflows preferentially eroded the shales and caused headward migration of several knickpoints until, by 1976, a dramatic two-step falls occupied the channel between sta 3+00 and sta 4+50.

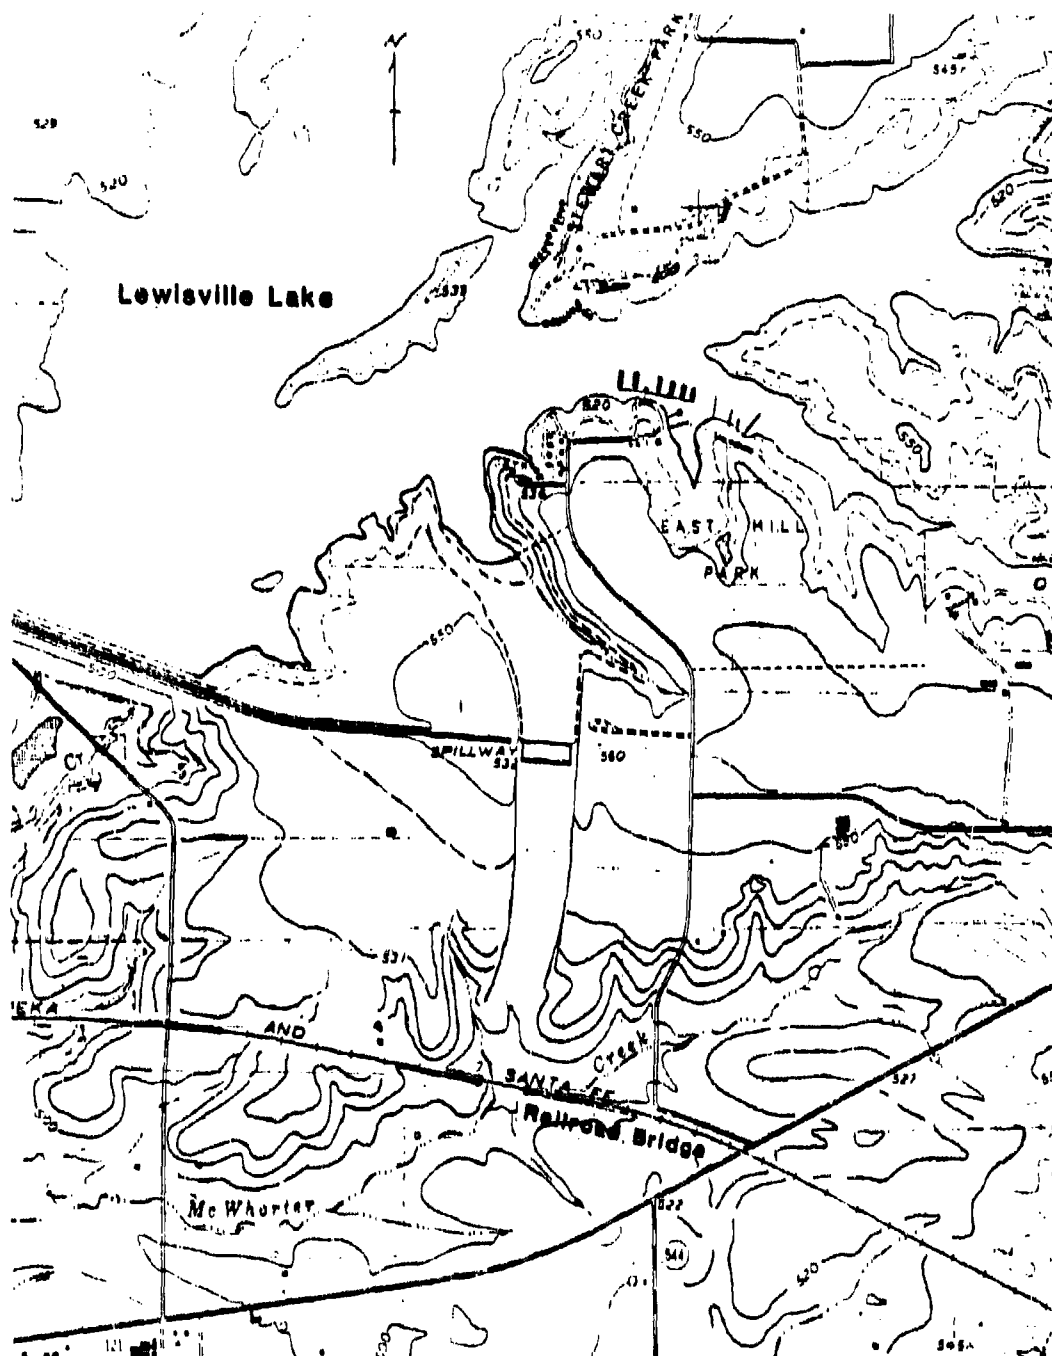
98. The only place where noteworthy erosion occurred at Lewisville was downstream in the vicinity of the railroad bridge (Figure 40). The severe erosion which threatened the Grapevine structure was initiated just downstream from the road (Point A, Figure 39). In both cases these were the locations of the steepest gradients. In the case of Grapevine, the sharp gradient change also corresponded to a lithologic discontinuity which formed an encroaching waterfall too close to the structure.

Figure 40. Spillway at Lewisville Lake, from Lewisville East 7-1/2 min topographic quadrangle (1960), 10-ft contours. Spillway crest is in the center of the figure (Note slight increase in gradient near railroad, lower center)

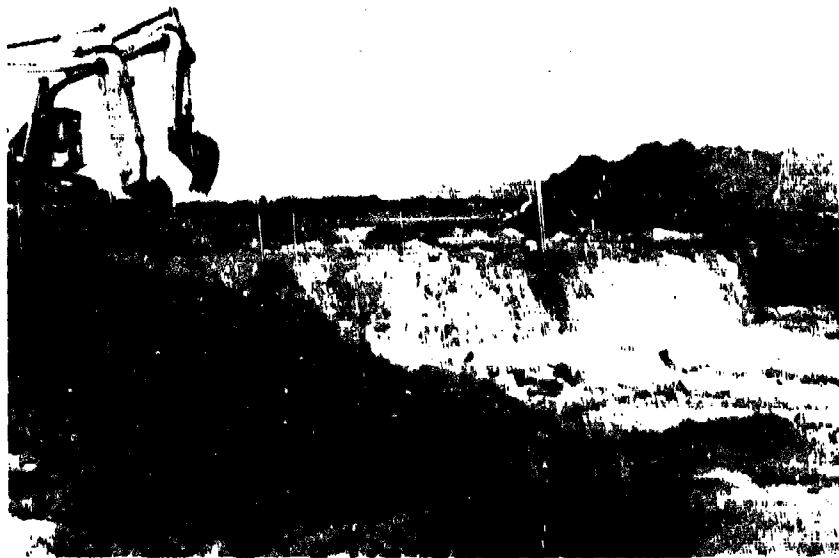
129. Serious damage and loss of property can occur when erosion causes failure of the spillway and catastrophic release of the reservoir. When the DMAD Reservoir drained because of erosion-induced spillway failure, the Gunnison Bend Reservoir downstream had to be breached (Figure 47) to avoid overtopping of its earthen dam from the sudden large influx of floodwaters. Breaching the reservoir triggered severe flooding of the communities downstream when already swollen channels received sudden additional flow.

Figure 47. Intentional breaching of spillway at Gunnison Bend Reservoir, Utah, during 1983 flood

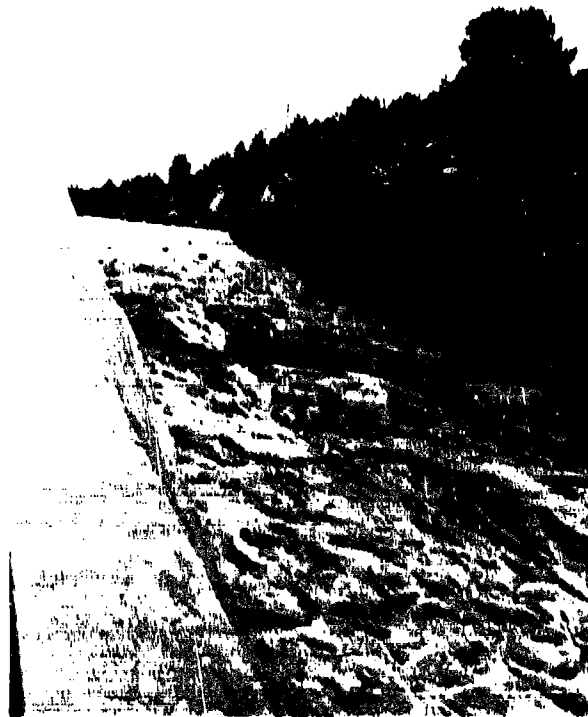
133. The level of remedial measures recommended by the evaluation report will normally fall somewhat on a "best case" to "worst case" continuum. The former involves spillways that will probably never experience flow or those floored in homogeneous "hardrock," such as granite. For example, at the Isabella Dam (Kern River, California) the excellent concrete spillway structure will probably erode faster than the granite forming the spillway channel bottom (Figure 48). The Isabella Dam furnishes a bounding case on the nonerosive side.

Figure 48. Upstream view of the excavated emergency spillway discharge channel at Isabella Dam, California. The channel floor and the left bank were excavated in very hard granite. The right wall is of concrete

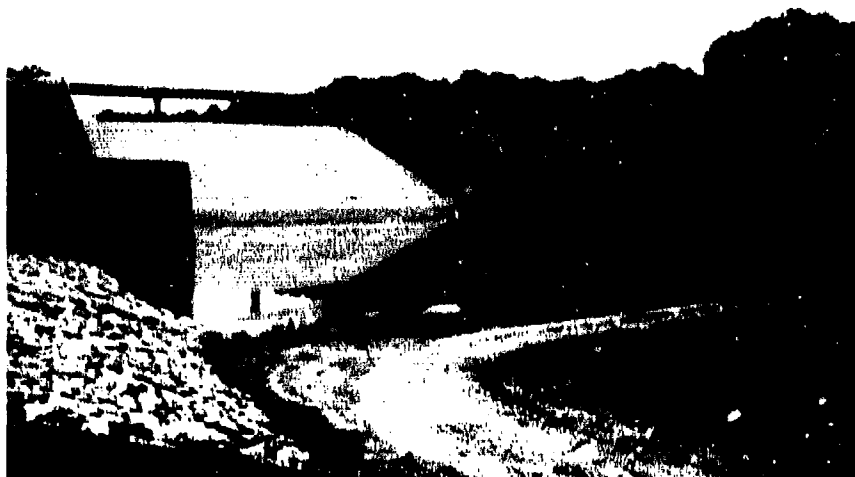
Figure B6. Uncontrolled overflow weir and chute at Grenada Dam, Mississippi
