US Army Corps  
of Engineers  
Construction Engineering  
Research Laboratory

TECHNICAL REPORT M-86/14  
July 1986

# Field Test Results of Aluminum Standing-Seam Roofing

by  
Myer J. Rosenfield

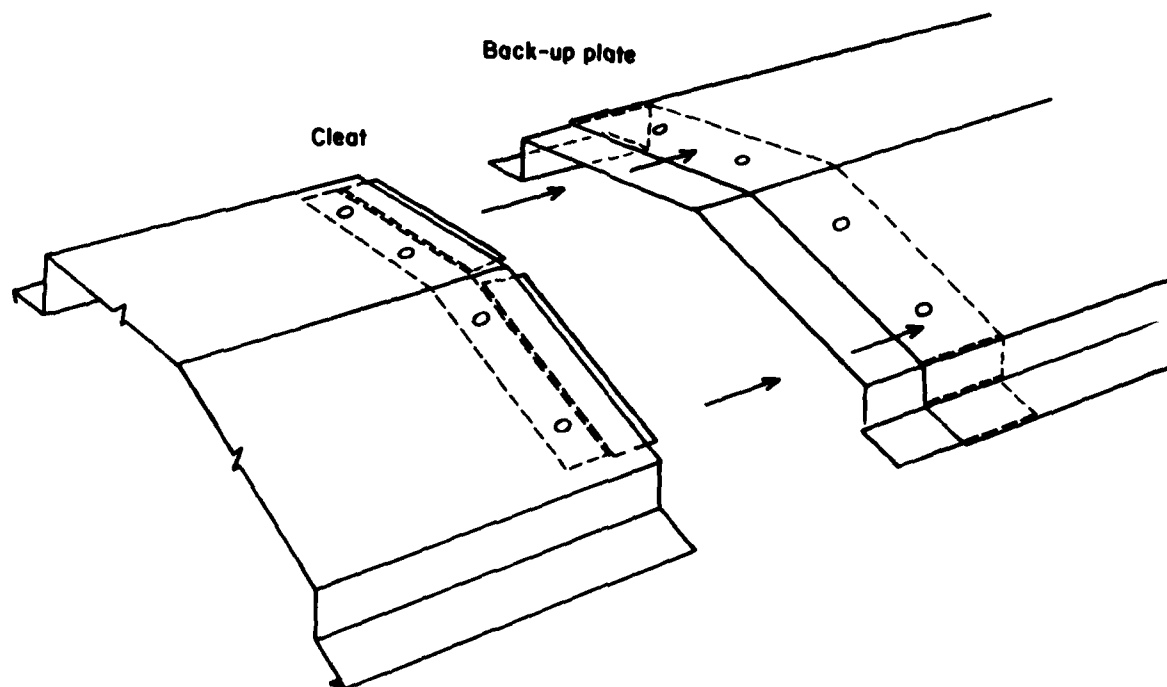
Figure 19. Manufacturer's design of ridge cap expansion joint.

Figure 18 shows a damaged expansion joint in the ridge cap. It also shows that the expansion joint was fabricated similar to the manufacturer's design, as detailed in Figure 19, but was not installed properly. A buckled flange was noted at one location on the ridge cap (Figure 20). This may have occurred during original installation rather than as a result of expansion. However, the exact cause is not known. The effect is not serious since there is already a space between the top of the panel closure and the ridge cap, which is not gasketed.

The ridge caps will be the easiest components of the roofing system to remove, repair, and replace. At the firewall ends, the ridge caps should be anchored to the walls by aluminum or stainless steel clip angles. The counterflashing could then incorporate a flange to cover the cap. Fasteners holding the ridge cap flanges to the panel closures should be removed and the holes sealed with closures similar to tinker's dams. Clip angles should be attached to the panel closures, and the ridge cap fastened to these clips through slotted holes. This recommendation is illustrated in Figure 34. Ridge cap expansion joints should be checked to determine if they are free to slide, and comply with the manufacturer's recommendation (Figure 19).
