## SPILLWAY MODIFICATION GRAPEVINE LAKE, TEXAS

JUNE 1986

FINAL  
FOUNDATION REPORT

GRAPEVINE LAKE  
SPILLWAY MODIFICATION

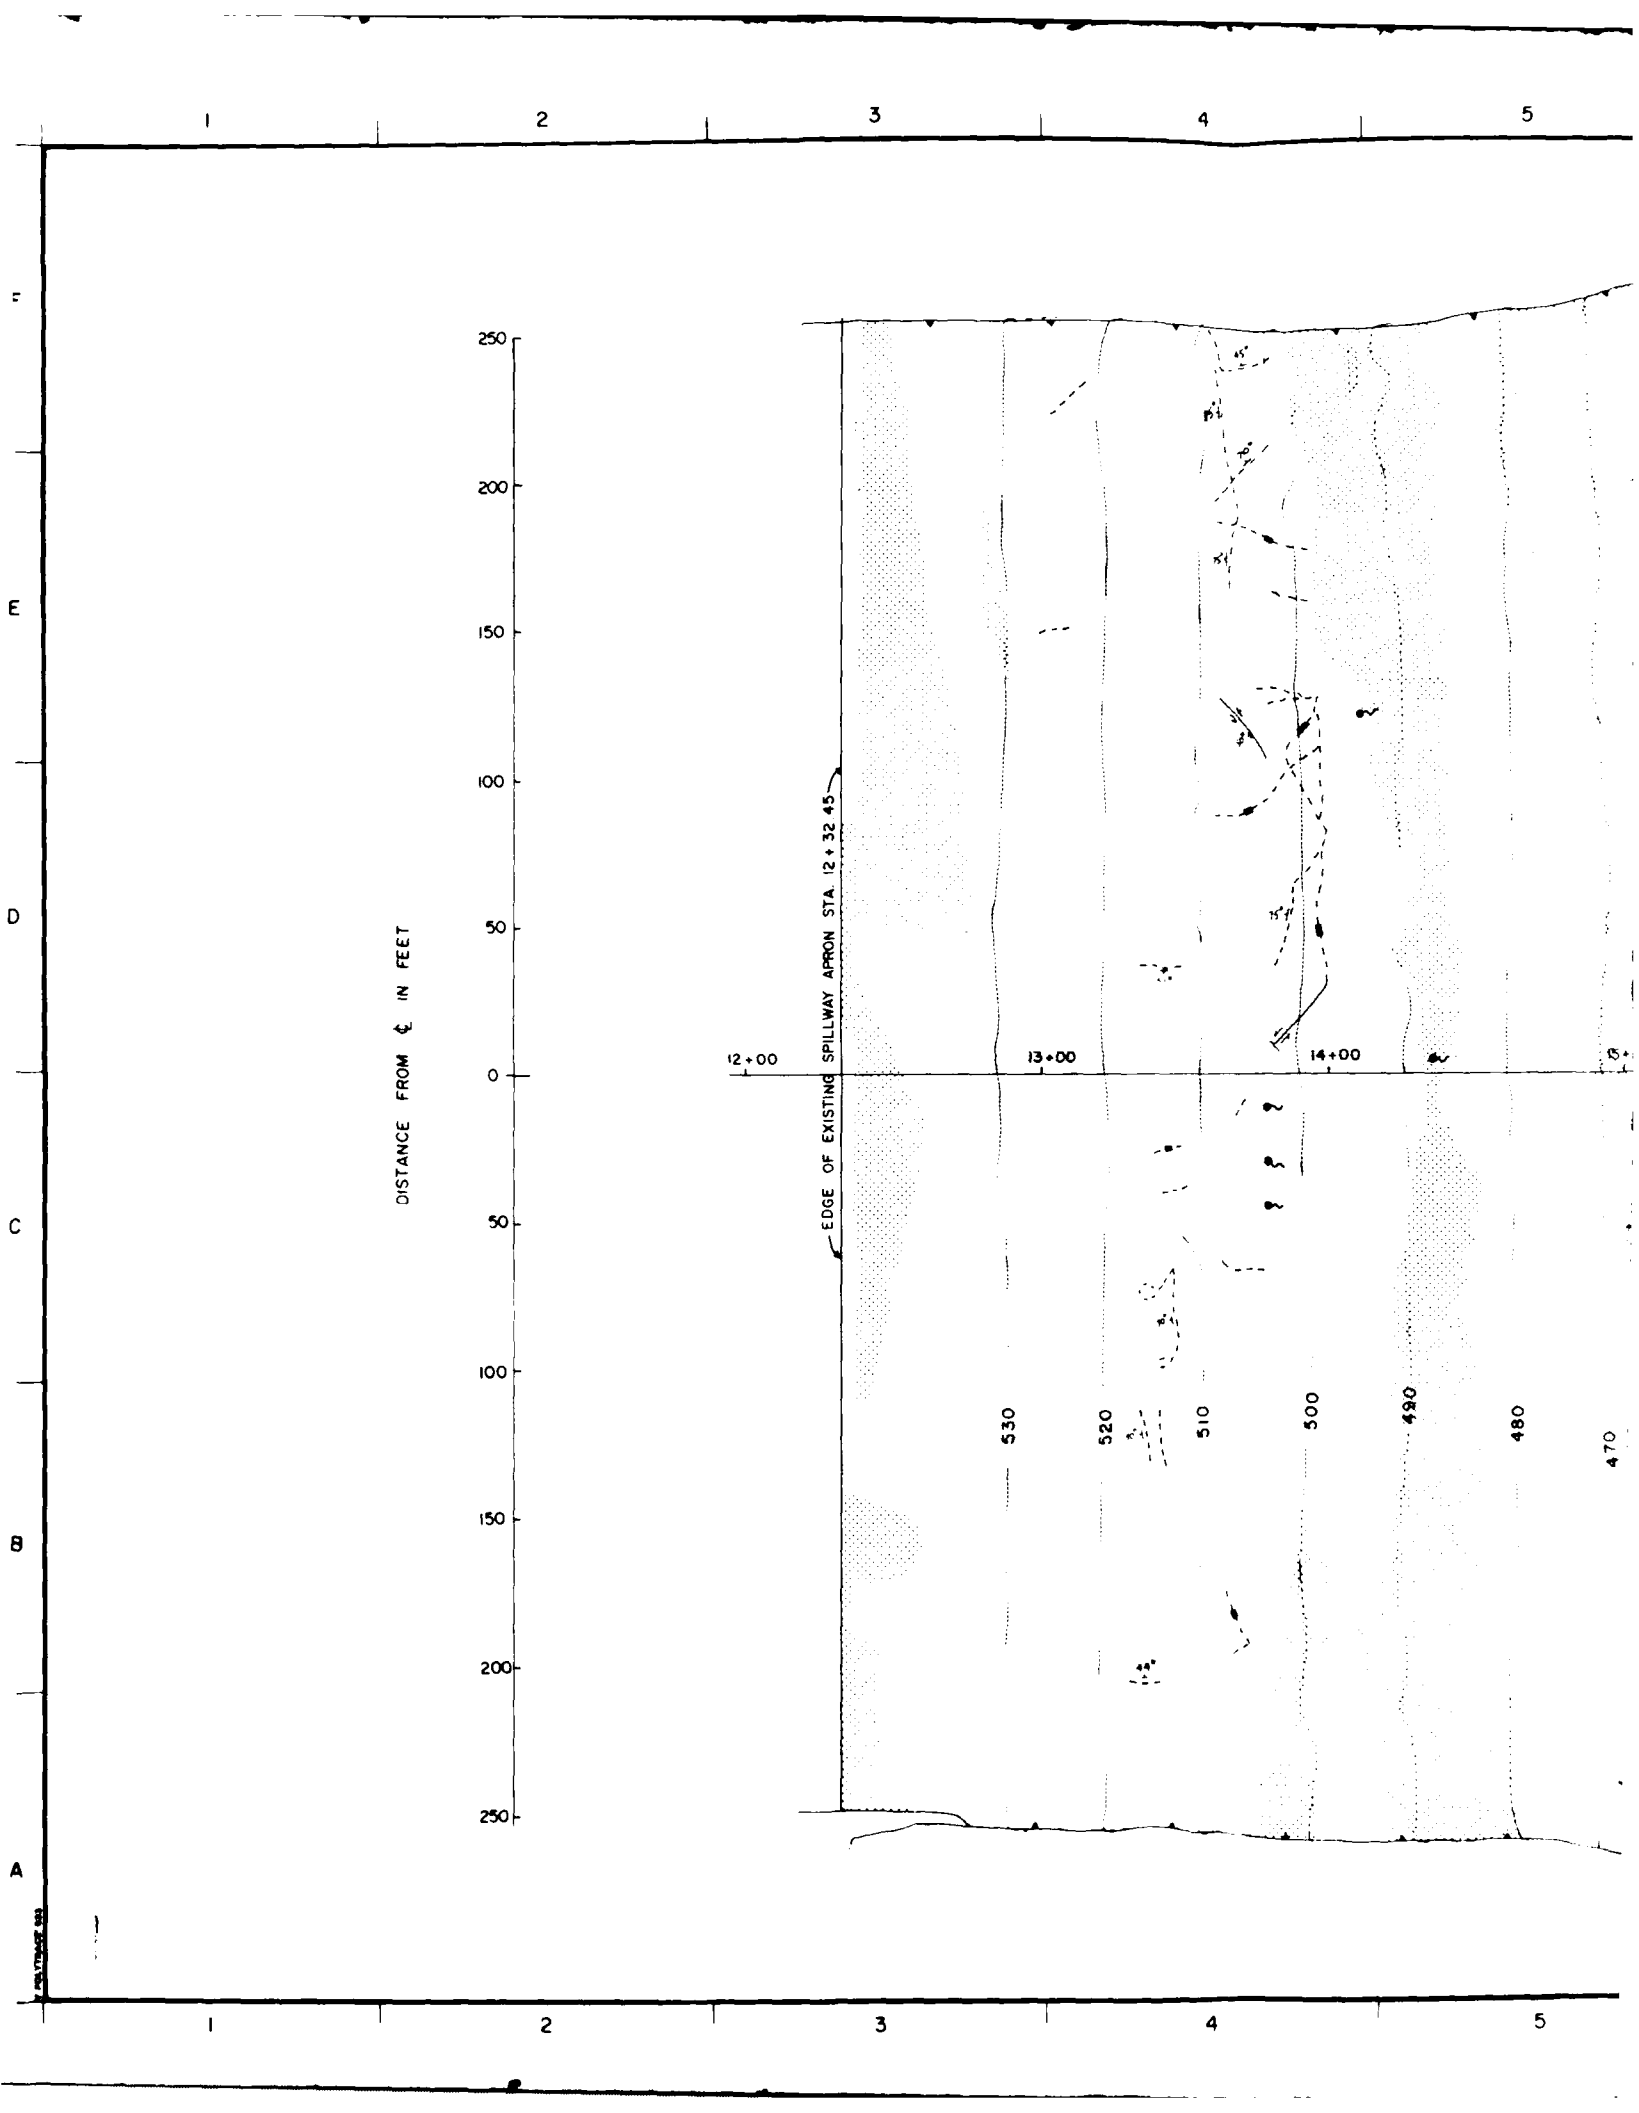
| DRAWING NUMBER | | OF | 9 |

(e) Ground Water. Ground water encountered during the course of the spillway excavation was minor and was adequately controlled using collector ditches and sump pumps. Minor amounts of ground water leaked out of the overburden on the upper slopes of the excavation. The amount of seepage and number of seepage areas varied according to the amount of rainfall. During dry periods there were only 3 seepage areas which continued to produce water. The 3 areas are shown on Plate 9.

After the excavation reached the stilling basin level the Contractor installed a collector well with collector ditches to care for both surface water and ground water entering the excavation. The location of the collector well is shown on Plate 9. Details of the collector well are described in Dewatering Provisions, Section V-2 of this report.

(c) Overburden. Overburden materials exposed in the excavation slopes are shown on Plate 9. Horizontal and vertical limits of the overburden are shown on the cross-section on Plate 12. No backfill occurred adjacent to overburden materials. Overburden materials exposed in the slopes were covered with topsoil and turf to protect against erosion.
