TECHNICAL NOTE

MRL-TN-504

GRINDING OF STEEL - A CASE STUDY

G.R. Wilms and R.L. Aghan

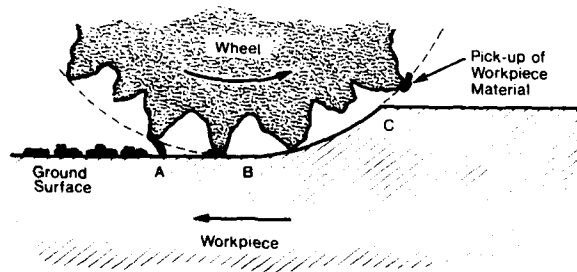
To first ascertain the material aspects associated with dry grinding, a tooth of a reject gear was ground on a surface grinder at MRL under similar conditions to those used in production with respect to wheel grade, wheel speed and feed. Two cuts of 25 μm (0.001 in) were made followed by one of 5 μm (0.0002 in), beginning with a freshly dressed wheel. The general appearance of the dry ground surface is shown in Fig. 3. The surface finish is poor, a particular feature being the presence of discrete pieces of metal adhering to the surface together with what appear to be smeared surface layers. This type of surface is similar to that previously found on ground 70/30 brass (1), which was attributed to a redeposition process depicted schematically in Fig. 4. It was suggested (1) that metal is picked up on some grits as they pass through the cutting zone BC and then is redeposited back onto the workpiece surface just prior to the grits re-entering the cutting zone. The region where redeposition from the wheel starts to occur is indicated by A. Progressing further towards the beginning of the cutting zone B the angle of approach between the wheel and workpiece decreases, and metal redeposited in this region is subjected to increasing amounts of plastic deformation and smearing.

FIG. 4 Schematic illustration of the redeposition process. Redeposition starts at A, smearing of redeposited metal occurs between A and B, and B-C is the cutting zone.
