Report No. CG-D-29-86

**THE MAINTENANCE AND OPERATION OF A SMALL  
WIND GENERATOR IN THE MARINE ENVIRONMENT**

WARREN HEERLEIN

U.S. COAST GUARD RESEARCH AND DEVELOPMENT CENTER  
AVERY POINT, GROTON, CONNECTICUT 06340-6096

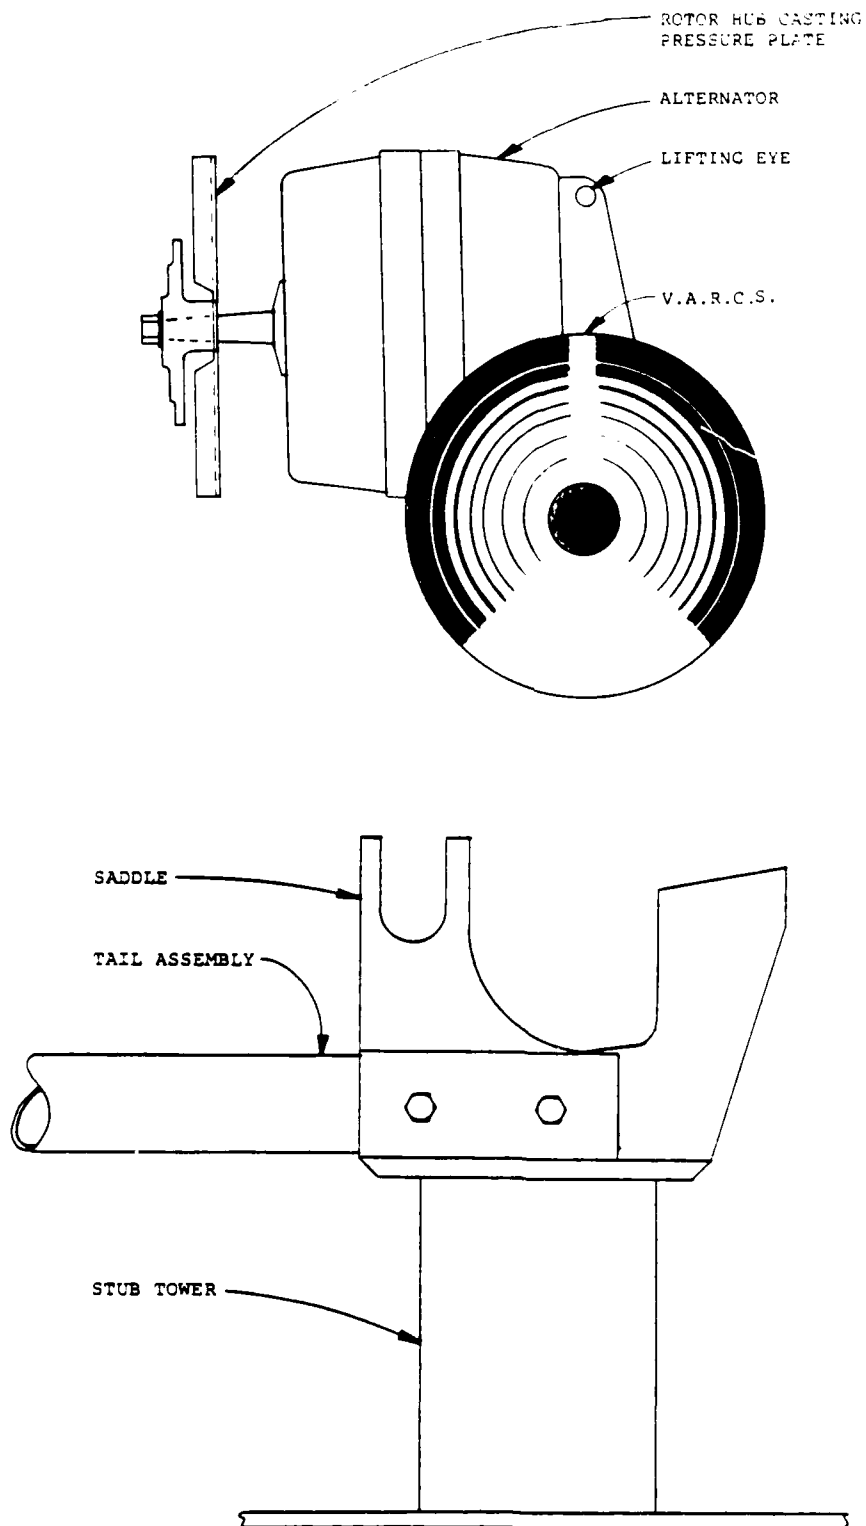
FIGURE 3. HR2 ASSEMBLIES

The third sub-component is the saddle/yaw control system. The HR2's base, or saddle, contains a large bearing and tail/vane assembly that allows the generator to rotate and stay directed into the wind. The saddle provides the pivot axis for the VARCS hinge, (see Figure 3). Also included in this piece is the electrical power connection through a brush and ring system that allows unlimited turning of the machine without the limit stops necessary with directly connected wires.

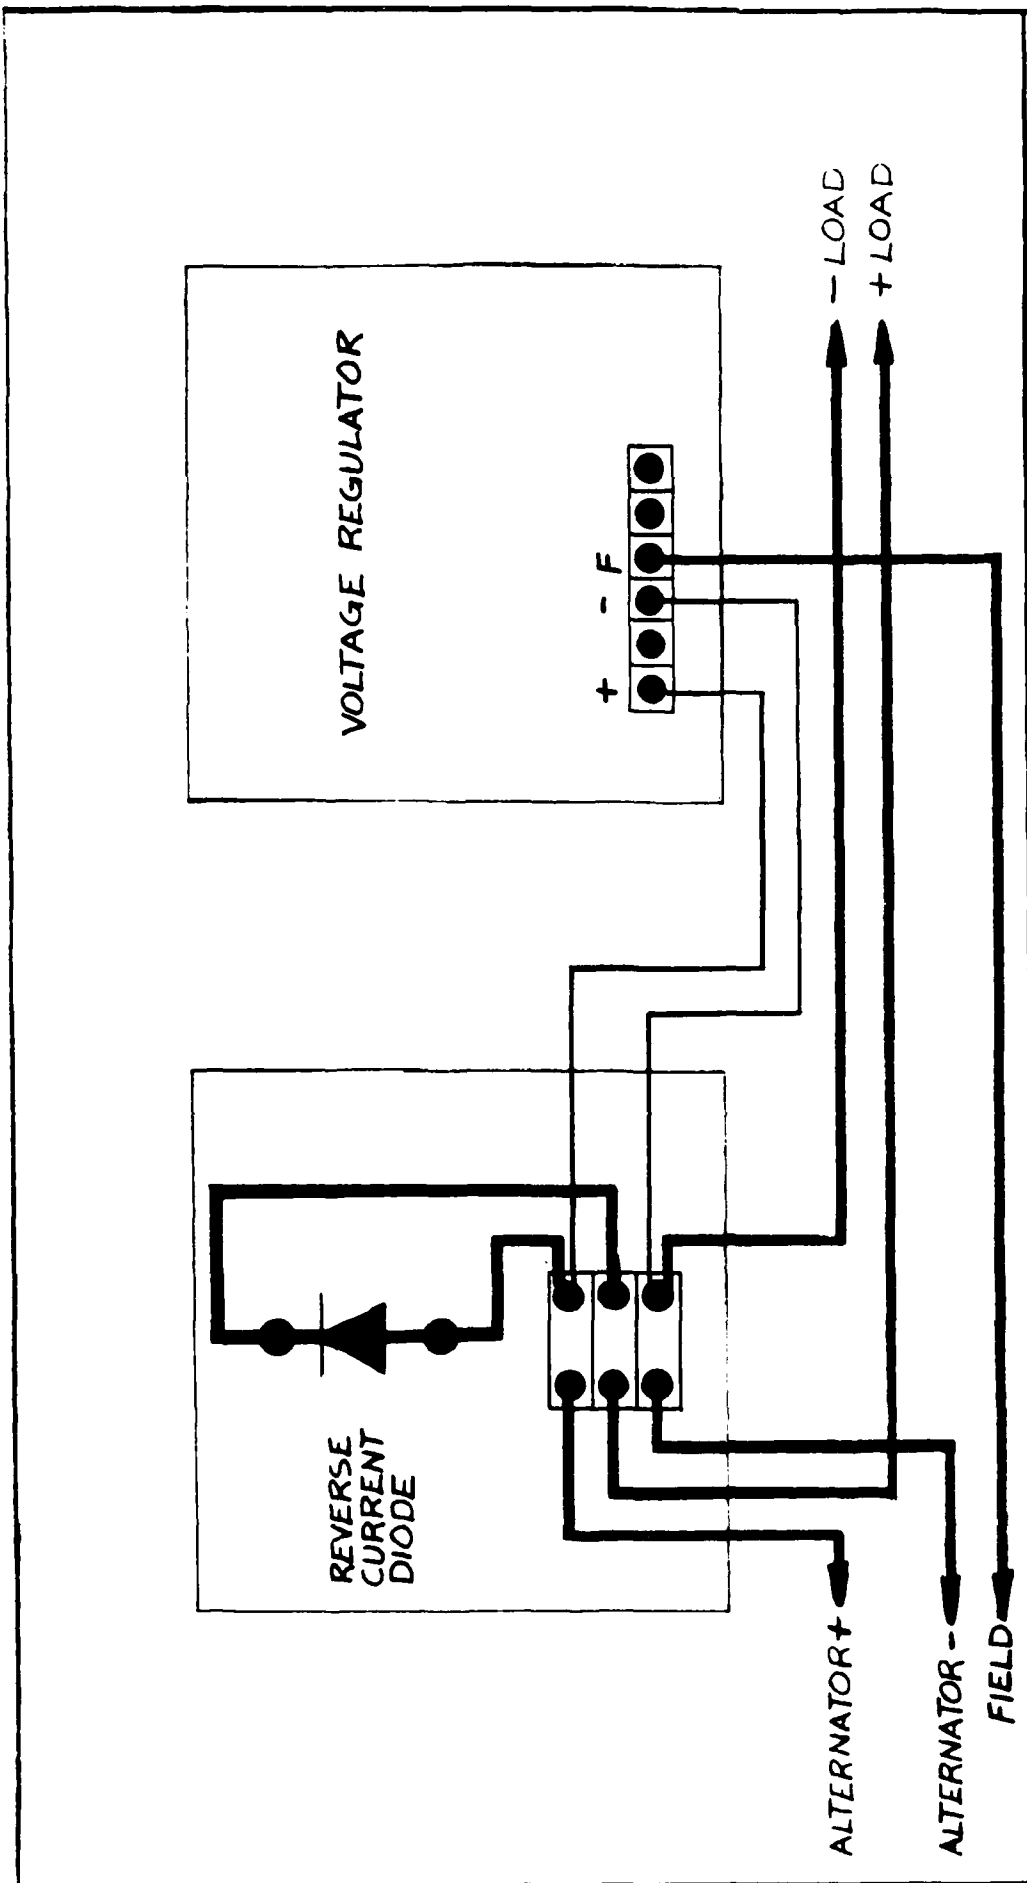
FIGURE 4. VOLTAGE REGULATOR AND RCD WIRING SCHEMATIC

The reverse current diode (RCD) provided with the HR2 is a GE model #A70PB(1N3296), (see Figure 4). It is rated at 150 amps and its peak reverse voltage (PRV) is rated for 1400 volts. The RCD is necessary for a battery charging application to prevent reverse current flow from the batteries to the HR2.

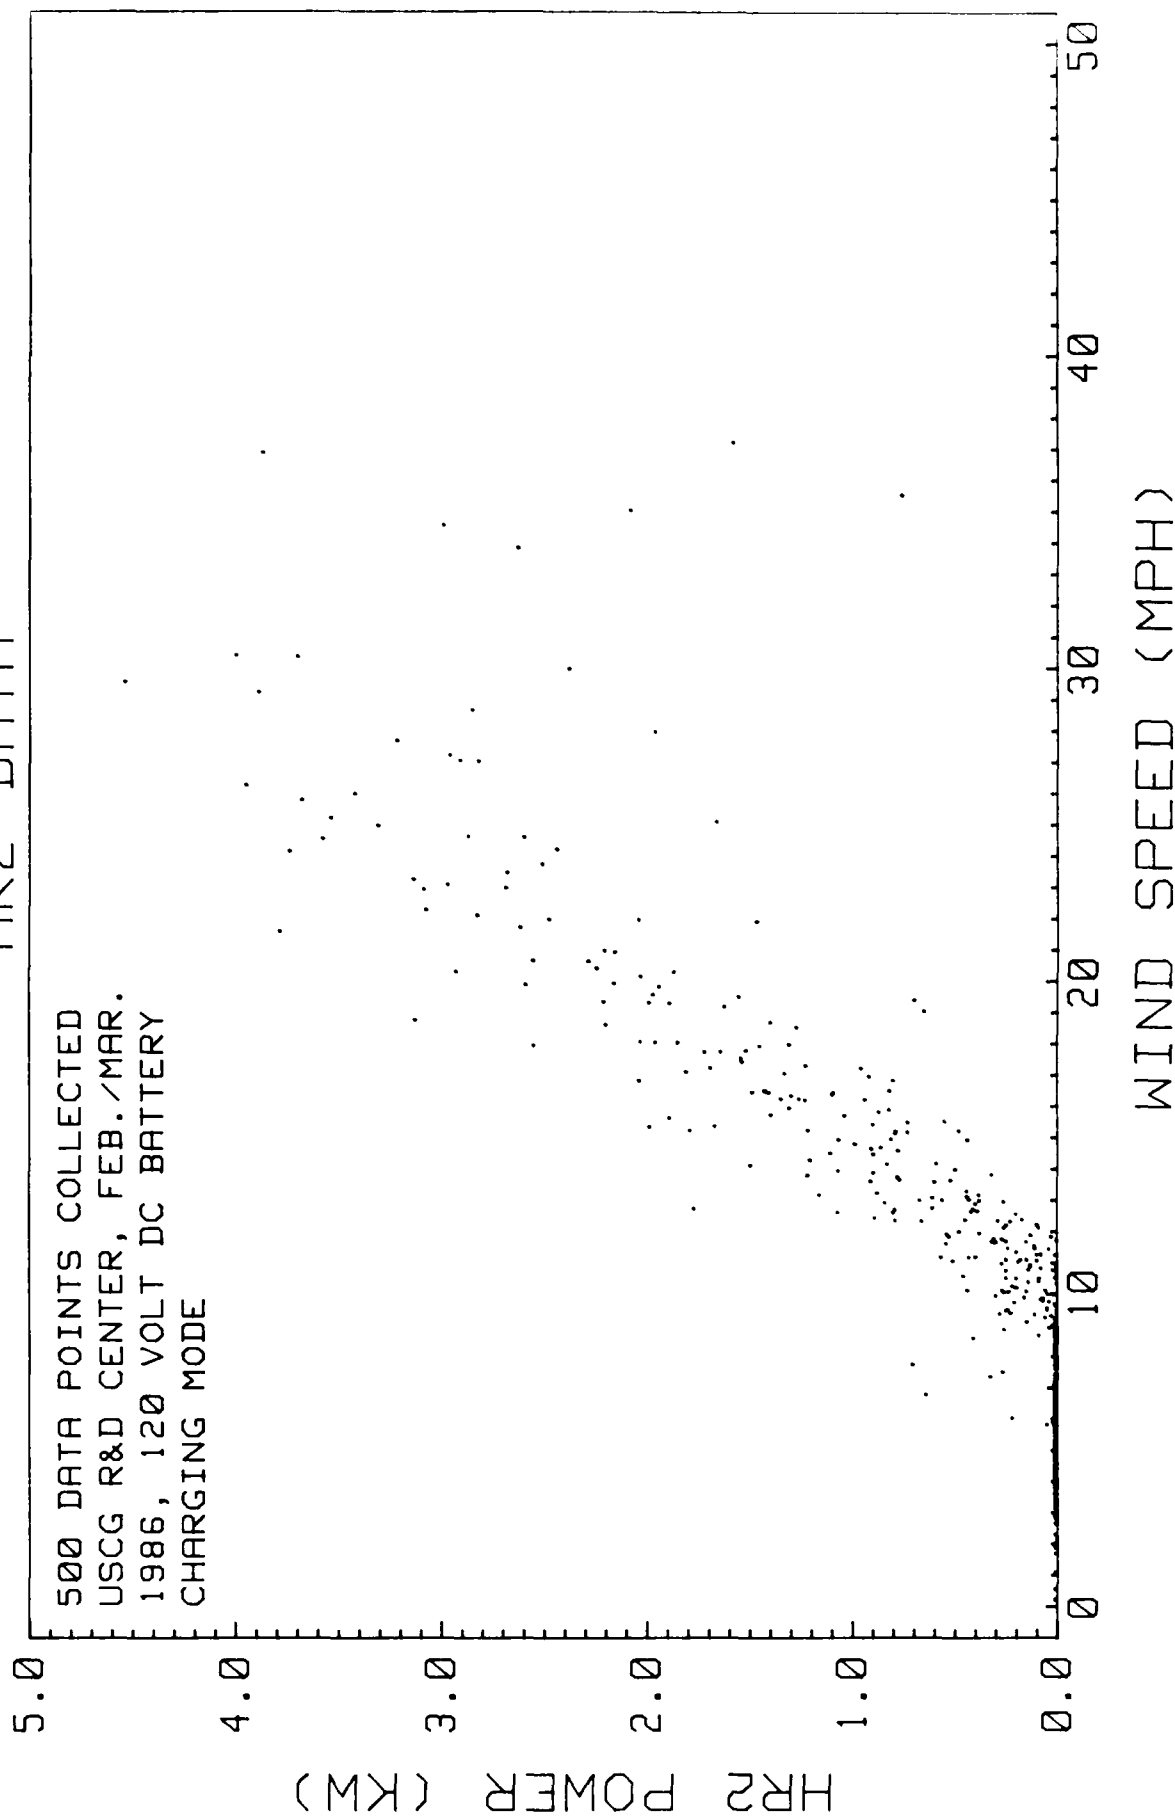
FIGURE 5. HR2 POWER DISTRIBUTION WITH WIND SPEED

Actual power produced by the HR2 seems to follow closely the ratings of the machine when loaded to conditions required for peak power production. As an example, data points can be found on Figure 5 that correspond to the manufacturer's mean power rating at 10, 12, and 16 mph. They are respectively 500, 760, and 1150 watts.

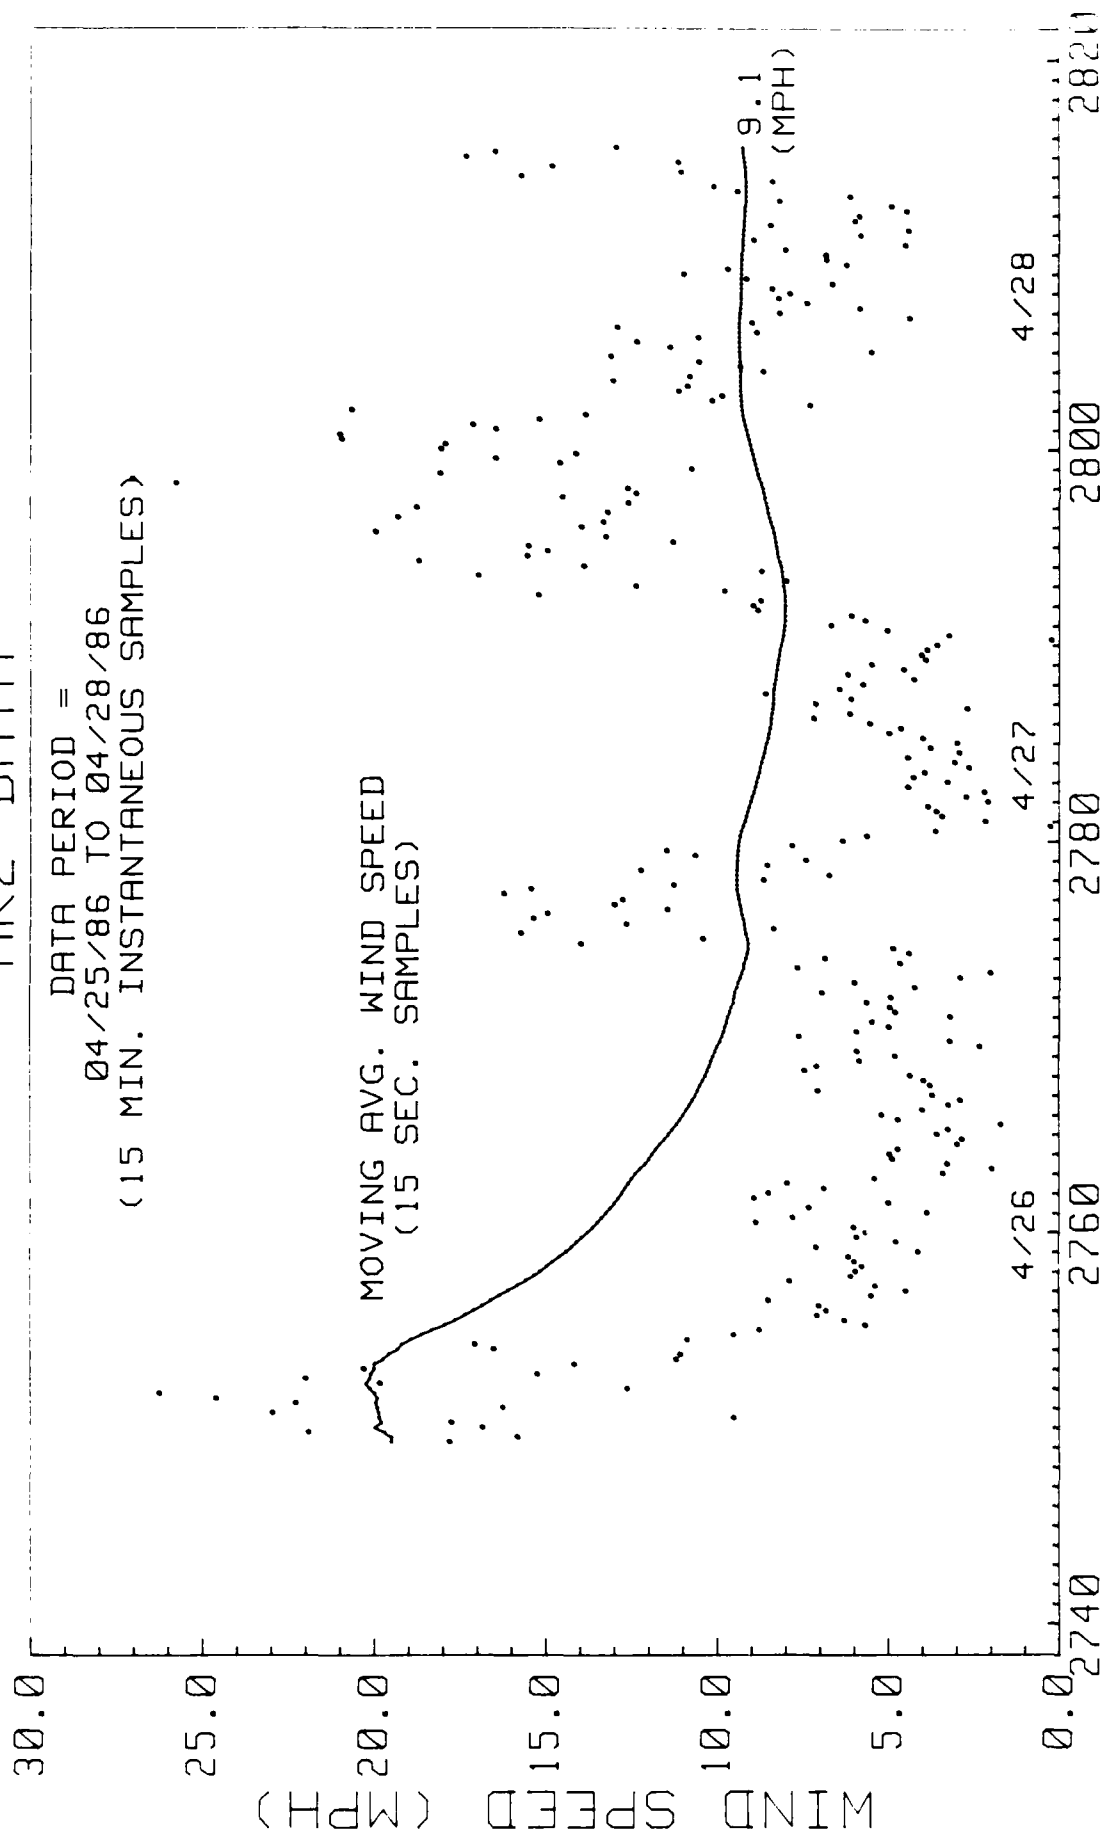
FIGURE 6. WIND SPEED DATA RECORD

period shows the Avery Point test site to be just outside of the measured 10 to 30 mph window during the sample period. Diurnal variations are wide as indicated by the instantaneous samples. Figure 7 reinforces the power production window. Figure 8 shows current flow into the batteries and its magnitude overlayed to the instantaneous wind data. This graphic presentation is an alternative method of viewing the HR2 performance as previously shown with kw in Figures 5 and 7. Figure 9 shows the effect of battery resistance on power production. Wind speeds around hours 2778.50, 2779.25 and 2779.50 would normally be high enough to produce peak power but happened to come along when the diesel generator was charging the batteries and bank voltage was artificially high.
