**DEPARTMENT OF DEFENCE
DEFENCE SCIENCE AND TECHNOLOGY ORGANISATION
MATERIALS RESEARCH LABORATORIES
MELBOURNE, VICTORIA**

MRL-R-1060

**AN EXAMINATION OF COATING FAILURE ON WING PIVOT FITTINGS
OF F111 AIRCRAFT**

L.V. Wake

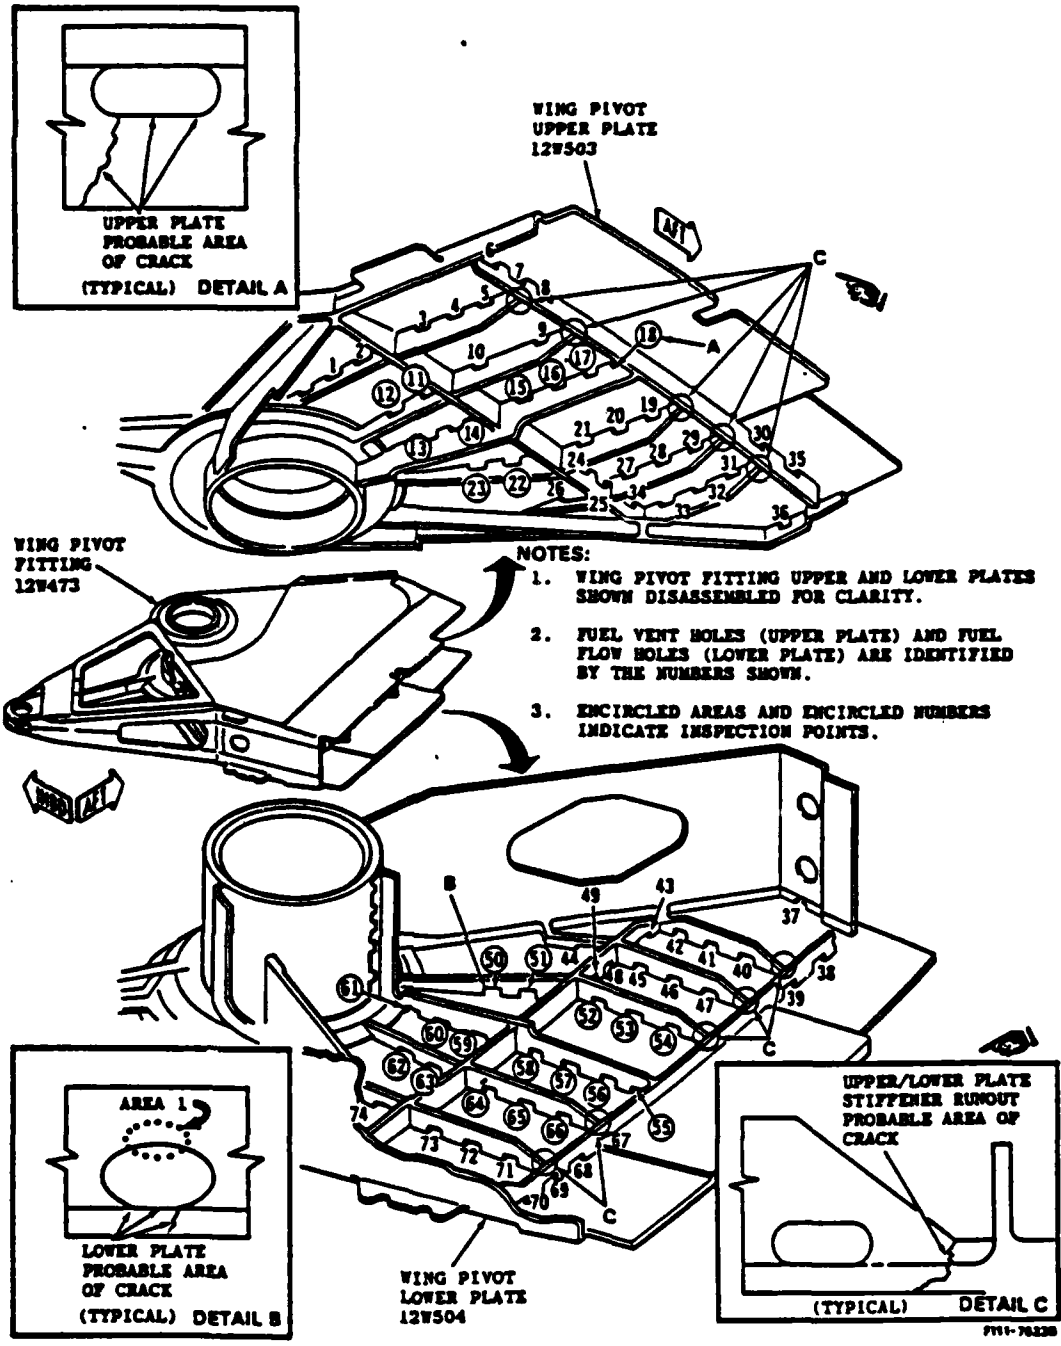
Fig. 1. Wing Pivot Fitting - Fuel Flow/Vent Holes and Stiffener Runouts
