| REPORT DOCUMENTATION PAGE | | READ INSTRUCTIONS<br>BEFORE COMPLETING FORM |
|---|---|---|
| 4. TITLE (and Subtitle)<br>MULTIPLE-PURPOSE PROJECT; LITTLE BLUE RIVER BASIN;<br>LITTLE BLUE RIVER, MO; LONGVIEW LAKE, OPERATION AND<br>MAINTENANCE MANUAL; APPENDIX IV, VOLUMES ONE & TWO<br>CONSTRUCTION FOUNDATION REPORT | | 5. TYPE OF REPORT & PERIOD COVERED<br>12 Sep 79 to 16 Oct 82 |

**LONGVIEW LAKE**

**CONSTRUCTION FOUNDATION REPORT**

APPENDIX IV  
CONSTRUCTION FOUNDATION REPORT  
VOLUME ONE

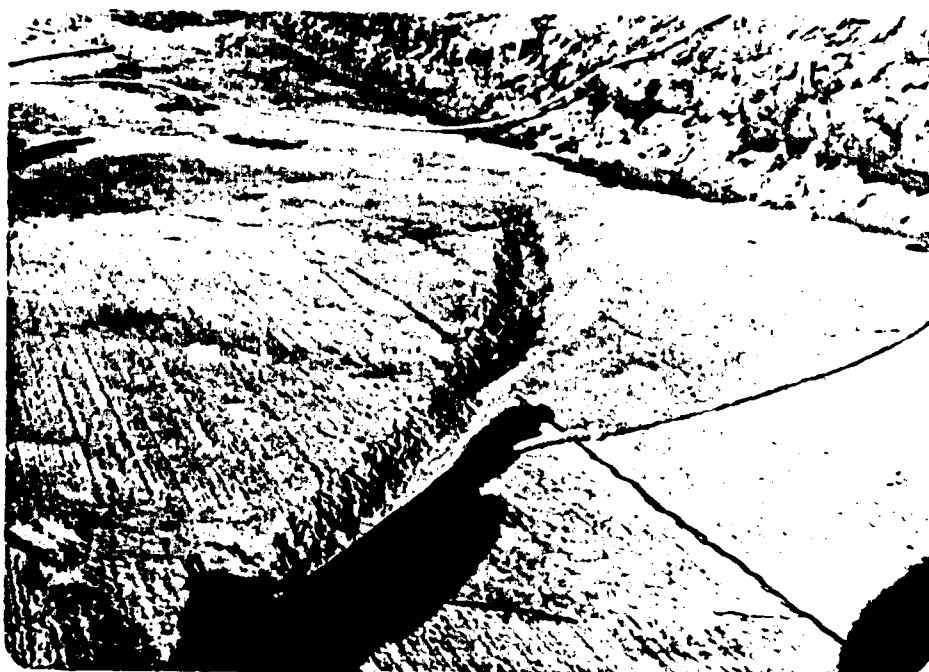
3. Longview Lake, 4 Dec 79, Neg. No. 4.  
Look right and downstream outlet works excavation.  
Station 51+14 to Station 51+33. Dozer blade mark.

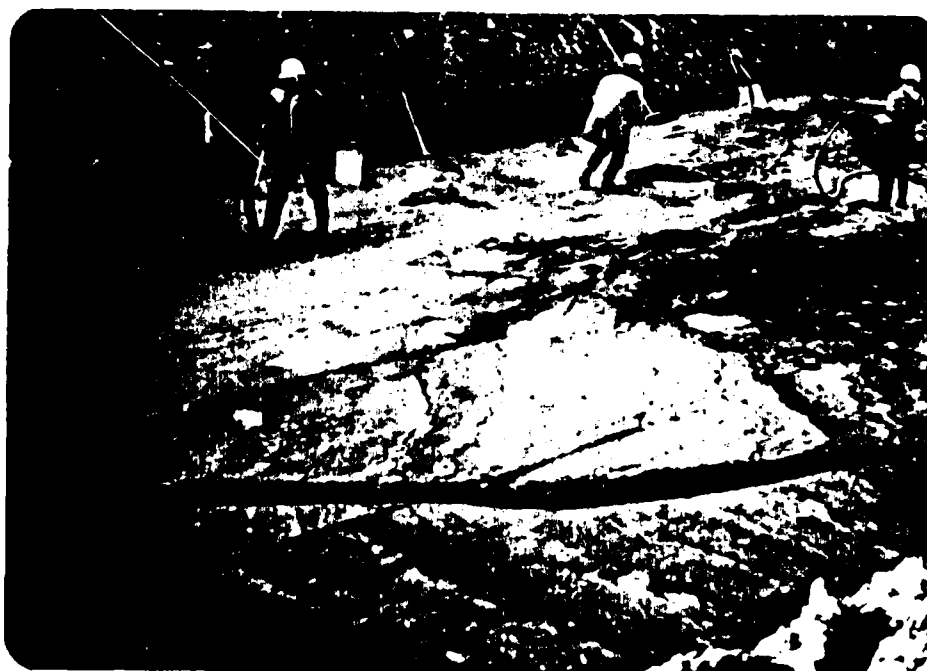
4. Longview Lake, 4 Dec 79, Neg. No. 5.  
Look left and downstream. Outlet works excavation.  
Station 51+14 to Station 51+33. Dozer blade mark.

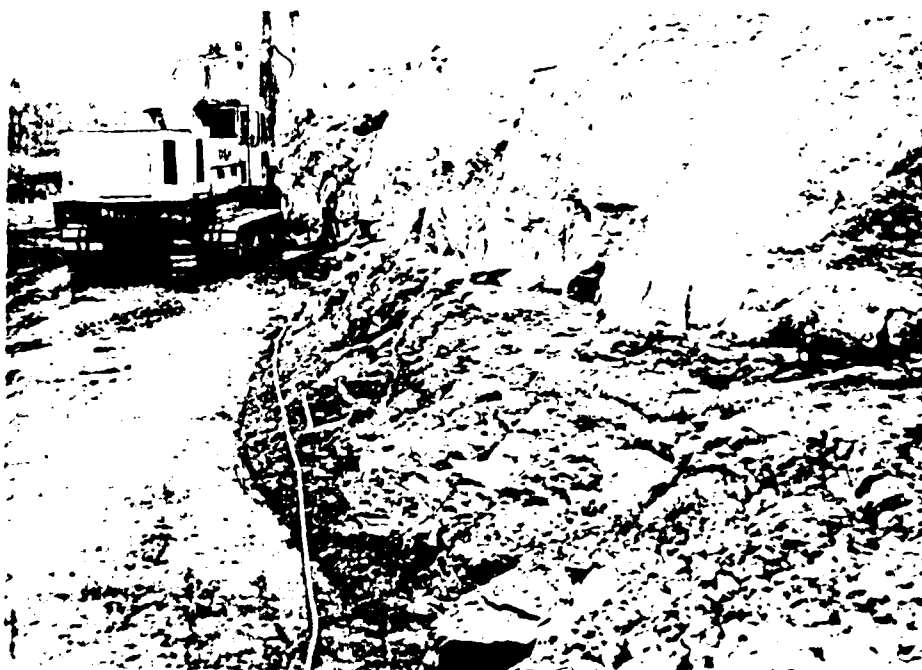
82. Longview Lake, 15 Dec 80, Neg. No. 467.  
Station 87+80. Look downstream at Bethany Falls  
LS and Hushpuckney Shale.

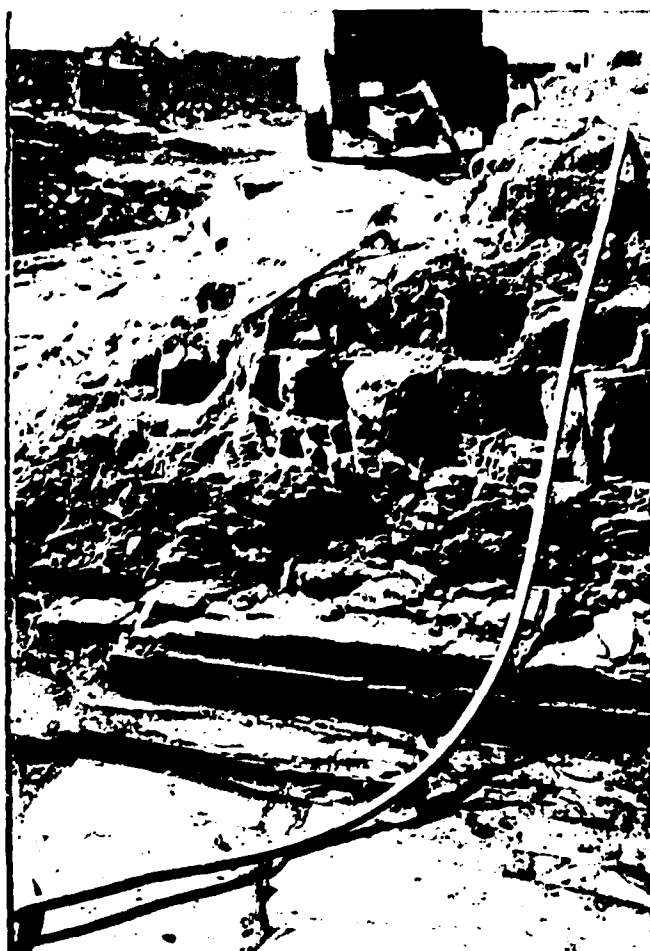
165. Longview Lake,  
31 Jul 84, Neg. No. 275.  
Station 87+301, range  
60'±UP. Look downstream  
at Stark shale.

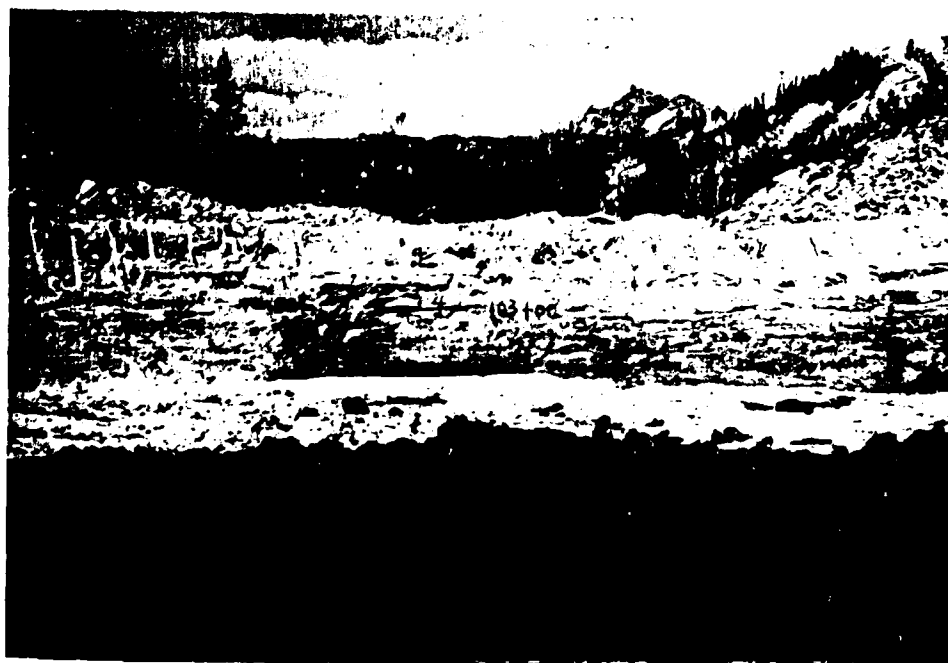
166. Longview Lake, 6 Aug 84, Neg. No. 277.  
Station 103+00. Look west at Block limestone.
