INSTALLATION RESTORATION PROGRAM PHASE 2  
CONFIRMATION/QUANTIFICATION STAGE 1 BERGSTROM AFB TEXAS  
VOLUME 1(U) RADIAN CORP AUSTIN TX 27 APR 87

INSTALLATION RESTORATION PROGRAM  
PHASE II - CONFIRMATION/QUANTIFICATION  
STAGE I - FINAL REPORT  
VOLUME I

BERGSTROM AIR FORCE BASE, TEXAS 78743

Final Report, March 1984 - August 1986

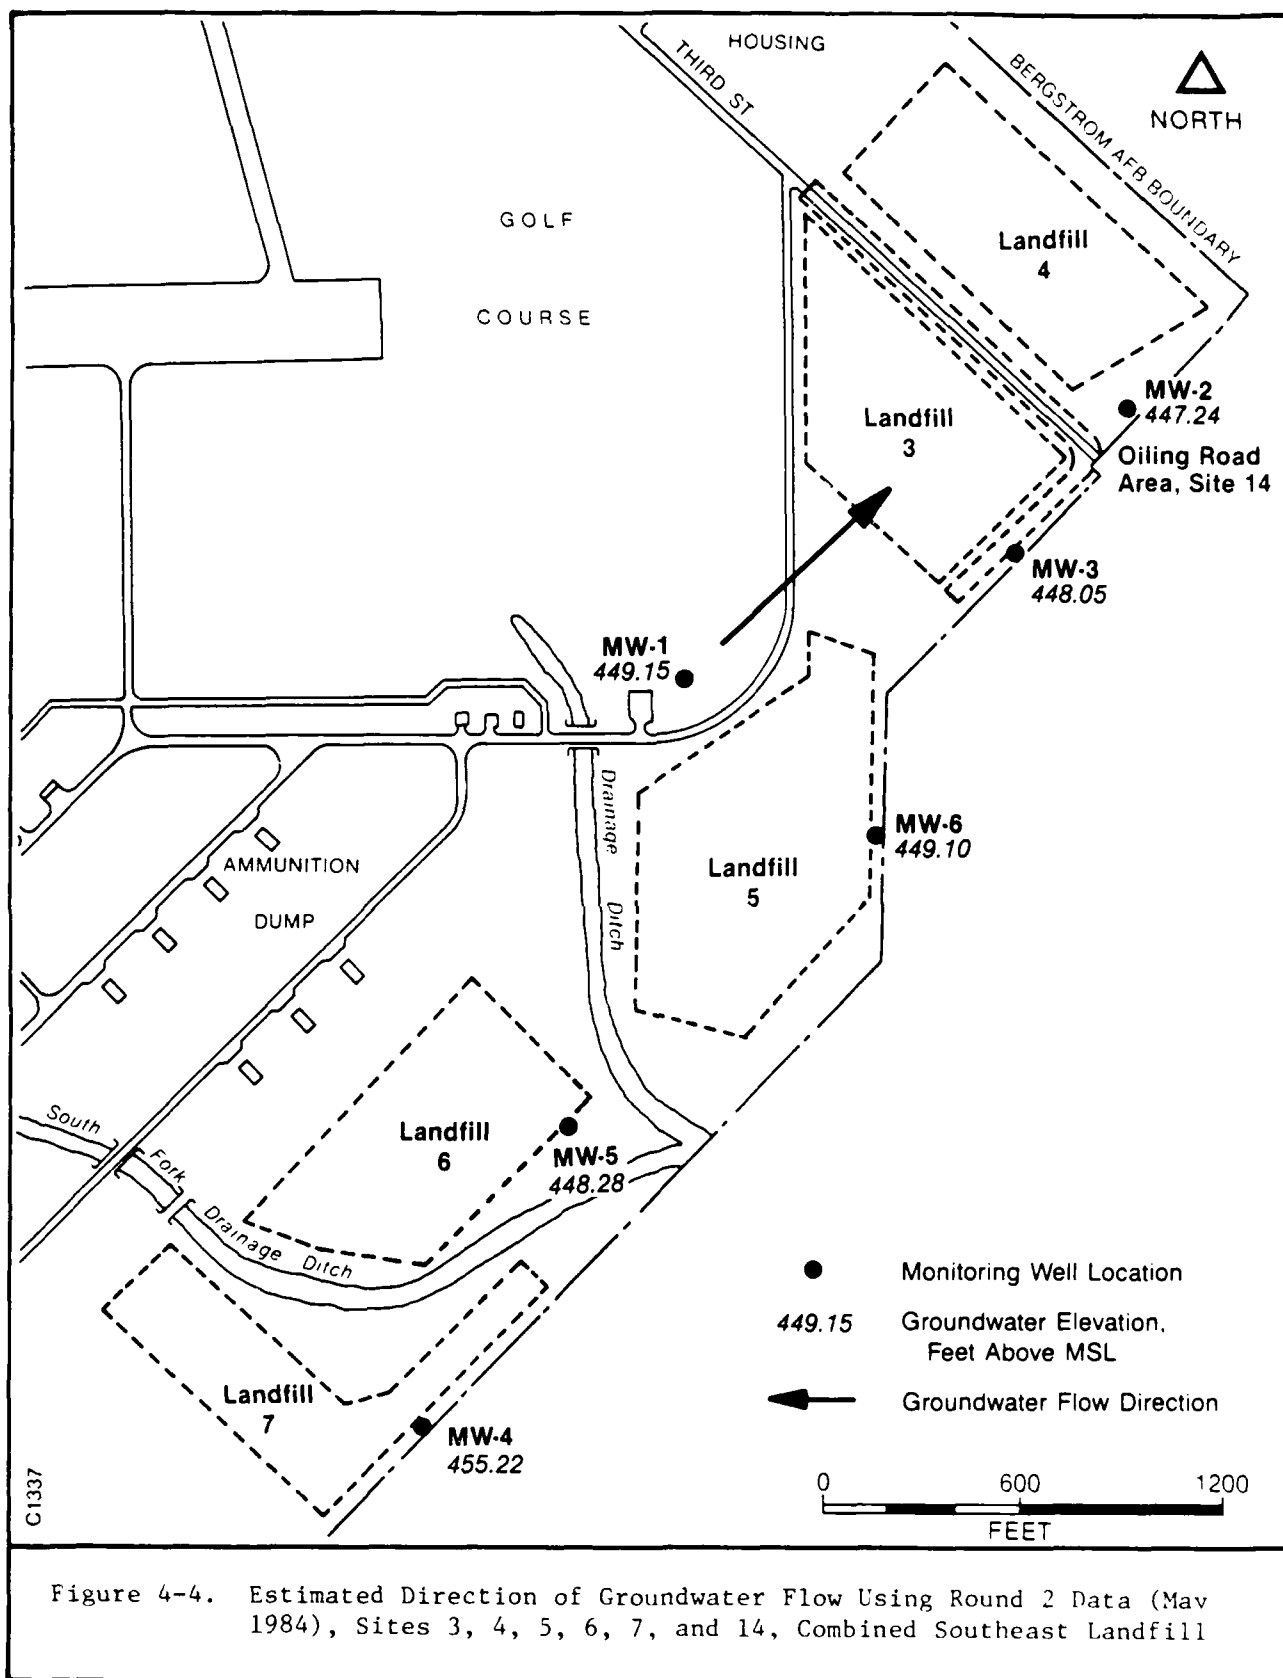
Water level measurements in each monitoring well are given in Table 4-12. Using data from wells 1, 2, 3, and 6, the direction of groundwater flow is approximately northeast (N 45° E). Data from Monitoring Wells 4 and 5 are not included in the analysis because the deep ditches (near MW-5) alter shallow groundwater flow patterns. Groundwater at Monitoring Wells 4 and 5 represent groundwater systems that are separate from the main landfill area (i.e., Landfill Nos. 3, 4, and 5). The groundwater flow directions at these two locations cannot be determined with only one control point, but some component of flow would be toward the drainage ditches. Figure 4-4 illustrates the direction of groundwater flow in the area estimated using Round 2 data. As seen in Table 4-12, water levels had dropped very similarly in wells 1, 2, 3, and 6 at the time of the second measurements. Therefore, the Round 1 data would show a similar flow direction.

Figure 4-4. Estimated Direction of Groundwater Flow Using Round 2 Data (May 1984), Sites 3, 4, 5, 6, 7, and 14, Combined Southeast Landfill
