| REPORT DOCUMENTATION PAGE | | | | Form Approved<br>OMB No 0704-0188<br>Exp Date Jun 30, 1986 | |
|---|---|---|---|---|---|
| 4. PERFORMING ORGANIZATION REPORT NUMBER(S)<br><b>Technical Report REMR-CS-16</b> | | | 5. MONITORING ORGANIZATION REPORT NUMBER(S) | | |
| 11. TITLE (Include Security Classification)<br><b>Repair of Dam Intake Structures and Conduits: Case Histories</b> | | | | | |

REPAIR OF DAM INTAKE STRUCTURES AND CONDUITS:  
CASE HISTORIES

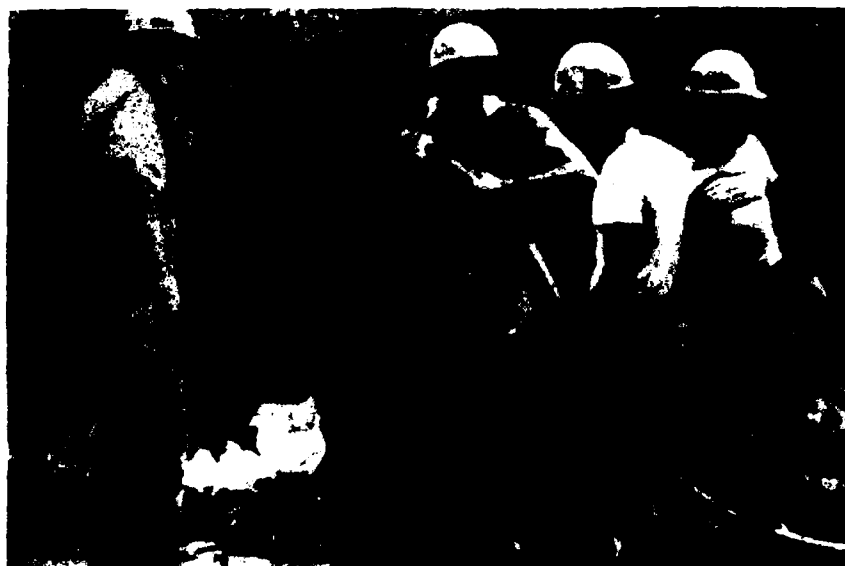
Figure 11. Grouting using standpipe, Arkabutla Dam, 1977

24. At the end of the grouting day, all grouted holes were inspected. Water dripping from a hole when the valve was slightly opened indicated grout had not sealed the leak. A 4-ft-tall standpipe was connected to the hole and filled with 1:1 grout (Figure 11). If water was observed dripping from the top of the standpipe the next day, adjacent ports were cleaned out, jetted with water, and then pressure grouted with a 1:1 mix.

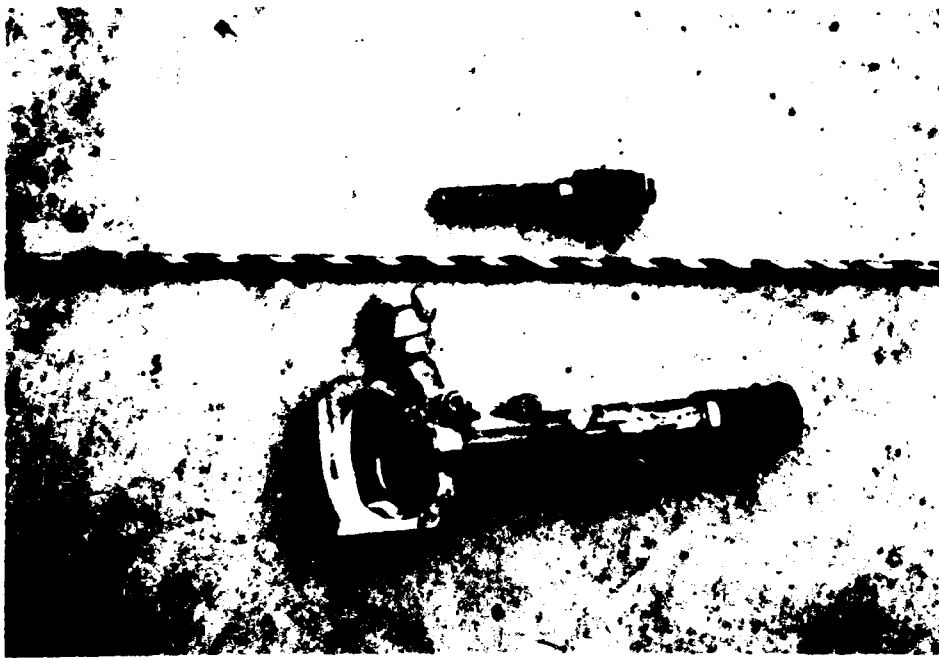
Figure 14. Rotary hammer drill, adapter, and bit, Blakely Mountain Dam, 1986

Five hundred and fifty feet of hose was used to supply air to monolith joint 20/21 where the drilling was started. Two Chicago pneumatic rotary hammer drills, model number 9A, were used to drill the grout holes. The grout holes were 5/8 in. in diameter and were drilled using 18 and 36-in.-long masonry bits that were carbide tipped and had SDS (SR) series shanks (Figure 14).

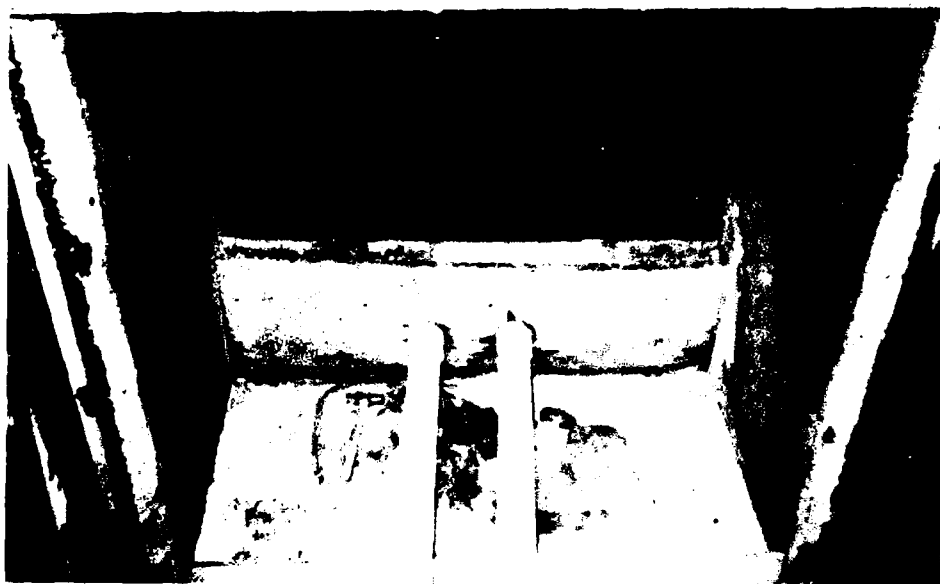
Figure 36. Cofferdam, Isabella Dam, December 1983

145. Cofferdams (Figure 36) were constructed by project personnel upstream and downstream of the work area with two 3-in. PVC pipes between them to keep the water leaking pass the emergency gate from entering the work area. One airbag was installed at the upstream coffer dam to prevent water that was spraying from around the emergency gate from entering the repair area (Figure 37).

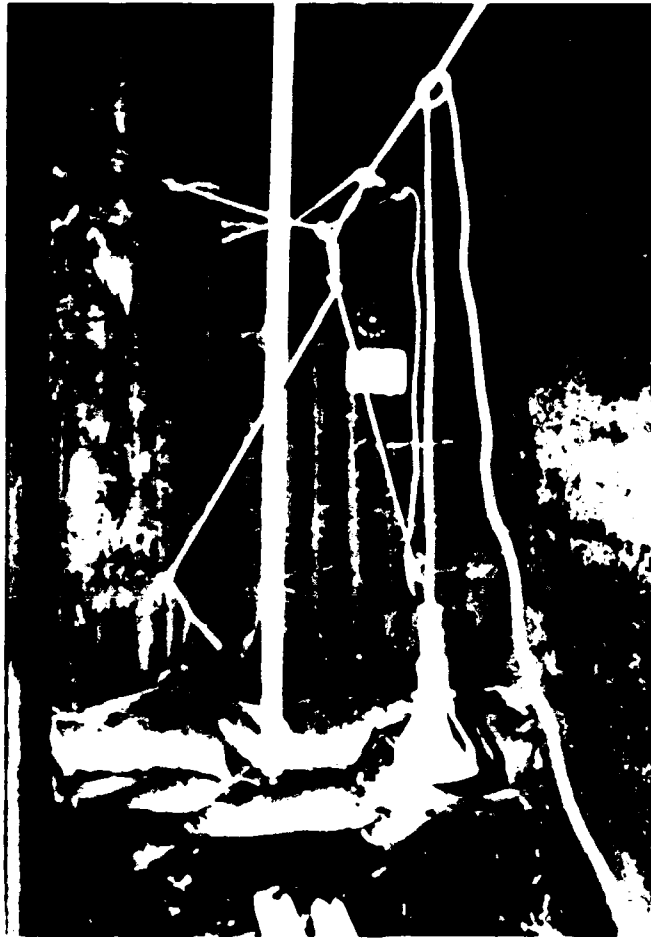
Figure 37. Airbag, Isabella Dam, December 1983

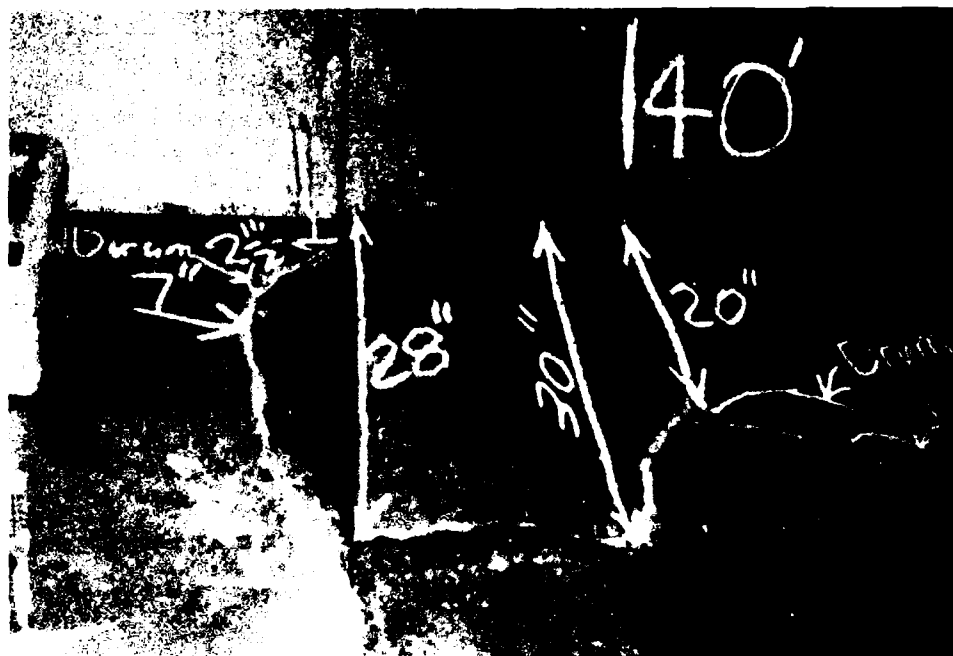
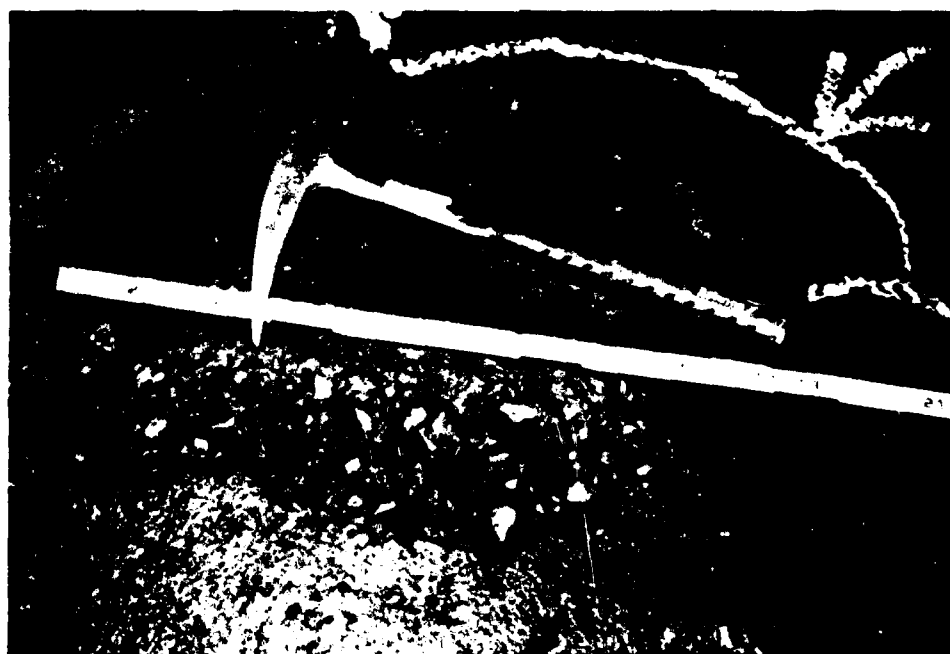
189. In 1974, approximately 80 percent of the 3/4-in.-thick epoxy mortar in the invert was missing with delamination evident in some of the areas where the mortar remained. The area of loss was primarily between the service gate steel liner and the construction joint between the tower and first conduit monolith (Figure 44). The epoxy mortar on the walls was intact and appeared sound (no drumming was detected when tapped with a hammer). It was suspected that the loss of epoxy mortar was the result of strains caused by differences in thermal expansion between the epoxy mortar and concrete and strains caused by cavitation forces produced by the high discharges that occurred in the spring of 1973.

a. Downstream end of passage

b. Closeup

Figure 44. Mortar loss, Milford Dam

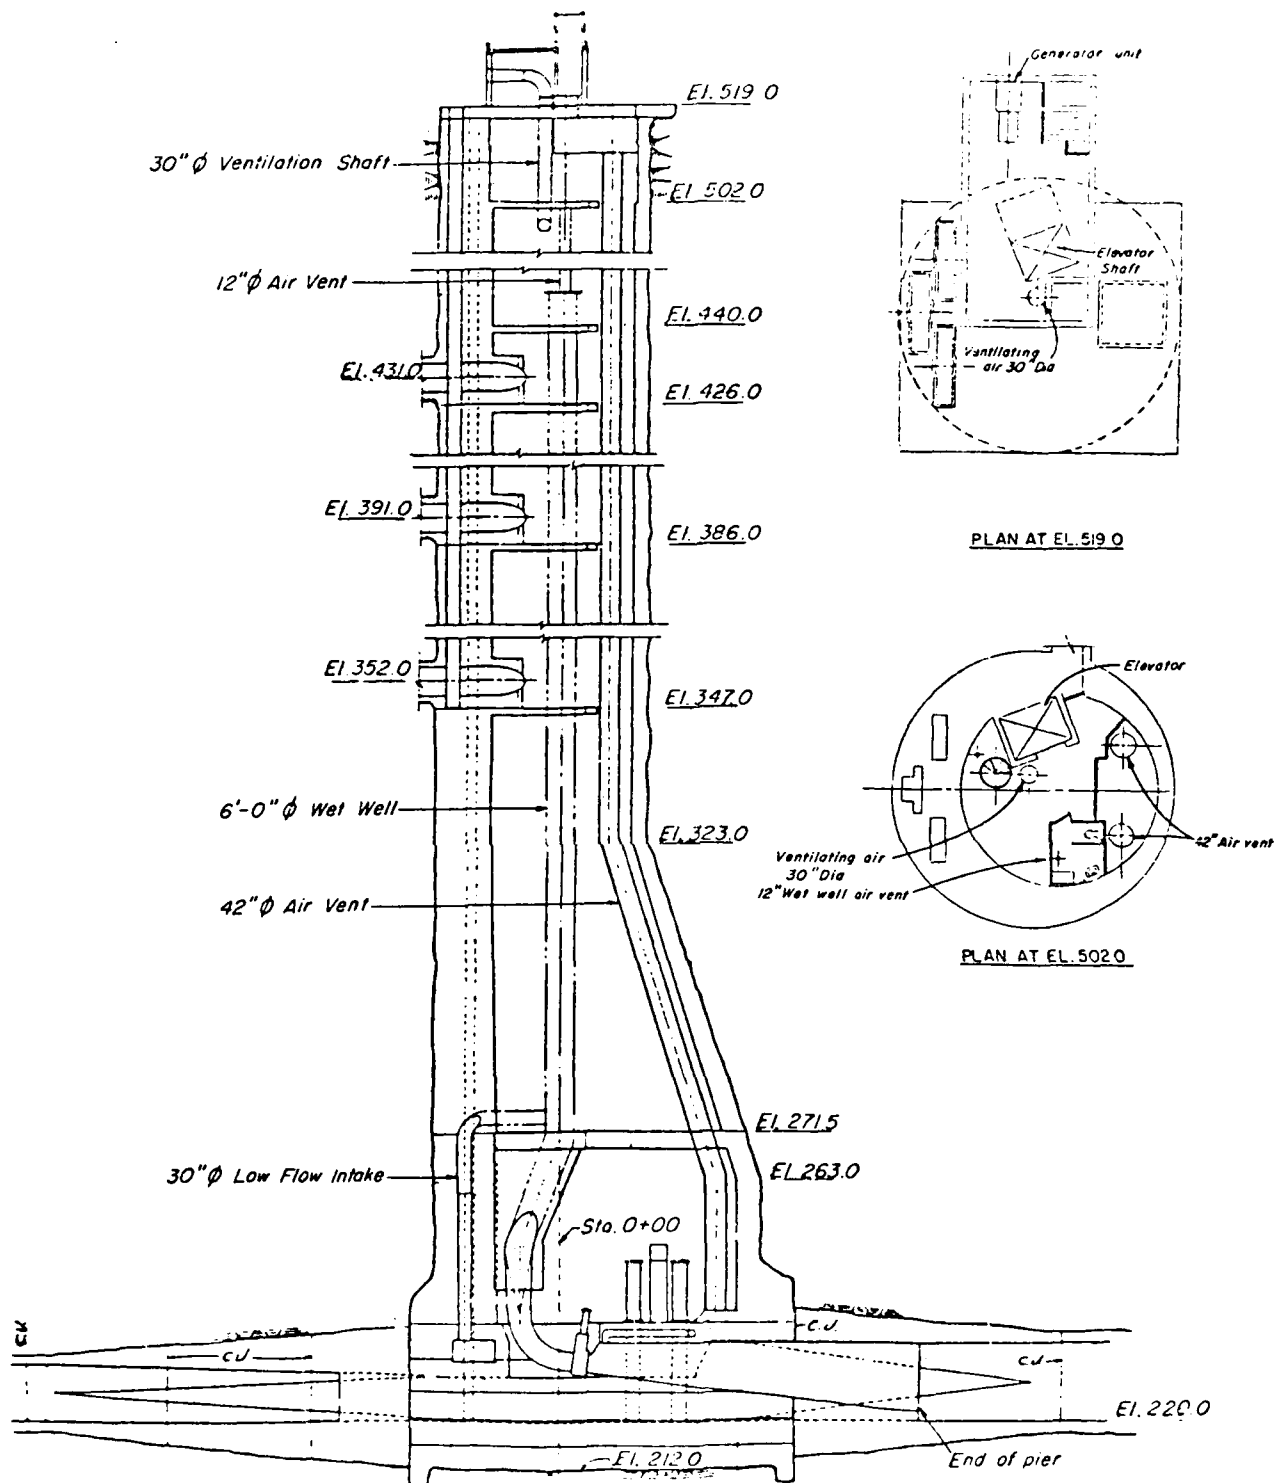
213. Leakage from horizontal construction joints and vertical cracks in the wall of the intake control structure was noted during the first periodic inspection in November of 1982. Groundwater was the leakage source since the embankment of the dam had just been completed and no water had been impounded. The extent of the leakage at the joints was highly variable, ranging from very slight, isolated flows covering 0.5 ft to 3 ft of the joint to much heavier flows wetting virtually the entire joint circumference. Many of the vertical cracks were essentially continuous across horizontal construction joints and extended over 100 ft in length. At the lower levels substantial portions of the interior surface were continuously wet and at many locations covered with mineral deposits and efflorescence. The floors at these levels were ponding water.

Figure 51. Centerline elevation view of intake control structure, Warm Springs Dam
