HUMAN FACTORS ASSESSMENT: M9 ARMORED COMBAT EARTHMOVER (ACE)

Gregory S. Krohn  
Essex Corporation

April 1988

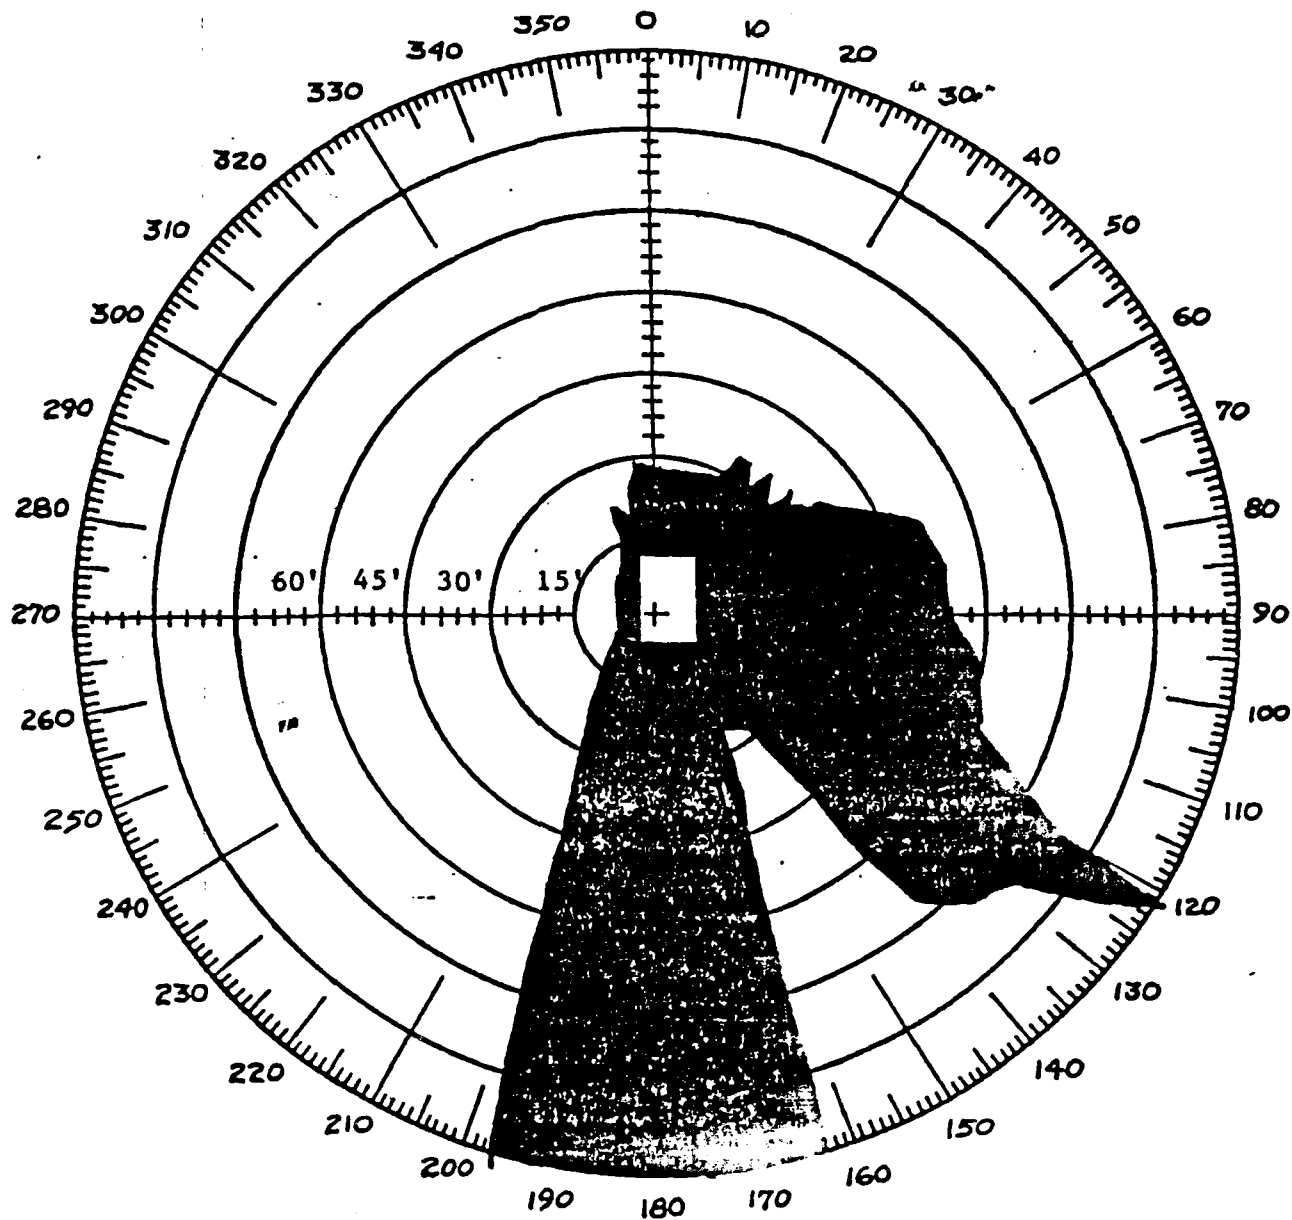
Figure 10. Blade in work position, suspension lowered and tilted forward, hatch open; 5th percentile operator, seated, measured at eye height.

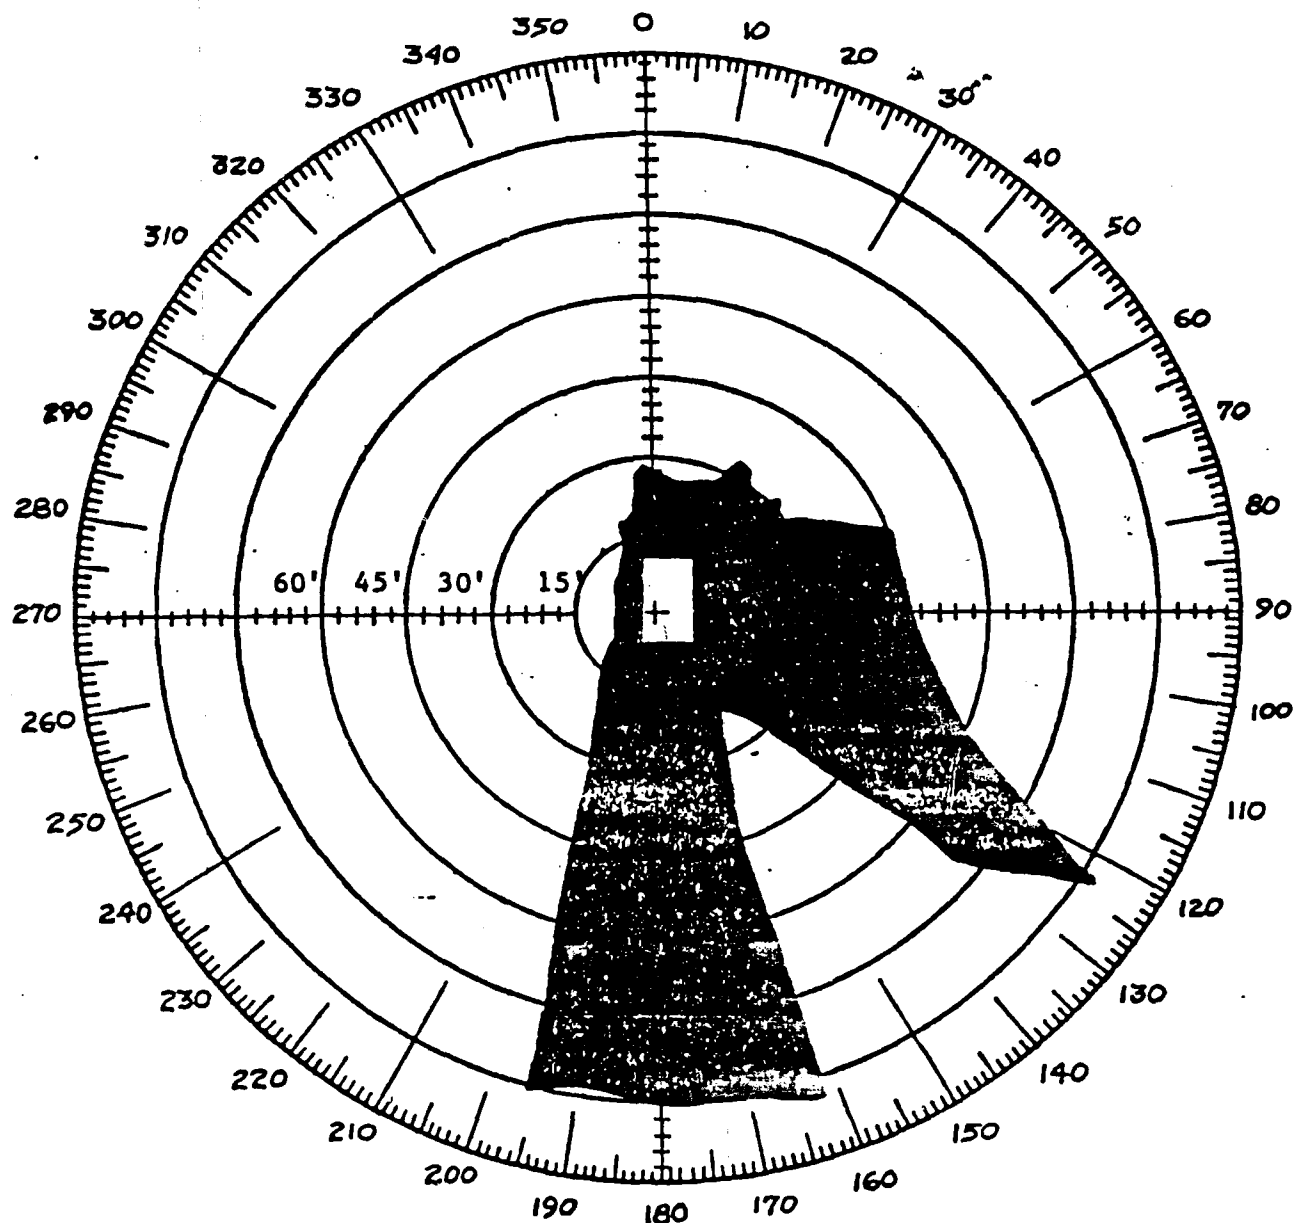
Figure 11. Blade in work position, suspension lowered and tilted forward, hatch open; 95th percentile operator, seated, measured at eye height.

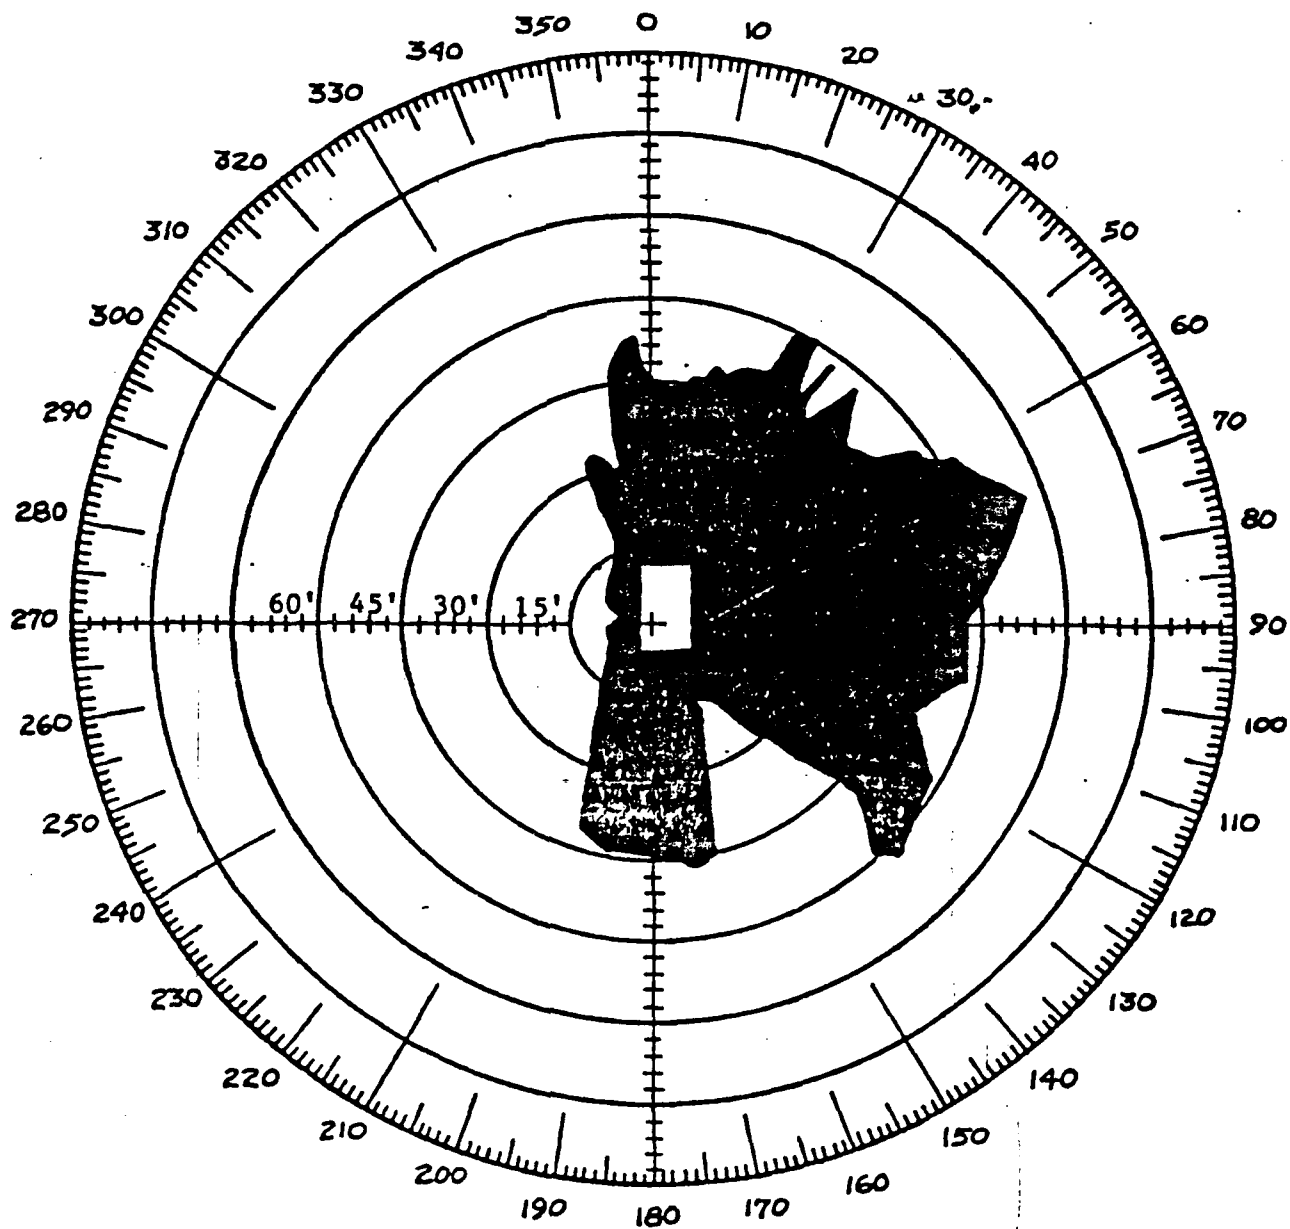
Figure 12. Blade in travel position, suspension lowered and tilted forward, hatch open; 5th percentile operator, seated, measured at eye height.

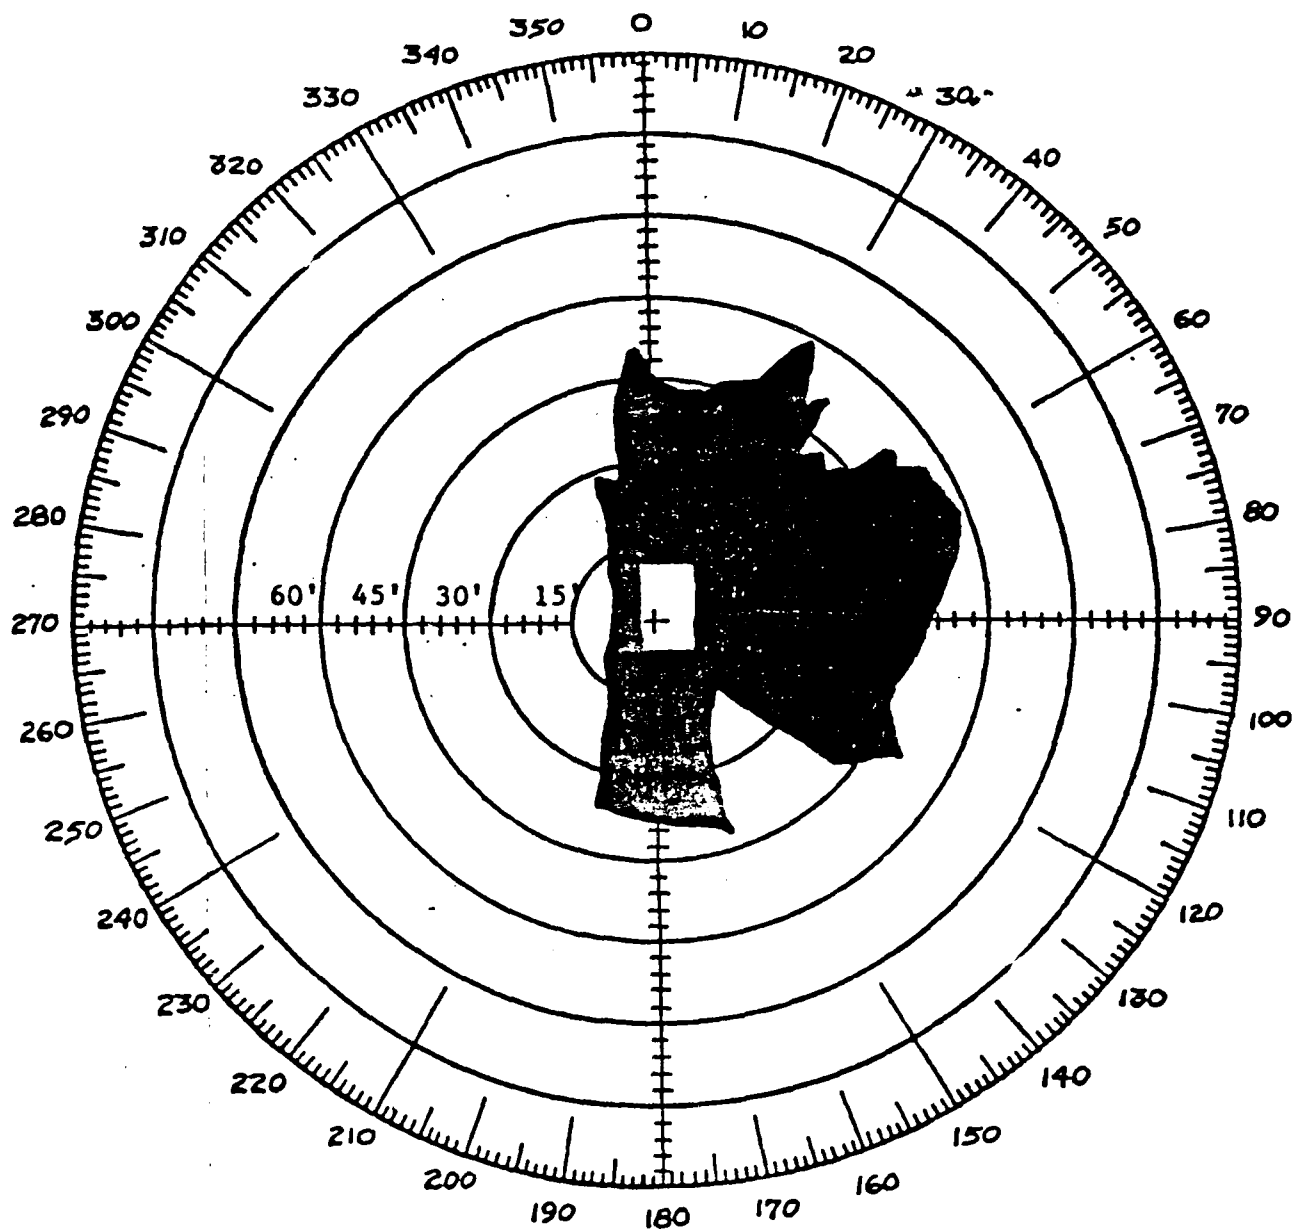
Figure 13. Blade in travel position, suspension raised and level, hatch open, 95th percentile operator, seated, measured at eye height.

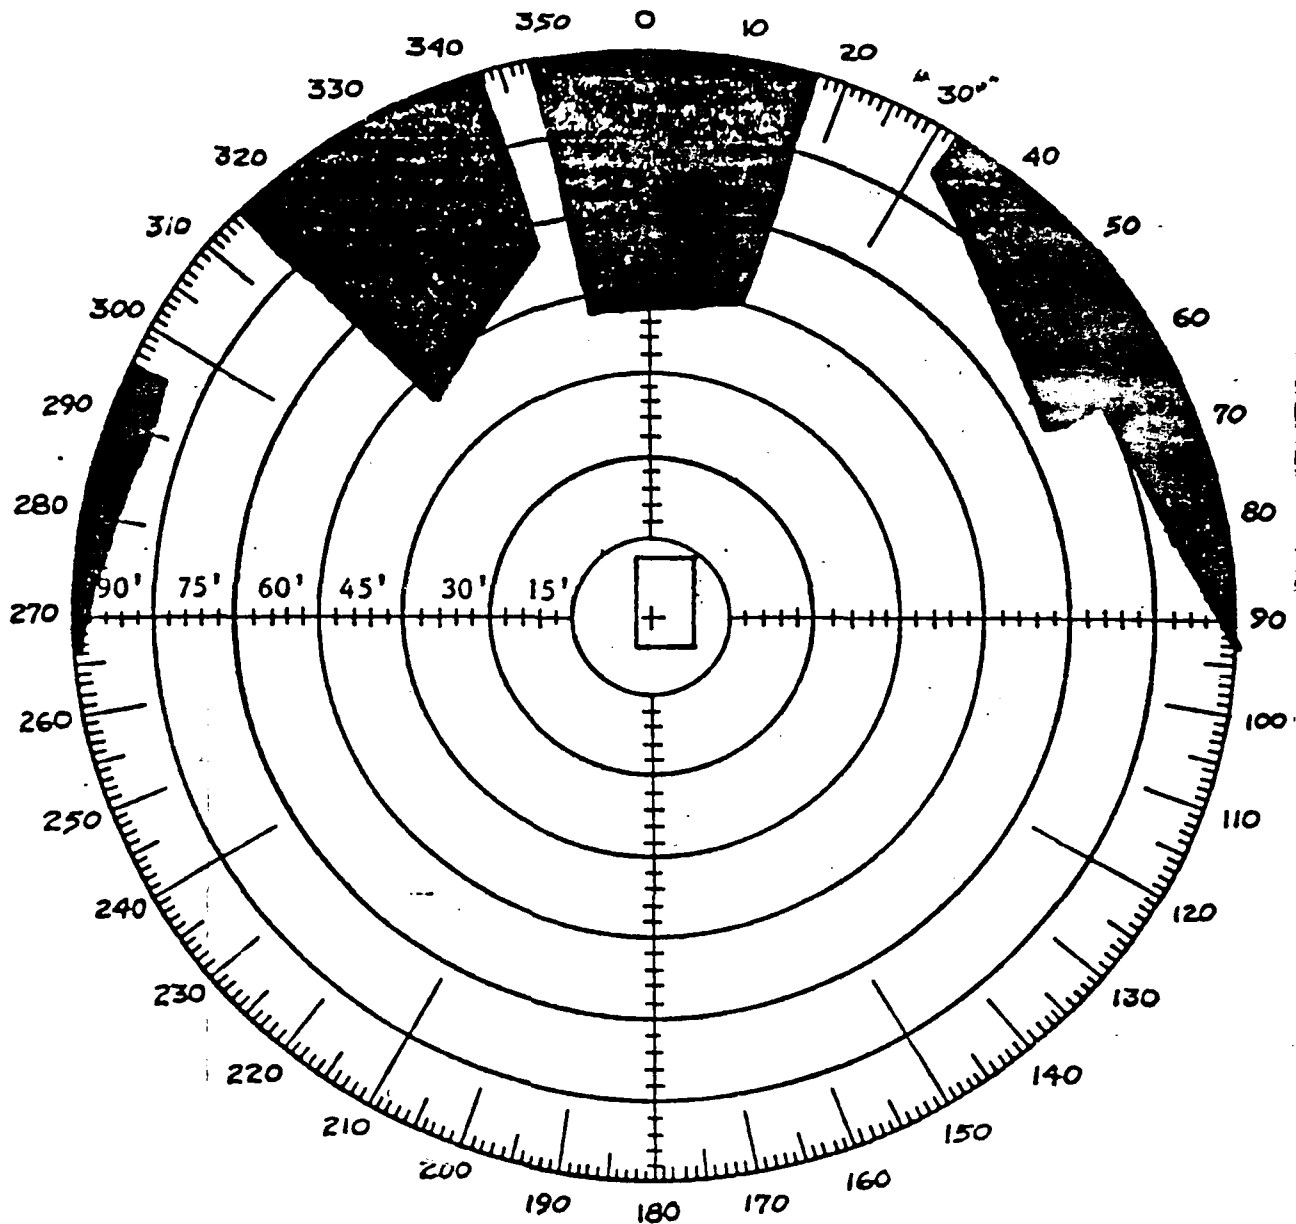
Figure 14. Blade in travel position, hatch closed; 5th and 95th percentile operators, measured at the same eye height.

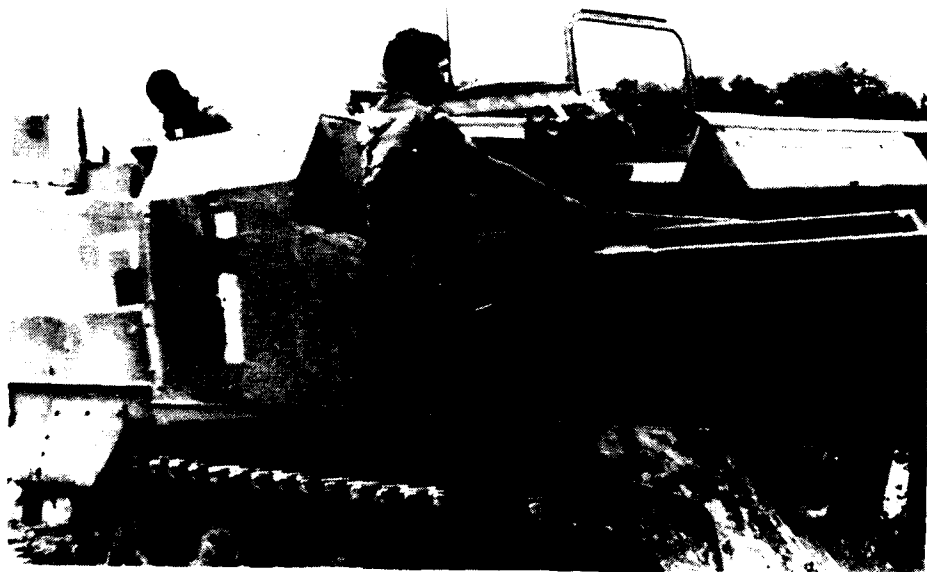
Figure 41. The route operators use to climb in and out of the bowl.

Implications for the Operator and the Equipment: Slip and fall accidents are likely, especially when existing steps and handholds are damaged.
