TECHNICAL REPORT CERC-88-4

# EFFECTIVENESS OF EXPEDIENT LEVEE-RAISING STRUCTURES

Experimental Model Investigation

April 1988

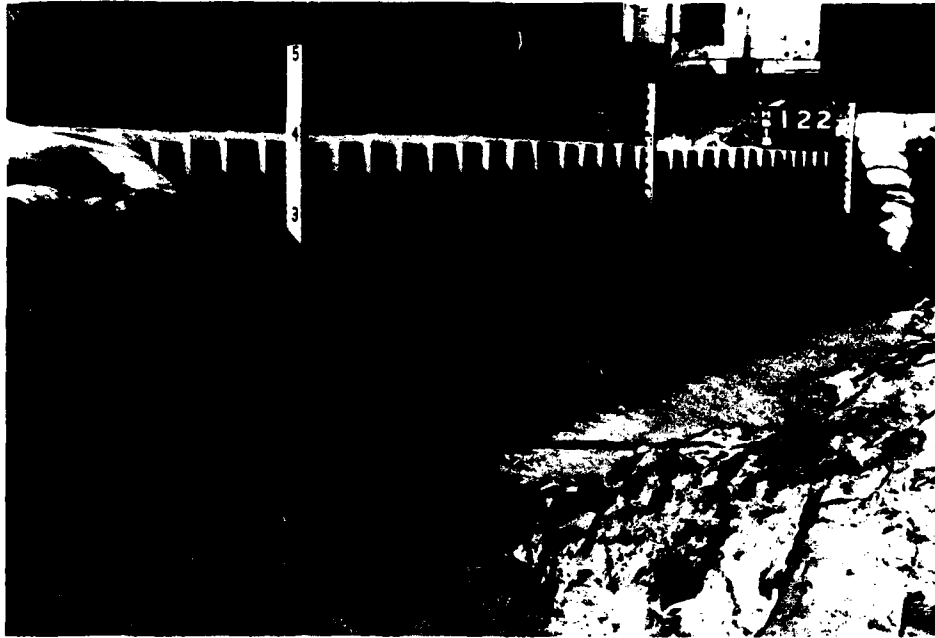
Photo 85. Riverside view of Section 4-2 before testing
