MTL TR 88-6

# METALLURGICAL EXAMINATION OF A DIAPHRAGM - LOCKUP CLUTCH PISTON

VICTOR K. CHAMPAGNE, Jr.

April 1988

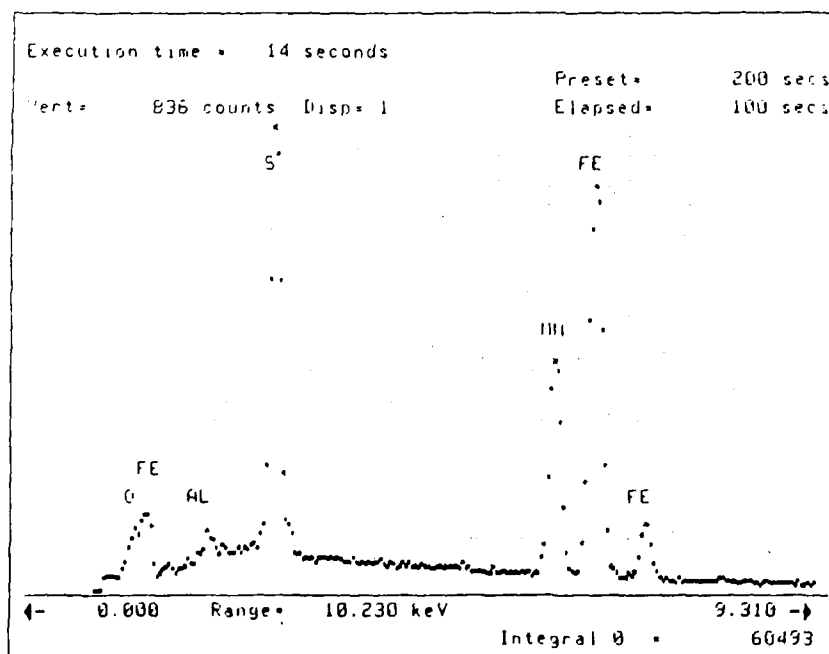
While examining the surfaces of cracked regions, it was found that cracking was sometimes associated with inclusions and other discontinuities in the material. Figure 15 reveals such an instance. Here a crack has originated at the surface irregularity. This small defect acted as a stress concentration area and when the stress parameters of the material were exceeded, a crack initiated here. Figure 16 shows the presence of inclusions over the entire surface of a longitudinal section. In many areas, cracks were found propagating through inclusions and in other instances cracks had originated at sites occupied by inclusions. Some of these were identified as manganese sulfide inclusions. Figure 17 illustrates representative results obtained from an EDS analysis performed on three different regions (see Figure 16 for exact locations).

Figure 17. Typical EDS spectra of the areas identified in Figure 16.
