Corrosion Phenomena During Overcharge
in Polymer Electrolyte Cells

M.Z.A. Munshi
R. Gopaliengar
B.B. Owens

Department of Chemical Engineering and Material Science
Corrosion Research Center
University of Minnesota
221 Church St. SE
Minneapolis, MN 55455
USA

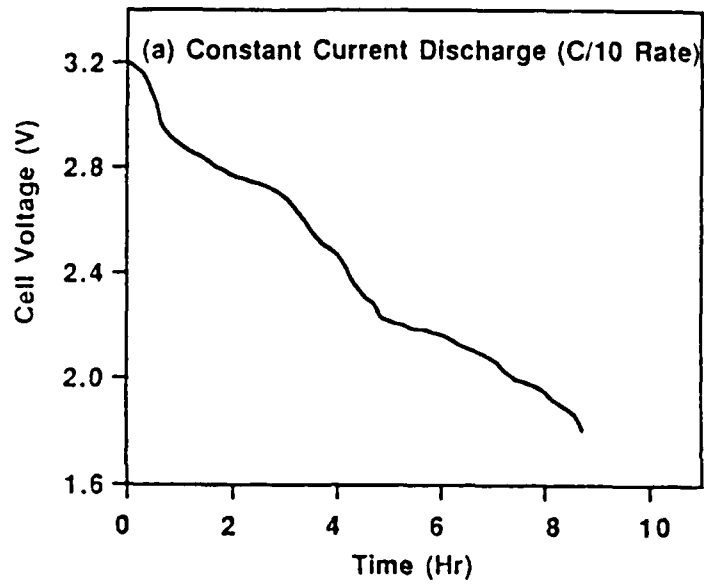
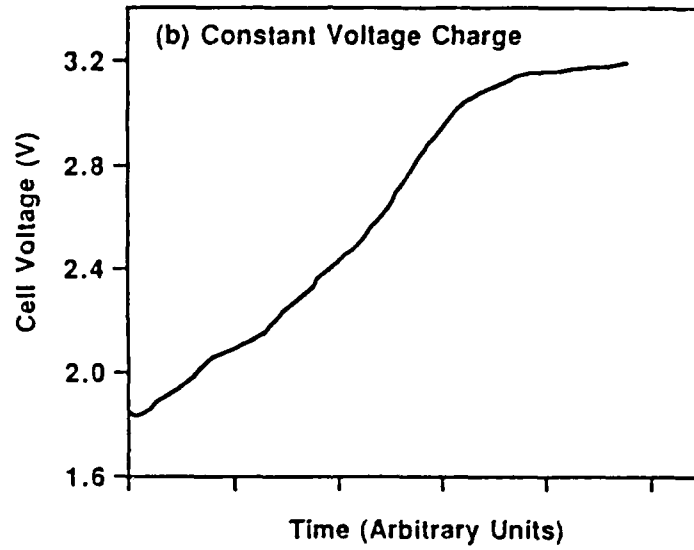
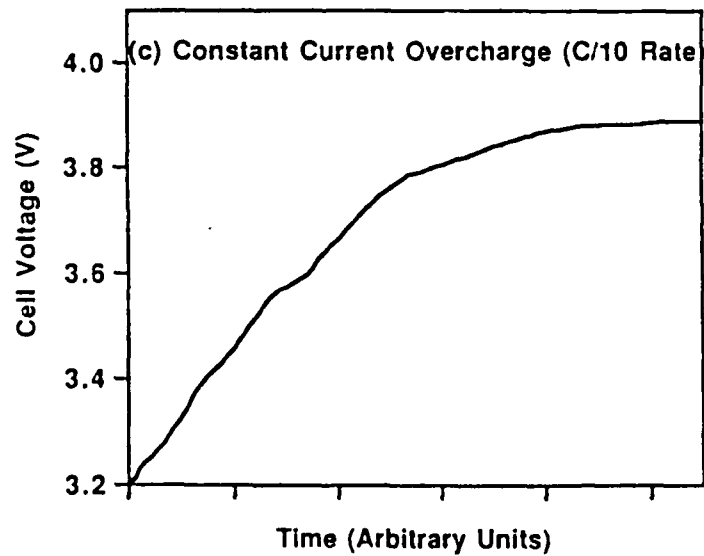
Figure 1 shows the cycling sequences for the polymer electrolyte cells. Figure 1a depicts a typical constant current discharge followed by a typical constant voltage charge (Figure 1b) through a current limiting resistor. The constant potential is maintained across the fixed resistor and the cell such that as the cell charges, the voltage drop across it increases with a corresponding decrease across the fixed resistor. The current flowing through the cell decreases until the cell is fully charged. Once the cell has attained stabilization in capacity with cycle number and the coulombic efficiency in the final charging cycle has reached close to 100%, the cell is placed on overcharge at the C/10 rate. A voltage-time profile for cell #1 utilizing a thin cathode is shown in Figure 1c. In this case the cell stabilizes at 3.9V. The behavior appears to be quite different from cells utilizing thick cathodes [7] where the cell reached about +5V, sufficient to decompose the electrolyte.

Figure 1. Cycling profiles for the polymer electrolyte cells.
