# RETROGRESSIVE FAILURES IN SAND DEPOSITS OF THE MISSISSIPPI RIVER

Report 2

EMPIRICAL EVIDENCE IN SUPPORT OF THE  
HYPOTHESIZED FAILURE MECHANISM AND  
DEVELOPMENT OF THE LEVEE SAFETY  
FLOW SLIDE MONITORING SYSTEM

PART II: CASE HISTORY OF THE CELOTEX BATTURE AND LEVEE FAILURE OF  
30 JULY 1985

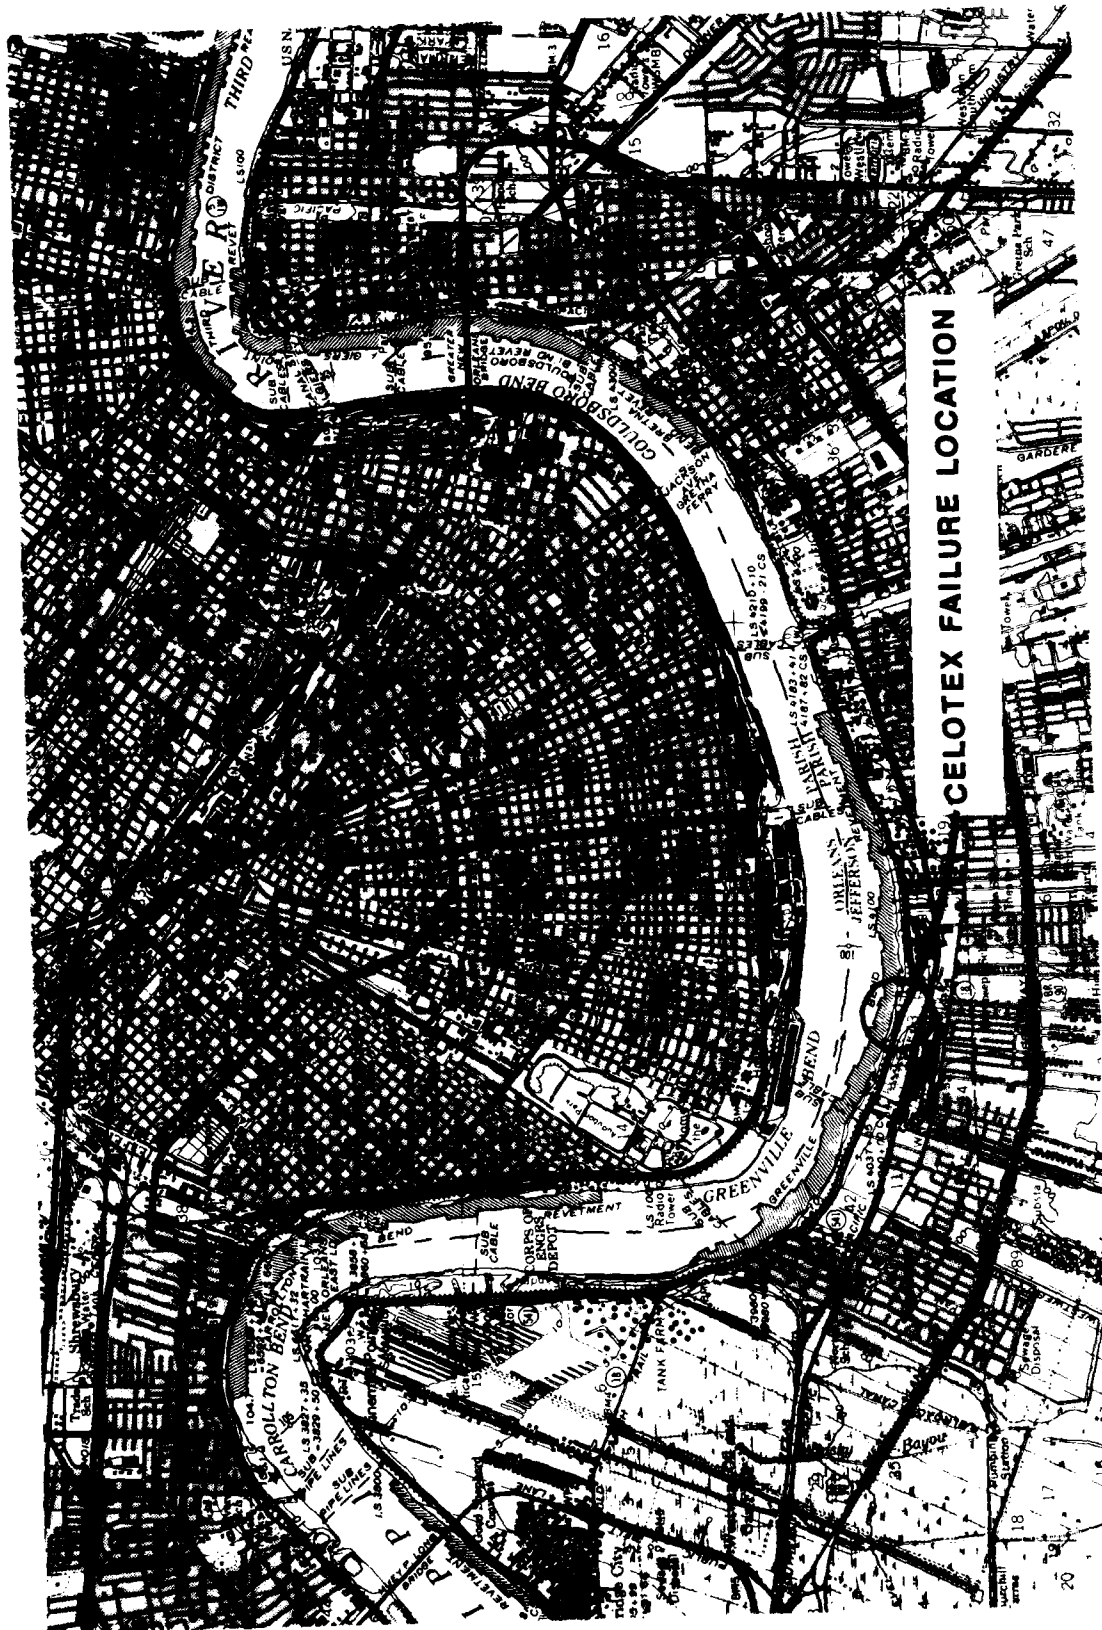
Figure 1. Vicinity map, Celotex batture and levee failure

5. Around 2 a.m. on the morning of 30 July 1985, a tugboat operator reported to NOD Operations Division his observation of a riverbank failure at mile 100.4 above head of passes (AHP) on the west bank (right descending) of the Mississippi River in the Jefferson Levee District, approximately 0.5 mile south of Westwego, LA, and within the Greenville Bend revetment reach. The failure progressed landward and involved the levee crown by 6 a.m. Figure 1 is a vicinity map showing the failure area. Figure 2 shows the specific location of the failure. In Figure 2, it is seen that landward of the levee near the failure is the industrial complex of the Celotex Corp. Consequently, the failure is referred to by that name. An aerial photograph also showing the failure location is given in Figure 3.

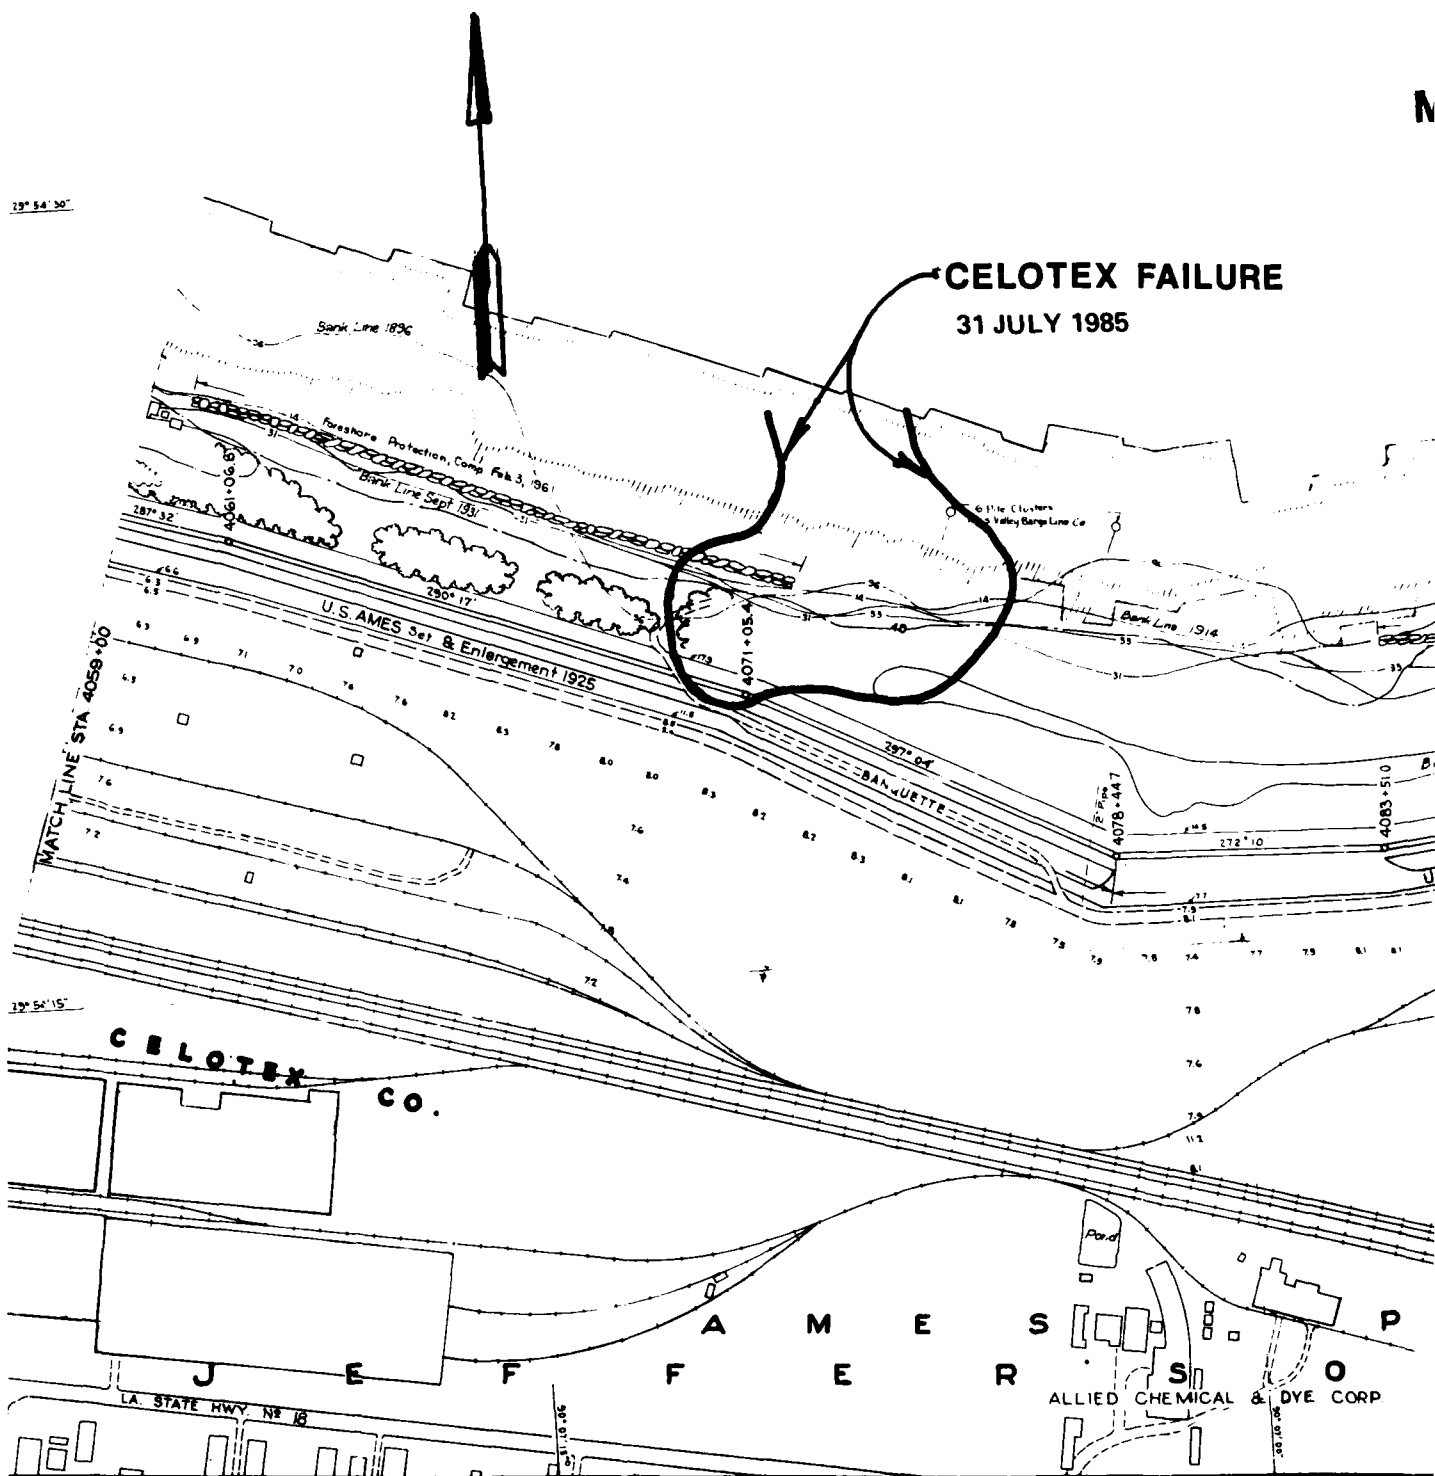
Figure 12. Bank line history, Greenville revetment reach

16. The history of the bank line along Greenville Bend revetment reach is shown in Figure 12 (file map, New Orleans District). The bank line in 1949 was determined from aerial photos. Earlier bank lines were established by ground surveys. The most apparent observation is that a major bank failure area existed in 1896 precisely at the Celotex location. In addition, looking downstream, other scallops are seen in the bank line over the years. In 1901, 1909, and 1922, setbacks were constructed in front of Amesville, LA, and the old General Alcohol Co. indicating the severity of bank losses during those times. A major failure highly likely to have been a flow slide because of the proportions of the batture loss is indicated in the 1900 bank line in front of the alcohol company complex. The 1973-1975 Mississippi River hydrographic survey shows a scour pool at this location. There is reason to believe that the bank loss patterns indicated by the old bank line data can be expected in the future all along the abandoned channel/point bar reach. The aerial photographs given as Figure 3 were taken in 1977 during an extremely low water period. Although small and difficult to see in the photographs, a scallop did exist at the Celotex failure location at that time. Other larger scallops are evident in Figure 3 in the downstream direction in various places in the point bar deposit. Of particular concern to the author is the very sharply defined scallop seen in the photograph just in front of the down stream end of the long, narrow complex of the Johns-Manville Co. (upper center of photo). The location corresponds to revetment ranges D-2 to D-3. Given the much smaller scallop preexistent at the Celotex site, this larger scallop demands special attention since the overburden is very thin, and no more batture than at Celotex protects the levee.

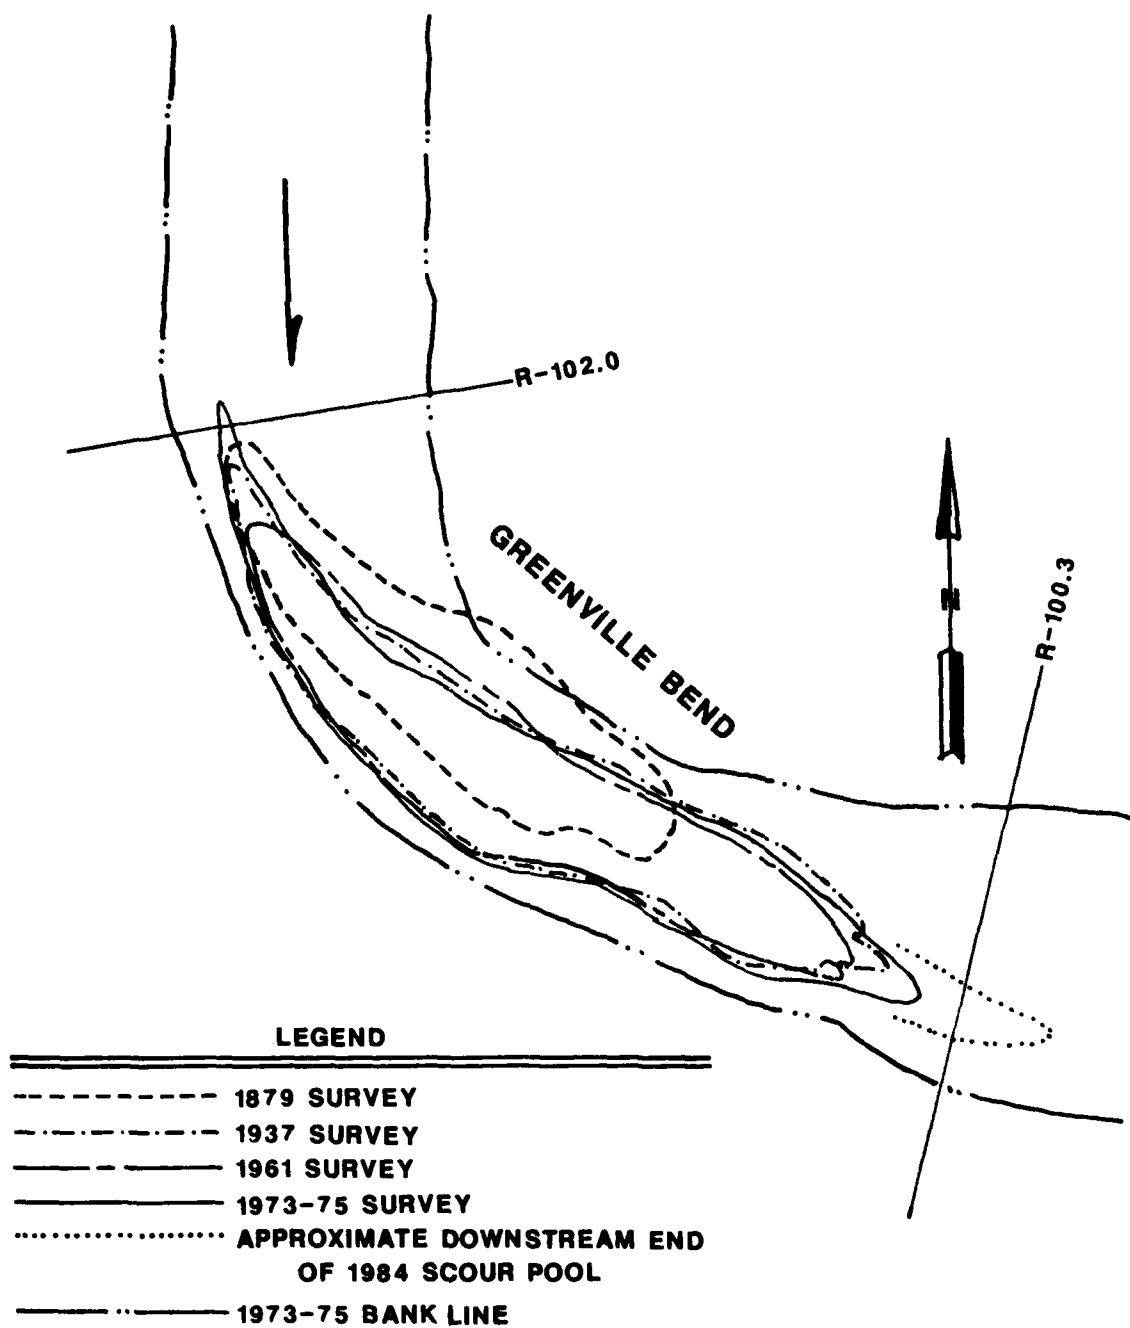
Figure 13. Historic trend in movement of permanent scour pool, Greenville Bend, Mississippi River

17. The historical migration of the Greenville Bend "permanent" scour pool is evident in Figure 13 where it is shown that the pool has been growing in length both upstream and downstream and moving in a southeasterly direction. The 1973-1975 hydrographic survey placed the downstream end of the pool based on el -100 at revetment range U-24. The previous discussion suggested that the pool in 1984 extended downstream close to range U-18 an additional 800 ft. The pool migration portends increasing attack along the Greenville revetment reach in the downstream direction. Particular watchfulness appears to be warranted from revetment range U-30 to D-15.

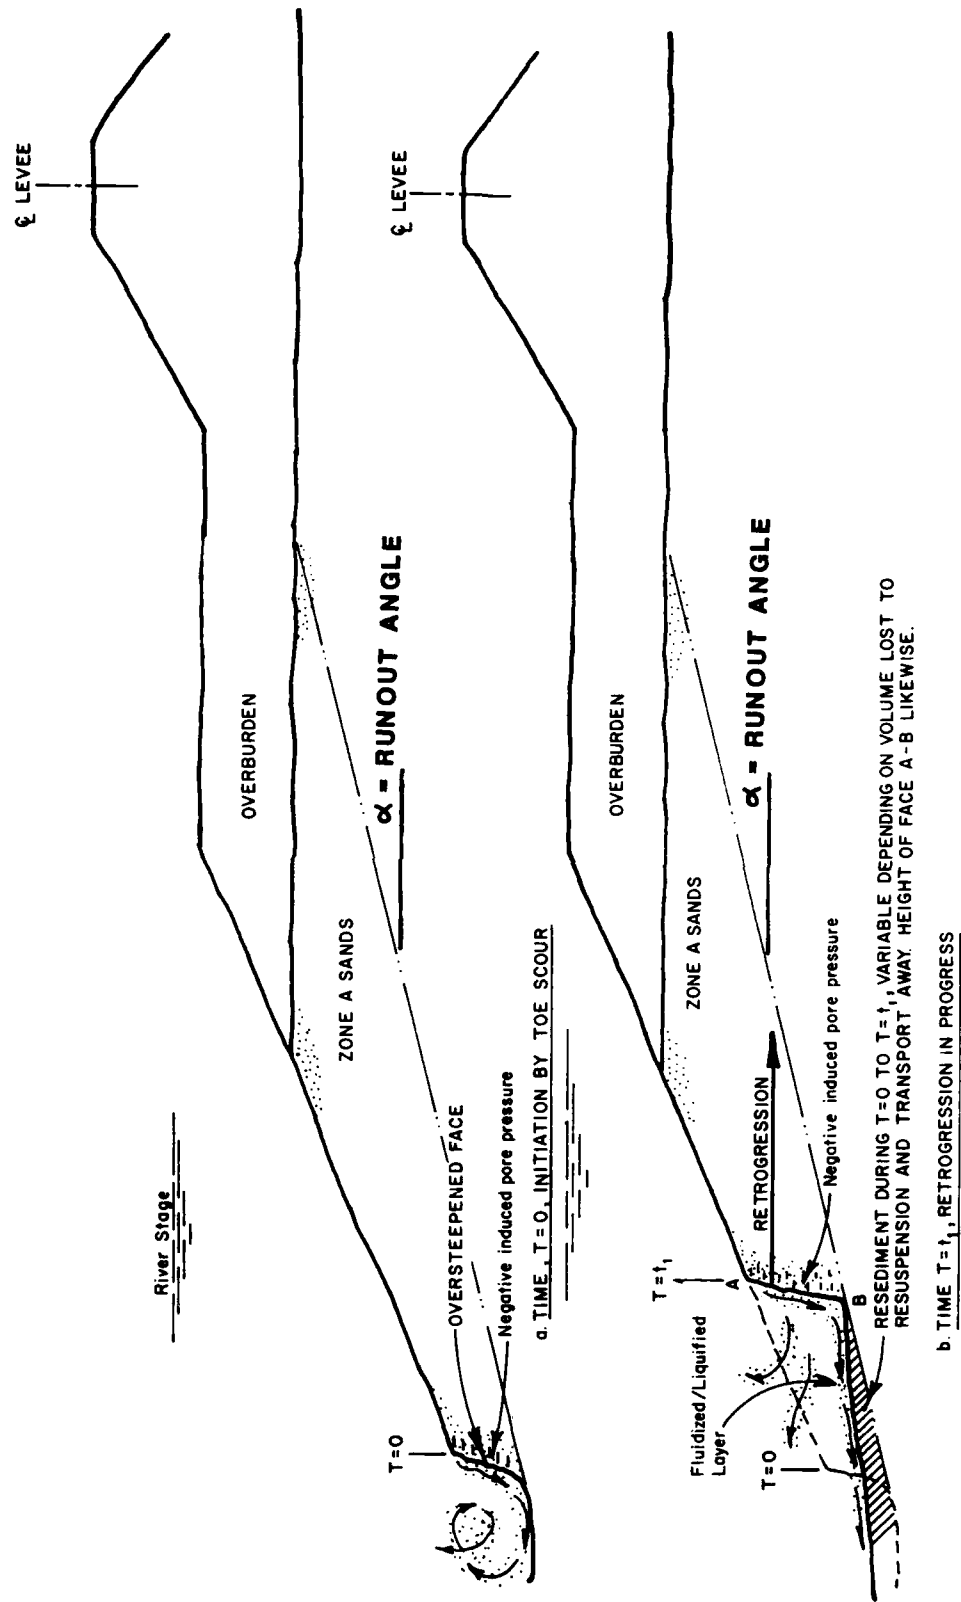
Figure 14. Sequential stages of retrogressive failure of a flow slide in dilatant sands (Sheet 1 of 3)

18. Among the accomplishments described in the last report to LMVD (Torrey, Dunbar, and Peterson 1986) was a theoretical analysis by Dr. Christopher Padfield of the retrogressive mechanism in dilatant (dense) sands. Out of the numerical treatment emerged the concept of the runout angle which defines the final geometry of a flow slide assuming no excess removal of soil by scour. Figure 14 illustrates the retrogression mechanism. Two most important questions relative to the runout angle concept are:

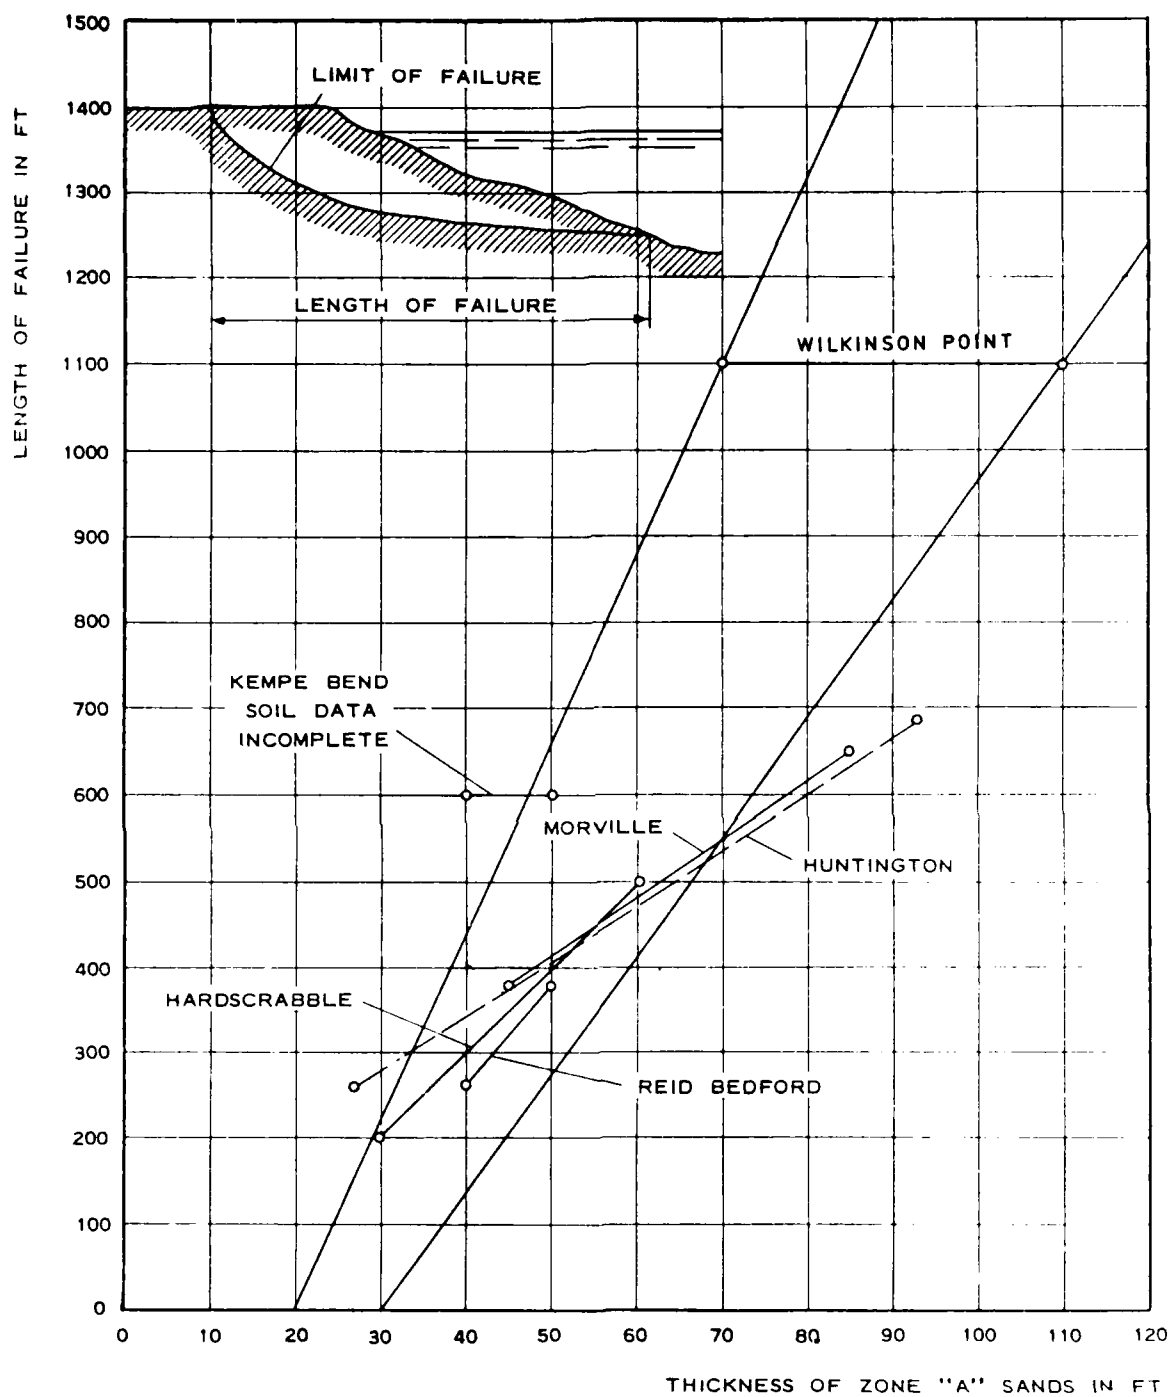
Figure 15. Length of failure versus thickness of Zone A sands  
(from Potamology Investigations Report 12-5)

21. The data of Figure 15 are plotted with data from the 1973 flow slides below Baton Rouge and the Celotex data in Figure 17. The parameters plotted in Figure 17 are explained in the inset on the figure. In keeping with the mechanism of failure illustrated in Figure 14, the beta angle,  $\beta$ , of Figure 17 is the approximate average slope of the resedimented material after failure. Note that in order for this to be true, the failure slope in the overburden must be relatively vertical as has been observed to be generally the case. If no major scour develops within the failure which removes material in excess of that involved in the retrogression mechanism,  $\beta$  must be less than or equal to the runout angle. If the failure proceeded with just the perfect assistance of scour such that every grain of sand raining off the retrogressing face and every piece of overburden were removed from the scar, then  $\beta$  would equal  $\alpha$ . In that special case, there would have been no resedimentation of any of the sand raining off the retrogressing face. It can be deduced from the sections of typical failures of record that with few exceptions some resedimentation does occur, and  $\beta$  is less than  $\alpha$ . This is because projections of the average  $\beta$  just do not conform to the concept of the scour pool/trench as the initiation point of failure. In other words, the projection of the average bottom slope of a typical failure would intersect the river bottom well out into the river and pass well above and beyond the scour pool/trench. The value of Figure 17 lies in the suggestion of a maximum

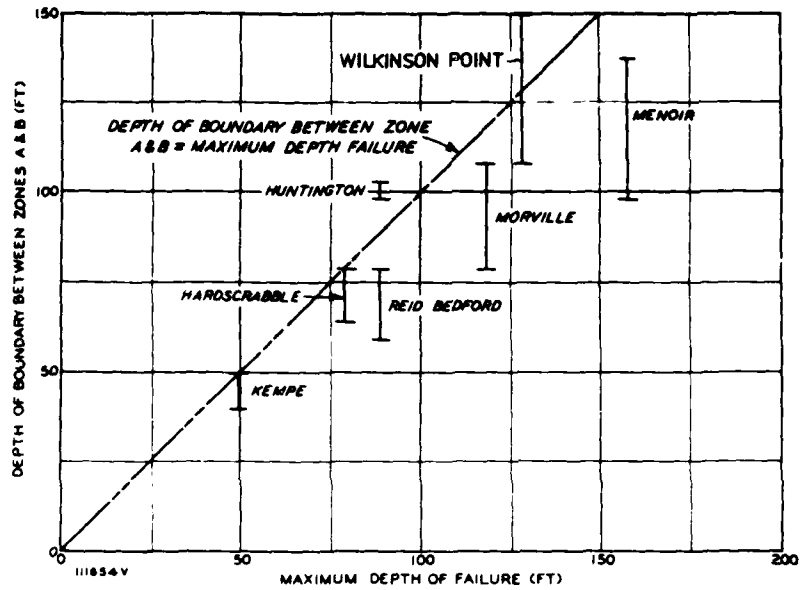
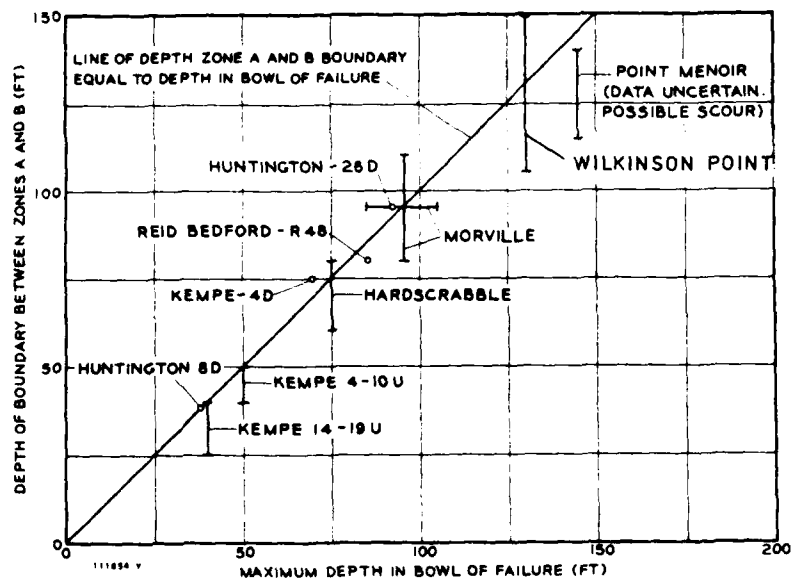
Figure 16. Depth of failure versus depth to Zones A and B boundary (from Potamology Investigations Report 12-5)

Report 12-5. Where Figure 16 shows that some failures extended into Zone B sands, two directions of reasoning arise:

- a. Scour conditions within the failures removed the additional sand below the Zone A/Zone B interface.
- b. The retrogressive mechanism also occurs in Zone B sands.

- a. Severe scour may develop within the failure as it apparently did at Wilkinson Point, Point Menoir, and other cases indicated in Figure 16.
- b. Secondary retrogression may be initiated landward of the original bank line by localized scour within a developing or essentially terminated failure as was previously postulated for the Celotex site.

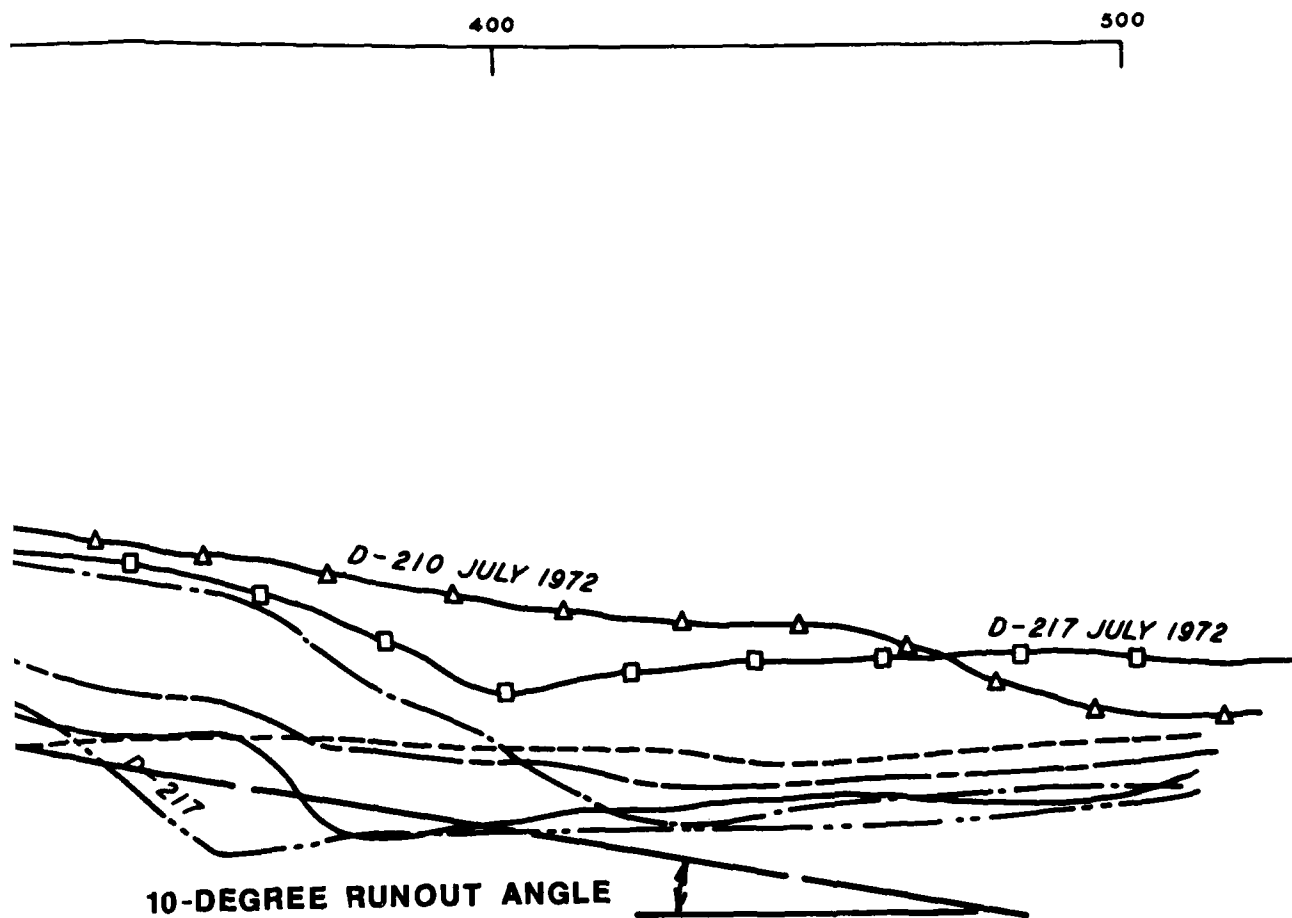
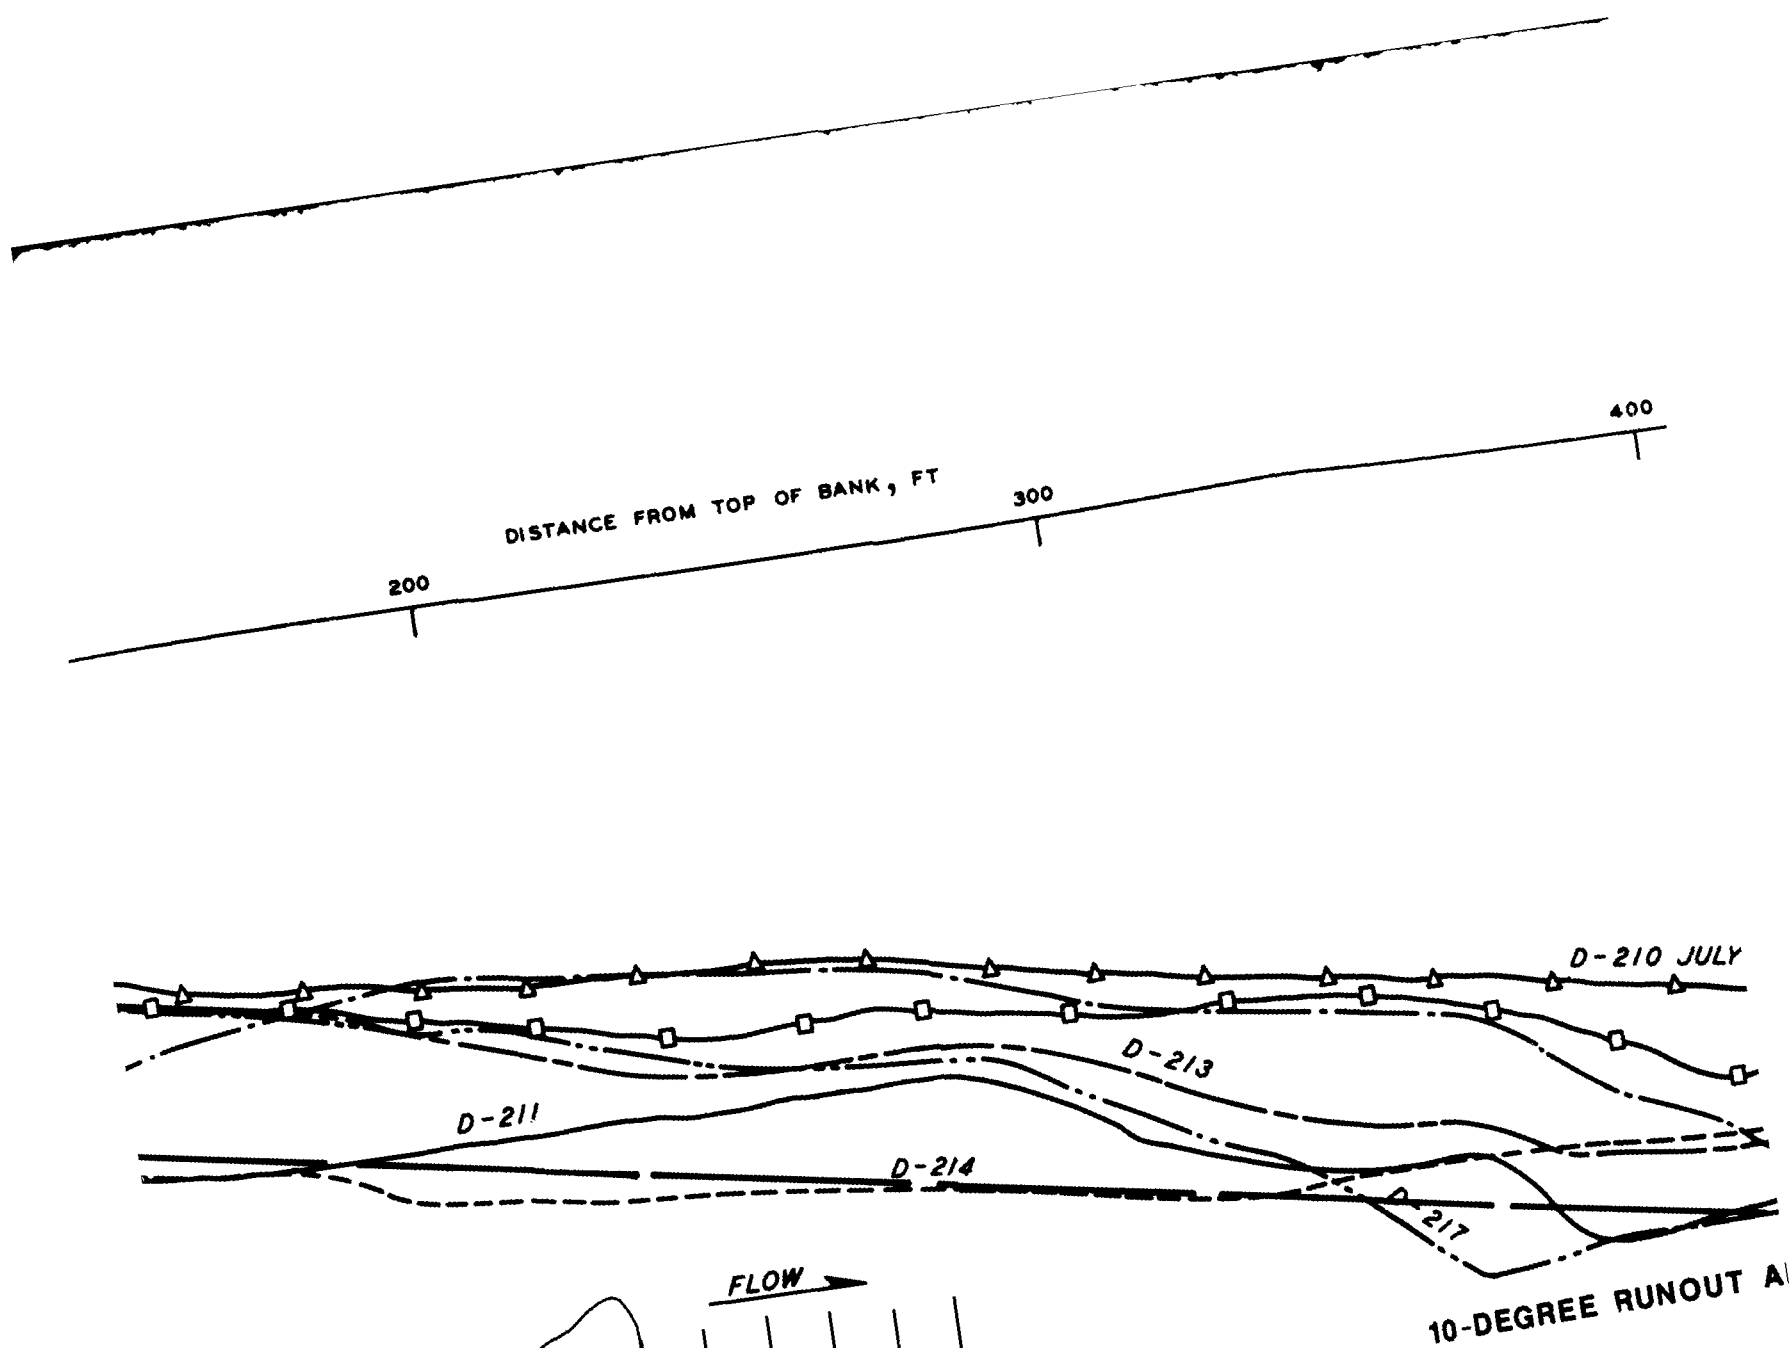
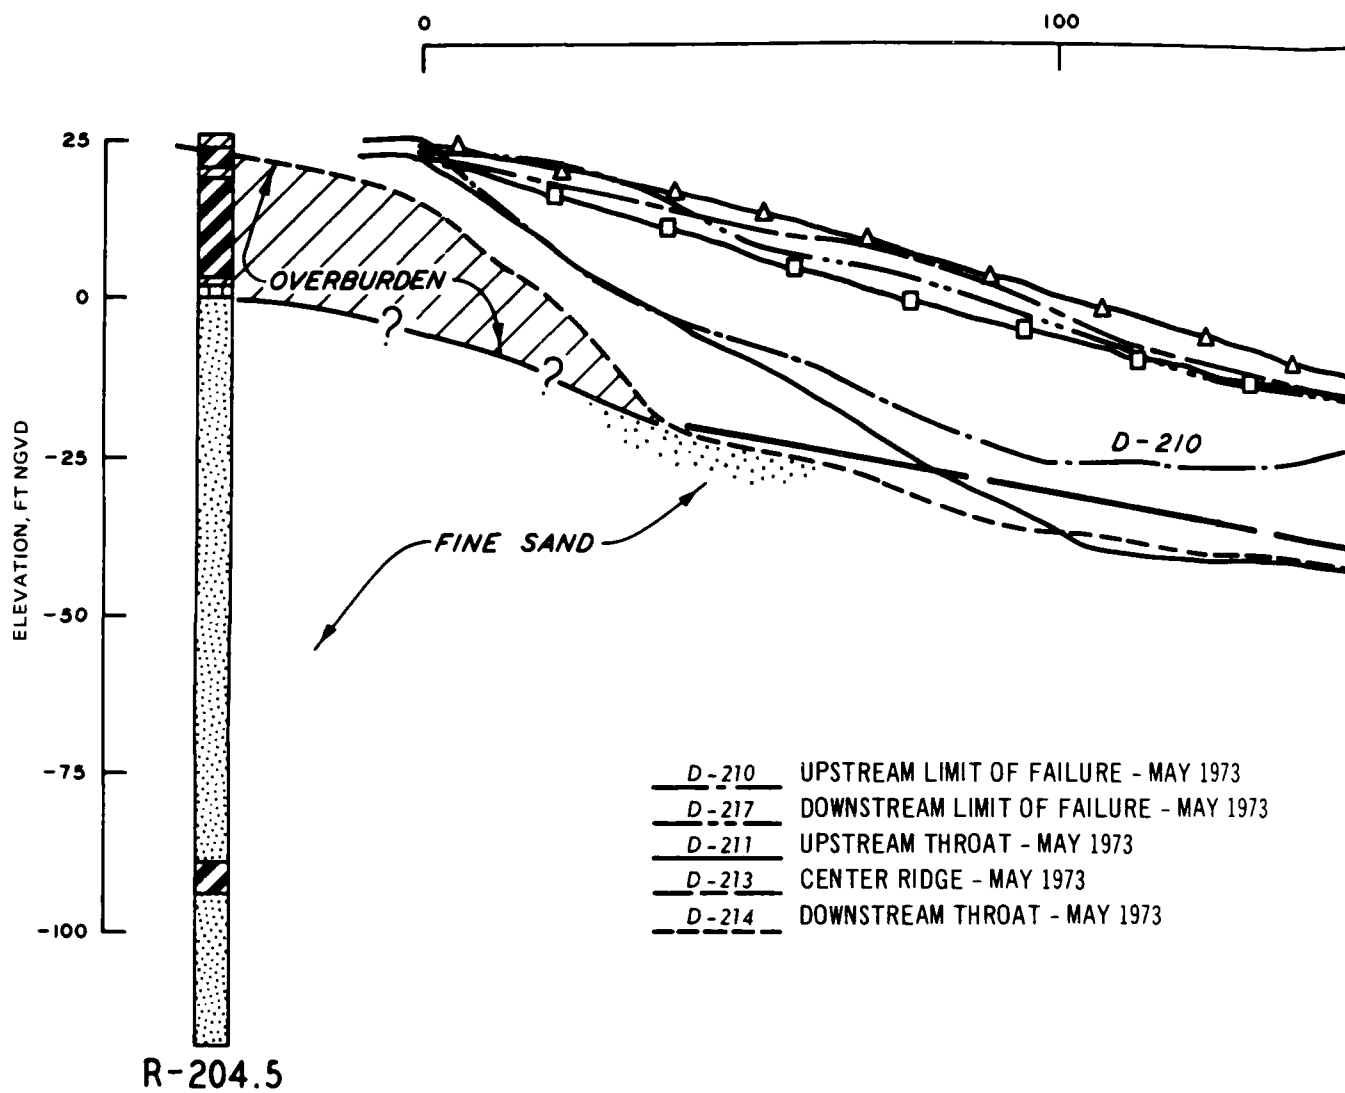
Figure 18. Sections perpendicular to the riverbank, 1973  
upstream failure at Plaquemine Bend, LA.

feasible. Those sections are for the failures at Plaquemine Bend, Montz, Stanton, and Nairn, LA, and are shown in Figures 18-22. They were taken from a report submitted to LMVD in 1976.\* Placement of the 10-deg runout angle must be done in reverse on the sections, i.e., from the overburden/sand interface point downward because prefailure scour conditions are not available. In each case, it is seen that the 10-deg line very feasibly "fits" the sections. The key to the word "fits" is that any line much flatter would imply an initiation of the failures too far out in the river to conform to "permanent" scour pool positions. The fit to the Nairn failure (Figure 22) is particularly close right down to the probable riverward slide fill (resedimented during retrogression) as it was originally labeled on the drawing over 10 years ago. Another pertinent observation from these sections and the Celotex sections are the typical landward bowls of the failures where the central sections lie a little below the 10-deg projections. It was pointed out previously that the bowl is thought to be attributable to relatively gentle eddy scour which develops within the scar.

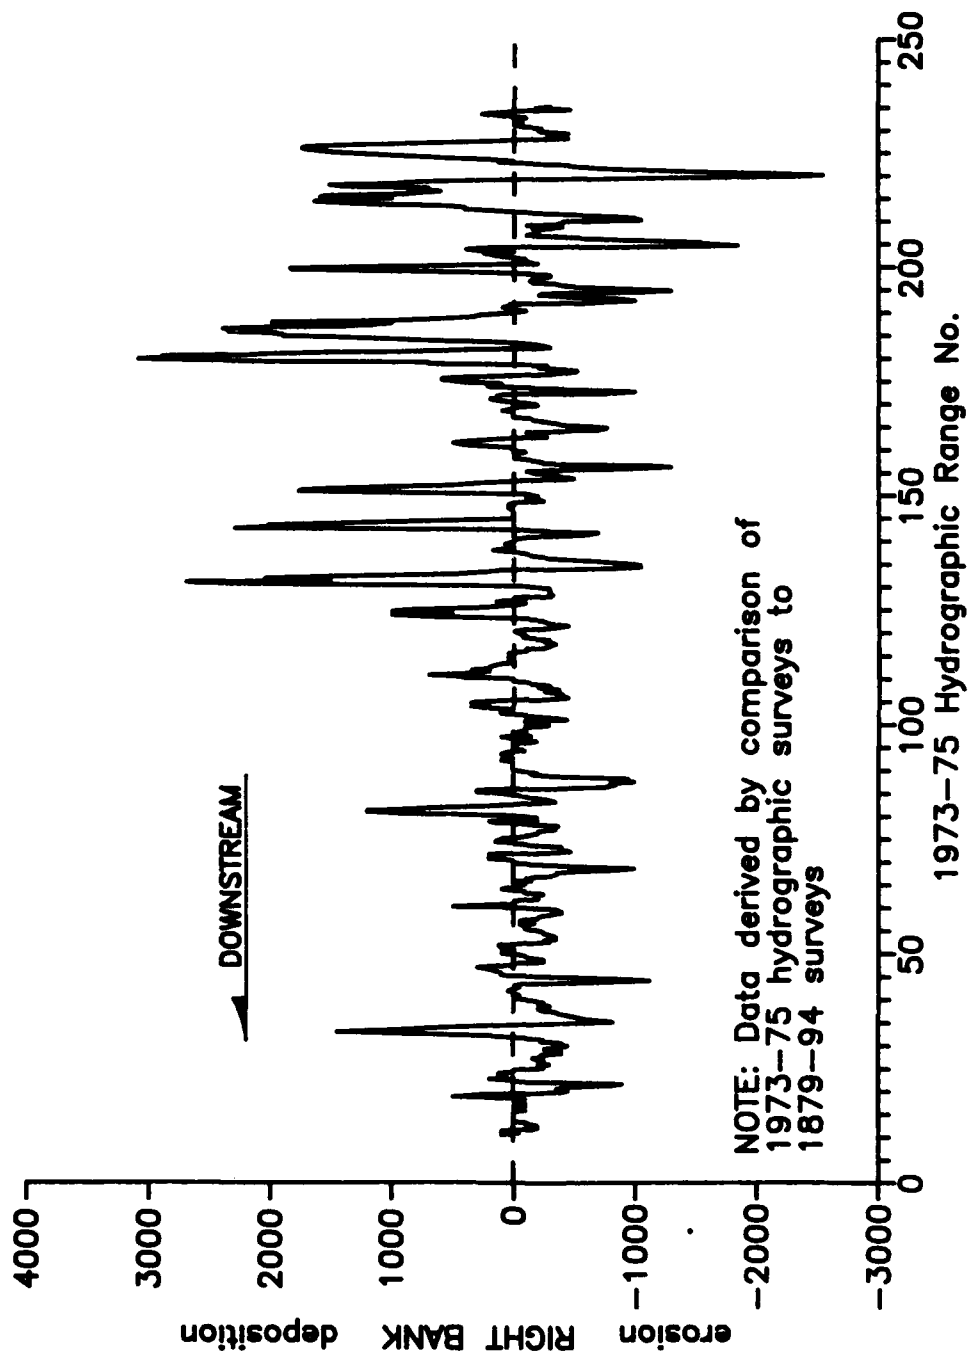
Figure 24. Historical erosion/deposition, right bank, Mississippi River,  
below Baton Rouge, LA

40. The discrete data of historical erosion and deposition given in Appendix C are plotted for the right and left banks in Figures 24 and 25, respectively. It is striking to see for both banks that the magnitudes of the river's movements and the frequency of those magnitudes are distinctly larger above (upriver) hydrographic range R-130 at the Bonnet Carre Spillway than below (downriver). The NOD geologist, Mr. Fred Smith, attributes this to a change in the geologic setting wherein more erosion-resistant Prodelta clays begin to occur regularly in the soil profile of the banks. Figure 26 presents the same data plotted as right bank versus left bank. If a line with a unit negative slope,  $-1$ , is also plotted in Figure 26 as shown, it divides the data into the set of ranges where a net narrowing of the channel occurred (points above the line) and where a net widening occurred (points below the line). In Report 1 (Torrey, Dunbar, and Peterson 1988), Dunbar calculated the total batture area of historic deposition and the total batture area of historic erosion for a 10-mile reach of river including the Bonnet Carre Point and Montz flow slide sites. He found only a 7-acre difference between erosion and deposition through the two bendways examined. The processes of erosion and deposition appear to be approximately balanced below Baton Rouge. Figures 27 and 28 break the total data set into that above hydrographic range R-129.8 (Bonnet Carre Spillway) and that below. These two figures really bring out the very different range of variations between the two subreaches and reveal the predominance of net channel narrowing between ranges 234.8 to 129.8 and predominance of net channel widening below range 129.8. Figures 29-34 present the erosion/deposition data in the form of frequency histograms. The histograms reveal the following:

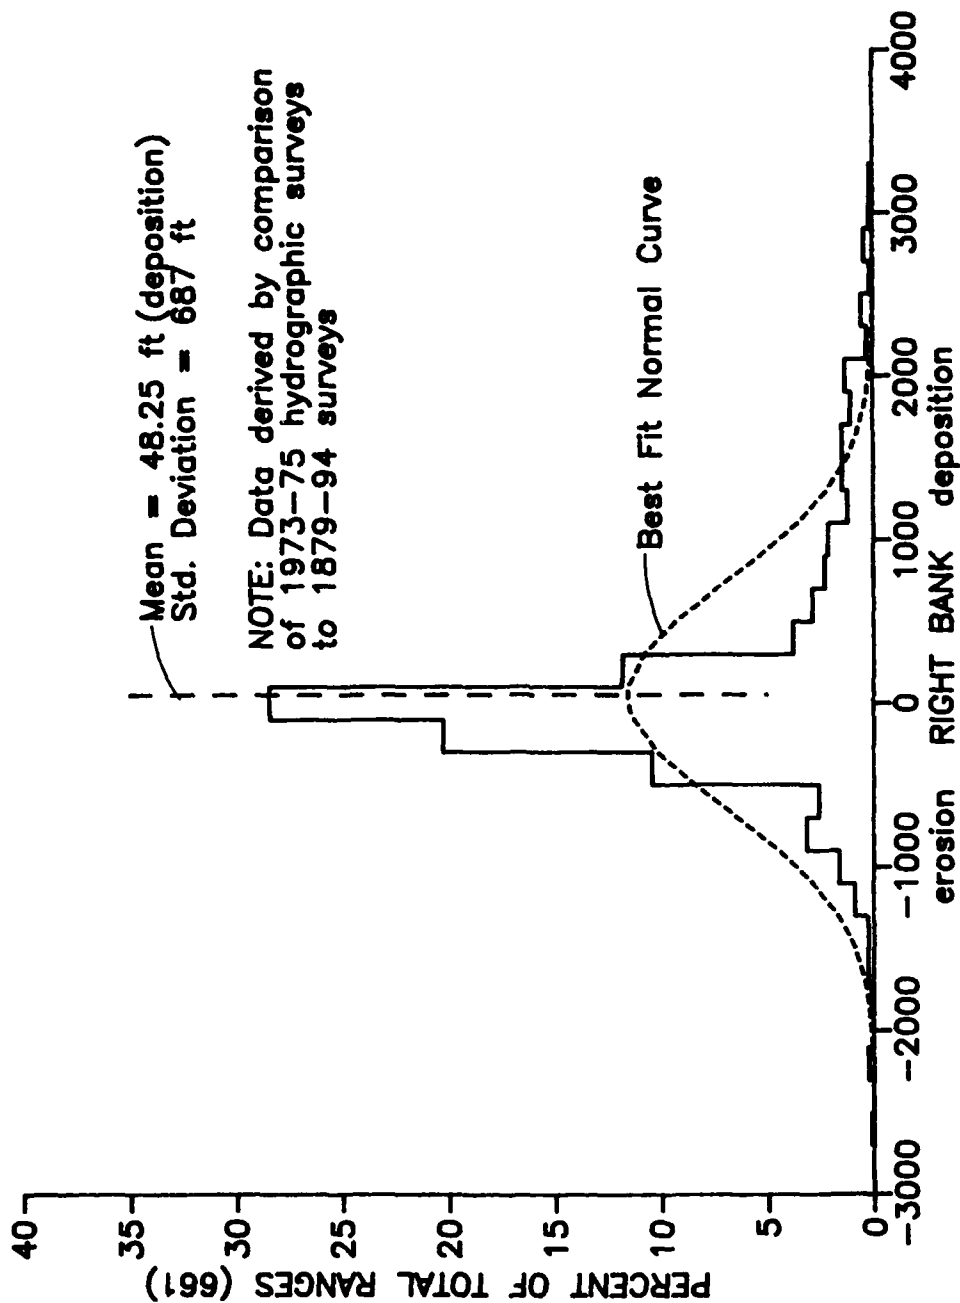
Figure 29. Frequency histogram, historical erosion/deposition, right bank, range 234.8 to 10.6, Mississippi River below Baton Rouge, LA

- a. For the entire reach of river below Baton Rouge and for both banks (Figures 29 and 32), the mean values are very close to zero. The right bank mean is that of deposition of only 48 ft of batture while the left bank mean is that of erosion of only

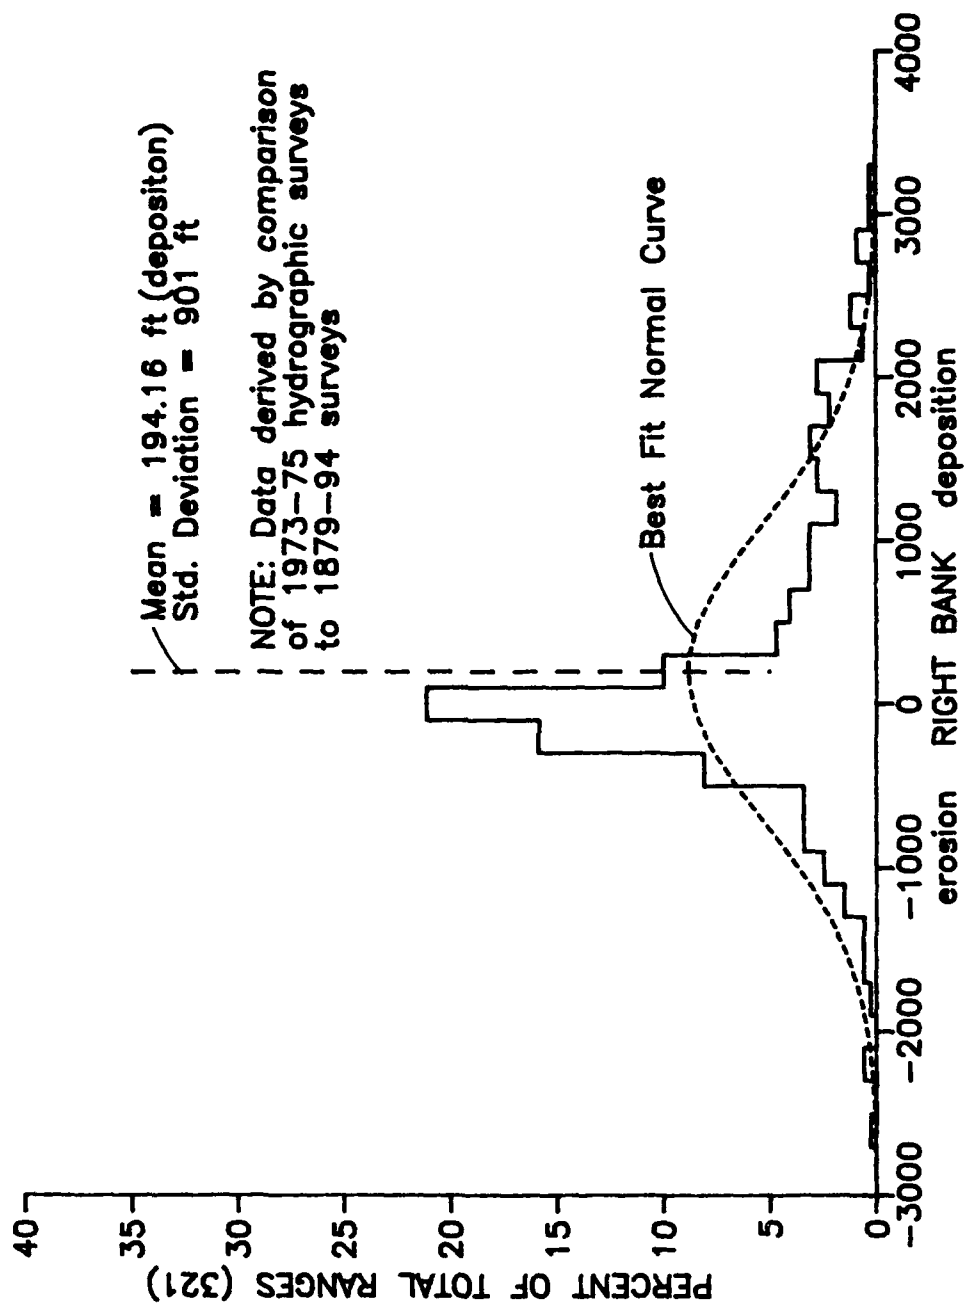
Figure 30. Frequency histogram, historical erosion/deposition, right bank, range 234.8 to 129.8, Mississippi River below Baton Rouge, LA

- b. When the total data sets are divided into the subsets above Bonnet Carre Spillway and below (right bank--Figures 30 and 31, left bank--Figures 33 and 34), the differences between the two reaches are again seen. The dispersions of the data for both banks above Bonnet Carre Spillway (hydrographic range R-129.8) are very similar (right bank standard deviation = 901 ft of batture; left bank standard deviation = 380 ft of batture). This reiterates the previous statement that the river has been much more active above Bonnet Carre Spillway than below. It is also seen that above R-129.8 the mean trend has been deposition for both banks, while below R-129.8 the mean trend has been erosion for both banks. Therefore, on the average, the river has tended to become narrower above Bonnet Carre Spillway but wider below.

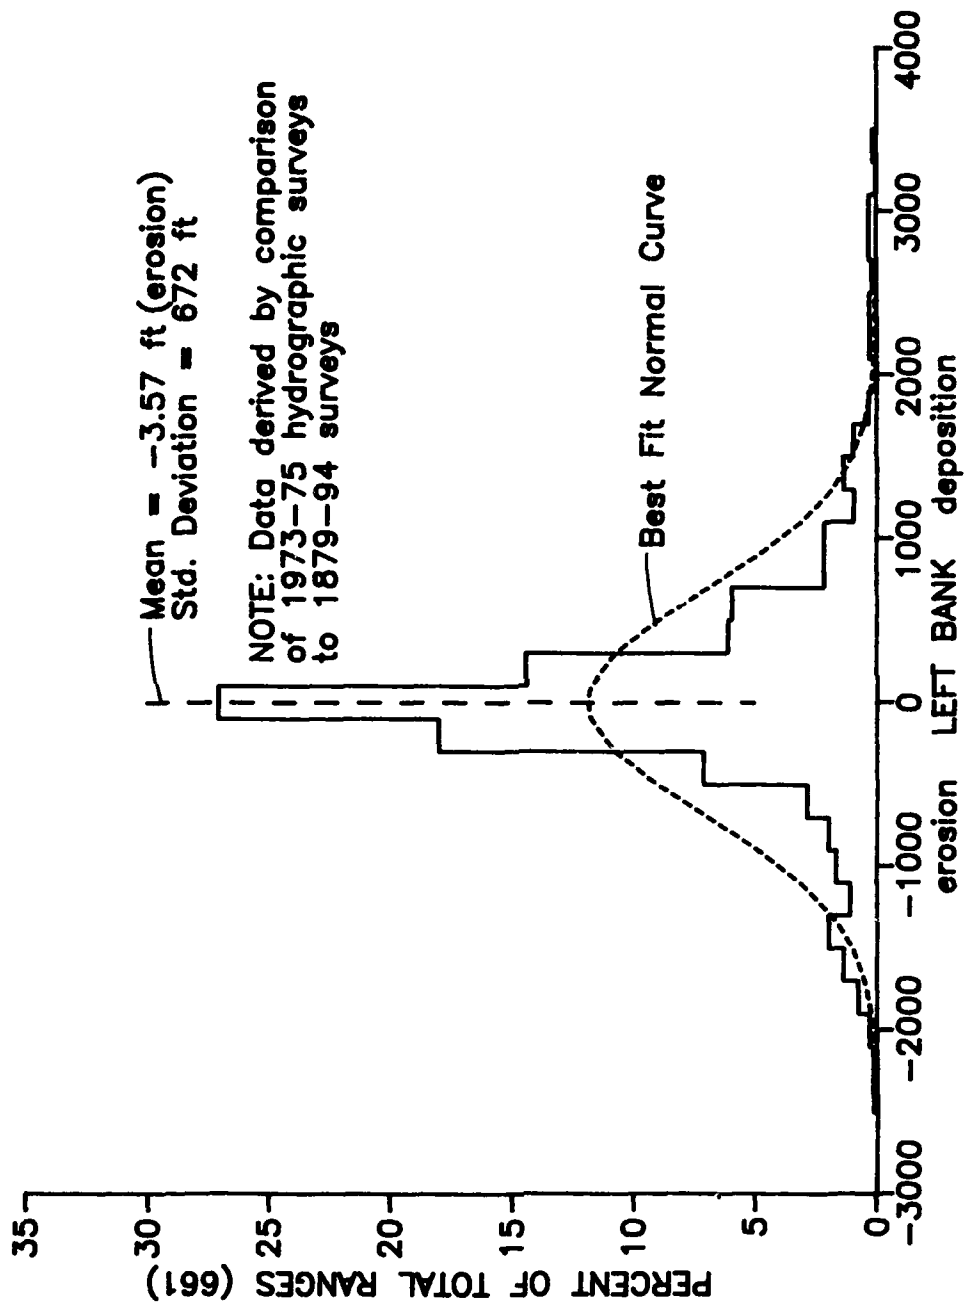
Figure 32. Frequency histogram, historical erosion/deposition, left bank, range 234.8 to 10.6, Mississippi River below Baton Rouge, LA
