# RETROGRESSIVE FAILURES IN SAND DEPOSITS OF THE MISSISSIPPI RIVER

Report 2

EMPIRICAL EVIDENCE IN SUPPORT OF THE  
HYPOTHESIZED FAILURE MECHANISM AND  
DEVELOPMENT OF THE LEVEE SAFETY  
FLOW SLIDE MONITORING SYSTEM

PART II: CASE HISTORY OF THE CELOTEX BATTURE AND LEVEE FAILURE OF  
30 JULY 1985

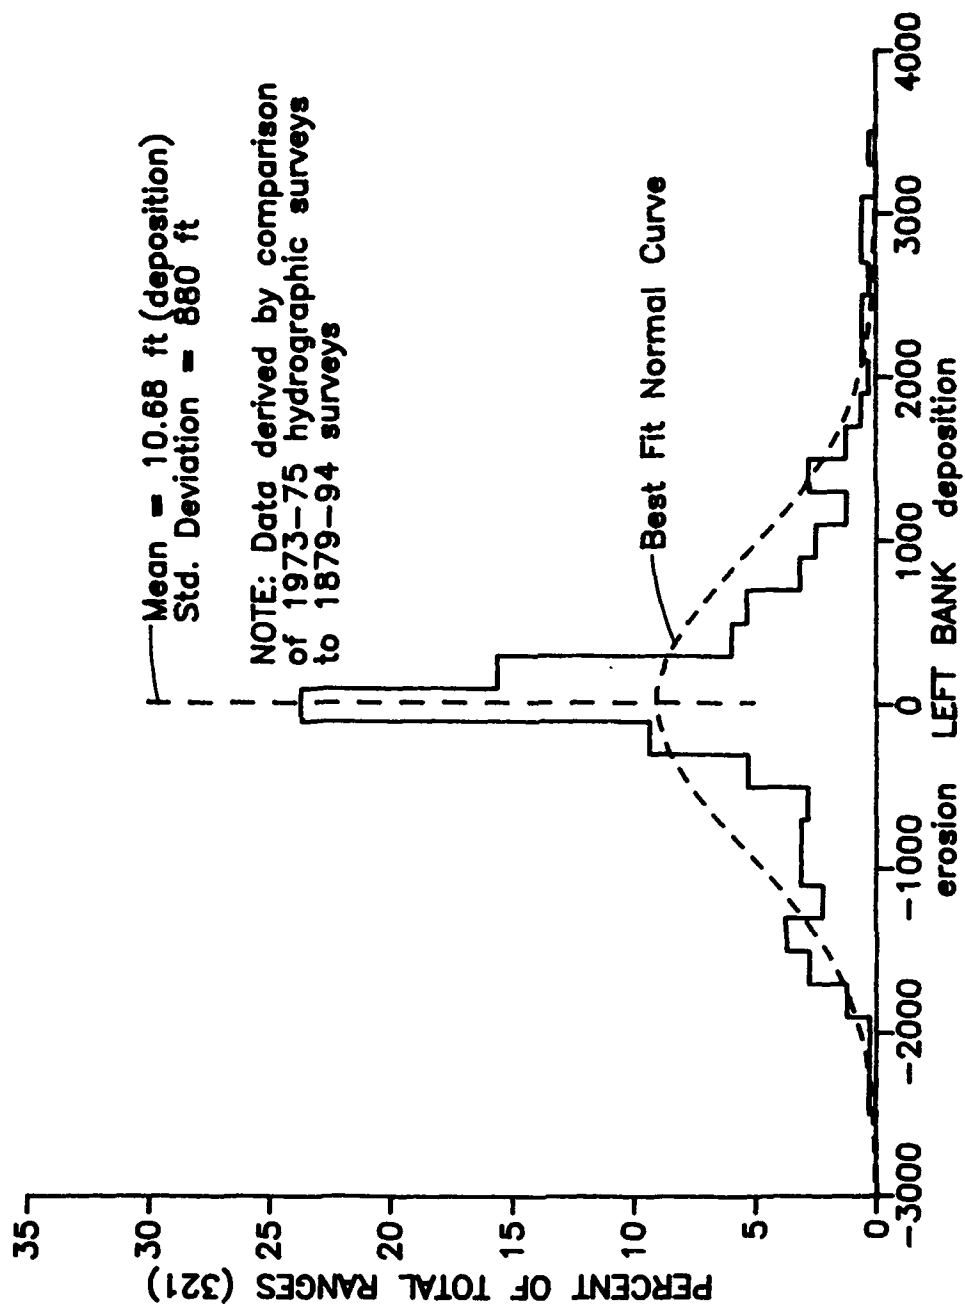
Figure 33. Frequency histogram, historical erosion/deposition, left bank, range 234.8 to 129.8, Mississippi River below Baton Rouge, LA

- b. When the total data sets are divided into the subsets above Bonnet Carre Spillway and below (right bank--Figures 30 and 31, left bank--Figures 33 and 34), the differences between the two reaches are again seen. The dispersions of the data for both banks above Bonnet Carre Spillway (hydrographic range R-129.8) are very similar (right bank standard deviation = 901 ft of batture; left bank standard deviation = 380 ft of batture). This reiterates the previous statement that the river has been much more active above Bonnet Carre Spillway than below. It is also seen that above R-129.8 the mean trend has been deposition for both banks, while below R-129.8 the mean trend has been erosion for both banks. Therefore, on the average, the river has tended to become narrower above Bonnet Carre Spillway but wider below.

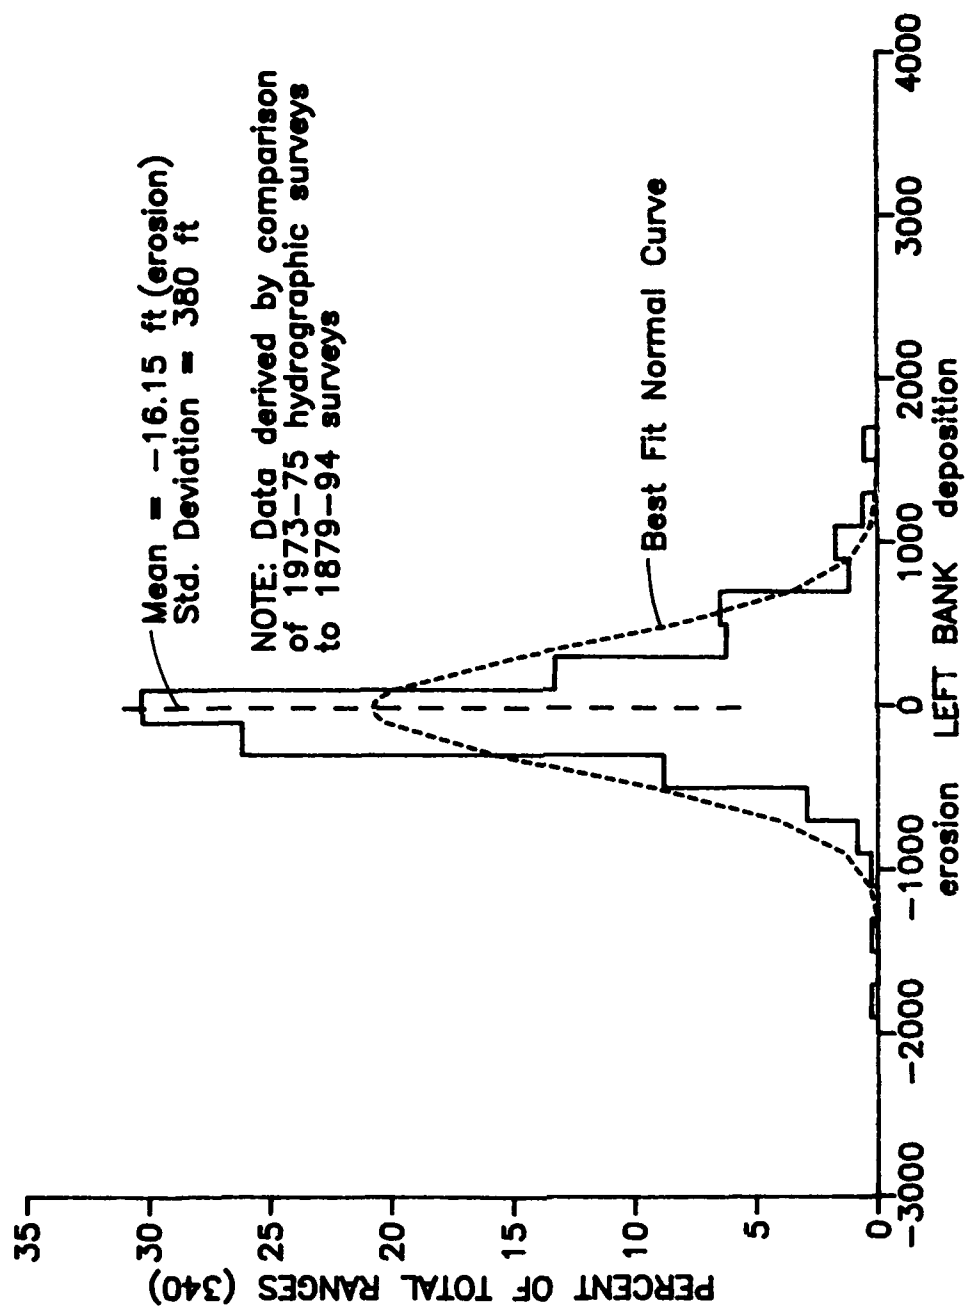
Figure 34. Frequency histogram, historical erosion/deposition, left bank, range 129.8 to 10.6, Mississippi River below Baton Rouge, LA

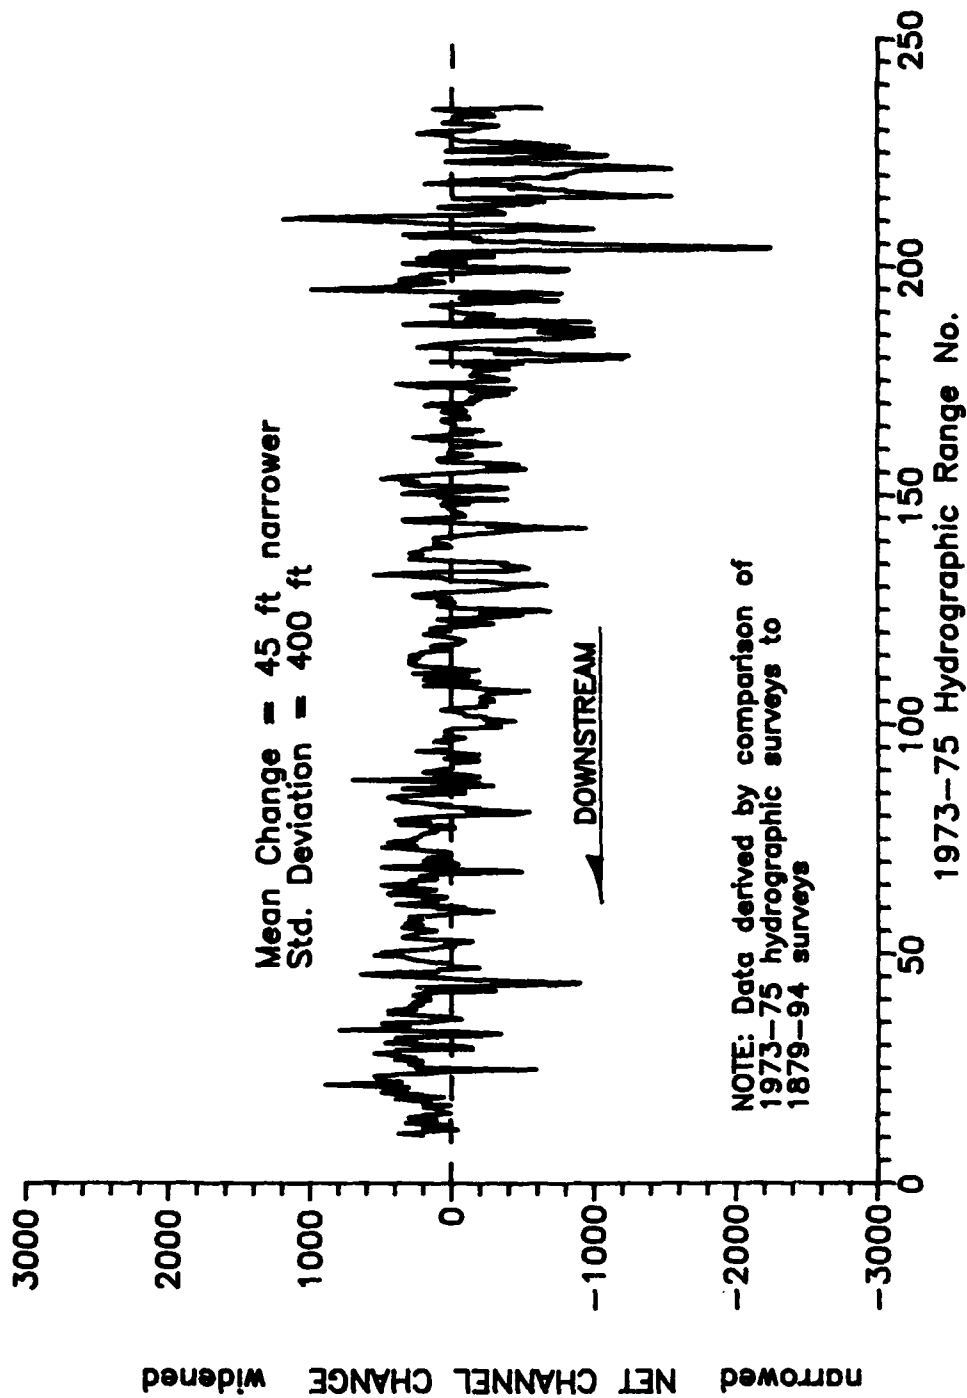
41. Figures 35 and 36 show the changes in channel width and maximum depth, respectively, over the period of record. The changes in depth are based roughly (maximum error judged to be less than 5 ft between the old and latest surveys) on LWRP. The change in width shown in Figure 35 exhibits a clear trend from upstream to downstream in that the river has tended to transition from becoming narrower to becoming wider with the crossover point again being near Bonnet Carre Spillway. This trend is not favorable since Figure 36 reveals that very little significant changes have occurred with respect to depth. If the river remains at the same depth above R-129.8 while it tends to become narrower in that same reach, it portends increasing average current velocities. This will cause trouble where erosion/scour hole formation, general bank stability, and flow slide problems are concerned. In addition, the tendency of the river to slowly widen below R-129.8 portends bank caving problems mostly in the "minor" category but, nonetheless, relentless. These trends just indicate that there is no relief in sight, and that the problems are likely to multiply.

Figure 35. Historical change in channel width, Mississippi River below  
Baton Rouge, LA

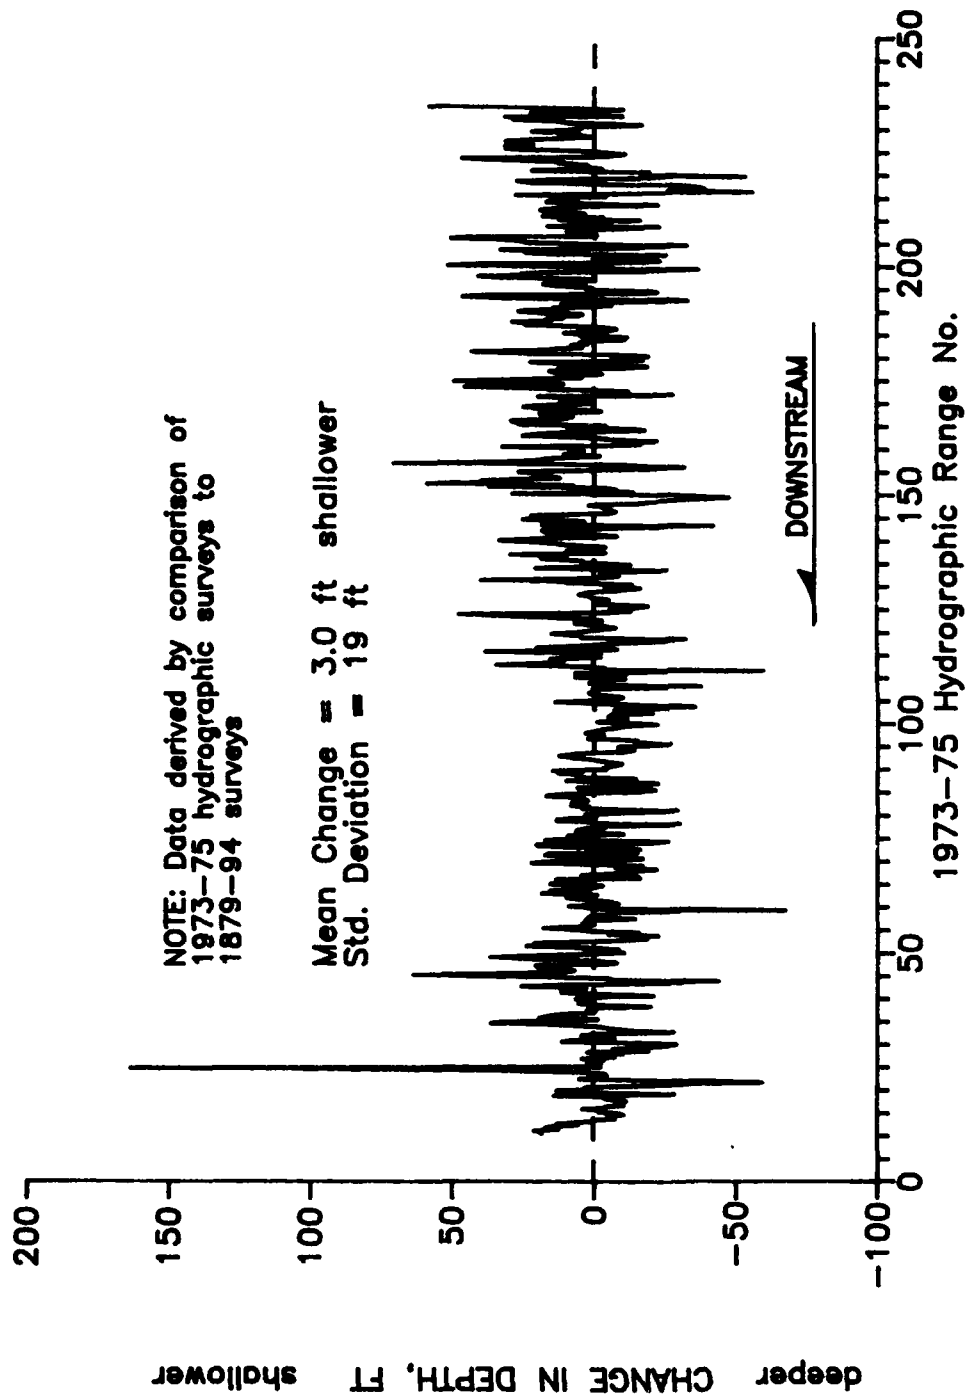
Figure 36. Historical change in channel depth, Mississippi River below Baton Rouge, LA

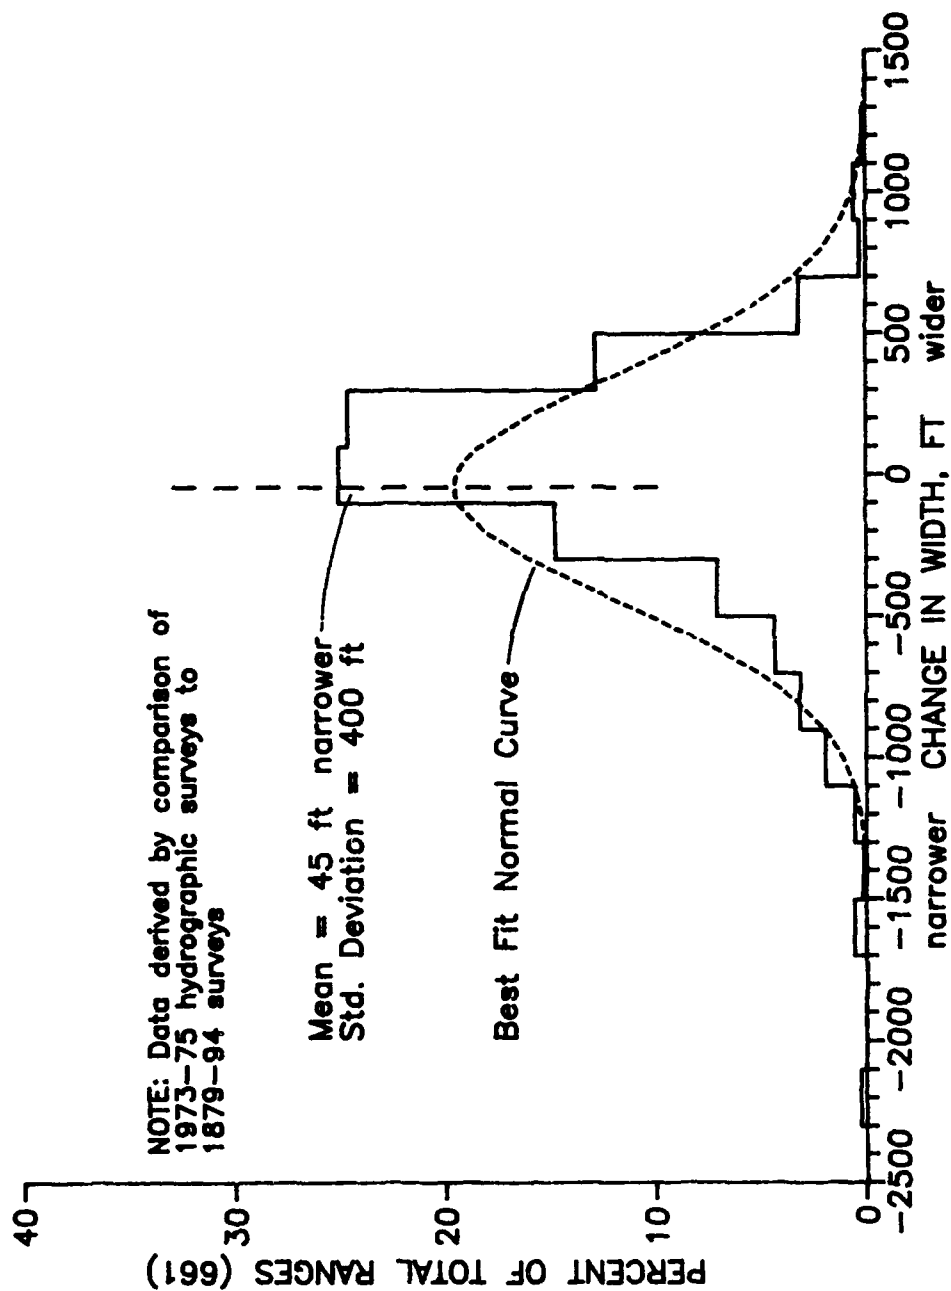
42. Frequency histograms for the change in channel width are given in Figures 37-39 and for change in channel depth in Figures 40-42. The change-in-width histograms illustrate the trends addressed above. The change-in-depth histograms show strong normal distribution tendencies and reveal how little depth has changed over the total period of record. For the total reach of river below Baton Rouge, over 90 percent of the ranges reflected a change

Figure 37. Frequency histogram, change in channel width, range 234.8 to 10.6, Mississippi River below Baton Rouge, LA

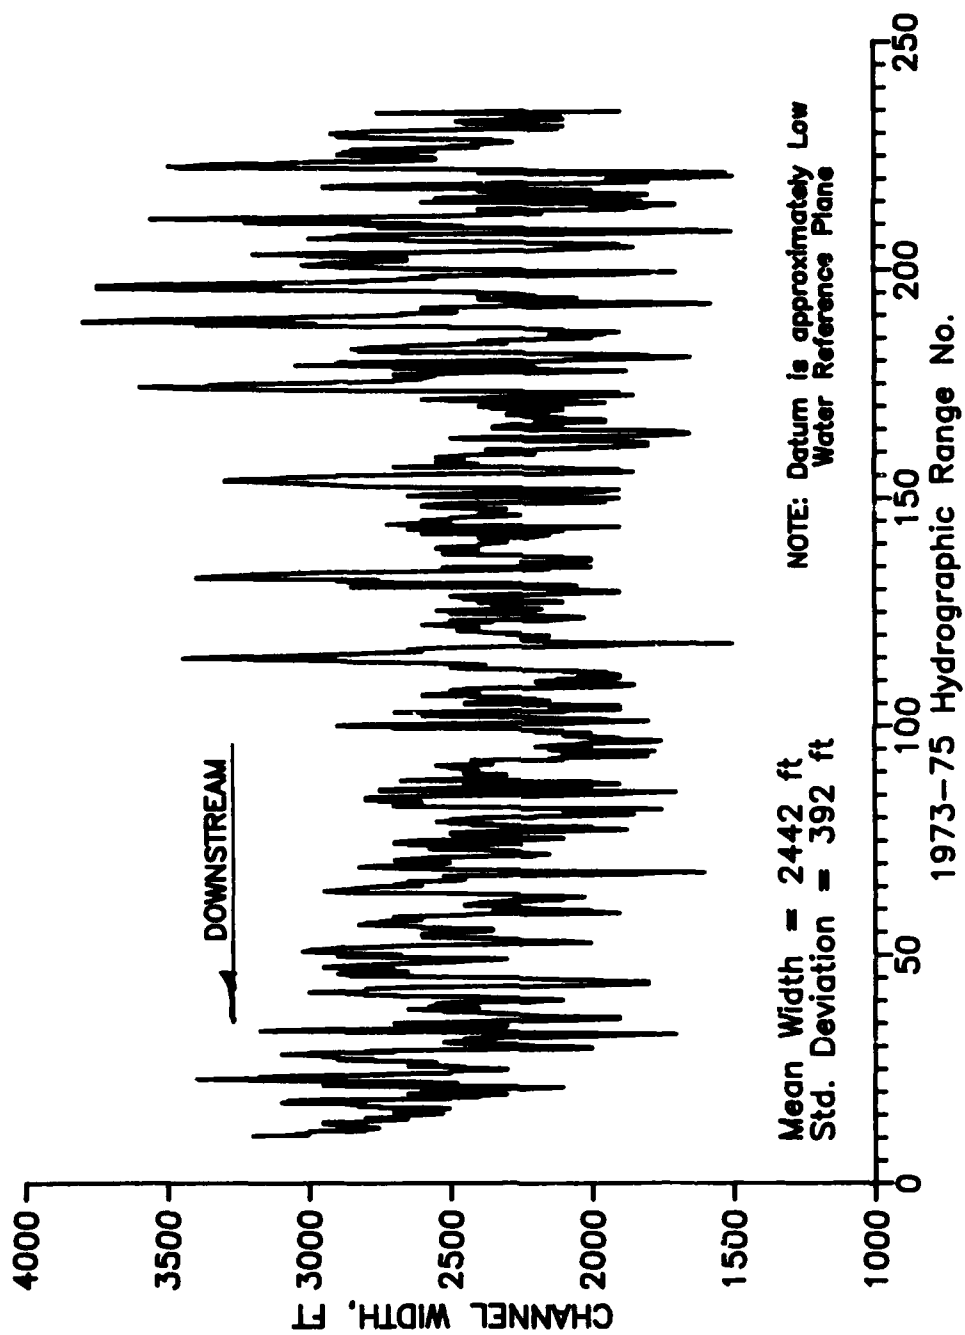
44. The discrete data for width, depth, W/D ratio, and triangular area are plotted in Figure 44-47, respectively. Corresponding frequency histograms are given in Figures 48-51. Figure 44 shows a slight tendency for the average channel width to be larger at both ends of the reach below Baton Rouge and for pronounced amplitude in width variation in the upstream half (R-234.8 to R-110.0) of the reach. Channel depth shown in Figure 45 tends to steadily

Figure 44. Channel width, Mississippi River below Baton Rouge, LA,  
1973-1975 hydrographic survey

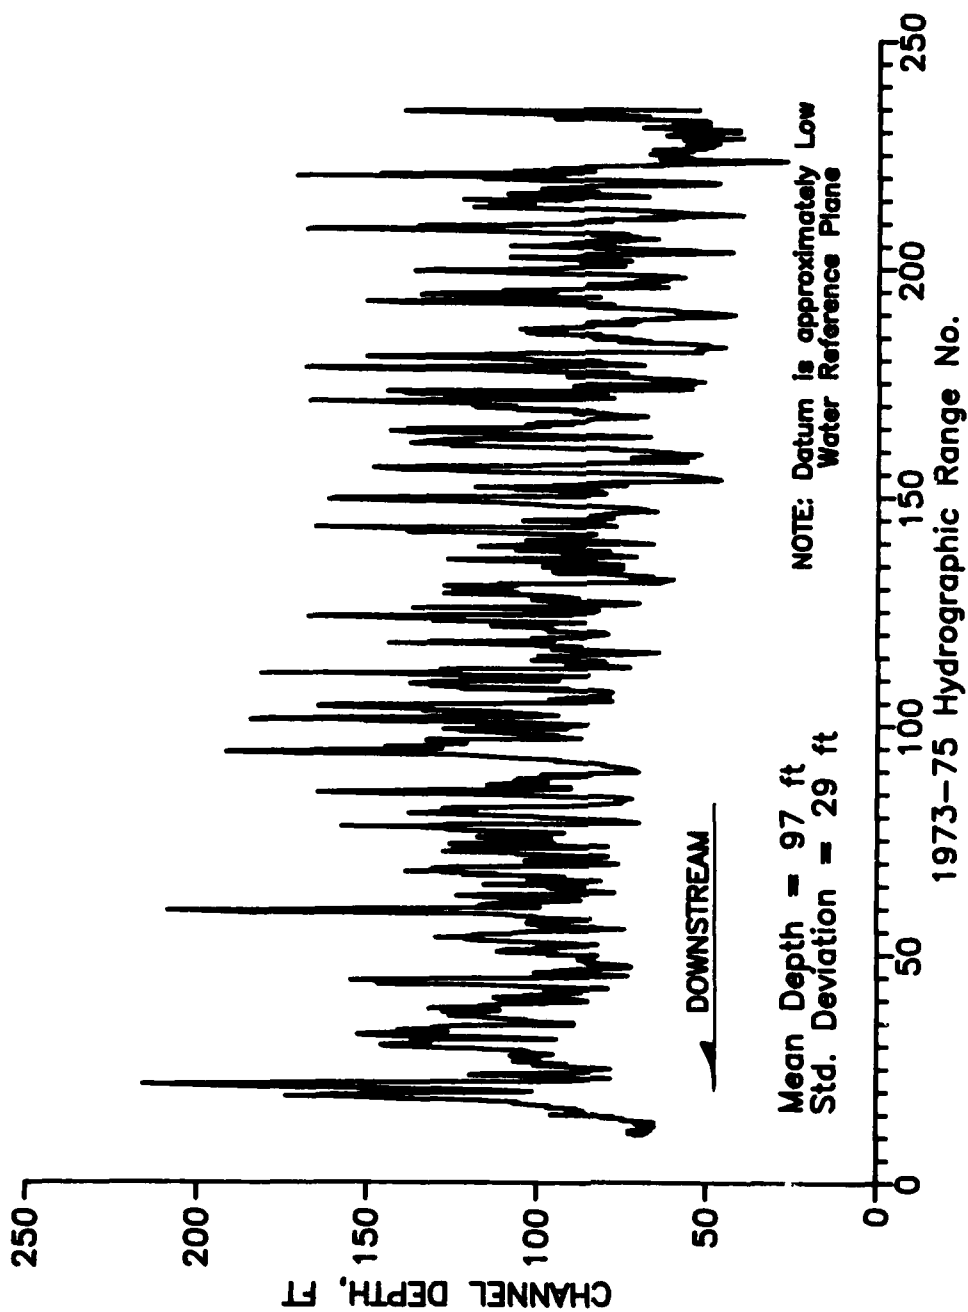
Figure 45. Channel depth, Mississippi River below Baton Rouge, LA, 1973-1975 hydrographic survey

increase on the average in the downstream direction. Width-to-depth ratio (Figure 46) shows a distinct change in pattern near range R-110 which reflects the trends in width previously mentioned. Channel triangular area (Figure 47) exhibits a consistent tendency to increase in the downstream direction. The histograms reveal that width (Figure 48) is almost perfectly normally distributed (random variable), while area (Figure 51) is relatively normally distributed and depth exhibits the least normal trend of the three parameters. Width-to-depth ratio (Figure 50) is clearly skewed in its distribution.

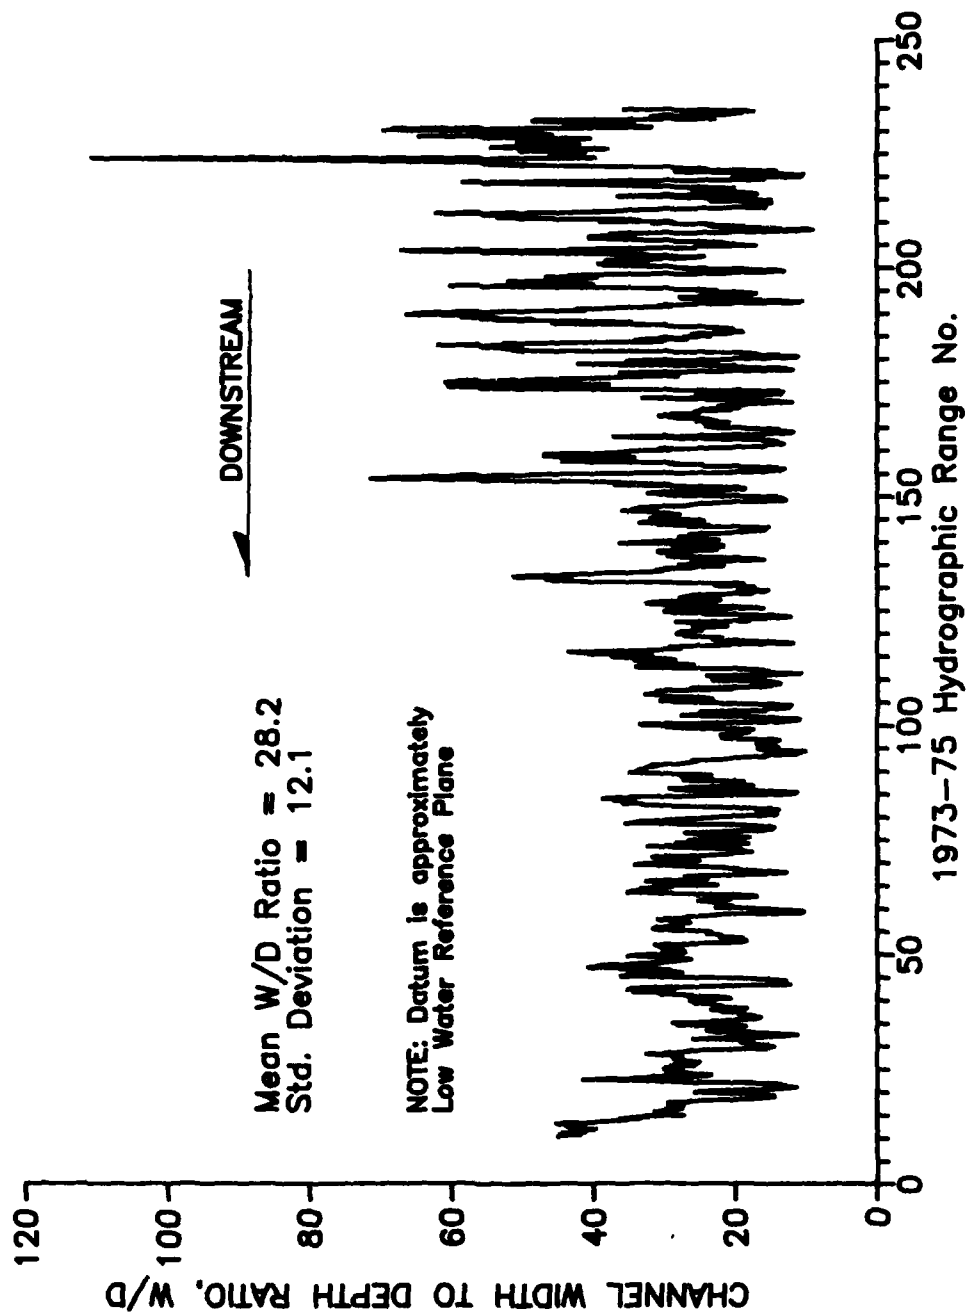
Figure 46. Channel W/D ratio, Mississippi River below Baton Rouge, LA,  
1973-1975 hydrographic survey

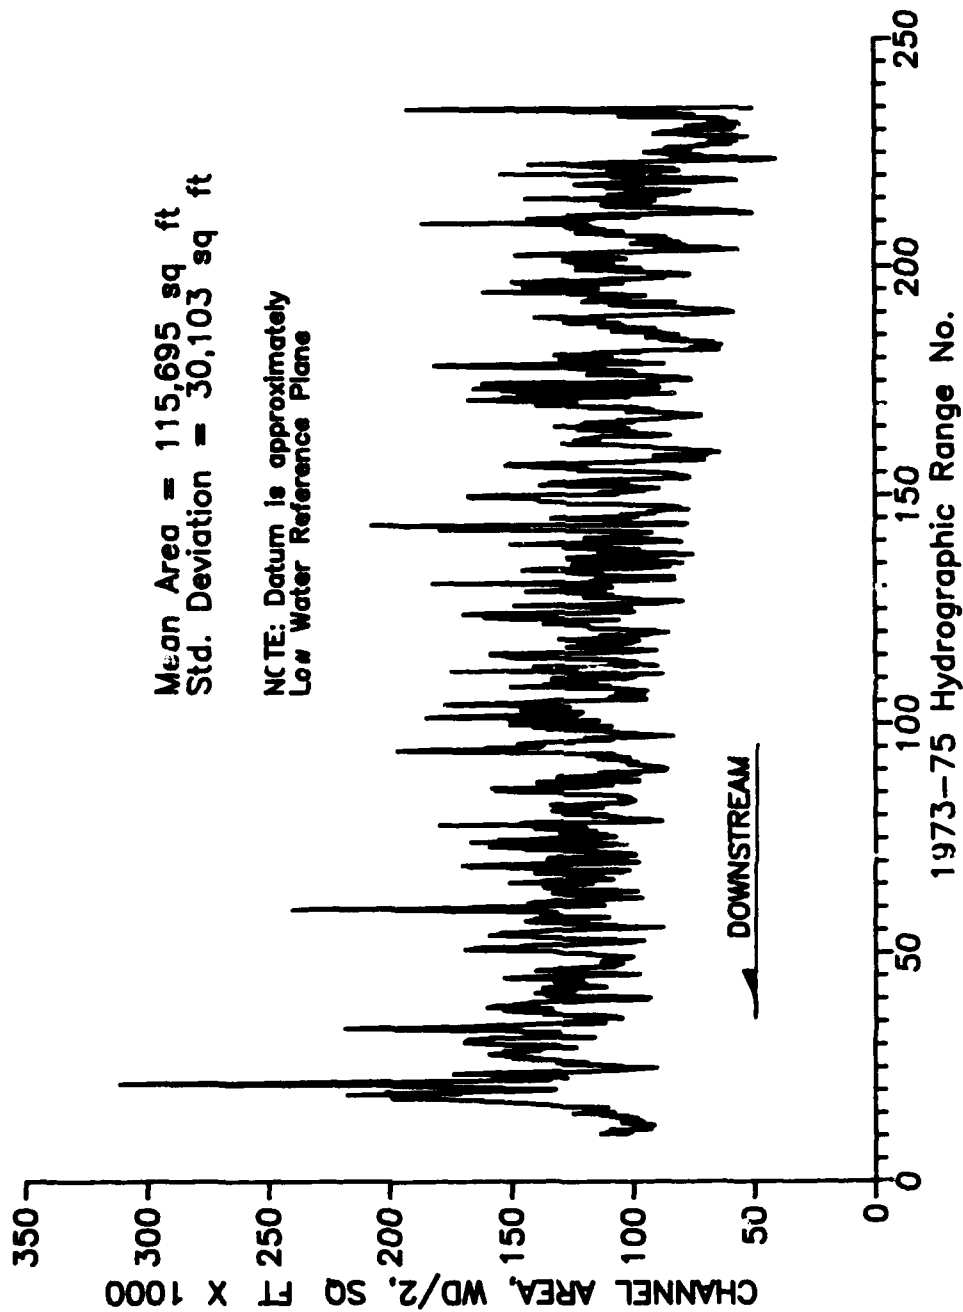
Figure 47. Channel triangular cross-sectional area, Mississippi River below  
Baton Rouge, LA, 1973-1975 hydrographic survey

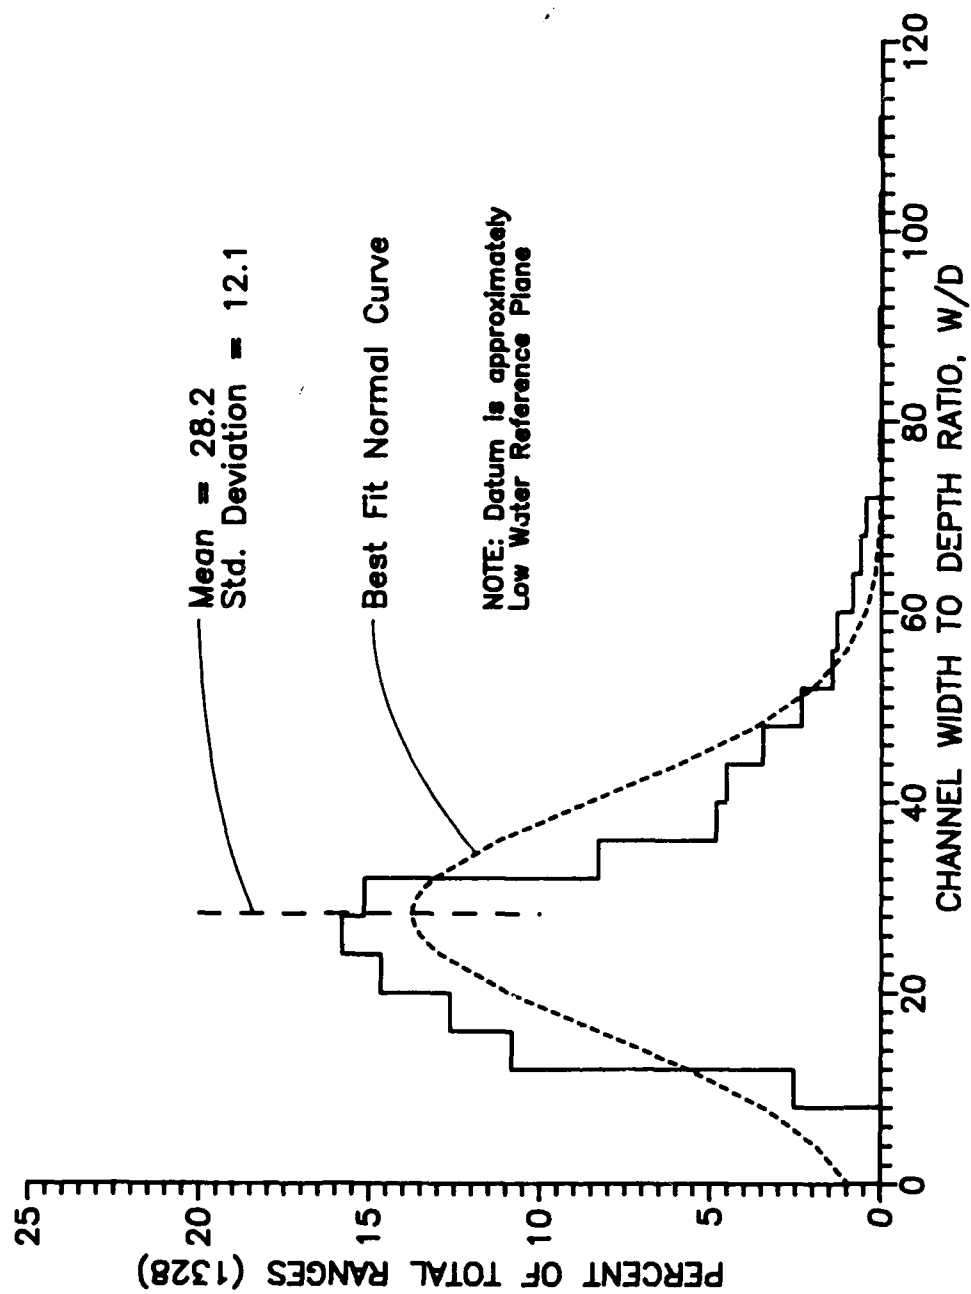
Figure 50. Frequency histogram, 1973-1975 channel W/D ratio, range 234.8 to 10.6, Mississippi River below Baton Rouge, LA
