AEFA Project No. 87-25

## EVALUATION OF THE IMPROVED OV-1D ANTI-ICING SYSTEM

April 1988  
Final Report

AVIATION ENGINEERING FLIGHT ACTIVITY  
Edwards Air Force Base, California 93523-5000

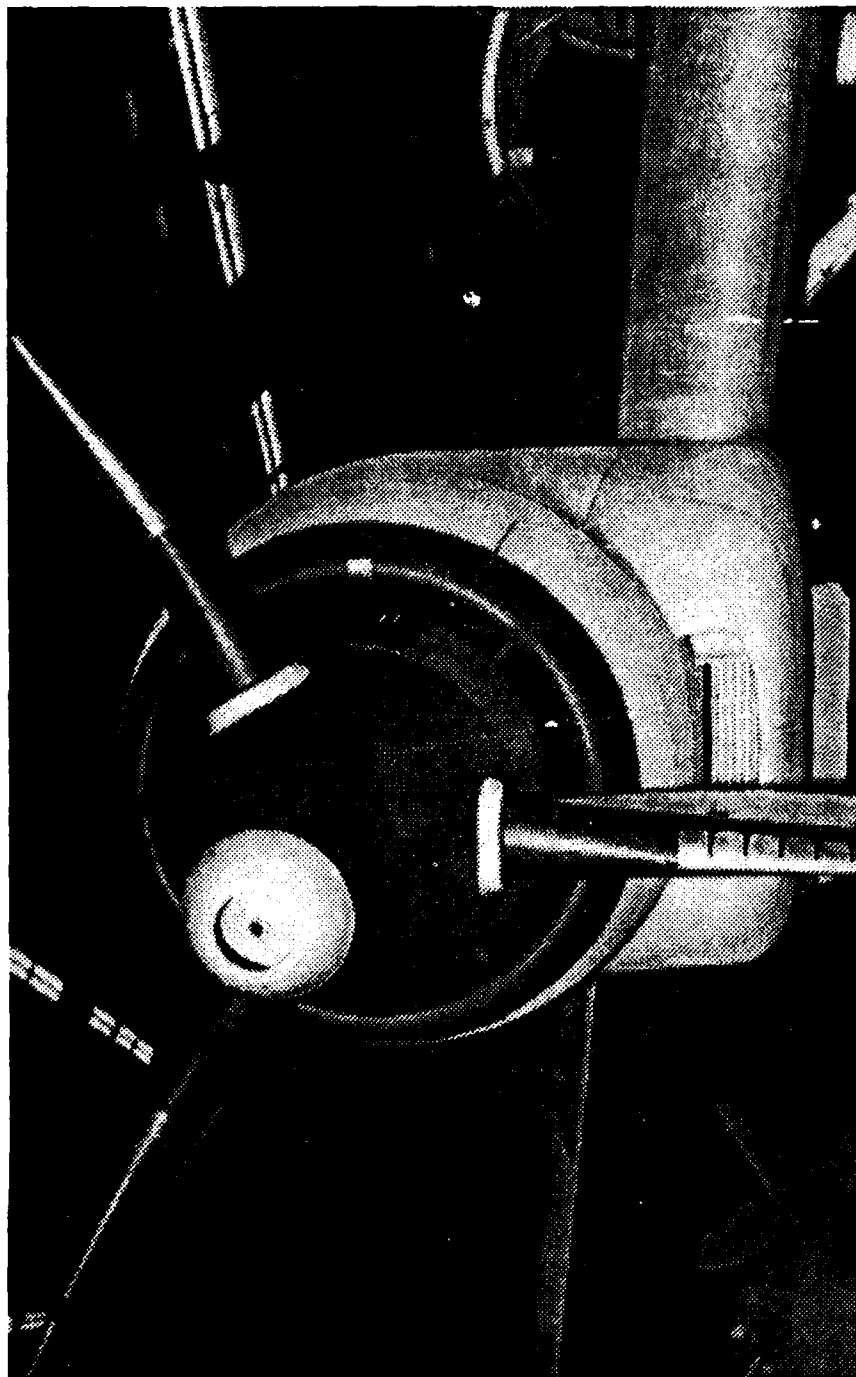
Figure E-16. Propeller and Engine Inlet

11. The propeller blades and plateaus are protected by a deice system (see app B). At temperatures colder than -15 degrees C, the propellers accreted ice to approximately three quarters of an inch. Ice accreted on the plateaus to approximately one-half inch radially out from the plateaus. When these components deiced, airframe vibration would increase and chunks of ice would impact the side of the fuselage and drop tanks causing slight damage (fig. E-6 and E-7). The ice accretion characteristics of the propellers and damage caused by their shedding characteristics are a shortcoming.
