Evaluation of Optical Materials Samples

FINAL REPORT

Prepared by:
University of Dayton
Research Institute
Dayton, Ohio 45469

JULY 1988

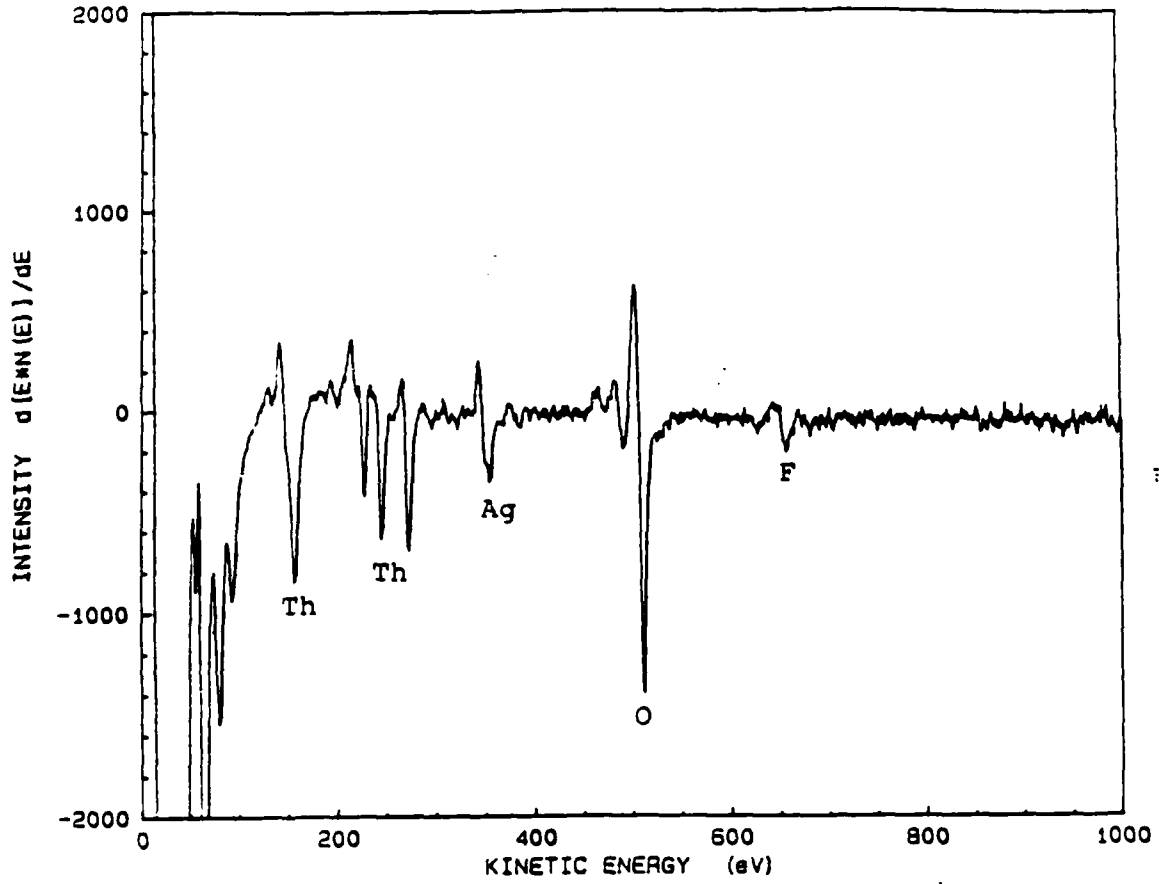
6-3788-2. FAR LEFT REGION OF LINE SCAN

Figure 9. An Auger spectrum from the far left portion of Figure 8 along the line scan.

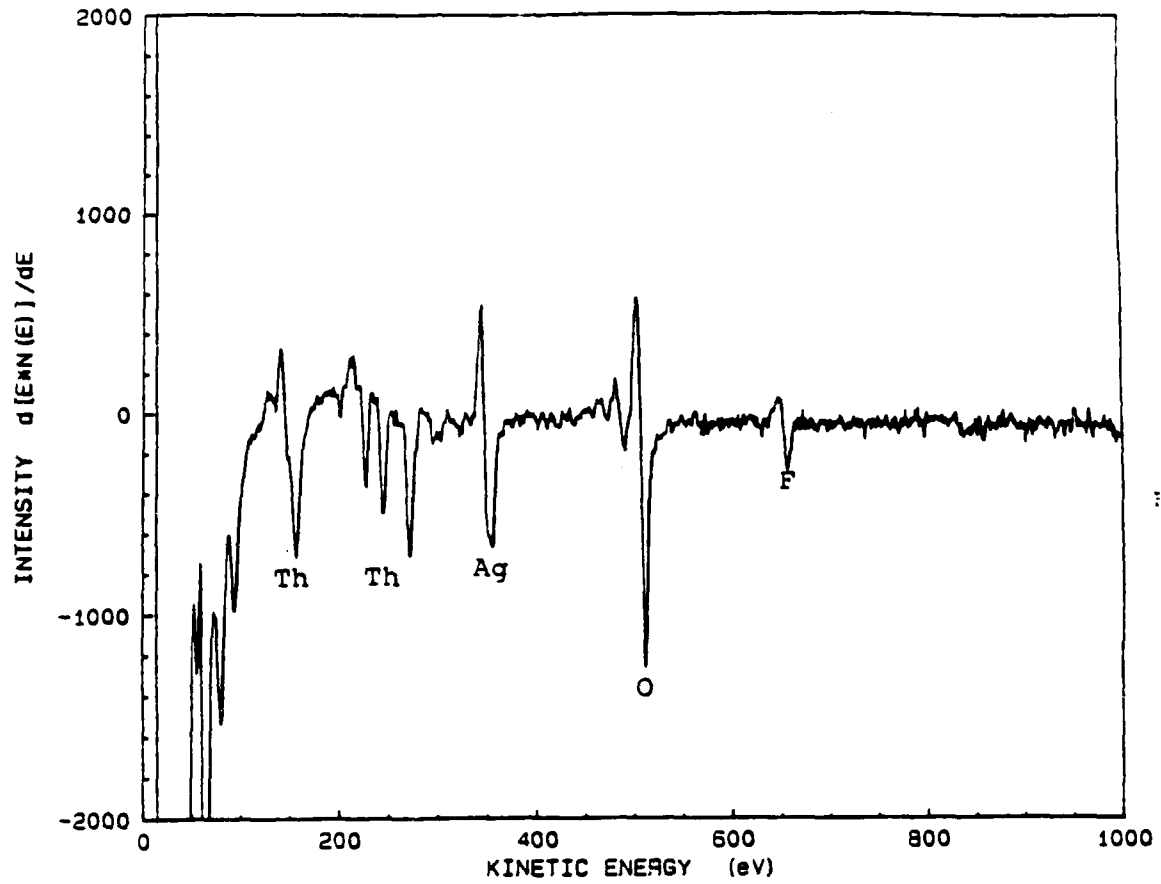
6-3788-2. LINE SCAN, LEFT RIM OF CRATER

Figure 10. An Auger spectrum from the left rim of crater #2 along the line scan.

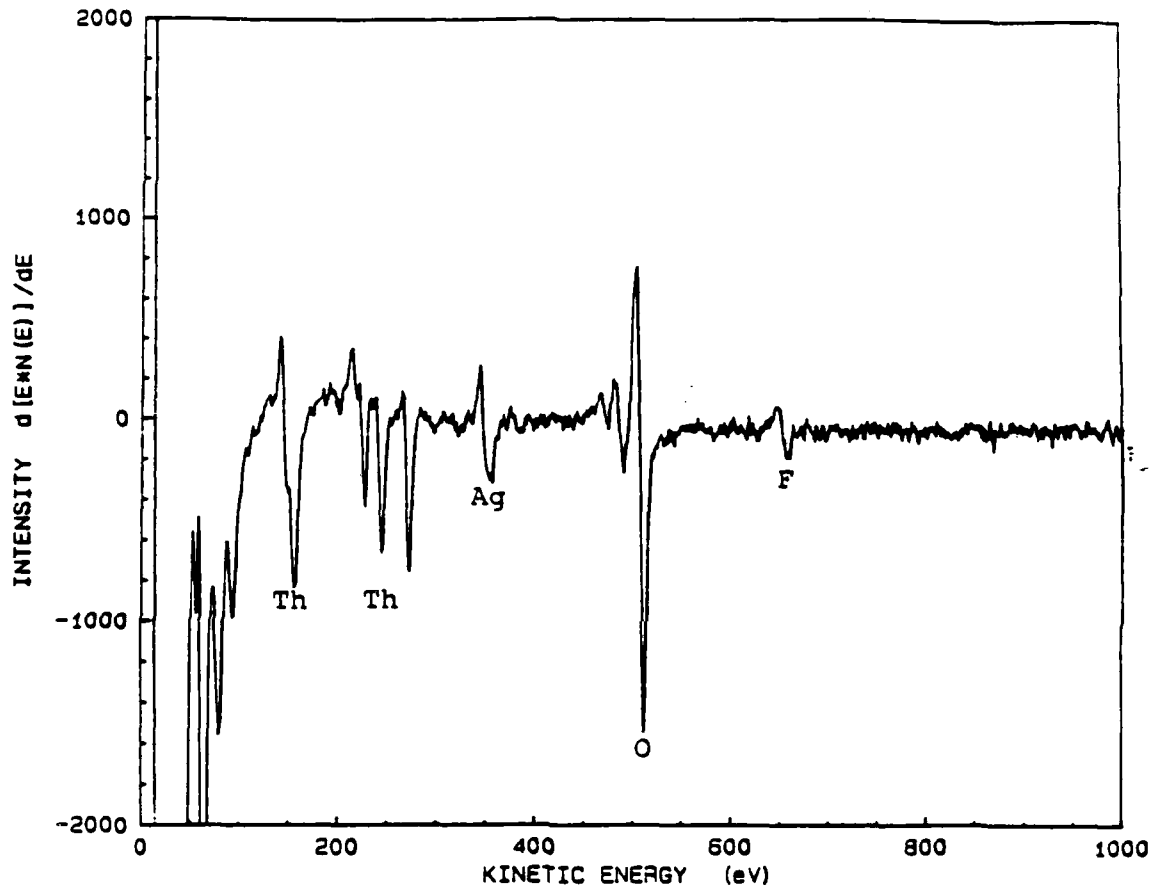
6-3788-2. WITHIN CRATER, BELOW CENTER OF LINE SCAN

Figure 11. An Auger spectrum from within the perimeter of crater #2 just below the central pit.

We conclude from Table 1 that the oxygen level is artificially high and probably results from exposure to oxygen during catastrophic failure as well as from oxygen gettered from the Auger vacuum system. The fluoride level is most definitely reduced by the Auger analysis and may also be further reduced during catastrophic failure if temperatures reach excessive levels. It is interesting to note that the fluoride level increases as the silver fluoride compound may be a reaction product in this failure mode. This could also explain the presence of fluoride in Figure 7 where thorium is not detected.

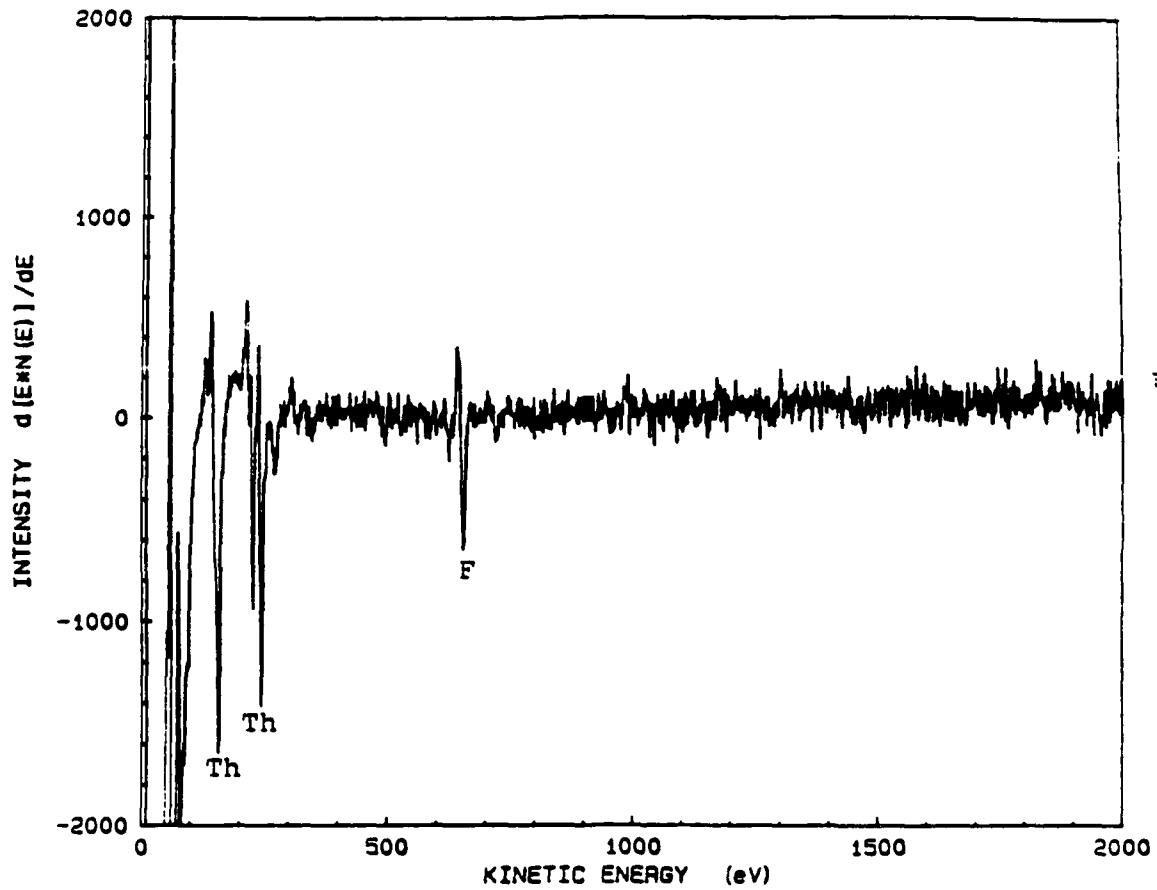
6-3788-02. THORIUM FLUORIDE WHILE SPUTTERING

Thorium fluoride presents several problems with regard to Auger spectroscopy. It is known from the literature and from our previous experience with calcium fluoride, that electron beam desorption of fluorine will almost certainly occur during Auger analysis. Consequently the levels measured with Auger spectroscopy may not reflect actual fluoride (fluorine) concentrations in an unperturbed specimen unless damage thresholds are established. Further, with ThF_4 , as fluoride is desorbed, the vacated sites are highly energetic and will tenaciously getter oxygen, even at pressures in the 10^{-7} Pa range. The fluorine and oxide concentrations shown in Table 1 must be interpreted in terms of these e-beam phenomena. Further, these anomalies can be shown graphically just by turning off the ion beam and comparing Auger spectra. Figure 12 is an Auger spectrum from the ThF_4 layer with the argon ion beam on. Figure 13 is an Auger spectrum taken from the same region immediately after the ion beam was turned off. The pressure at the specimen during this analysis was in the low 10^{-6} Pa range. The desorption of fluorine could be demonstrated by watching the fluorine peak decrease as a function of electron beam irradiation time.

Figure 12. An Auger spectrum of ThF_4 immediately after the ion beam was turned off. Note the absence of oxygen which would occur near 510 eV.

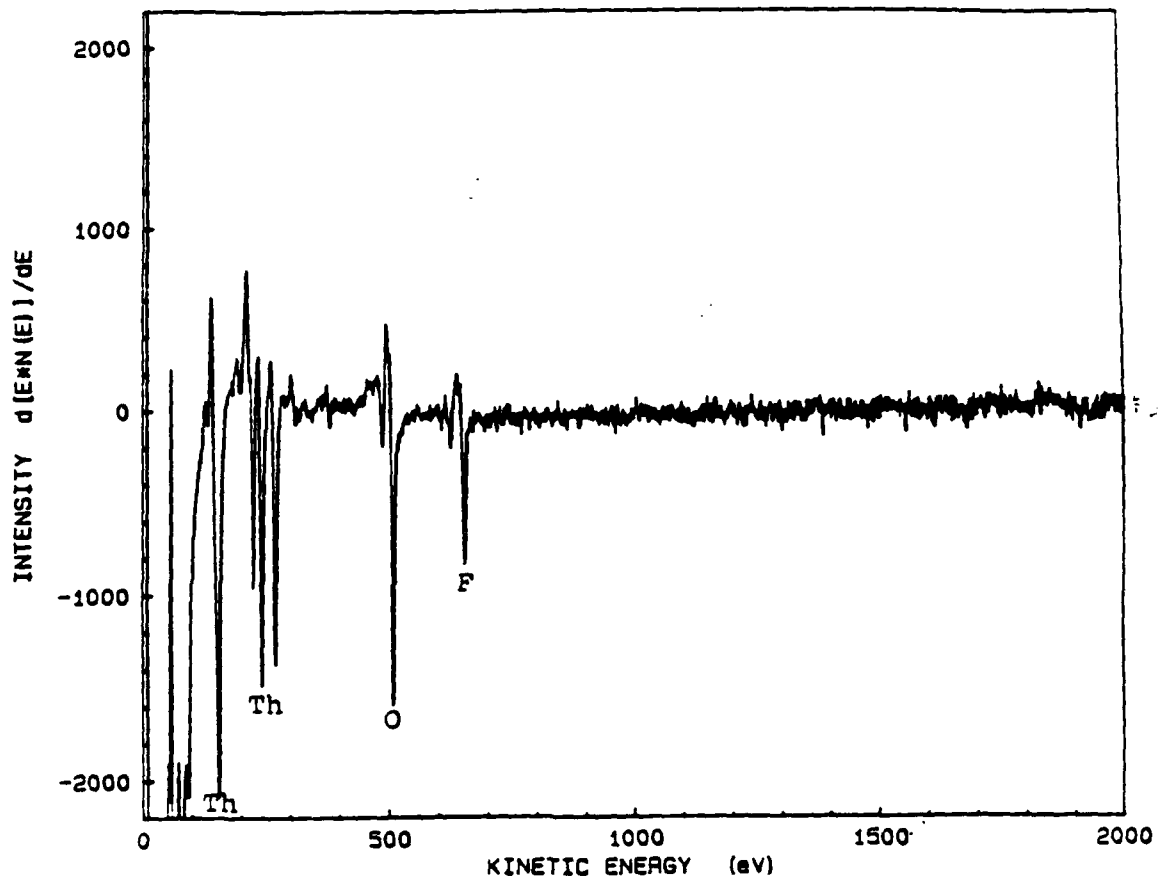
6-3788-02. THORIUM FLUORIDE. ION GUN OFF

Figure 13. An Auger spectrum of ThF_4 immediately after the ion beam was turned off. Note the large oxygen peak at 510 eV.

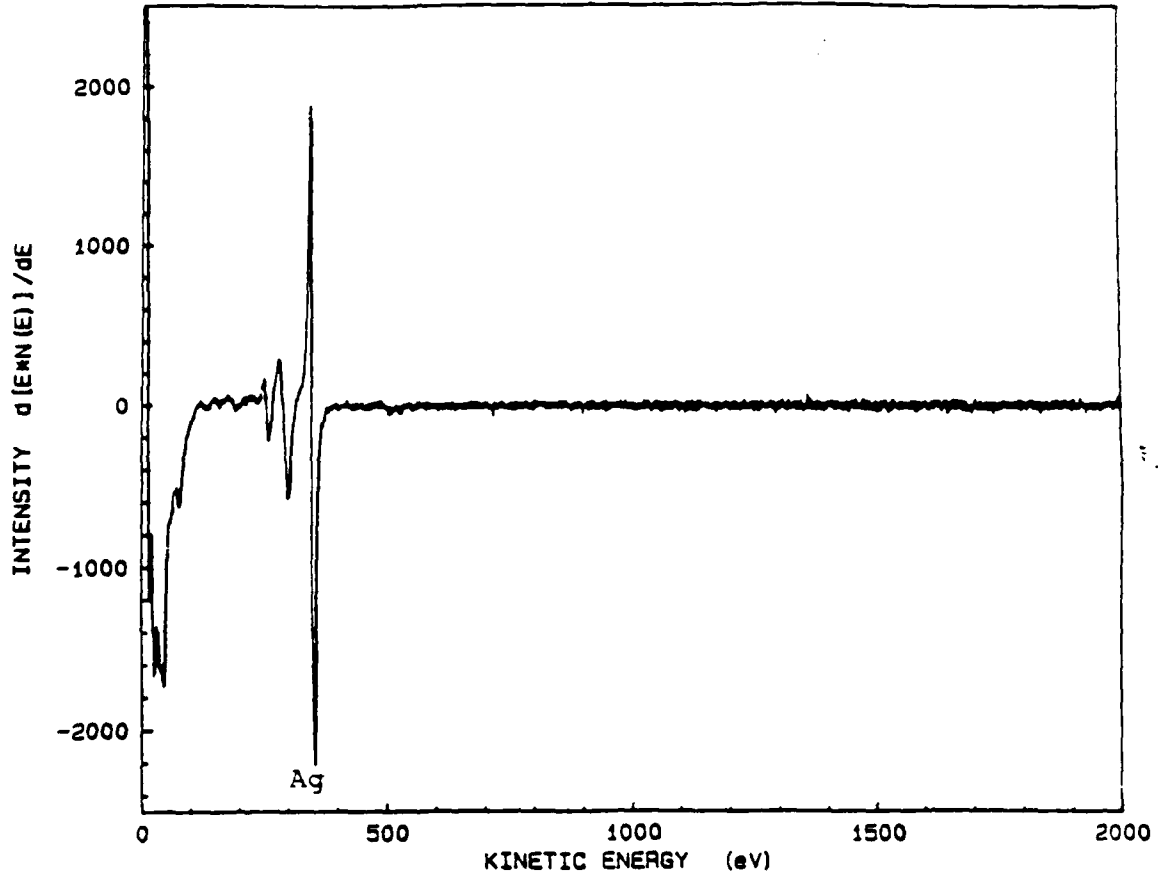
6-3788-2. SILVER FILM ABOVE CRATER #2

chromium, and silicon are present. The light colored region outside the crater is silver as shown by the Auger spectrum in Figure 16. It is interesting to note that silicon and chromium are seen within the crater and only silver is seen outside the crater even though both regions were sputtered for the same period of time. This suggests that most of the silver was expelled from the crater during failure. This is consistent with the Auger results. The gray region near the right and left hand edges of Figure 14 is the ThF_4 film. It appears that some blistering has occurred. Whether this is significant is unknown. This damage could very well be caused by the ion beam.

Figure 16. An Auger spectrum taken from a region above the damage site. Silver is the only element present.

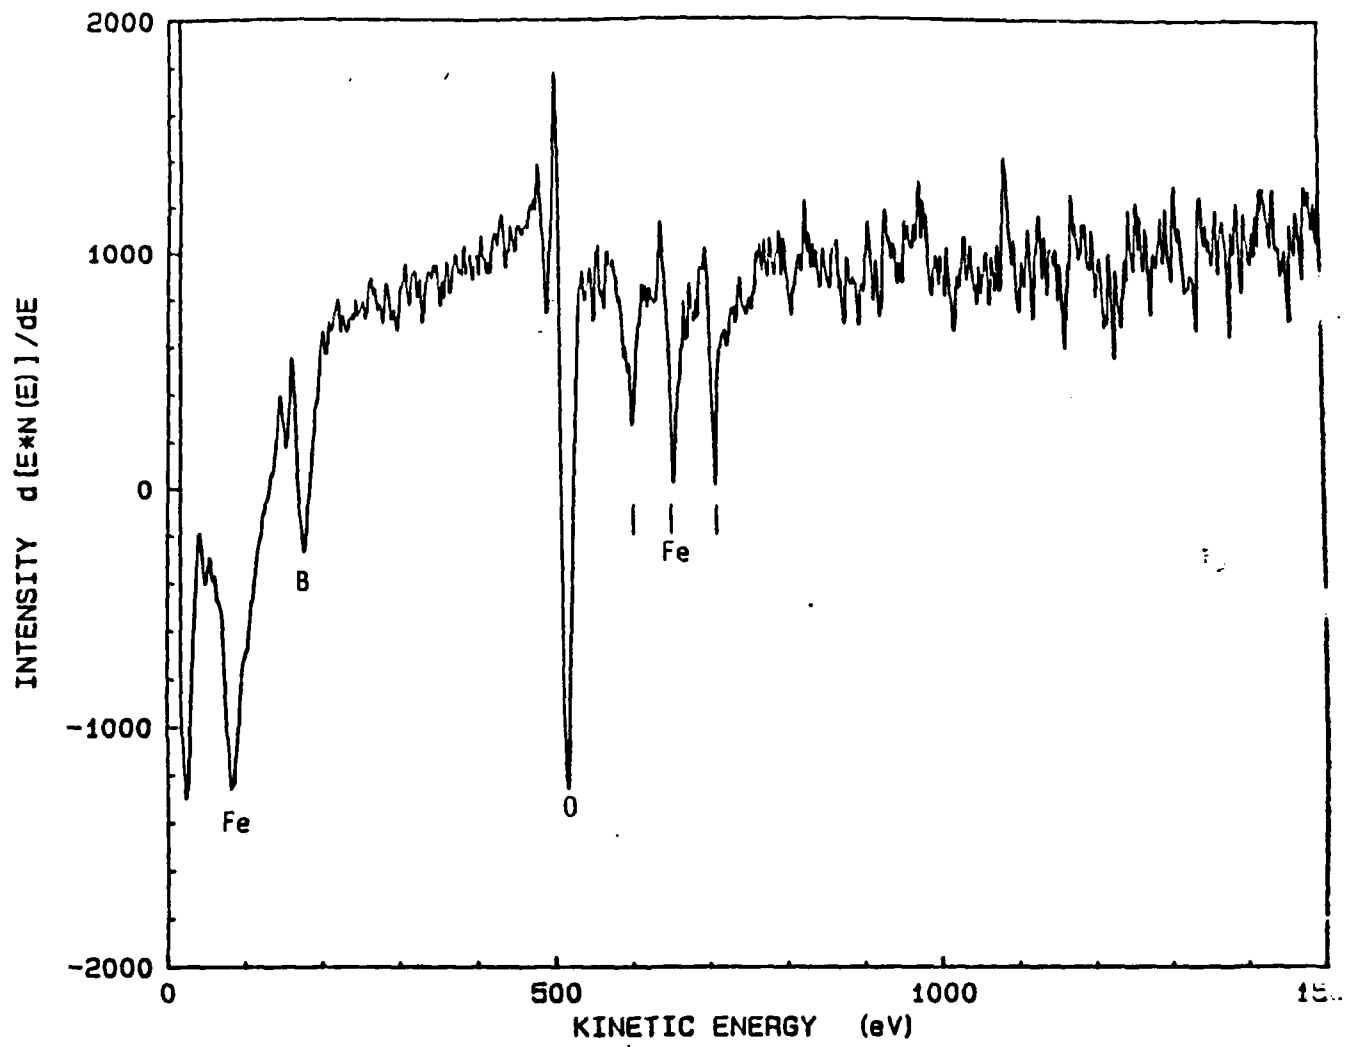
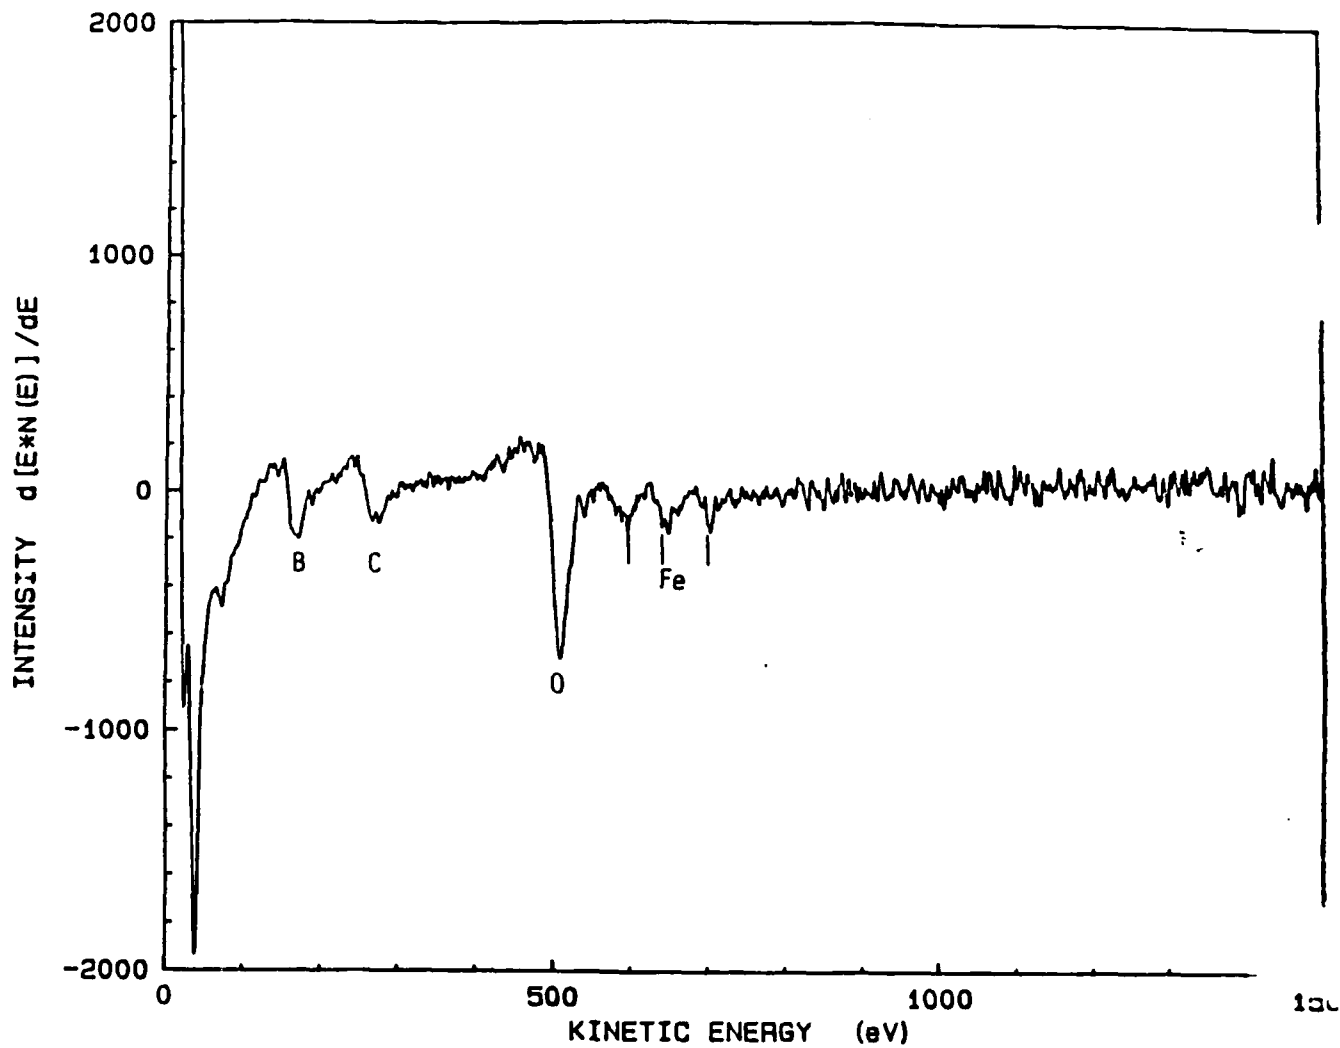
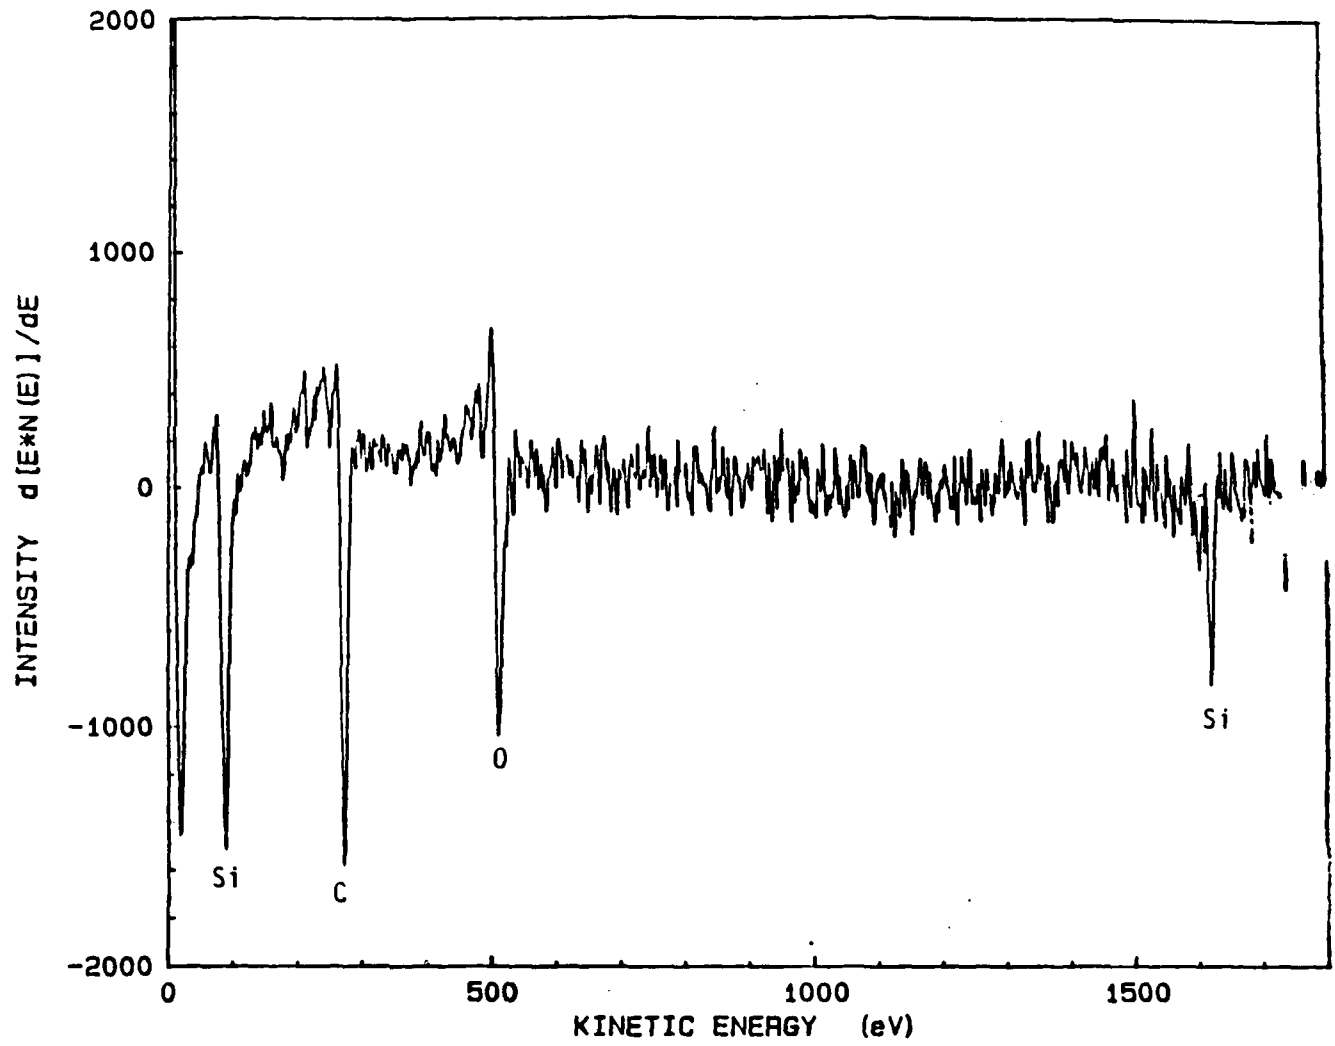
The results of the XRD analysis shown in Table 2 confirmed that the bulk porous material was only SiC. The Auger analysis, however, is more sensitive to the lighter elements and indicated the presence of O and B. Figures 27, 28, and 29 are ACS scans taken confirming that the contaminant was B and also a small amount of Fe. At the time, the presence of boron was not understood until it was discovered that boron carbide (B_4C) was used as the cutting agent in the ultrasonic machining operation. Figure 30 shows two regions investigated. Region 1 was a fracture area of a machined SiC post and region 2 an area of white "deposit". Figures 31 and 32 are magnified areas of regions 1 and 2, respectively.

Figure 27. Laser mirror mount contaminated region 1.

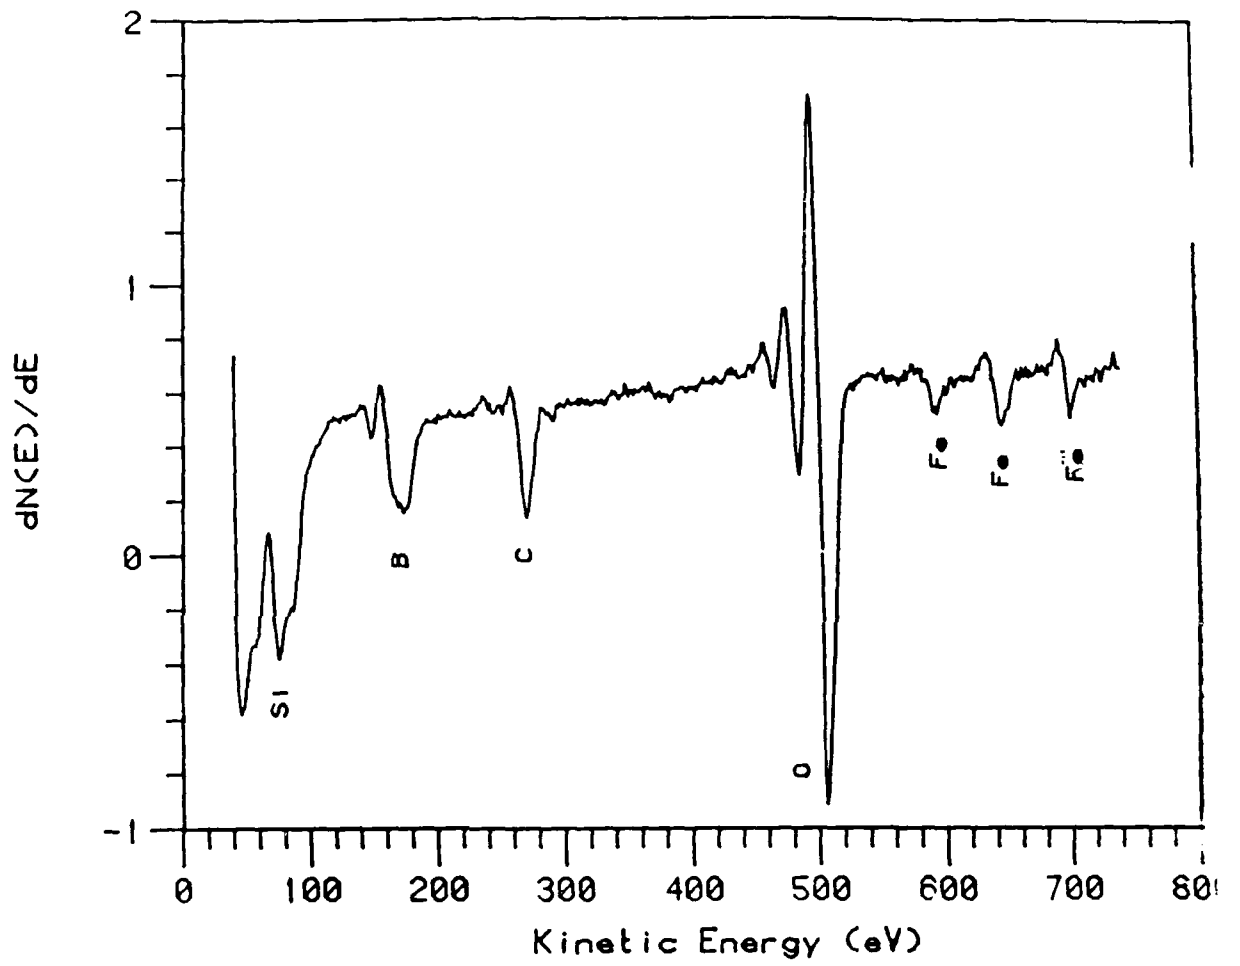
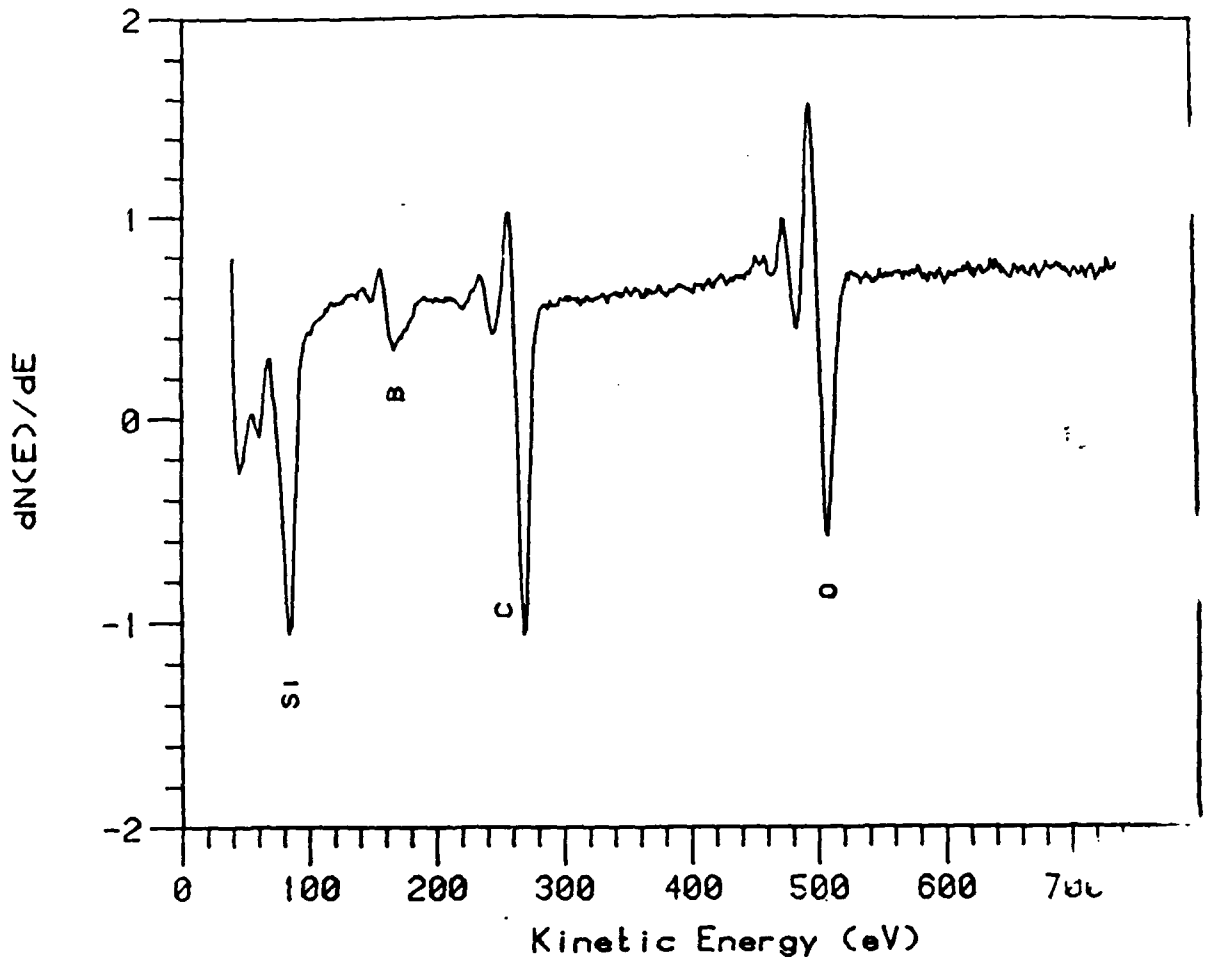
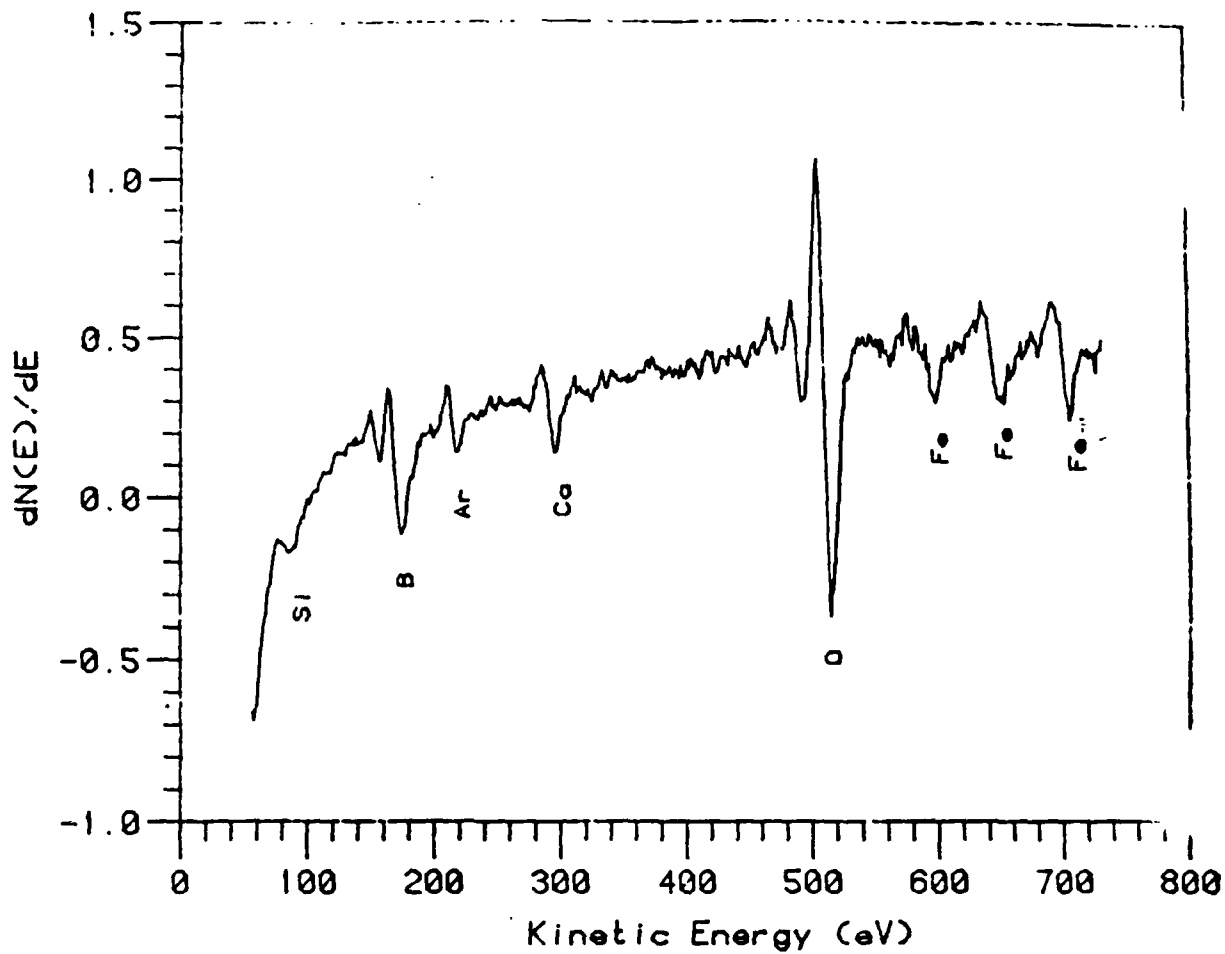
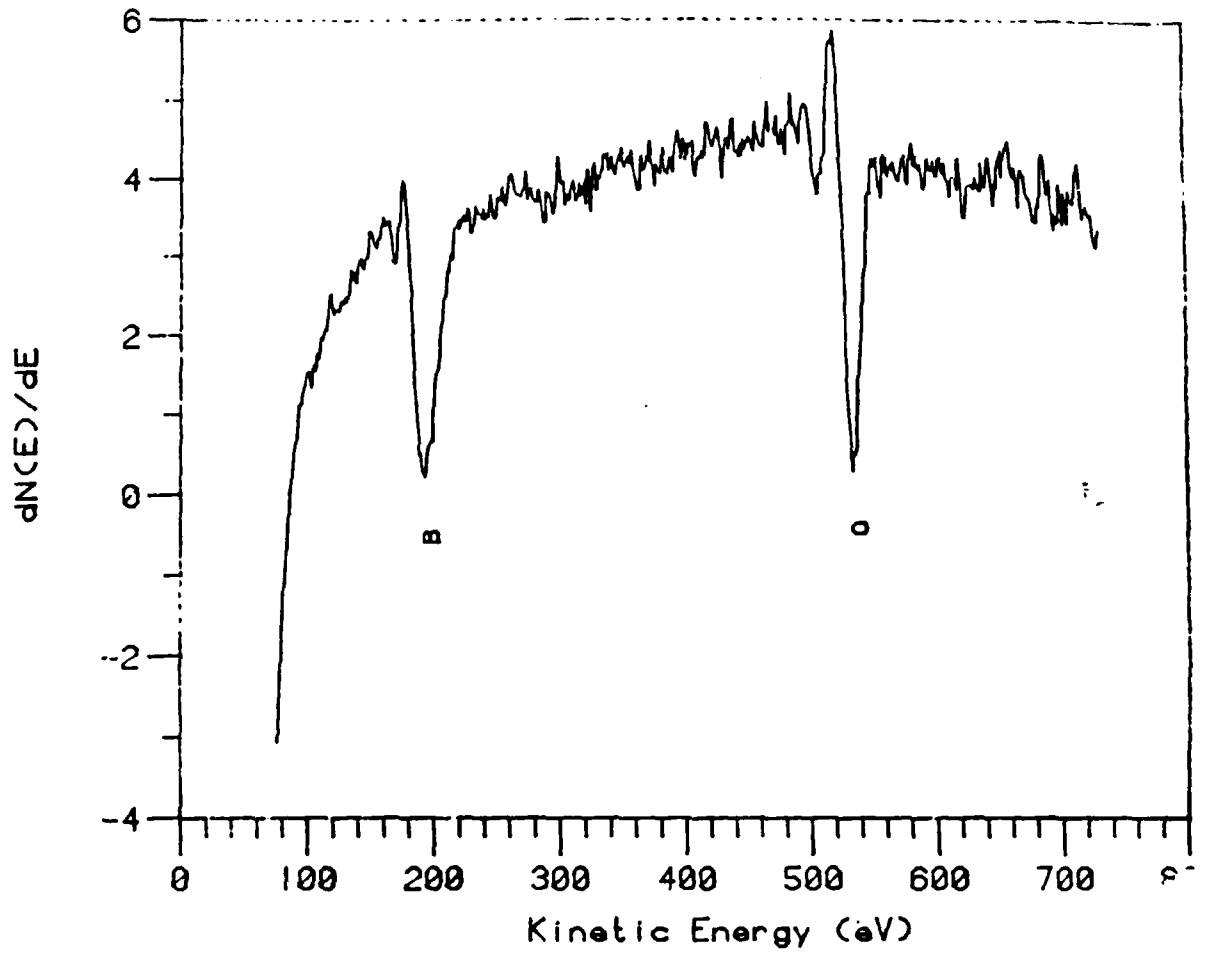
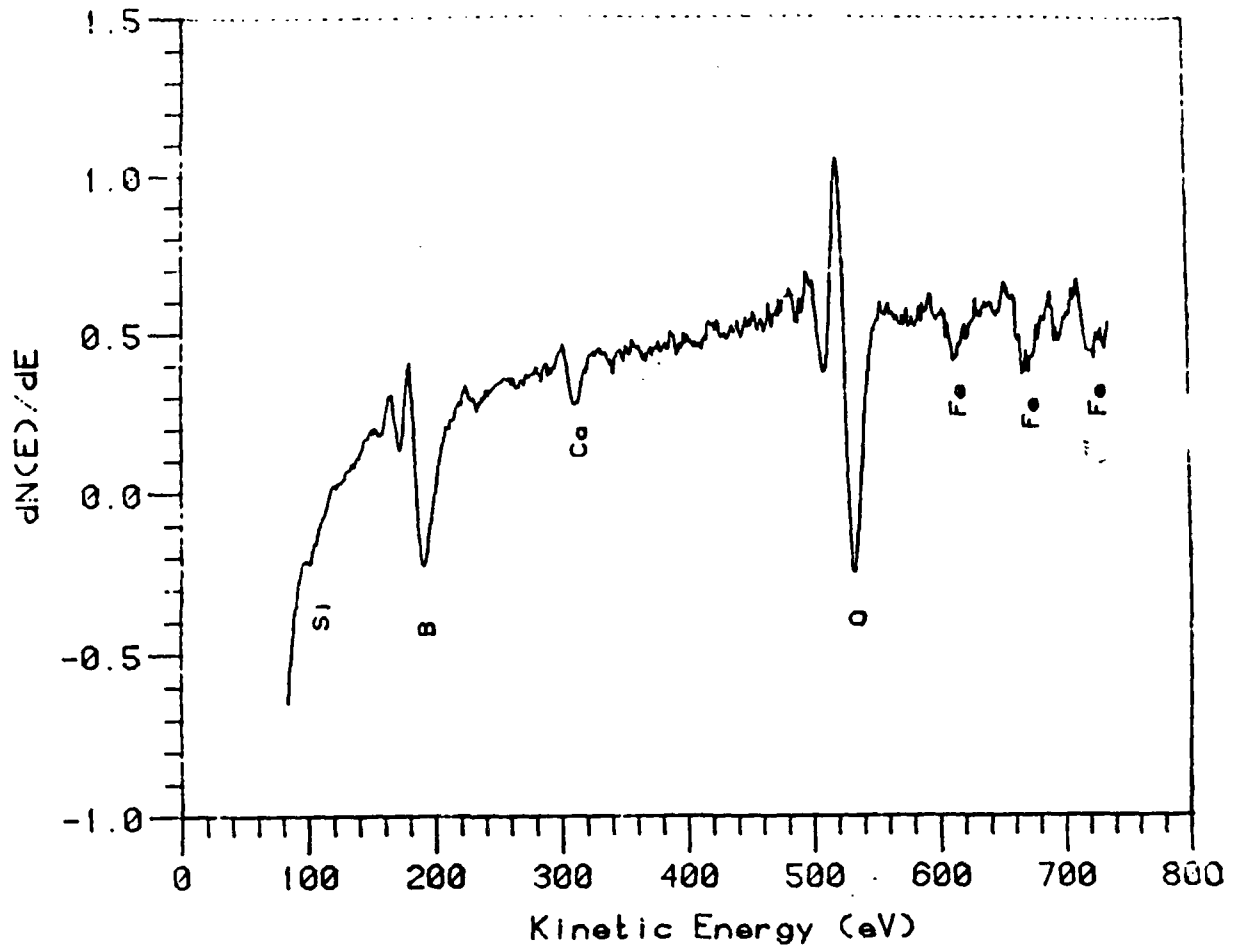
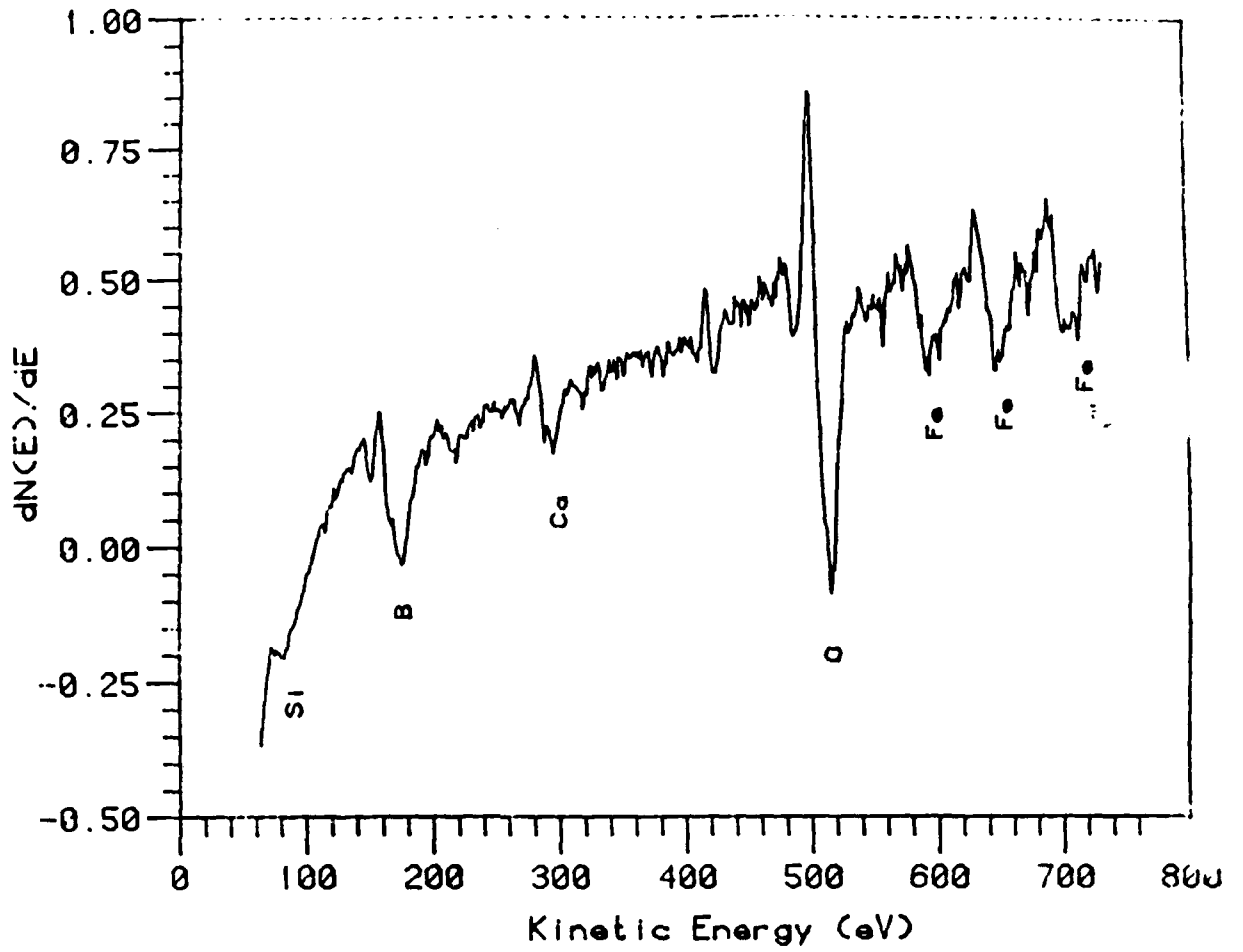
Figure 28. SiC piece next to region with pin broken off AES scan.

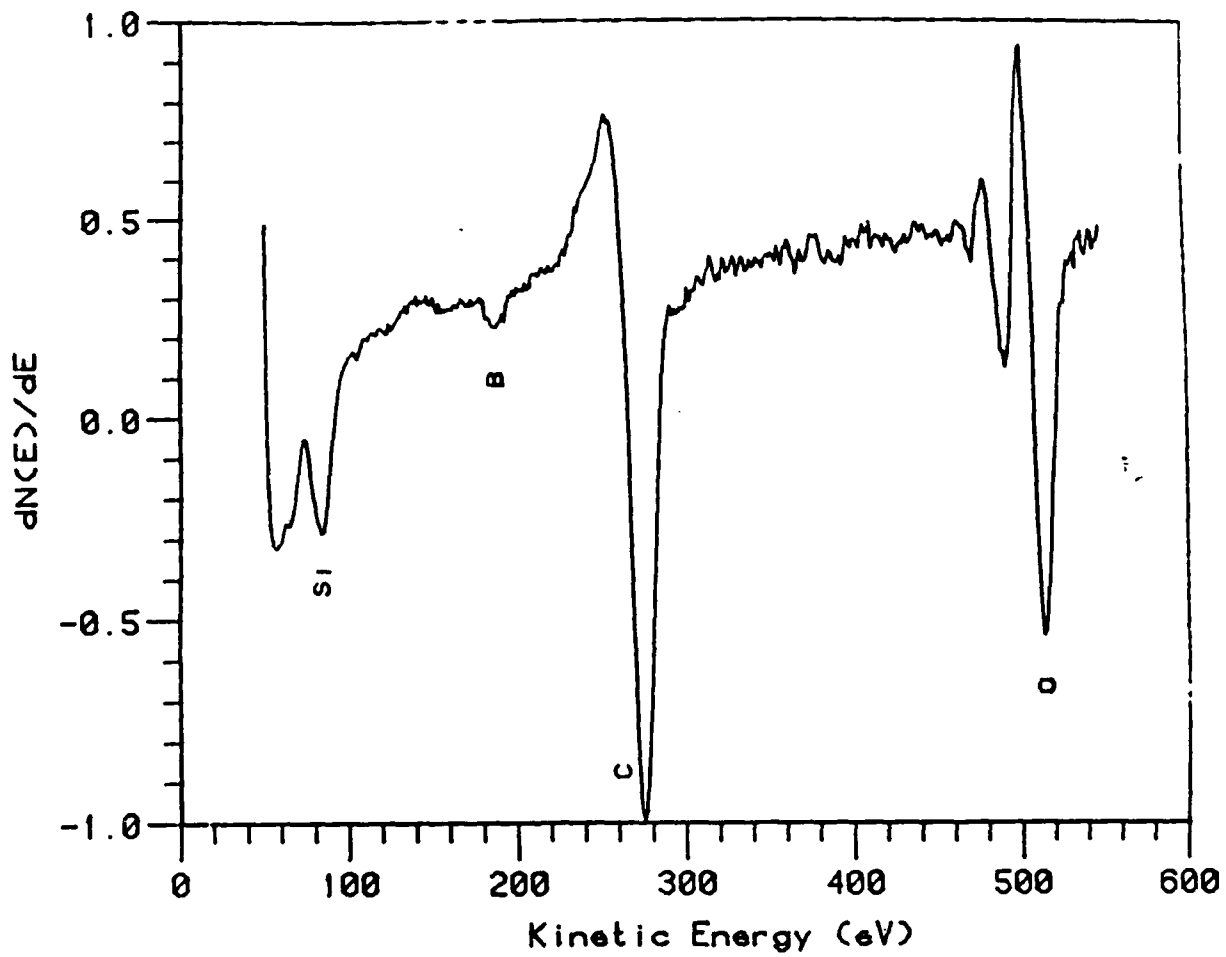
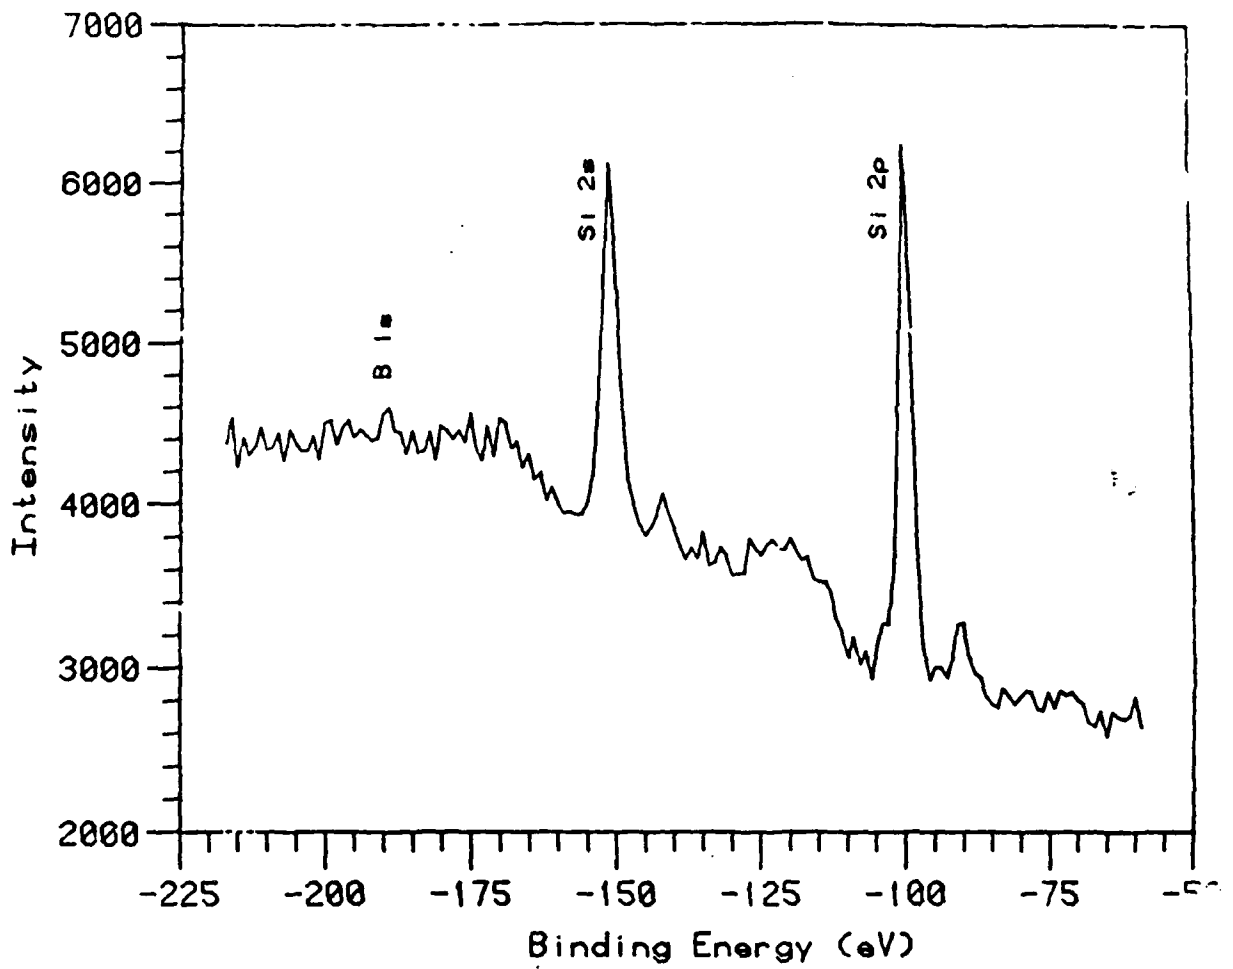
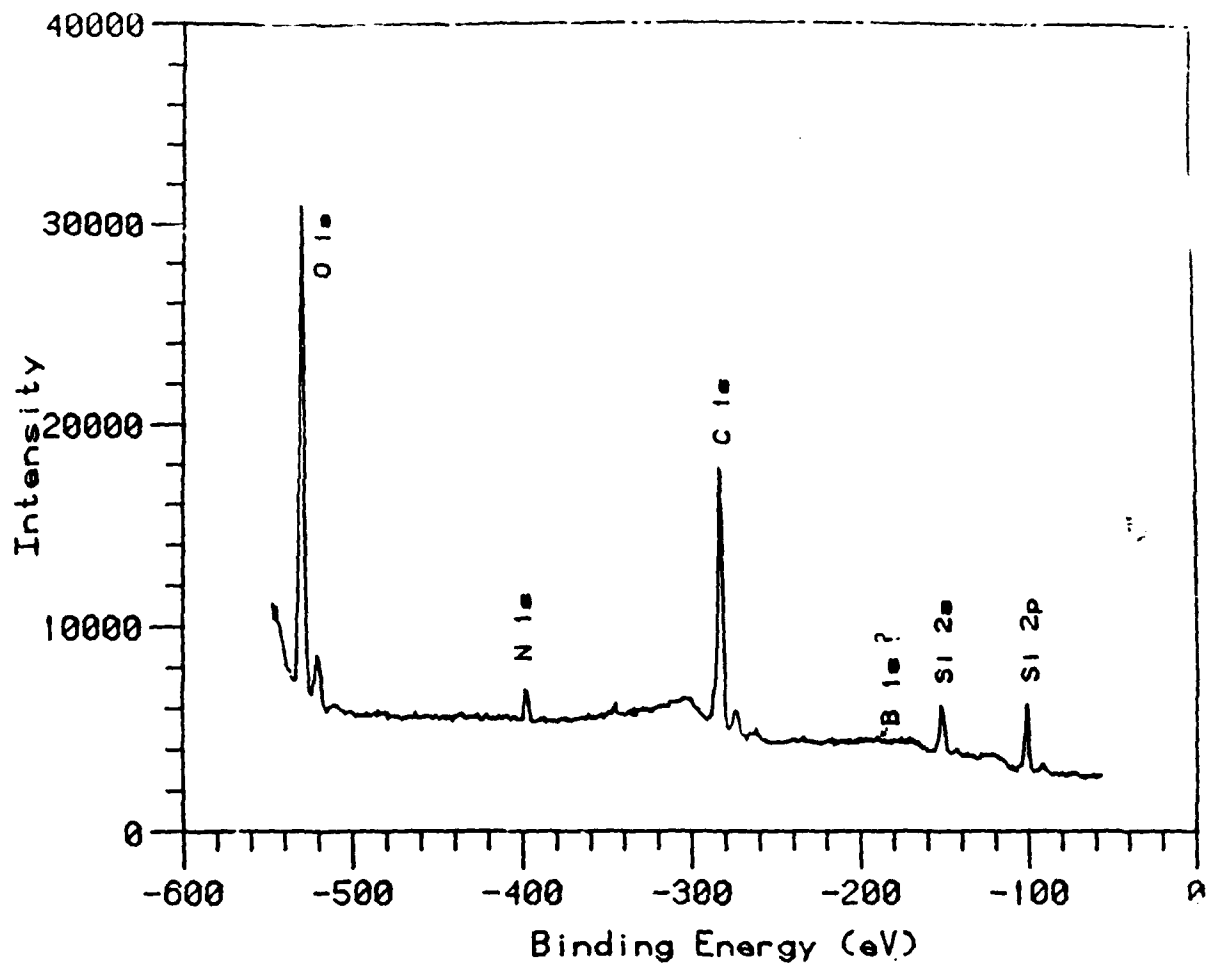
Figure 29. SiC and B₄C AES surface scan.
