Evaluation of Optical Materials Samples

FINAL REPORT

Prepared by:
University of Dayton
Research Institute
Dayton, Ohio 45469

JULY 1988

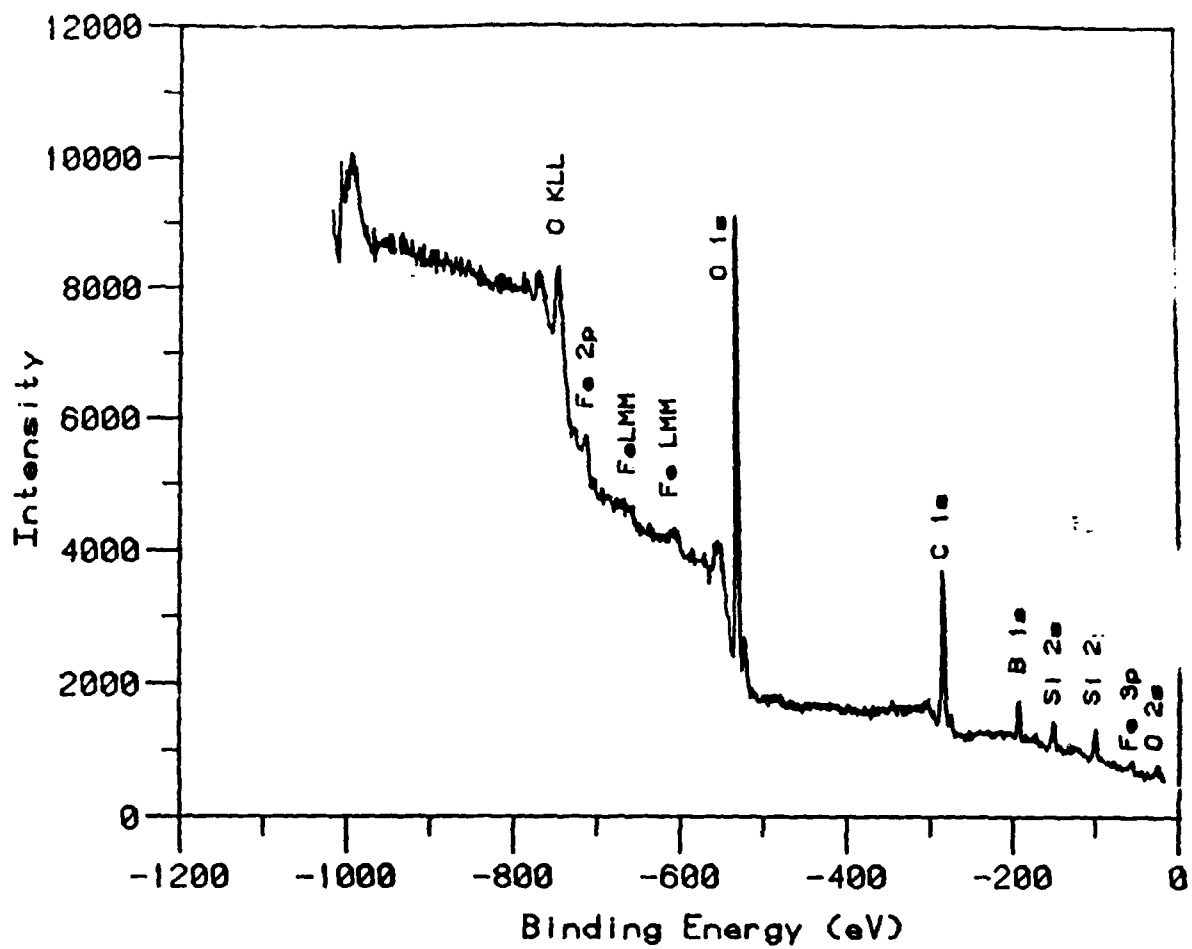
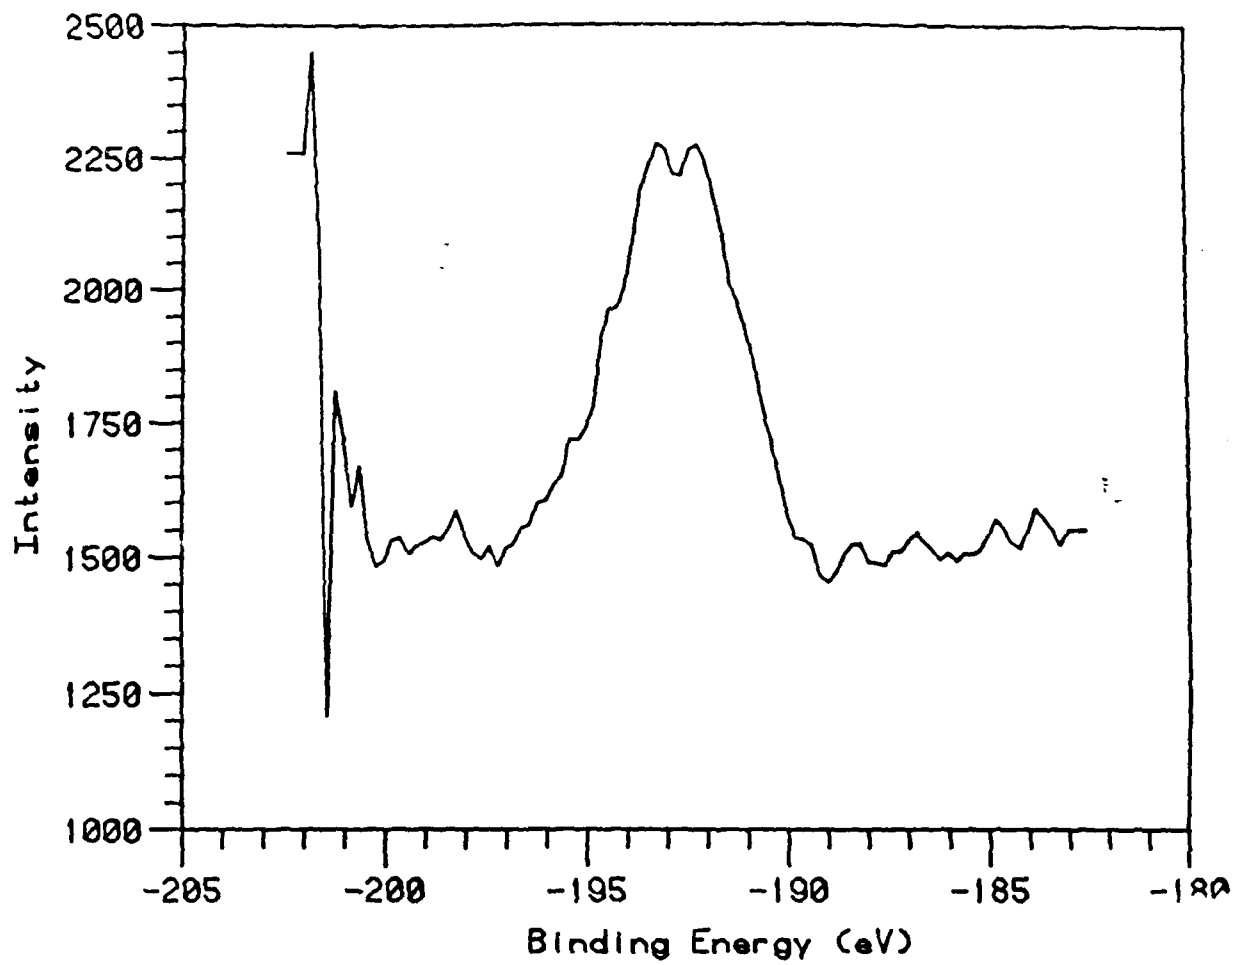
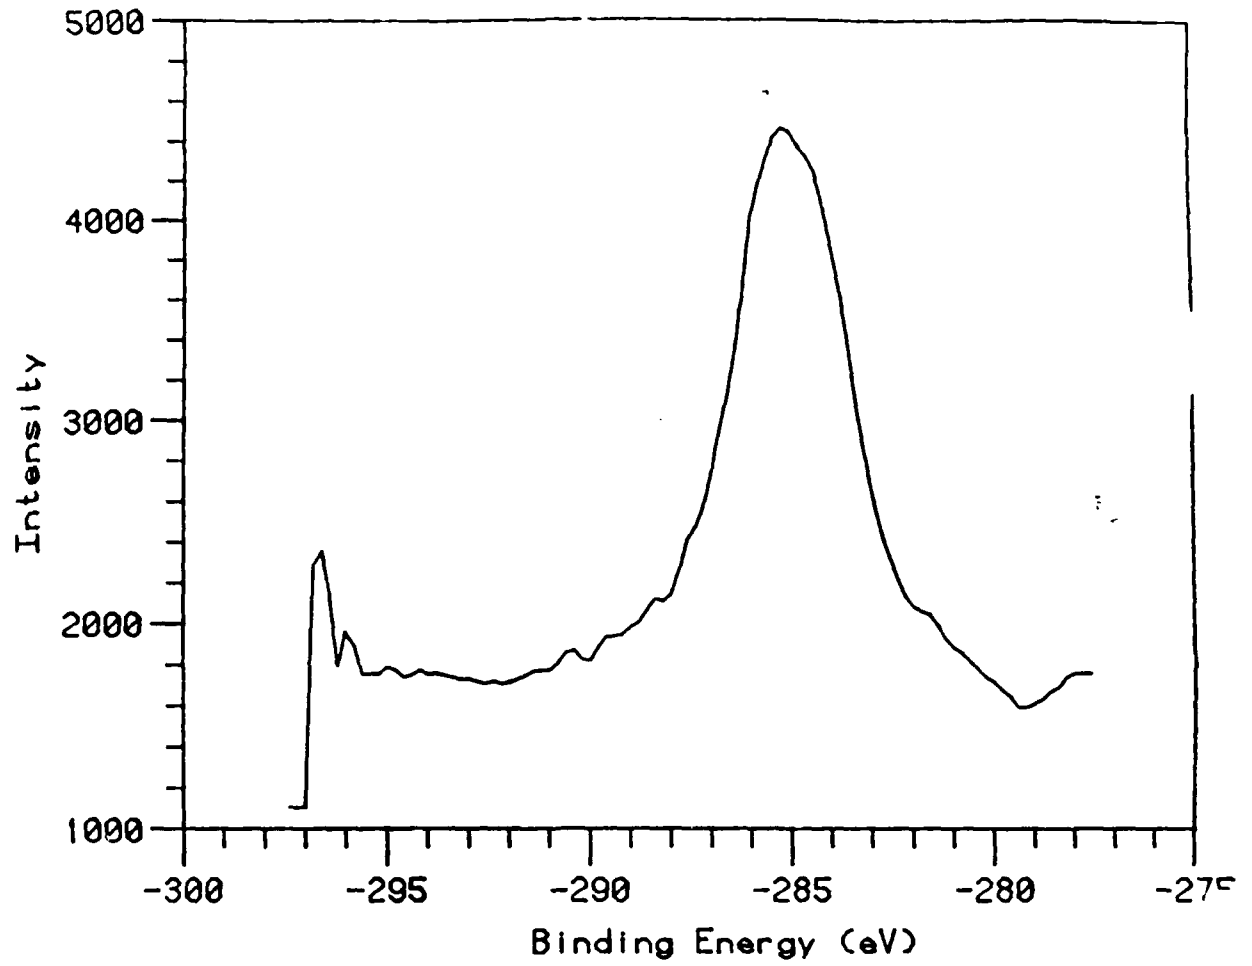
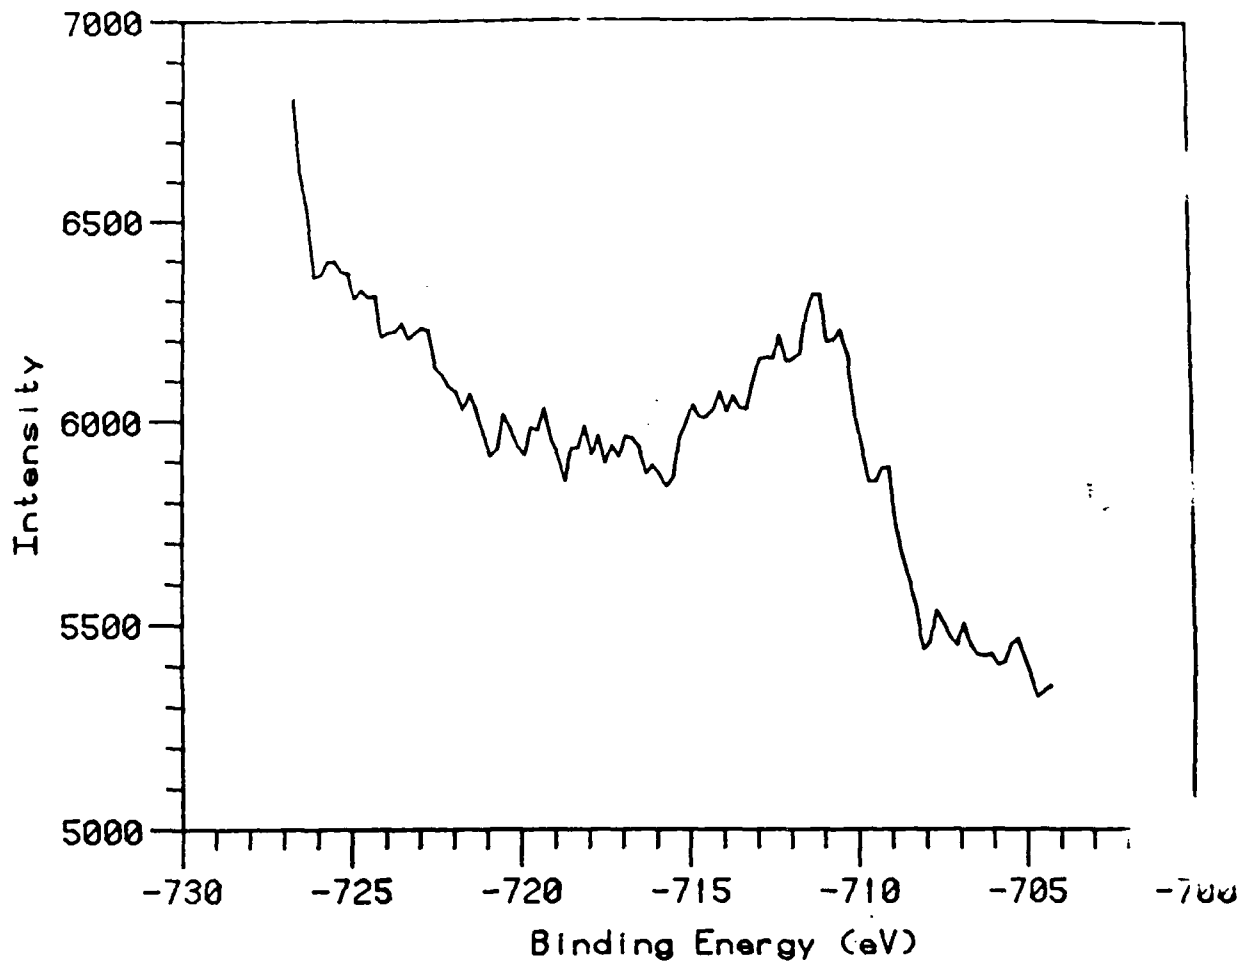
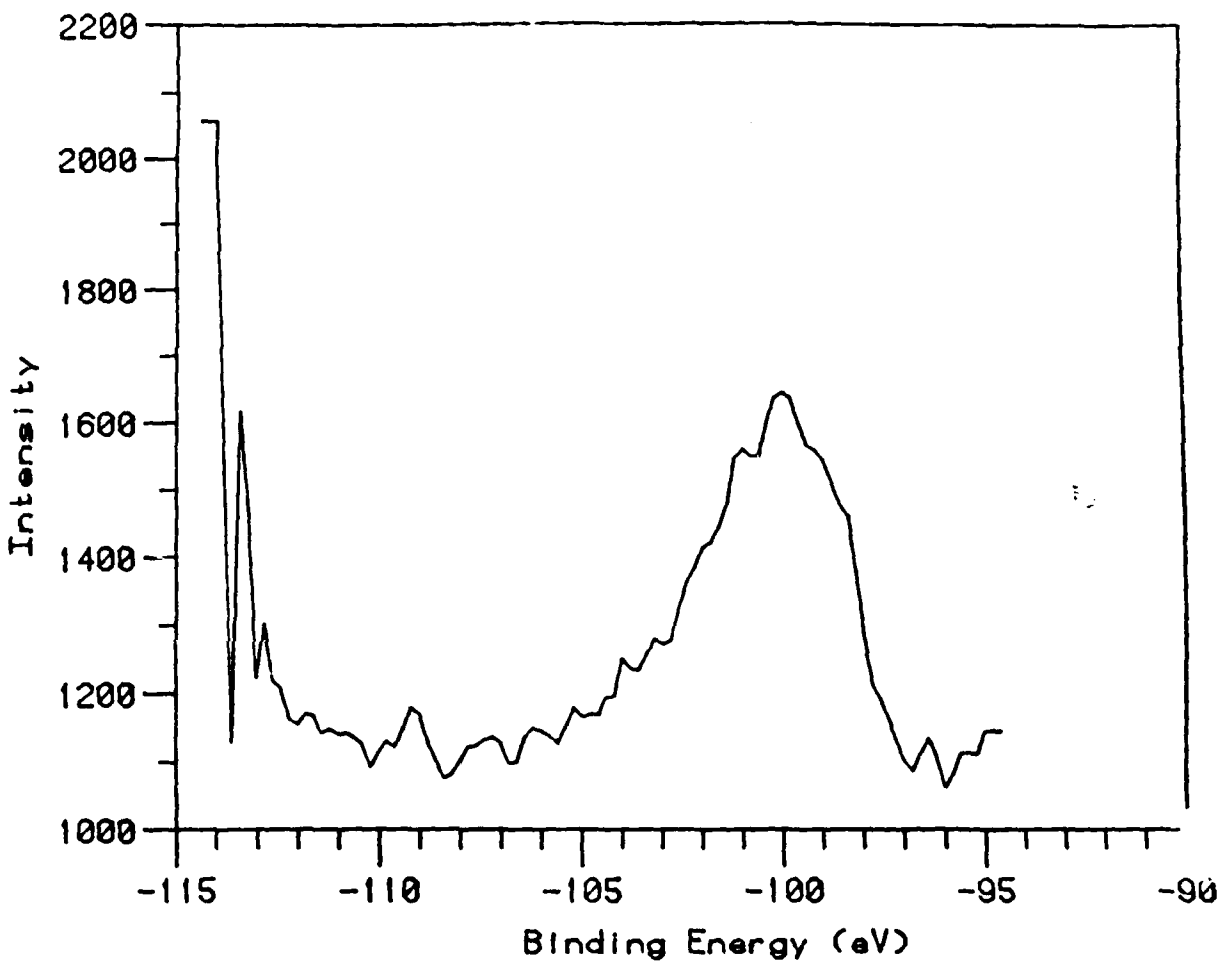
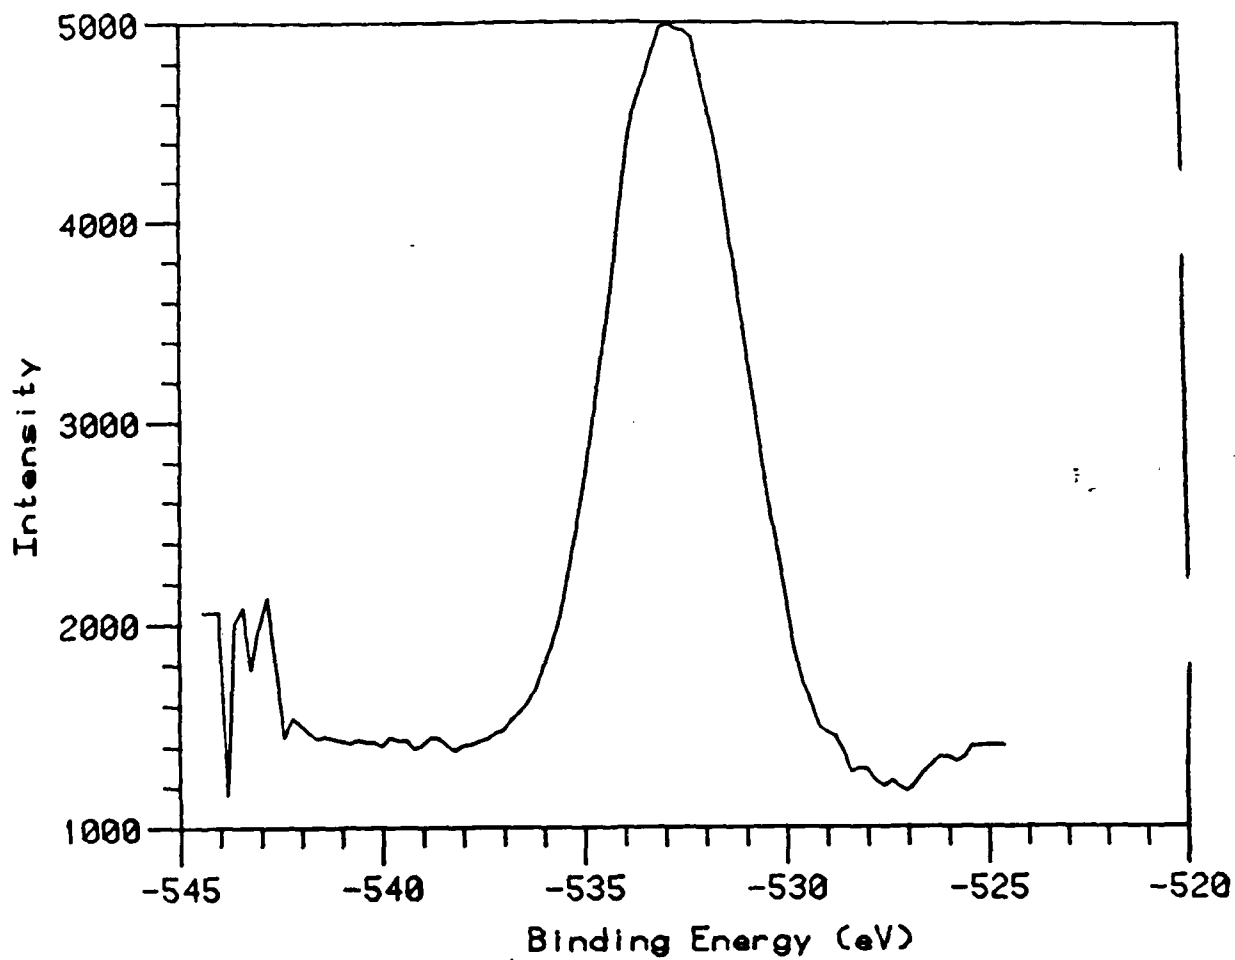
Further studies using an electron spectroscopy for chemical analysis apparatus (ESCA) (Figure 33) confirmed the Auger analysis and led to the conclusion that a borosilicate was formed through the combination of Si, B, O, and high temperature. The binding energy of the boron 1s peak, 192.7 eV, is quite close to that reported for B_2O_3 (193.0 eV). From the XPS data, there was no evidence of B_4C which should have a boron 1s peak at 186 eV. The silicon 2p peak is rather broad and asymmetrical. This is probably due to the presence of both SiC (peak at 100 eV) and an Si-O phase (peak at 102-103 eV). The oxygen 1s peak is also rather broad; this may be due to the fact that both hydroxides and oxides are present.

Figure 33. Porous SiC (side w/pins broken off) ESCA surface scan.
