TECHNICAL REPORT REMR-CO-3

CASE HISTORIES OF CORPS BREAKWATER  
AND JETTY STRUCTURES

Report 2

SOUTH ATLANTIC DIVISION

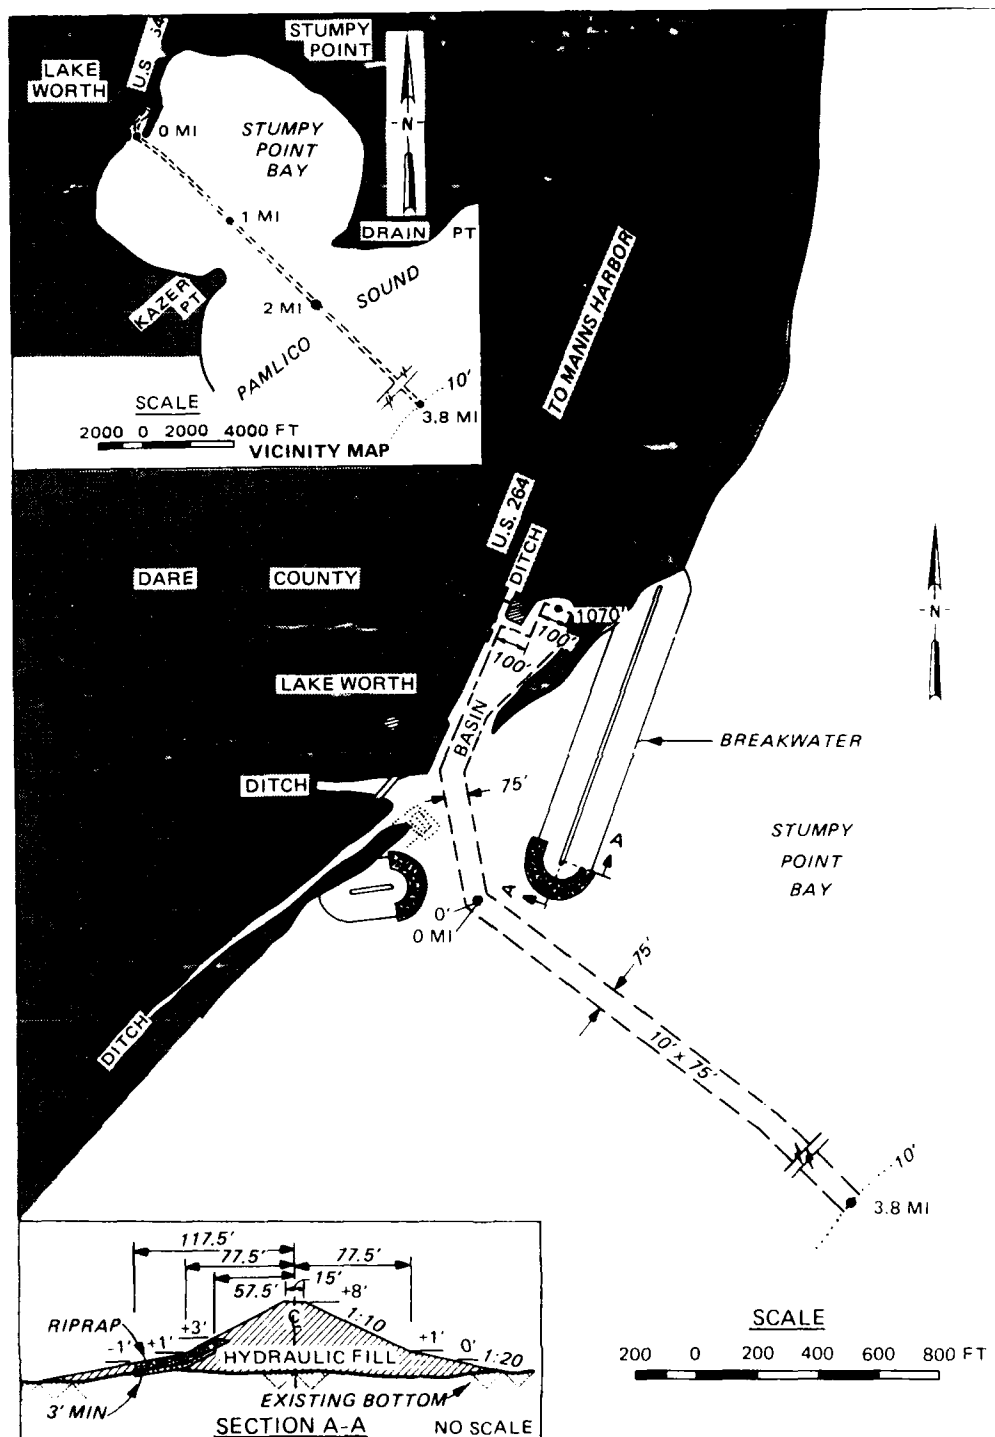
Figure 4. Stumpy Point Bay, North Carolina

| Date(s) | Construction and Rehabilitation History |
|---|---|
| 1974 | A reconnaissance survey was made to determine the severity of erosion to the breakwaters. It was found that the riprap protected sections were functioning satisfactorily but that the fill material adjacent to the riprap sections had substantially eroded. Maximum vertical scarps of 7, 3, and 3 ft, respectively, were noted on the bay and harbor sides of the north breakwater and bay side of the south breakwater. The erosion on the north breakwater was on directly opposite sides of the breakwater with only 30 ft of original material separating the narrowest point. It was felt that "the southeasterly wind with its associated fetch is very erosive to the breakwaters on both sides of the dredged channel." |

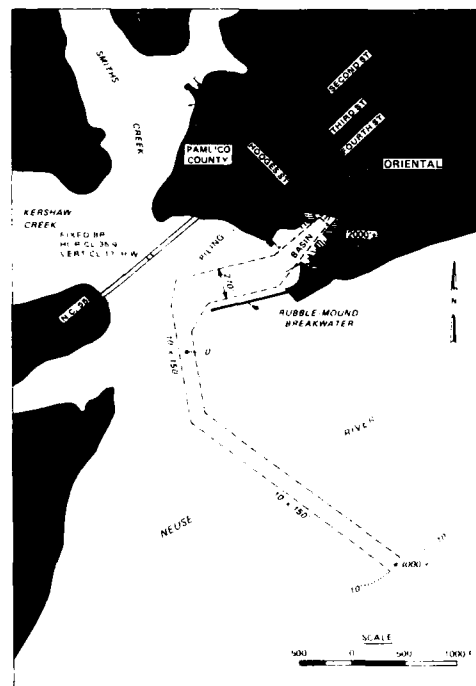
Figure 7. Smiths Creek (Pamlico  
 County), North Carolina

| Date(s) | Construction and Rehabilitation History |
|---|---|
| 1973 | An inspection of the breakwater showed that an 80-ft section, located approximately 100 ft from the outer end of the structure, was 2 ft below grade. This occurrence was attributed to structure settlement. Overall, the breakwater was considered to be in very good condition. |

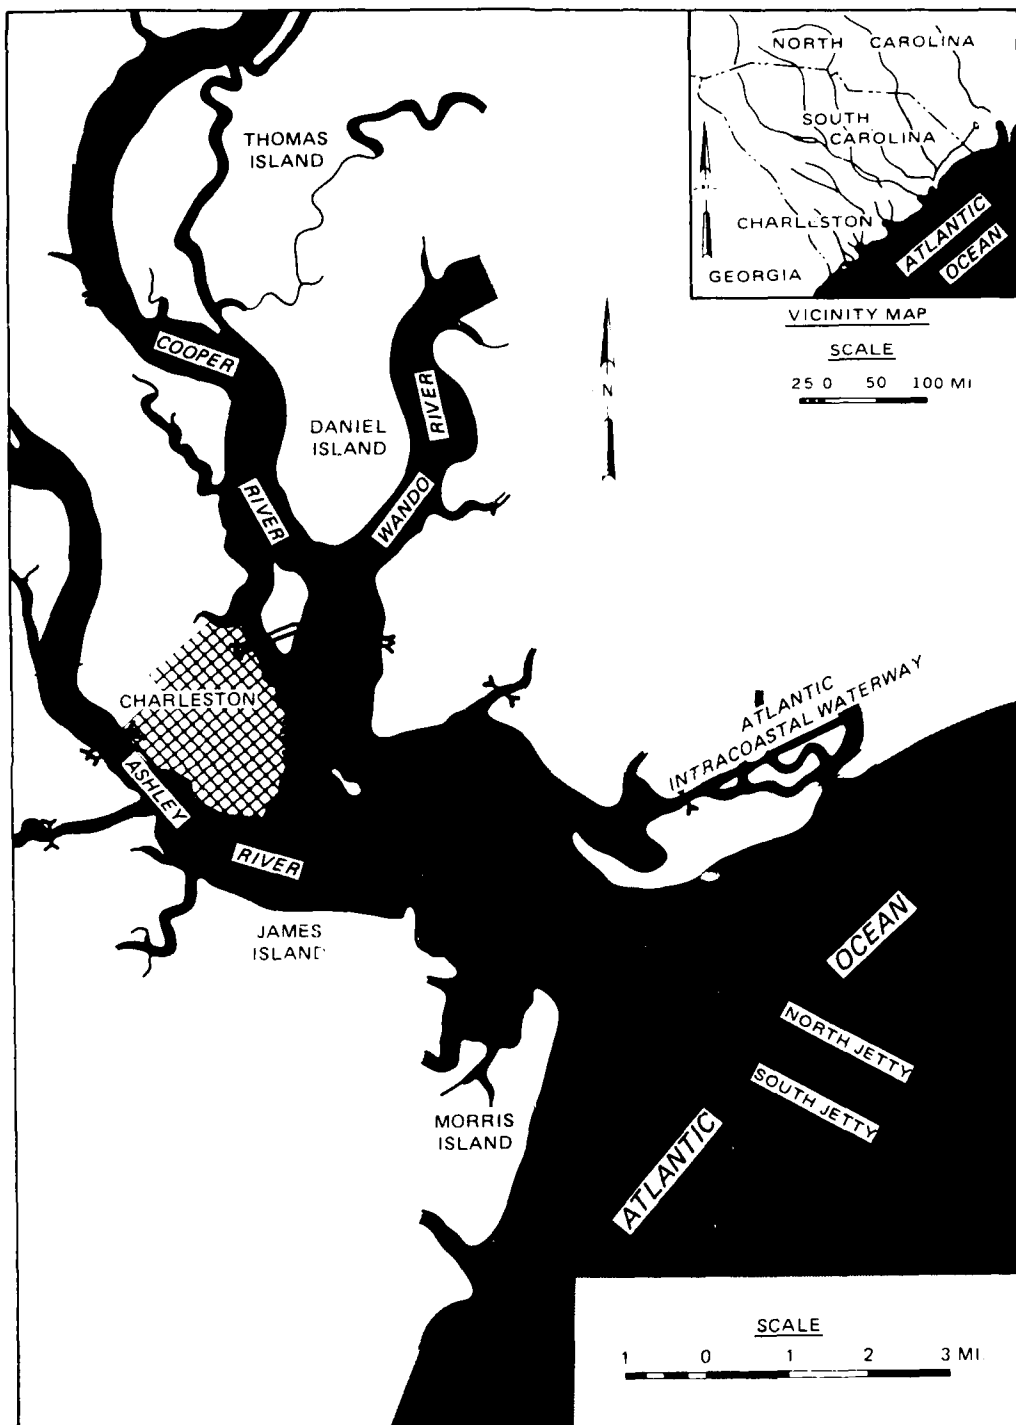
Figure 18. Charleston Harbor jetties, South Carolina

| <u>Date(s)</u> | <u>Construction and Rehabilitation History</u> |
|---|---|
| 1966 | Present channel depth of -35 ft mlw has been maintained since 1961. An inspection survey in August 1966 indicated a general subsidence of 1.5 to 3.5 ft along the raised portion of the jetties, with maximums of 5 and 6 ft over short sections of the north and south jetties, respectively. |

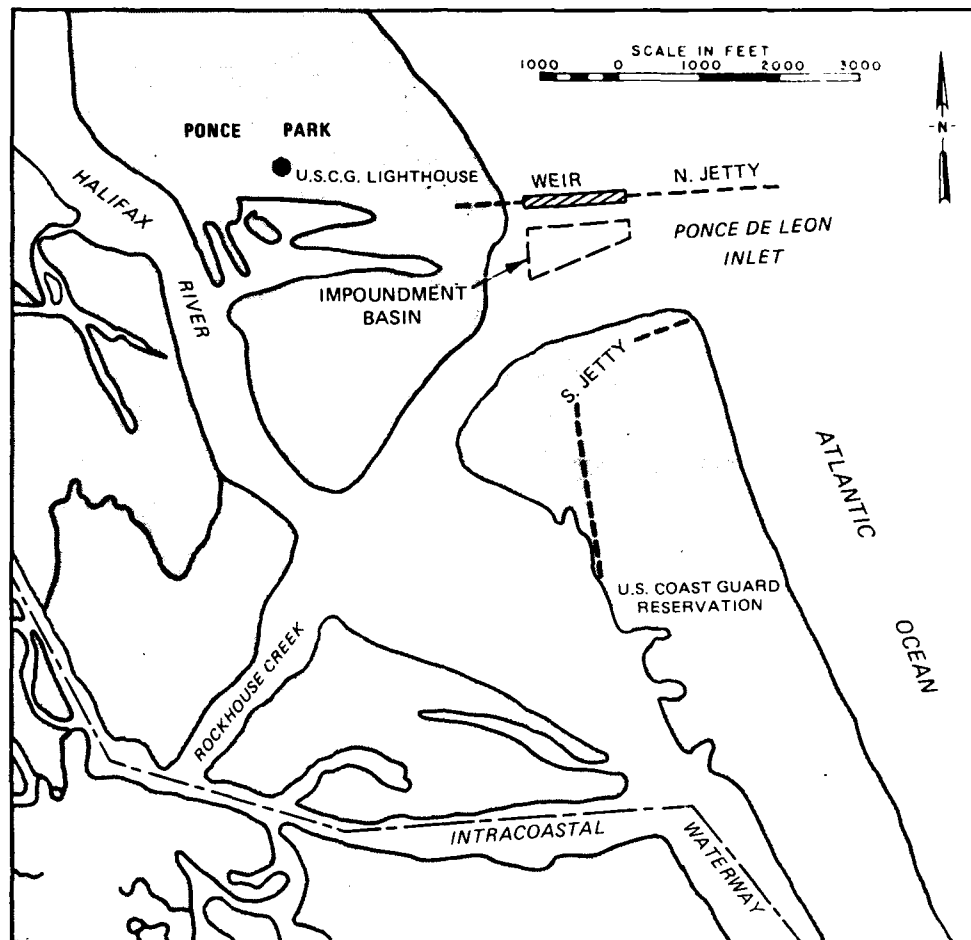
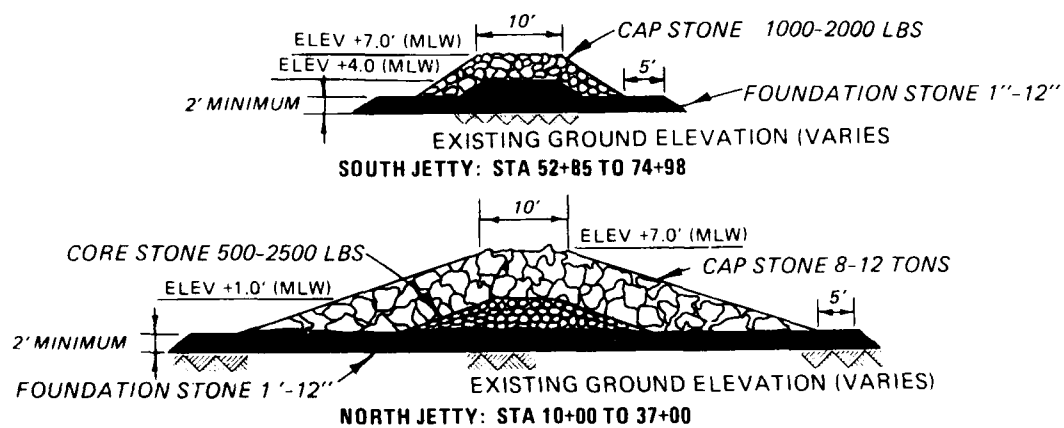
Figure 29. Ponce de Leon Inlet, Florida

| Date(s) | Construction and Rehabilitation History |
|---|---|
| 1985 | The jetties are presently in good condition except for some damage on the north jetty head because of a recent storm and continued erosion at the root of the jetty. |

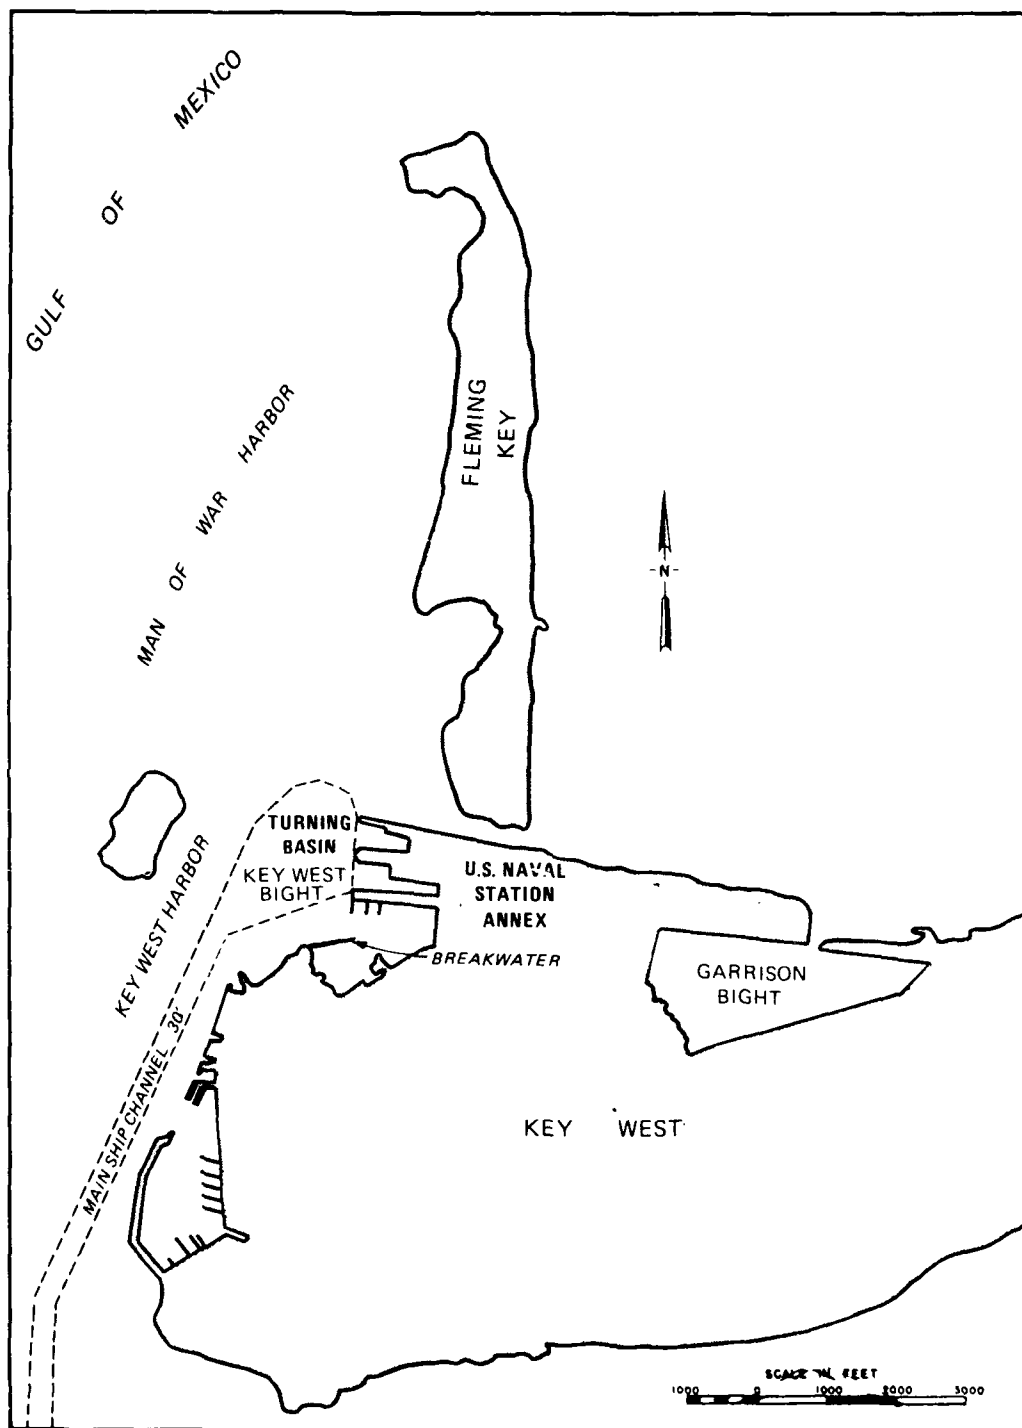
Figure 38. Key West Harbor, Florida

| <u>Date(s)</u> | <u>Construction and Rehabilitation History</u> |
|---|---|
| 1985 | The breakwater has never been repaired and is presently in good condition. |

| <u>Date(s)</u> | <u>Construction and Rehabilitation History</u> |
|---|---|
| 1971 | A portion of the breakwater was removed to aid in flushing of the harbor. The core stone removed was placed in a blanket 2 ft thick by 15 ft wide extending along one or each side of the breakwater as available stone would permit. The capstone removed was replaced to the existing design with the remainder placed in existing void spaces on the breakwater. The estimated cost of the modification was less than \$25,000. |

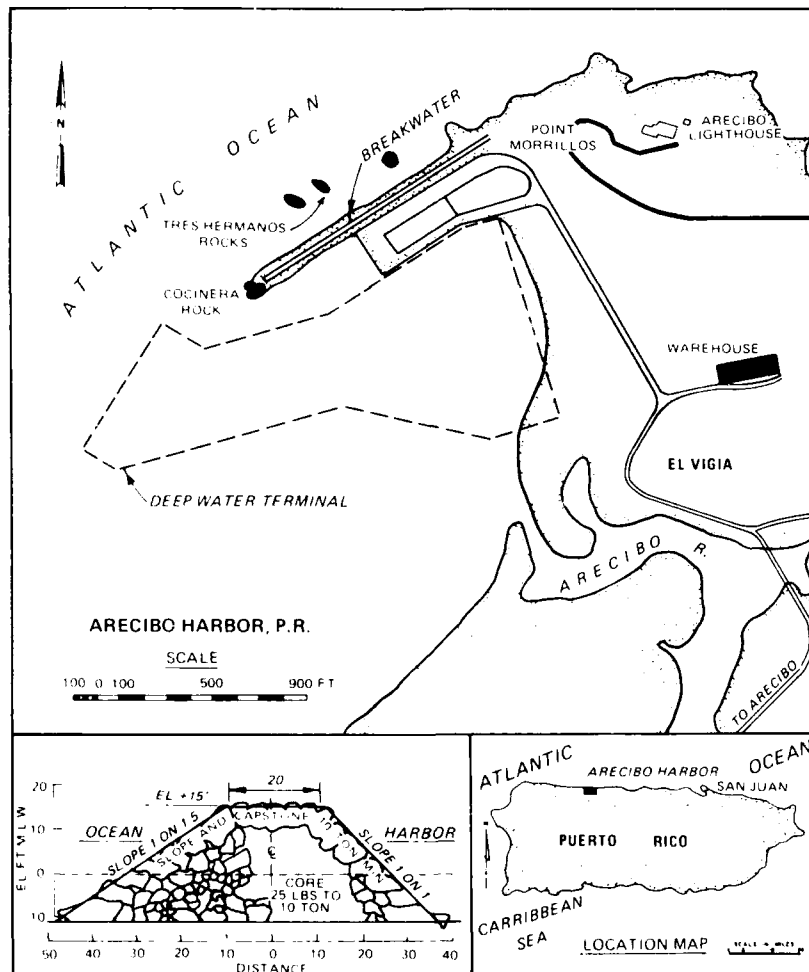
Figure 41. Arecibo Harbor, Puerto Rico

| Date(s) | Construction and Rehabilitation History |
|---|---|
| 1944 | A 1,200-ft armor stone breakwater was completed, providing protection for the harbor and its 25-ft-deep access channel (Figure 41). The breakwater cross section (Figure 41, inset) was comprised of 25-lb to 10-ton core stone protected with one layer of armor stone, 10-ton minimum weight. A recent (1983) visual examination indicated that most of the armor units were 10 to 18 tons). The side slopes were 1V:1.5H on the ocean side and 1V:1H on the harbor side. The crest width and elevation were 20 ft and +15 ft mlw, respectively. The breakwater was constructed along a reef with a depth varying from -20 ft mlw at its seaward end to mlw at its landward end. |

| Date(s) | Construction and Rehabilitation History |
|---|---|
| 1985 | The structure is in excellent condition. |

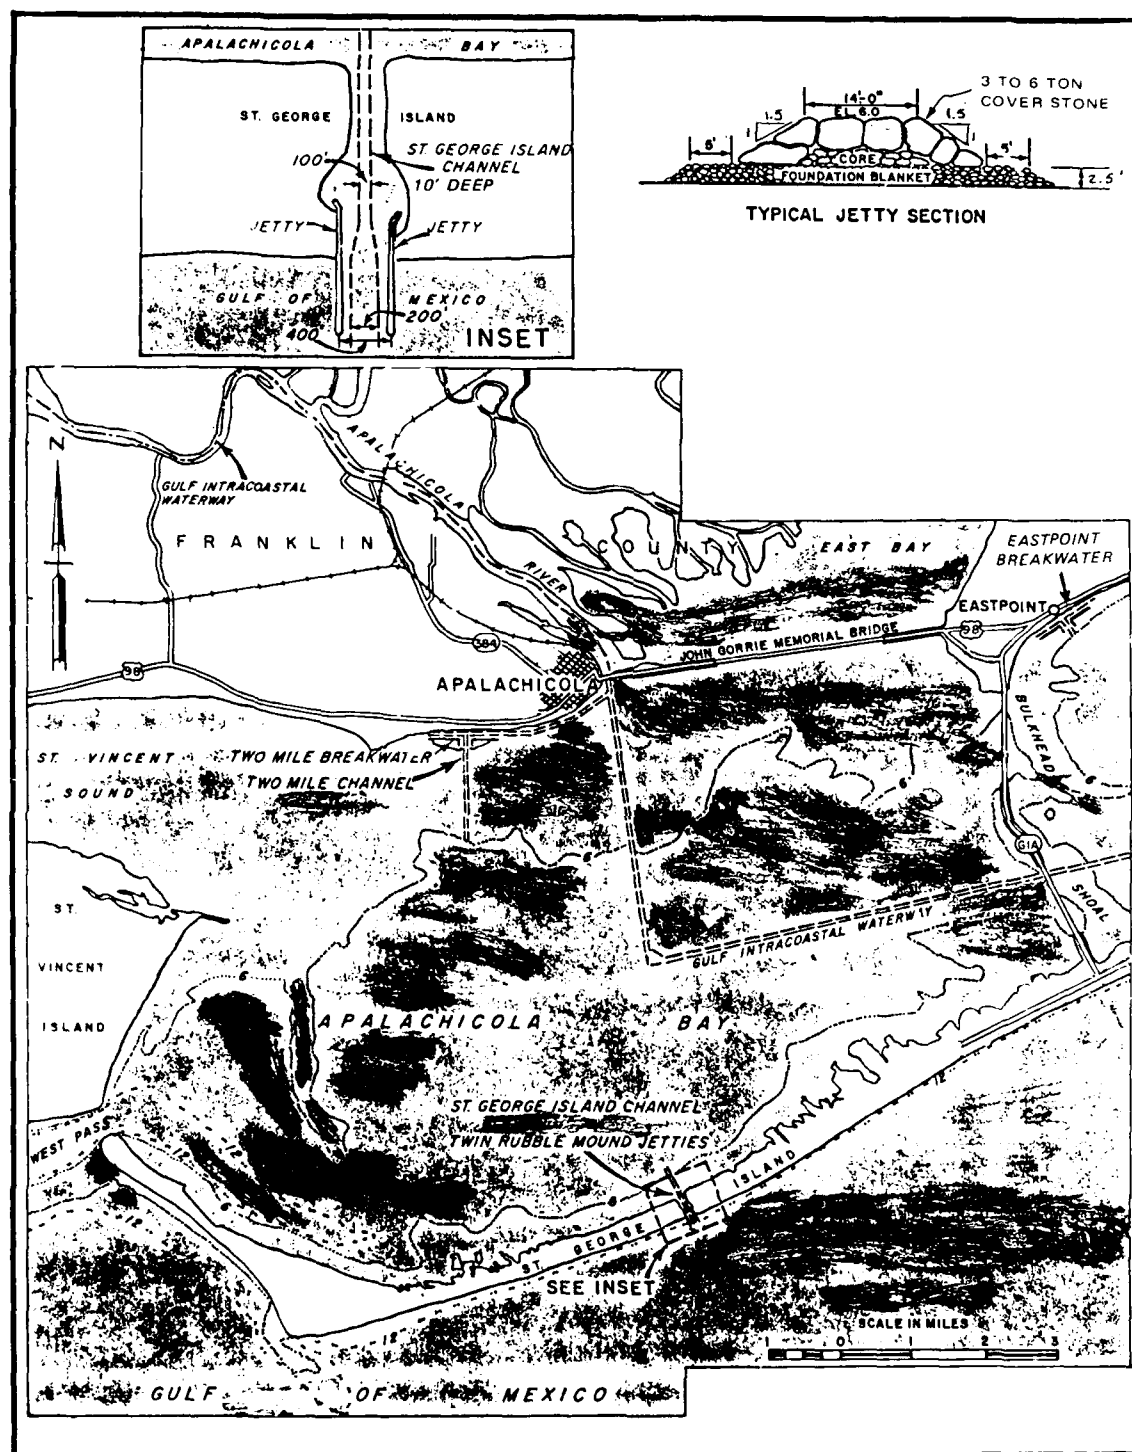
Figure 43. Projects at St. George Island, Two Mile, and Eastpoint Apalachicola Bay, Florida

| Date(s) | Construction and Rehabilitation History |
|---|---|
| 1977-<br>1978 | <p>The jetties and channel were surveyed in early 1977. The east jetty showed substantial loss of material over 250-ft section at the seaward end, the outer 50 ft was at or below mlw, and the remainder varied from +3 to +5 ft mlw. The landward 350 ft of the east jetty was typically at +5 ft mlw except for the flared portion which was at +3 ft mlw. The west jetty was in good condition except for minor sections and the landward 150 ft which varied from +3.5 to +4.5 ft mlw. In 1978 the jetties were rehabilitated. A total of 4,700 tons of 3- to 6-ton cover stone were placed as required at low sections to bring the jetties up to the previous design elevations.</p> |
| 1985 | <p>The jetties are presently in good condition. The major problem, at present, is the keyhole erosion that has been removing material at an apparently constant rate since jetty construction (and is expected to continue). The proposed solution is to purchase title to additional land on both sides of the channel.</p> |

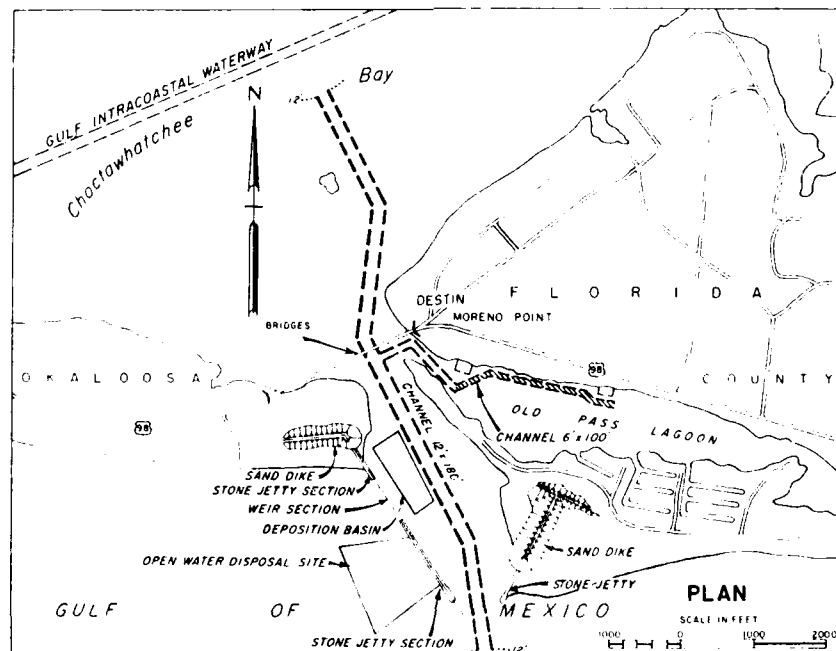
Figure 53. East Pass, Florida

| Date(s) | Construction and Rehabilitation History |
|---|---|
| 1985 | The weir section of the west jetty was modified with the placement of a rubble-mound trunk section identical to the trunk section used in the original design (except that the blanket stone was to have a minimum thickness of 1 ft directly over the sheet piles and 2.5 ft thick elsewhere as called for in the original design). Estimated volumes of blanket, core, and cover stone were 5,300, 1,500, and 4,600 cu yd, respectively. At present, toe stability problems exist and have been documented with video footage of scour along the toe of the east jetty. Otherwise, the jetties are in good condition. |
