TECHNICAL REPORT CERC-88-16

# SIDE-SCAN SONAR APPLICATIONS FOR EVALUATING COASTAL STRUCTURES

James E. Clausner, Joan Pope

November 1988

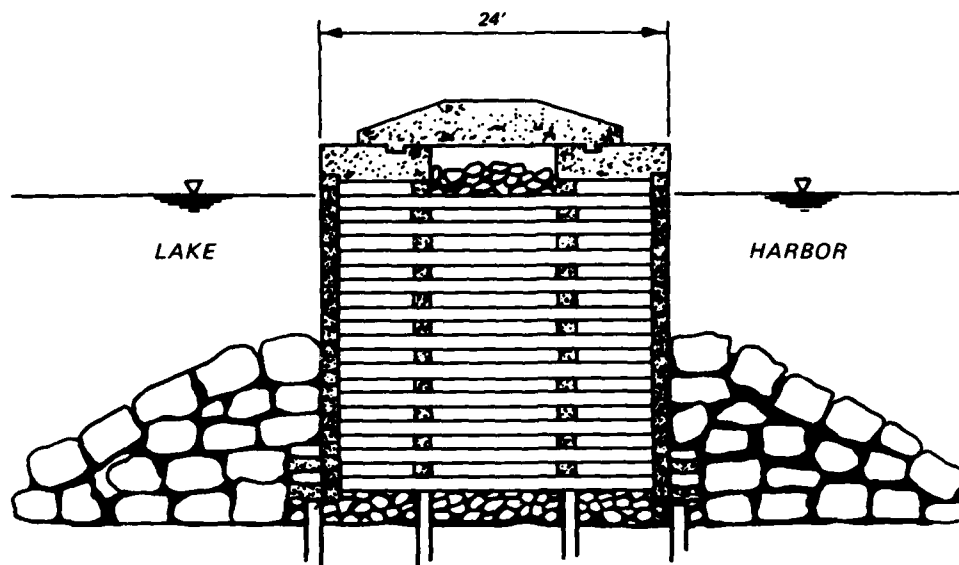
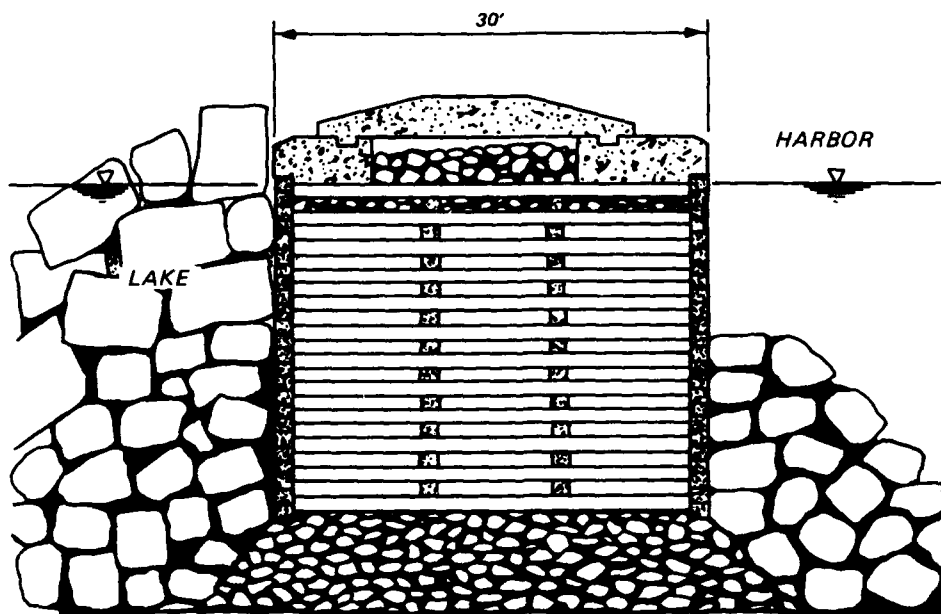
Figure 19. Timber crib construction typical of sections A and B of the Calumet Harbor breakwater

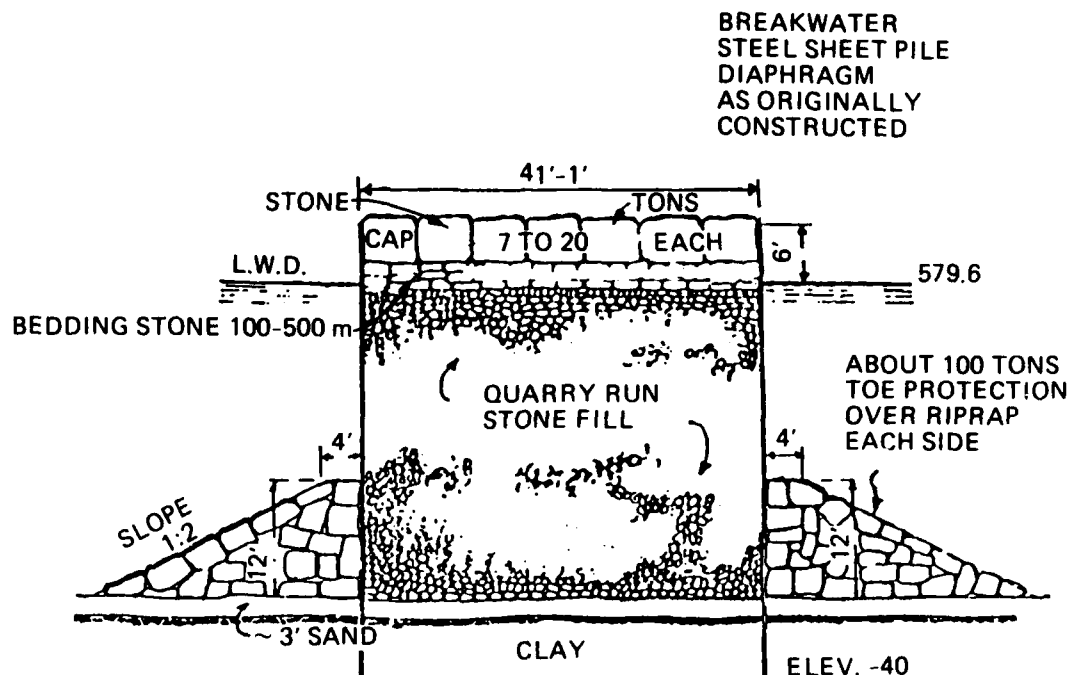
detached breakwater section, consists of 131 stone-filled, sheet-pile diaphragm cells (Figure 20). According to NCC reports, areas of hard limestone limited pile penetration into the sandy lake floor to approximately 7 ft.

Figure 20. Diaphragm sheet-pile cell construction typical of section C of the Calumet Harbor breakwater

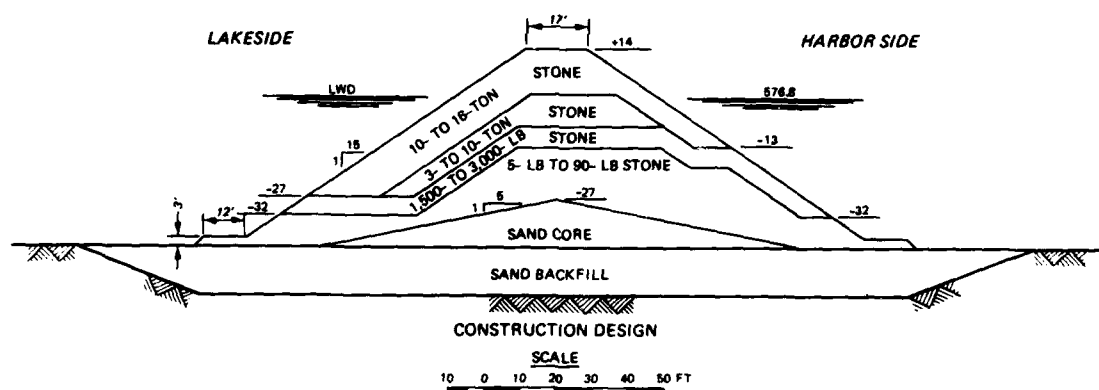
43. The Burns Harbor breakwater, constructed between 1967 and 1970, is a multi-layer rubble-mound design using 10- to 16-ton limestone blocks on the exposed surfaces (Figure 23). Soil borings prior to construction indicated that approximately 10 ft of soft clay were underlain by much harder clay. Before construction, the soft clay was to have been excavated and replaced with a sand mat which was to extend at least 30 ft beyond the toe of the structure. The excavated clay was disposed onto the lake bed about 150 to 300 ft from the toe of the structure in 50-ft depths.

Figure 23. Cross section of Burns Harbor breakwater

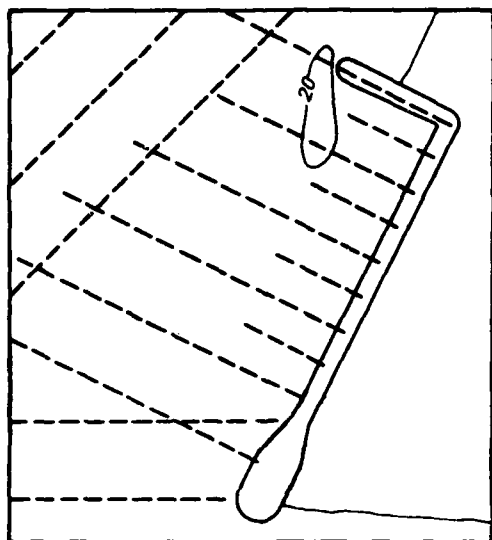
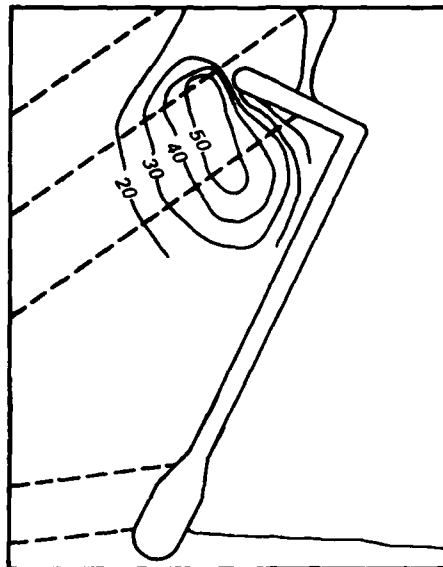
57. The records clearly showed the toe and the face of the structure. Also apparent were individual stones dislodged from the face and an approximately 1-ft-diam steel pipe, probably lost during dredging operations. Of particular interest are features that require more interpretation of the record. By examination of the initial bottom return and the shadow zones, it is possible to discern a scour-induced trench along a portion of the east jetty and a deeper scour hole at the southwest tip of the spur jetty.

58. Standard bathymetric surveys around the jetties were also obtained at 200-ft intervals. Comparison of Figures 32a (showing the results of a survey taken in July 1985) and 32b (showing the results of a survey taken in August 1986) illustrates the difficulty of delineating small-scale features at typical bathymetric survey line spacings. Notably, the fathometer survey tracklines miss the center of the scour hole. The principal benefit of a side-scan sonar survey, in this instance, is to identify and locate areas that require closer spacings between bathymetric survey lines.

Figure 32. Scour hole development at southwest tip of east jetty at East Pass Inlet, Florida

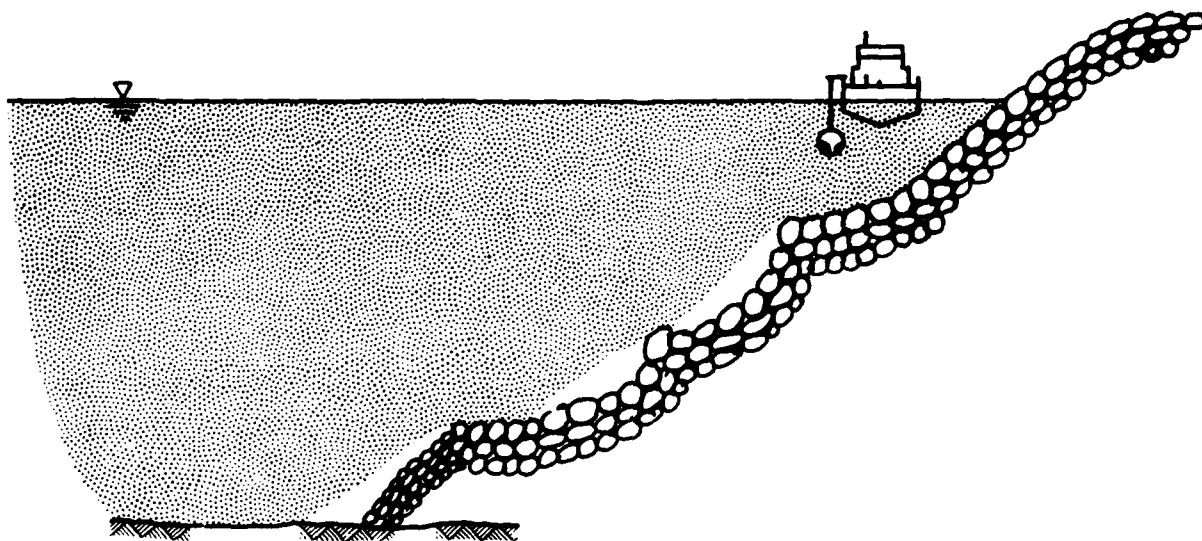
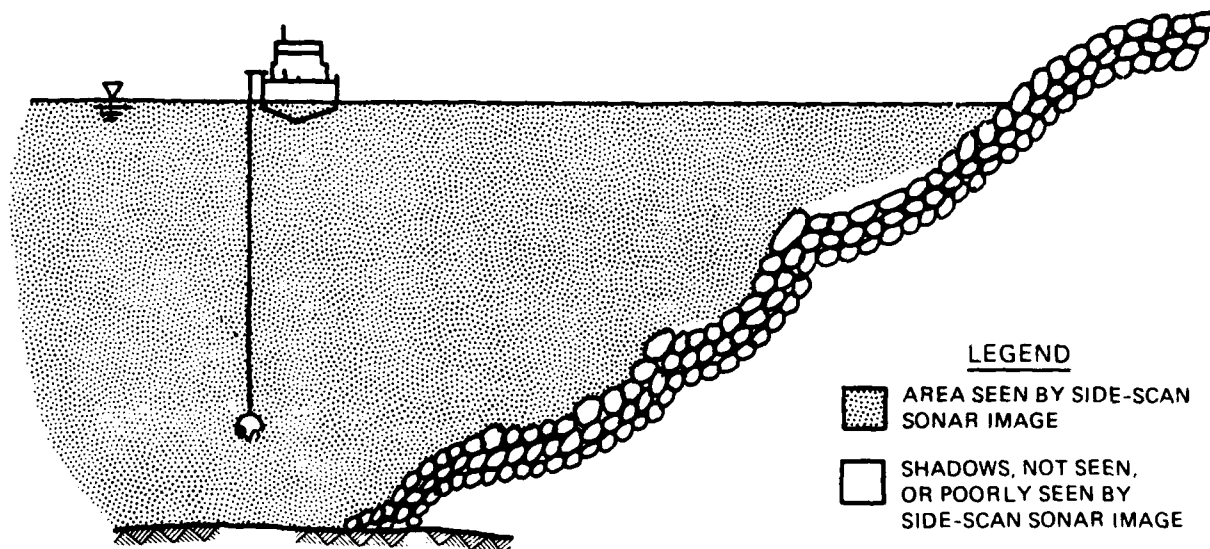
Figure 39. Example of two side-scan sonar inspection passes

83. Inspection requires finer control of the operating parameters than does reconnaissance and is usually done at slow speeds (2 to 4 knots) in ranges of 25 to 50 m. Electronic positioning is strongly recommended, although stations at 100-ft spacing along a structure can be used to determine location with less accuracy. Runs will often be made parallel to the structure, and at least two passes should be made. Runs seaward of the toe with the fish close to the bottom should provide good definition of the toe and berms (Figure 39). By paralleling the structure near the water's edge with the towfish near the surface, it should be possible to look down the structure slope (Figure 39) to observe slope irregularities.
