TECHNICAL REPORT REMR-CO-3

CASE HISTORIES OF CORPS BREAKWATER  
AND JETTY STRUCTURES

Report 6

NORTH PACIFIC DIVISION

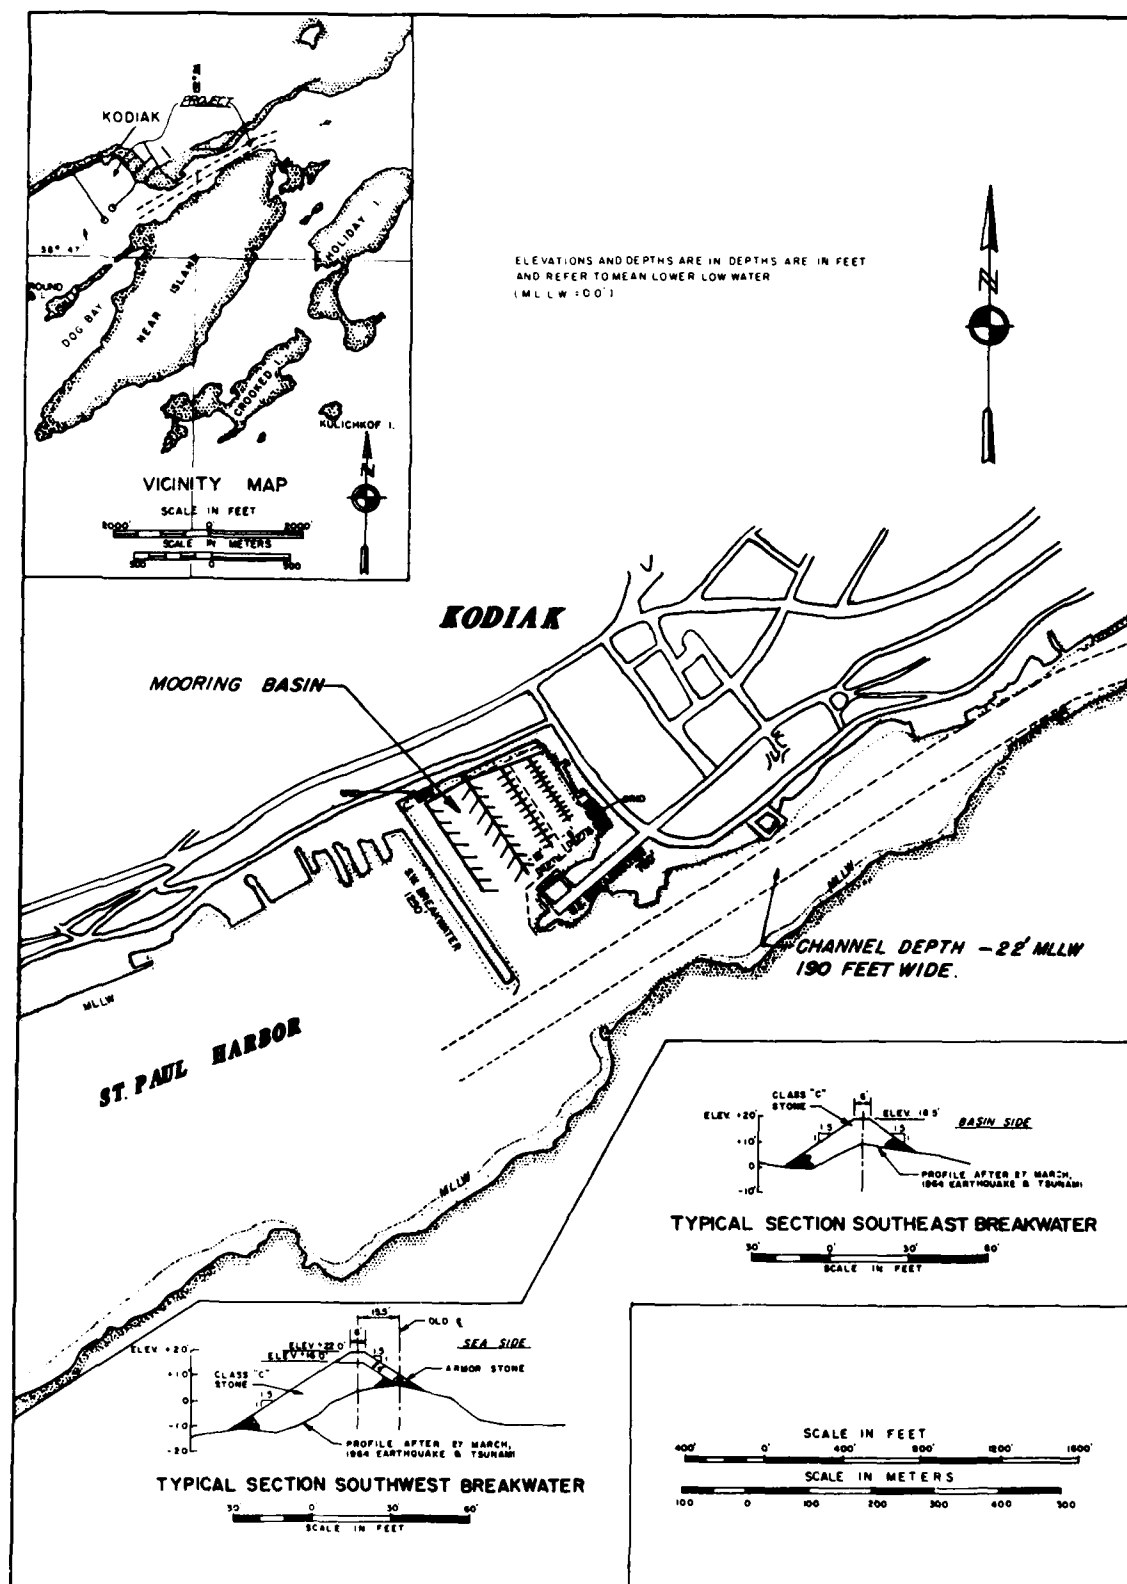
Figure 27. Site layout of Kodiak Harbor, Alaska (revised 1978)

| <u>Date(s)</u> | <u>Construction and Rehabilitation History</u> |
|---|---|
| 1964 | The ground subsided 5 ft in an earthquake causing severe damage to the basin and breakwaters. The breakwaters were rebuilt with 70,000 tons of rock. Cross sections of the repaired breakwaters are shown in Figure 27. |
| 1973 | The tip of the southeast breakwater was repaired. |

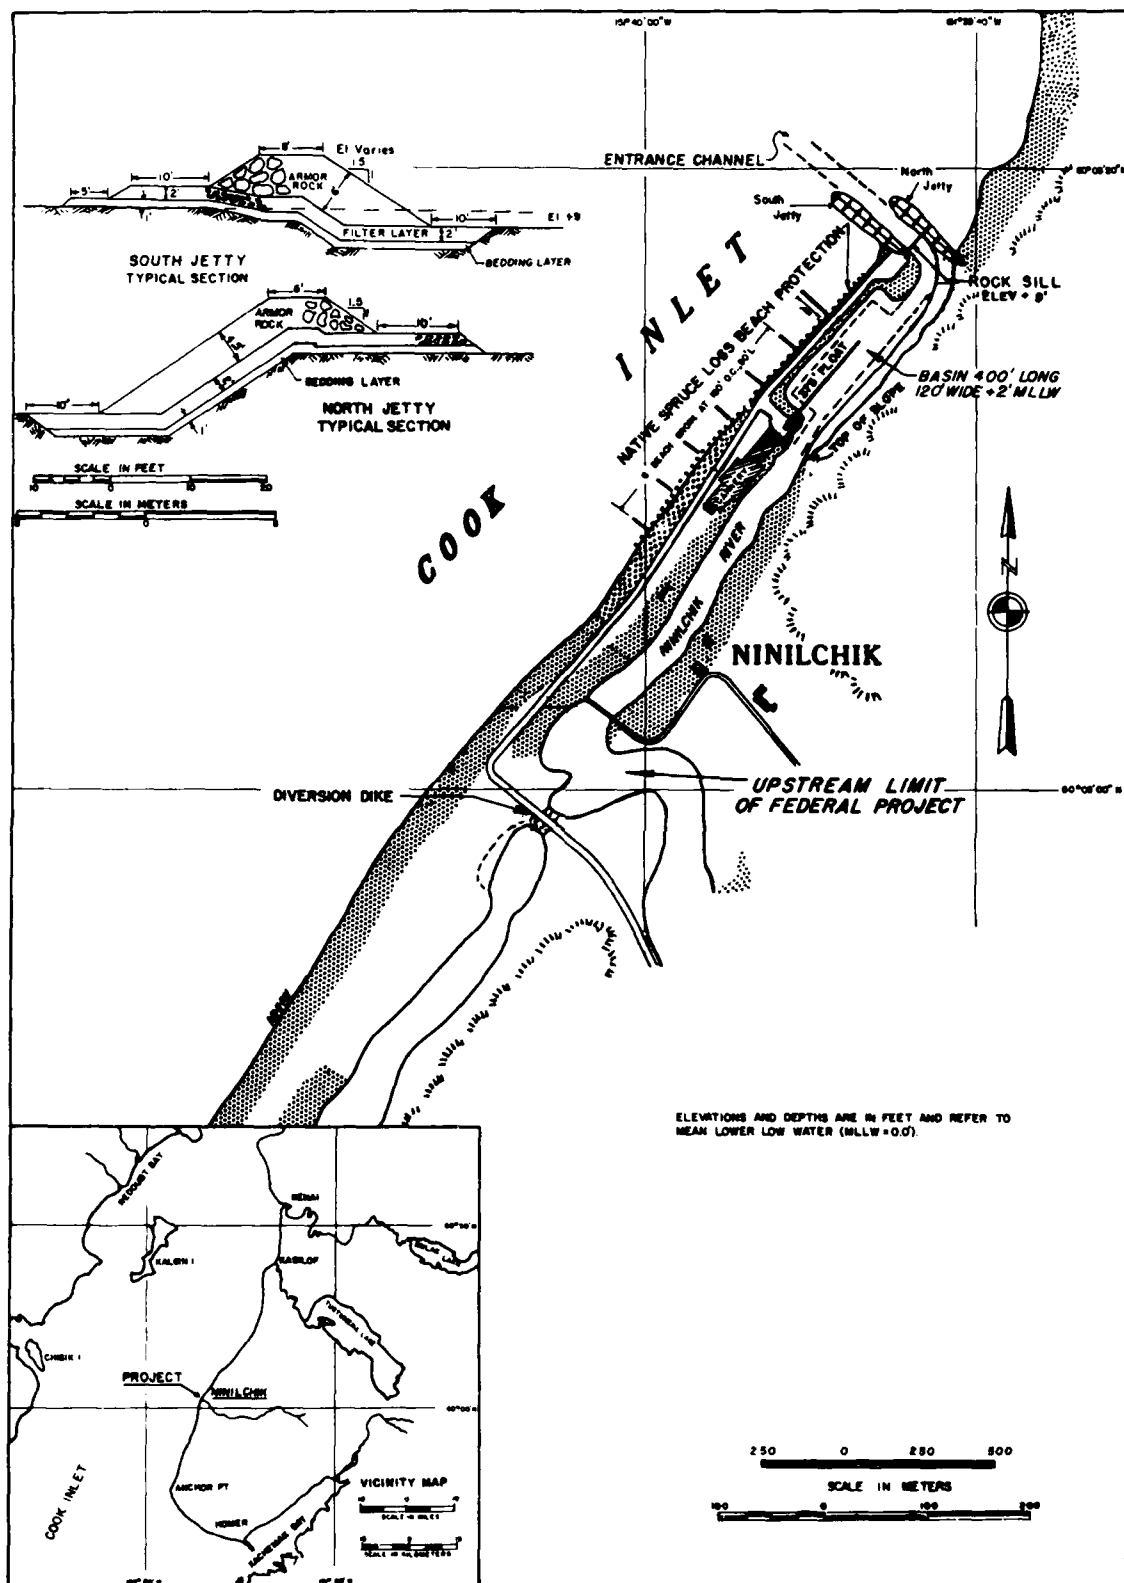
Figure 34. Layout of Ninilchik Harbor, Alaska (revised 1981)

| <u>Date(s)</u> | <u>Construction and Rehabilitation History</u> |
|---|---|
| 1985 | The harbor is illustrated in Figure 34, and an aerial photograph of the harbor is presented in Figure 35. The harbor has required annual maintenance dredging and repairs since its construction. |

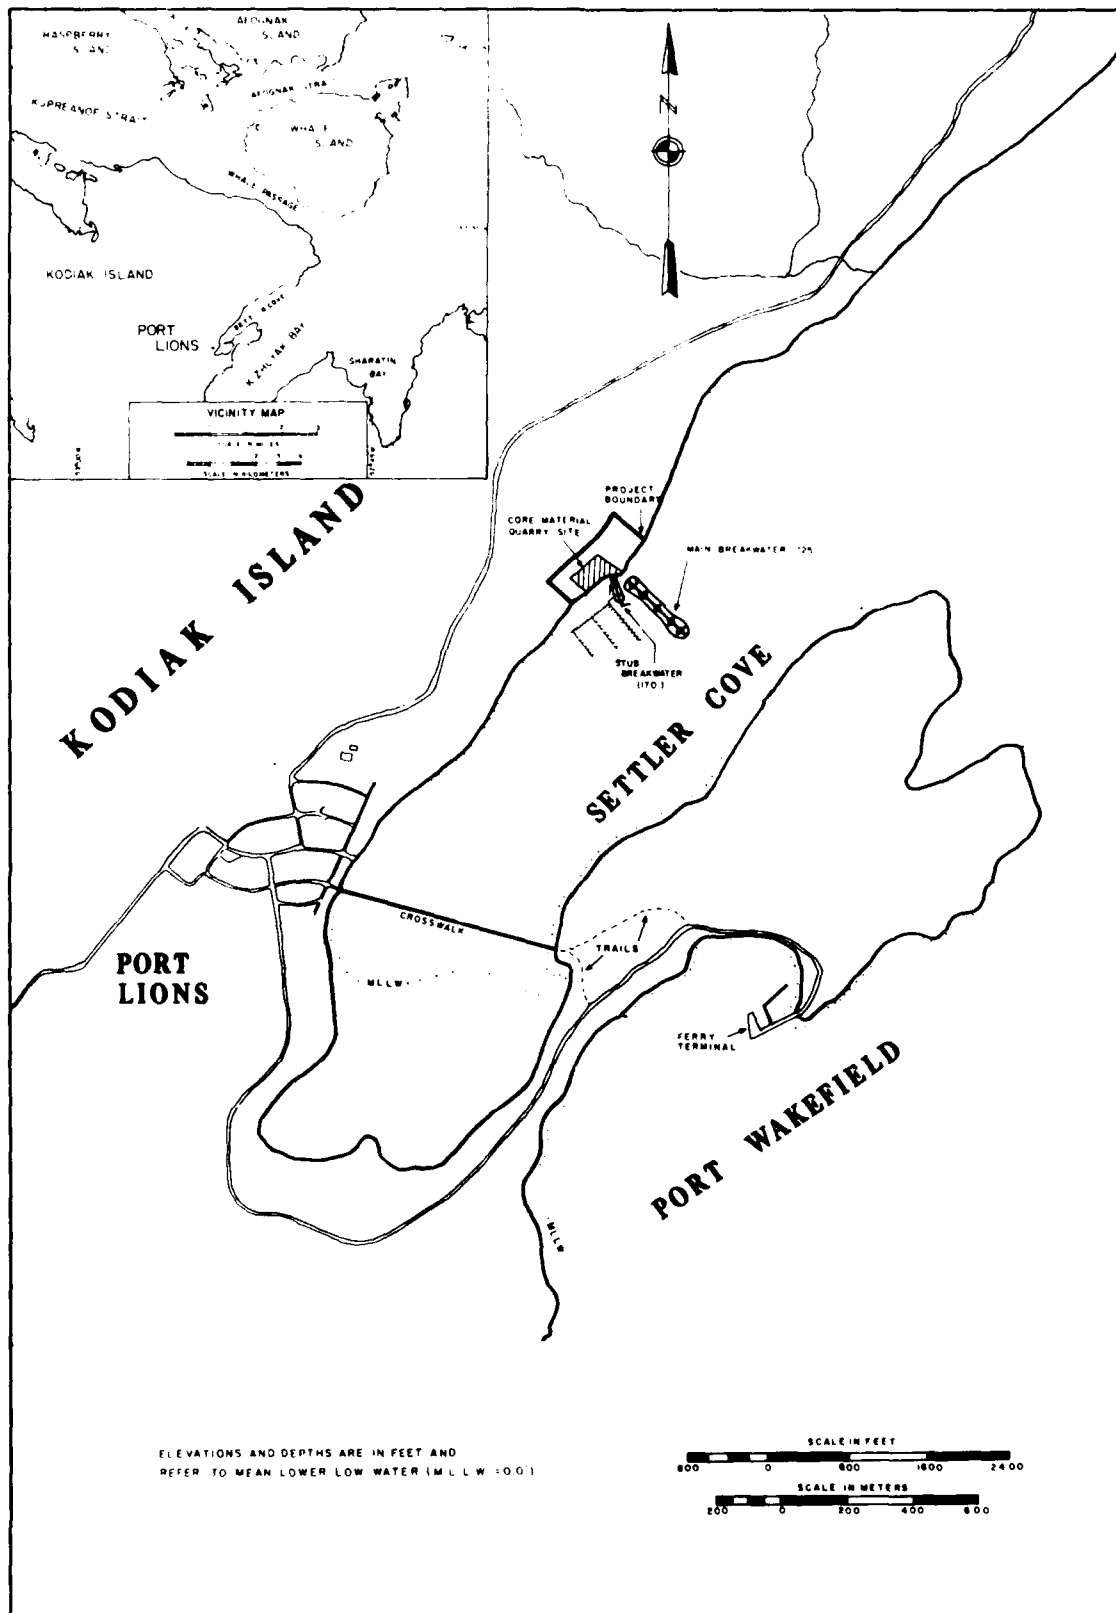
Figure 40. Site layout of Port Lions Harbor, Alaska (revised 1984)

| <u>Date(s)</u> | <u>Construction and Rehabilitation History</u> |
|---|---|
| 1985 | The harbor is illustrated in Figure 40, and an aerial photograph of the harbor is presented in Figure 41. There have been no reports of needed repairs or rehabilitation since 1983. |

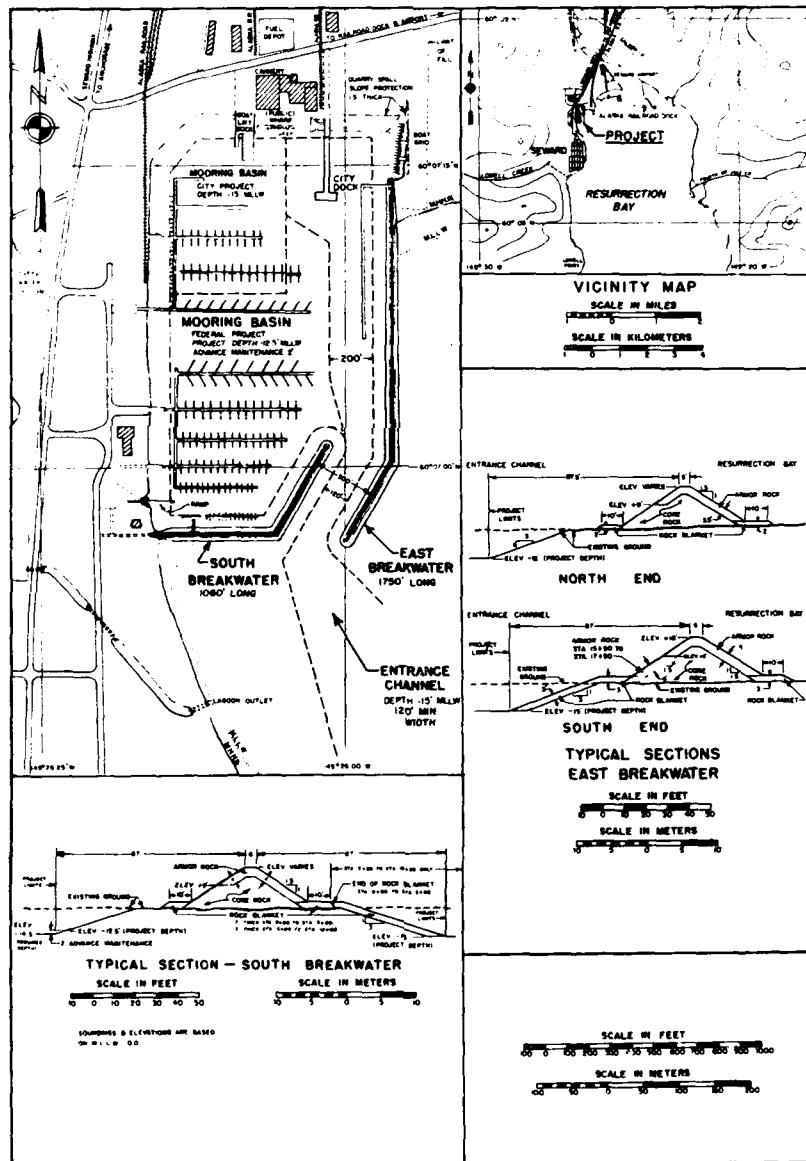
Figure 44. Site layout of Seward Harbor, Alaska (revised 1984)

| Date(s) | Construction and Rehabilitation History |
|---|---|
| 1985 | The harbor is illustrated in Figure 44, and an aerial photograph of the harbor is presented in Figure 45. There are no reports of needed repairs or rehabilitations, nor are there reports of action taken on recommendations for an additional basin. |

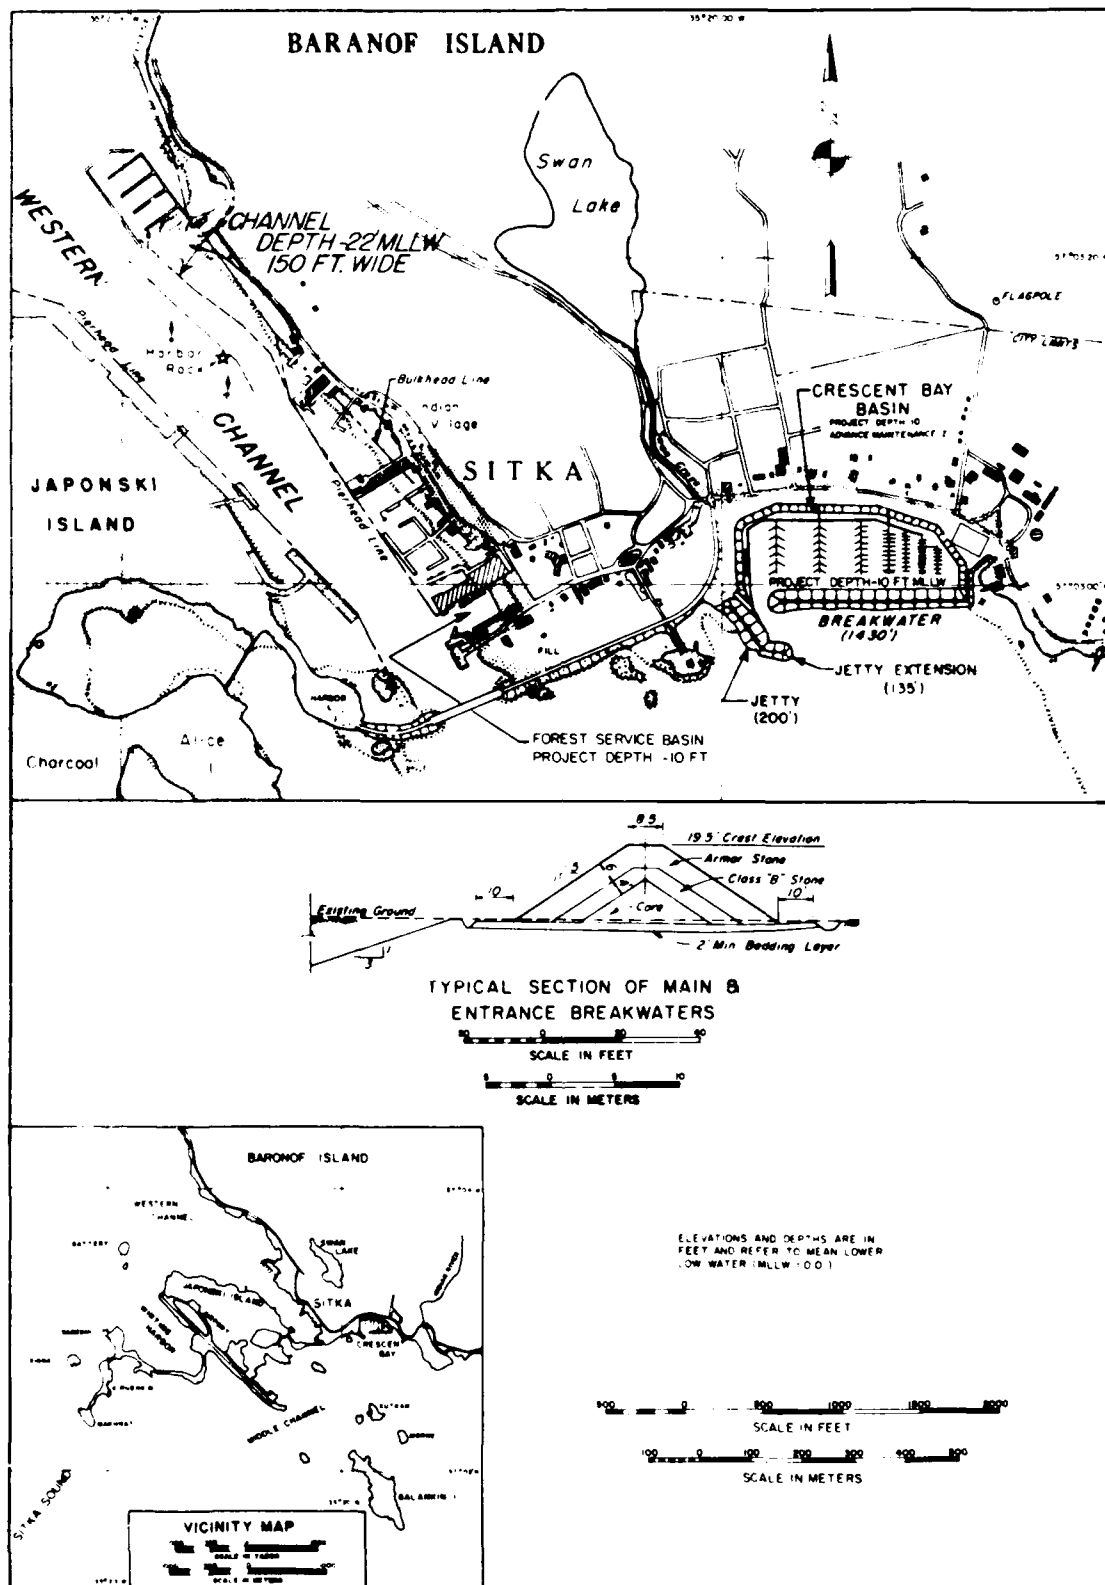
Figure 46. Site layout of Sitka Harbor, Alaska (revised 1981)

| <u>Date(s)</u> | <u>Construction and Rehabilitation History</u> |
|---|---|
| 1985 | The harbor is illustrated in Figure 46, and an aerial photograph is presented in Figure 47. There are no reports of needed repairs or rehabilitation. |

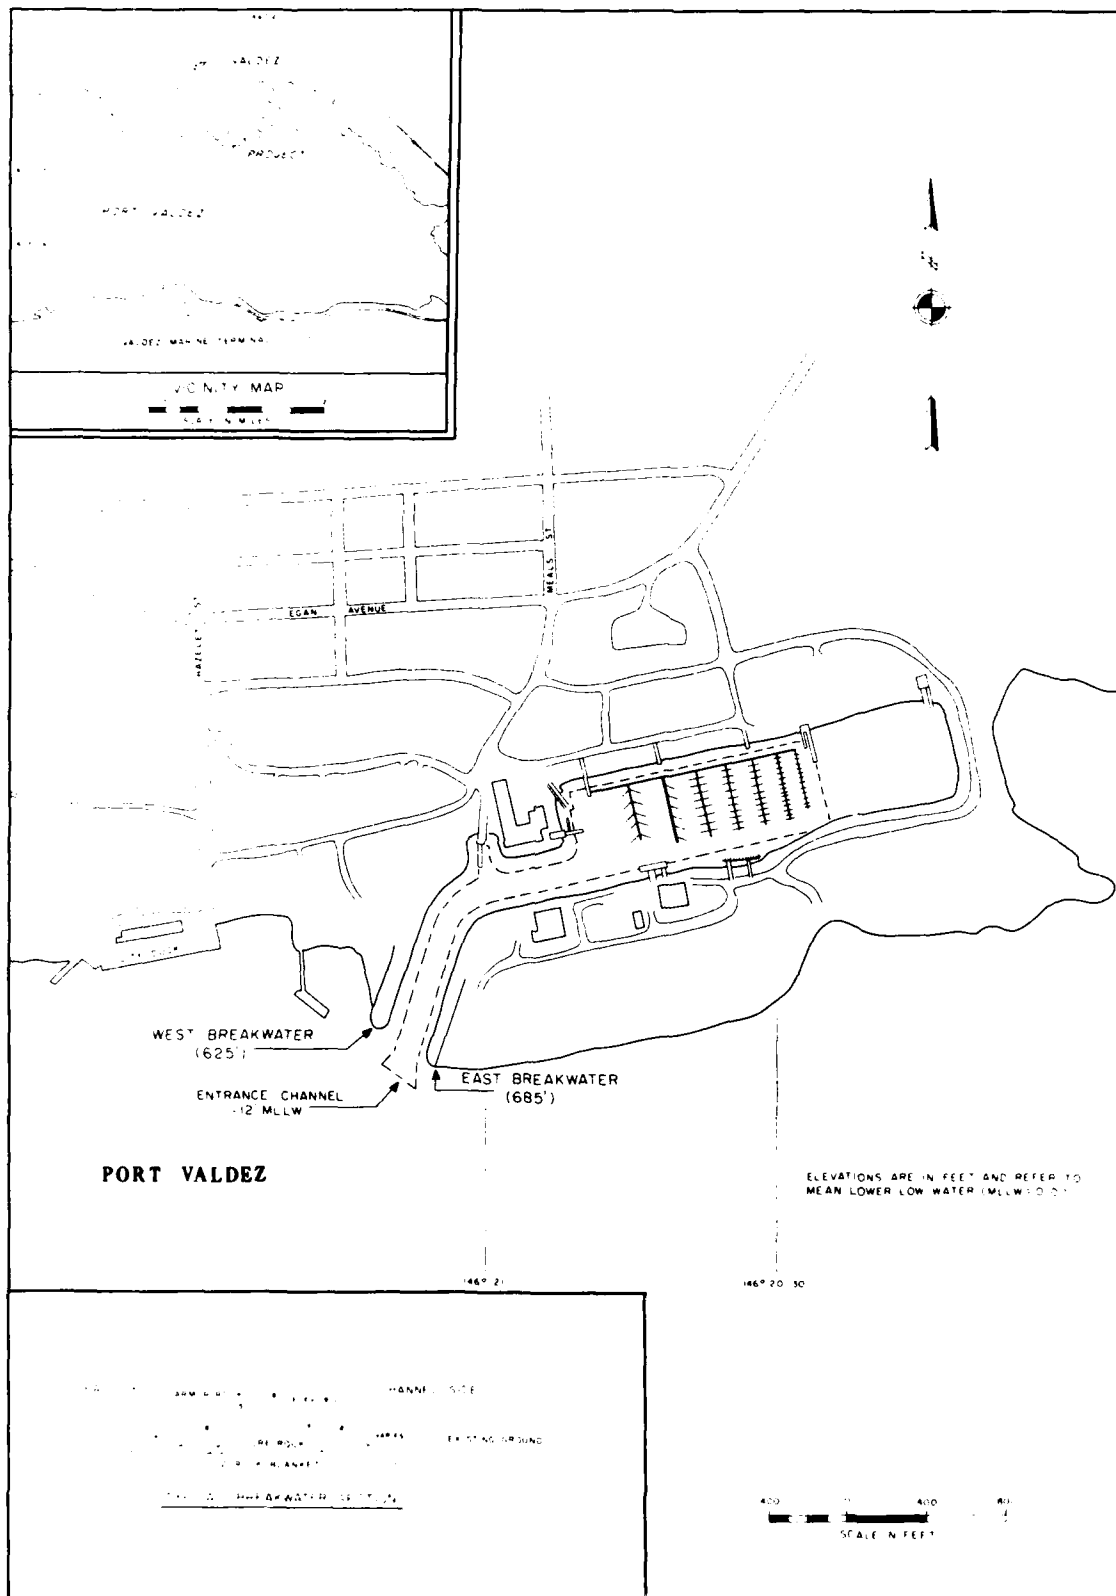
Figure 48. Site layout of Valdez Harbor, Alaska, 1985

| <u>Date(s)</u> | <u>Construction and Rehabilitation History</u> |
|---|---|
| 1985 | The harbor is illustrated in Figure 48, and an aerial photograph of the harbor is presented in Figure 49. The basin was expanded by local interests to 19 acres. There are no reports of needed repairs or rehabilitation at the new harbor. |

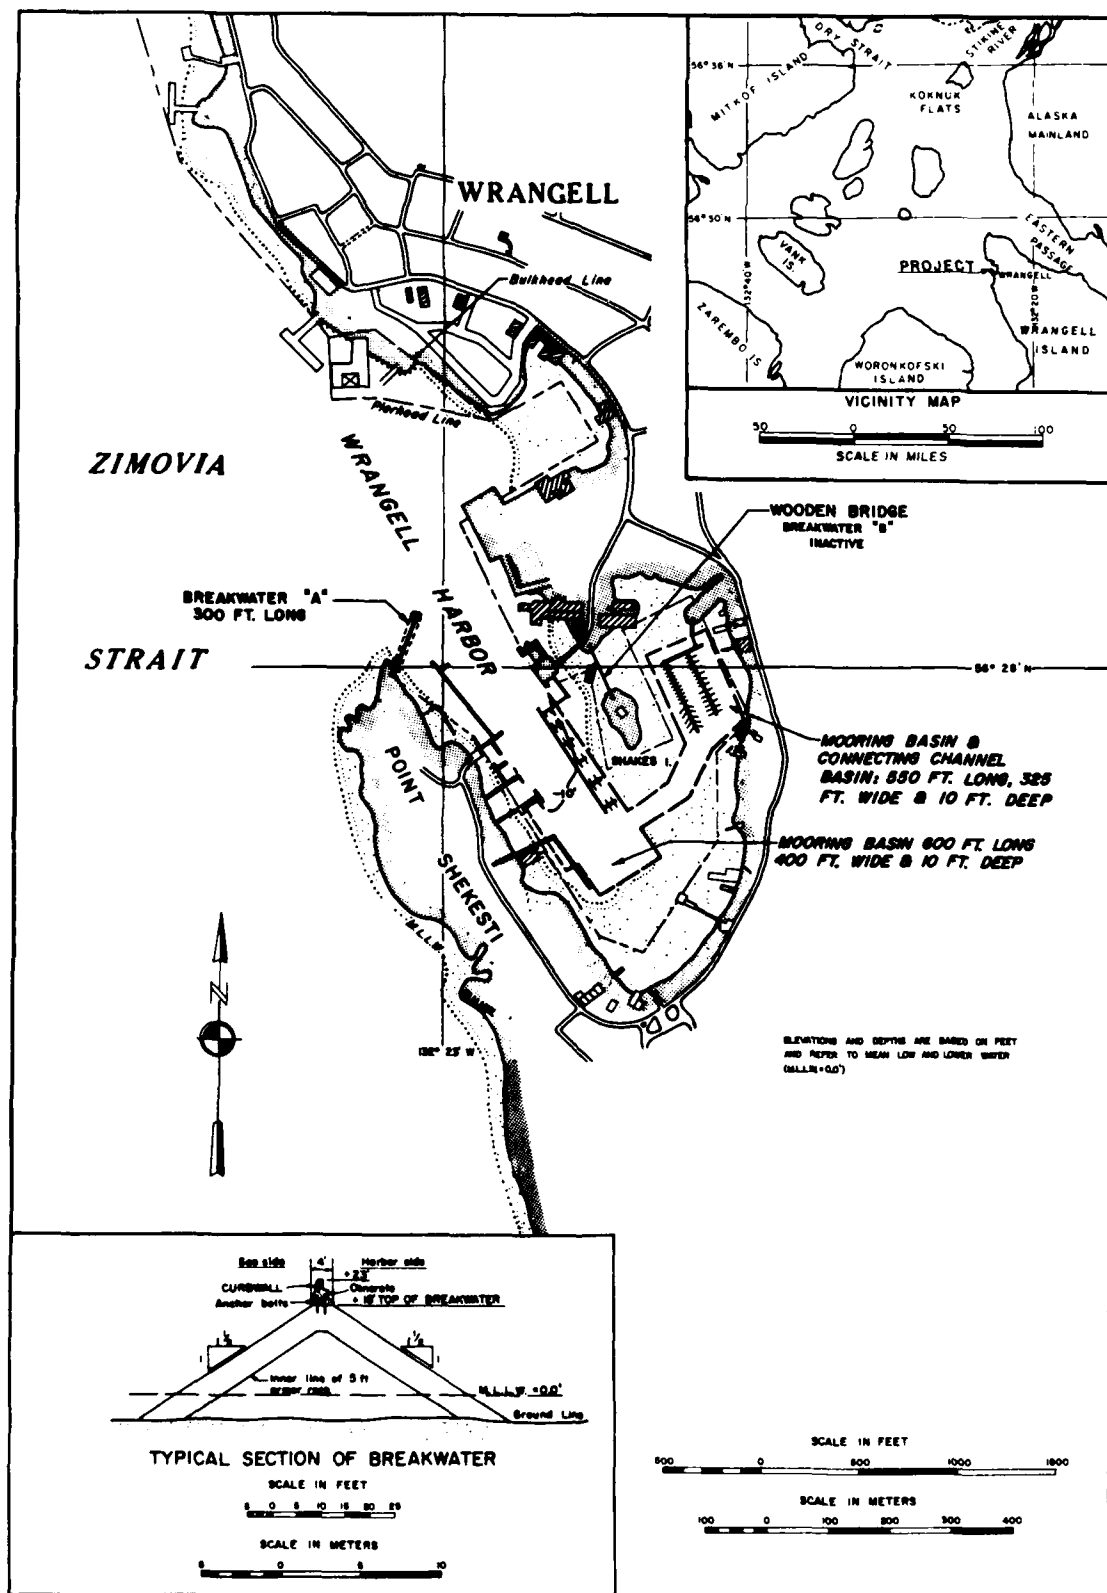
Figure 50. Site layout of Wrangell Harbor, Alaska (revised 1981)

| <u>Date(s)</u> | <u>Construction and Rehabilitation History</u> |
|---|---|
| 1985 | The harbor is illustrated in Figure 50, and an aerial photograph of the harbor is presented in Figure 51. There are no reports of repairs or rehabilitation. |

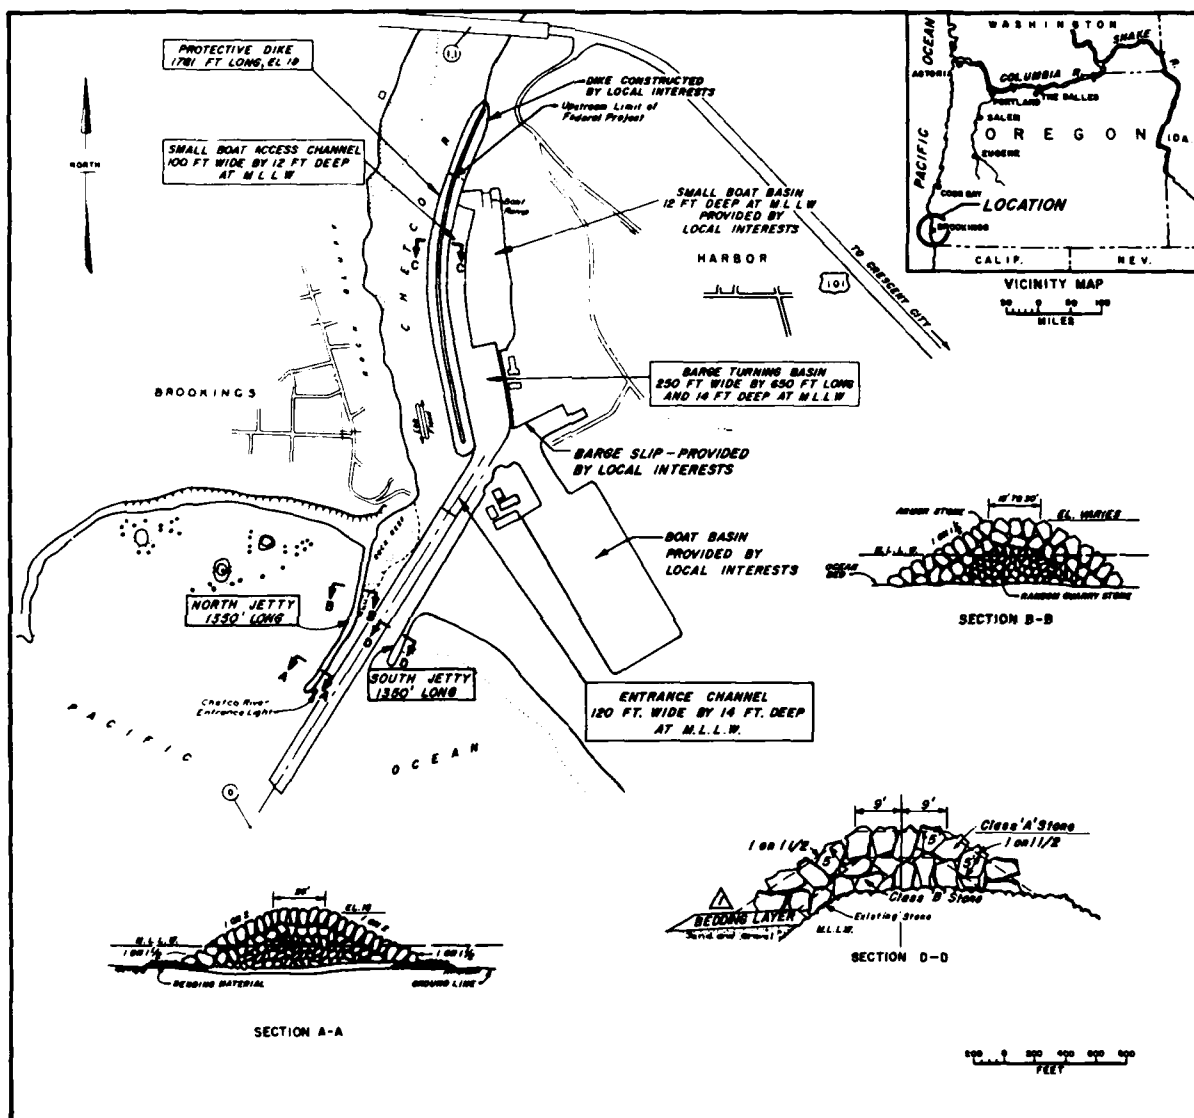
Figure 52. Site layout of Chetco River, Oregon (revised 1979)

| Date(s) | Construction and Rehabilitation History |
|---|---|
| 1985 | The harbor and jetty cross sections are shown in Figure 52. There have been no reports of repairs or rehabilitation since 1970. |

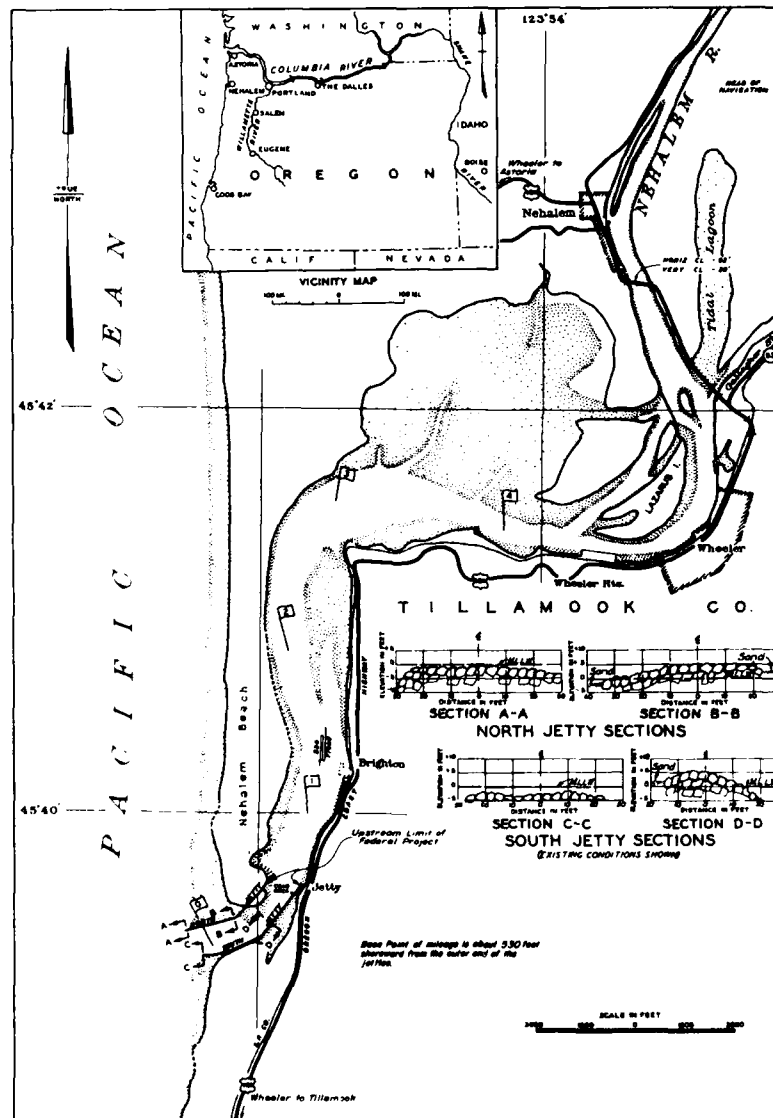
Figure 57. Site layout of Nehalem Bay, Oregon (revised 1979)

| Date(s) | Construction and Rehabilitation History |
|---|---|
| 1985 | The harbor and cross sections of the jetties are illustrated in Figure 57. The jetties are in good condition at this time. |

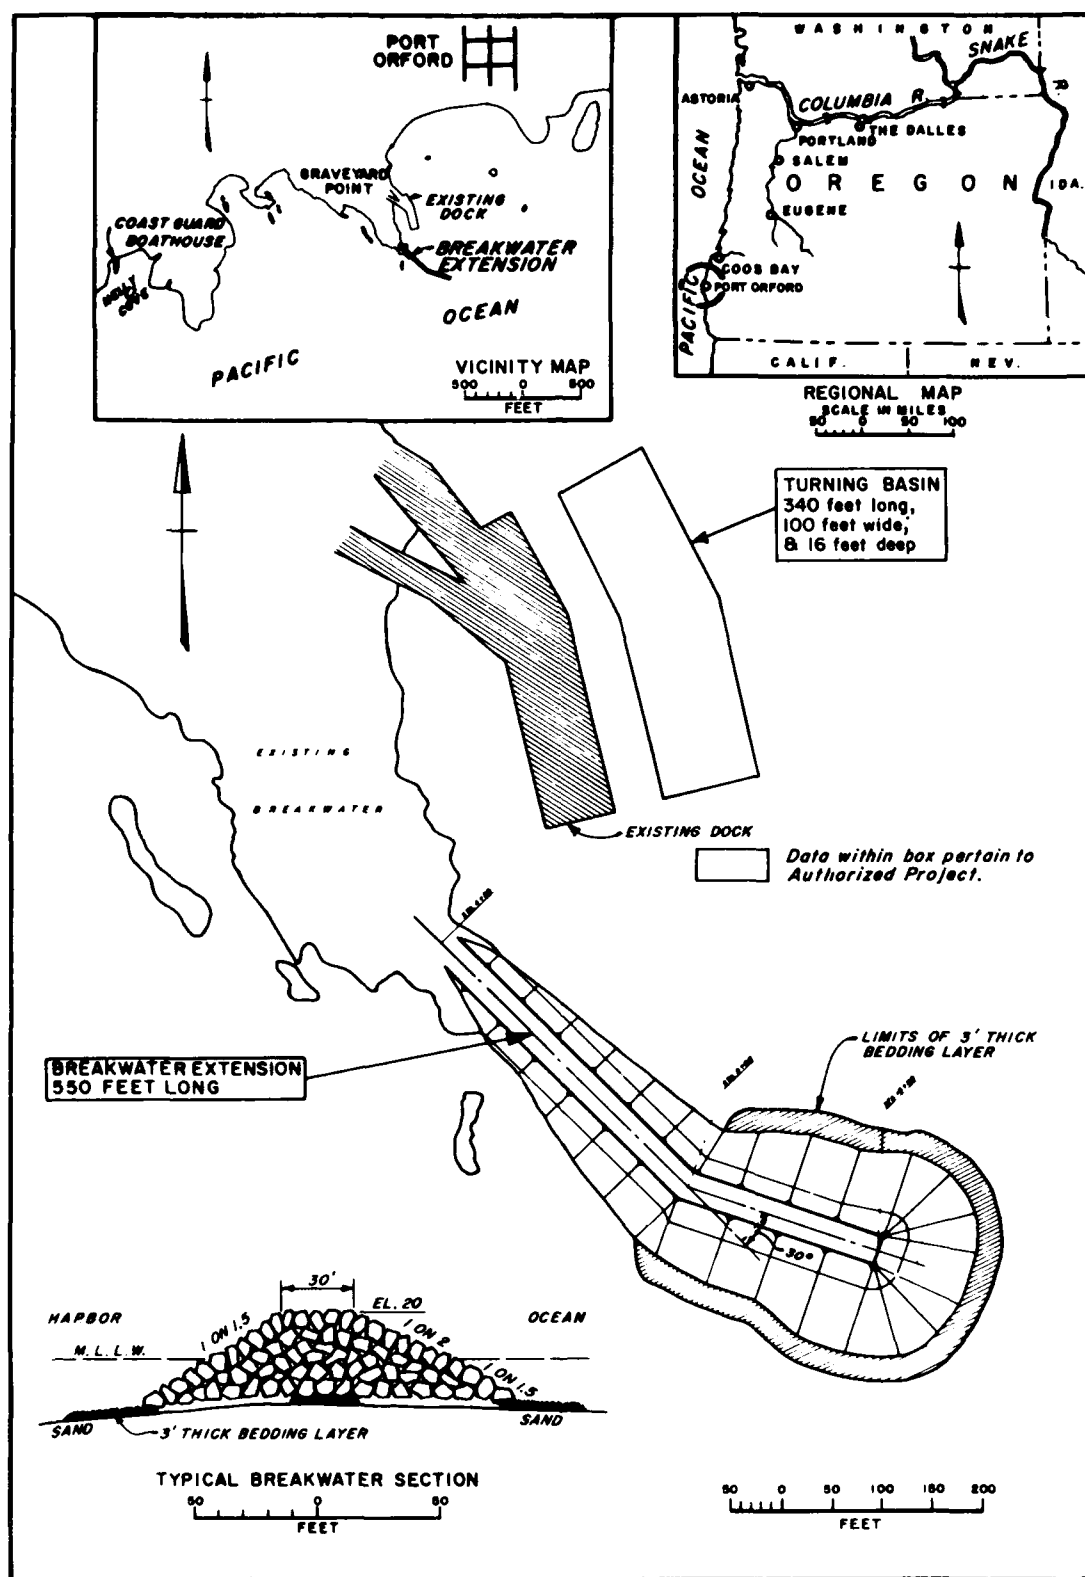
Figure 58. Site layout of Port Orford, Oregon (revised 1971)

| <u>Date(s)</u> | <u>Construction and Rehabilitation History</u> |
|---|---|
| 1985 | The harbor and cross section of the breakwater are illustrated in Figure 58. No repairs or rehabilitation are reported. |

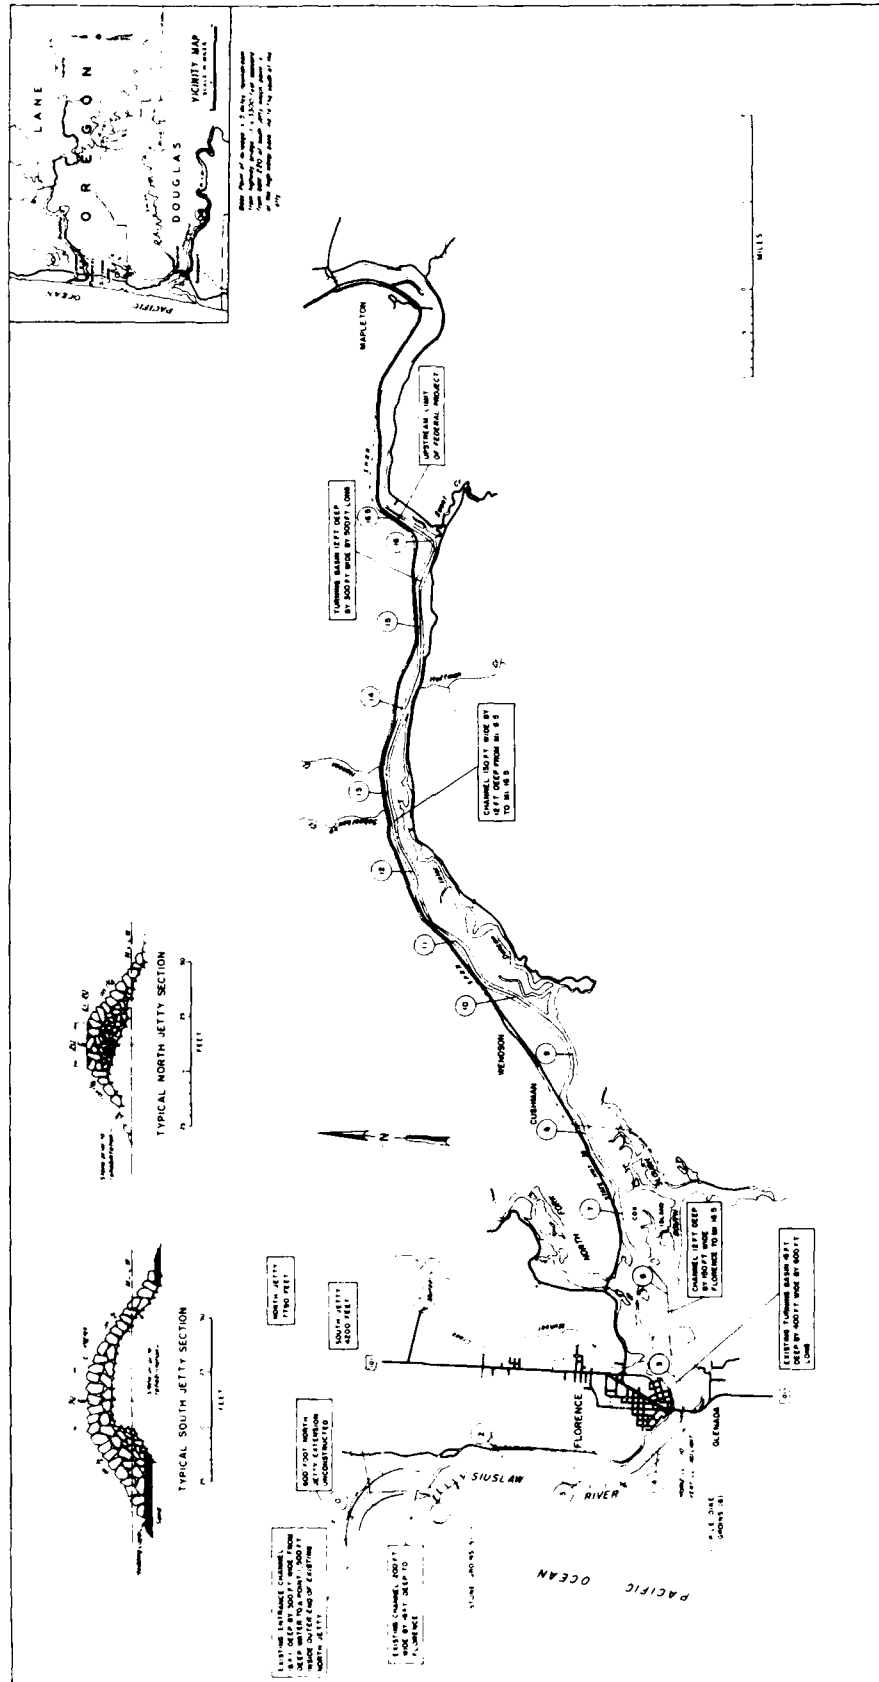
Figure 61. Site layout of Siuslaw River, Oregon

| Date(s) | Construction and Rehabilitation History |
|---|---|
| 1985 | The harbor and cross sections of the jetties are illustrated in Figure 61. Both jetties are in good condition at this time. |

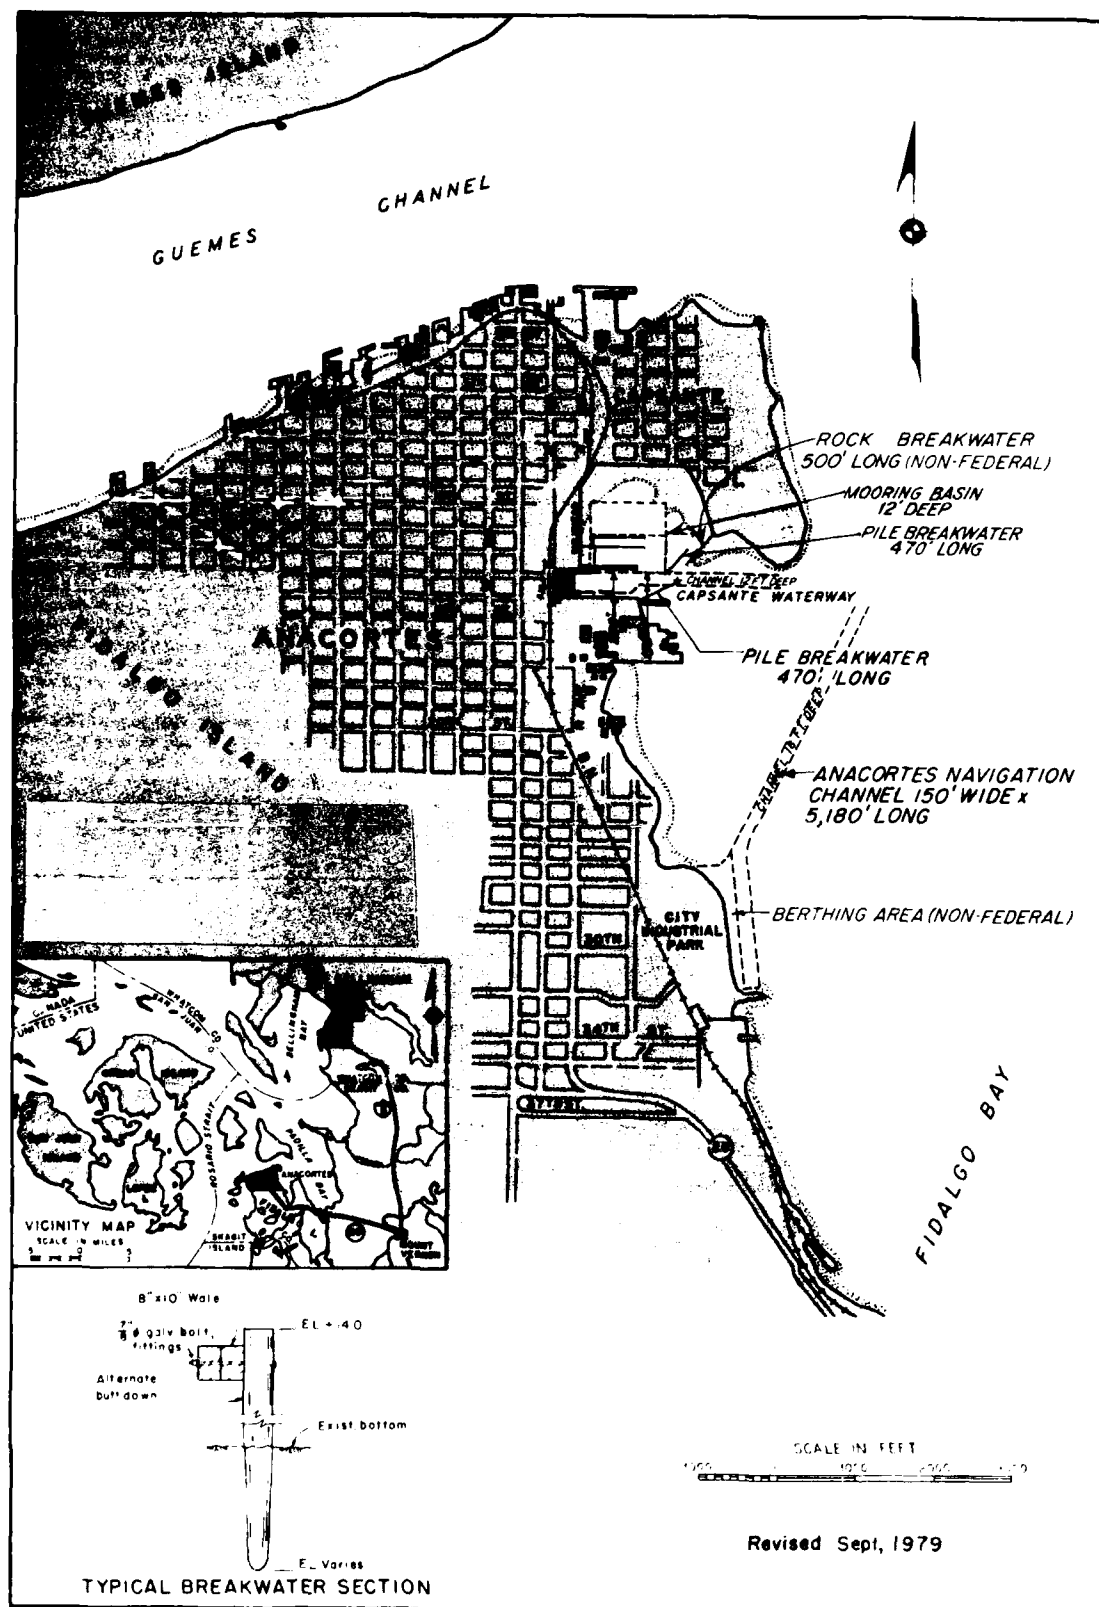
Figure 66. Site layout of Anacortes Harbor, Washington (revised 1979)

| <u>Date(s)</u> | <u>Construction and Rehabilitation History</u> |
|---|---|
| 1985 | The harbor is illustrated in Figure 66. There have been no reports of needed repairs or rehabilitation since 1976. |

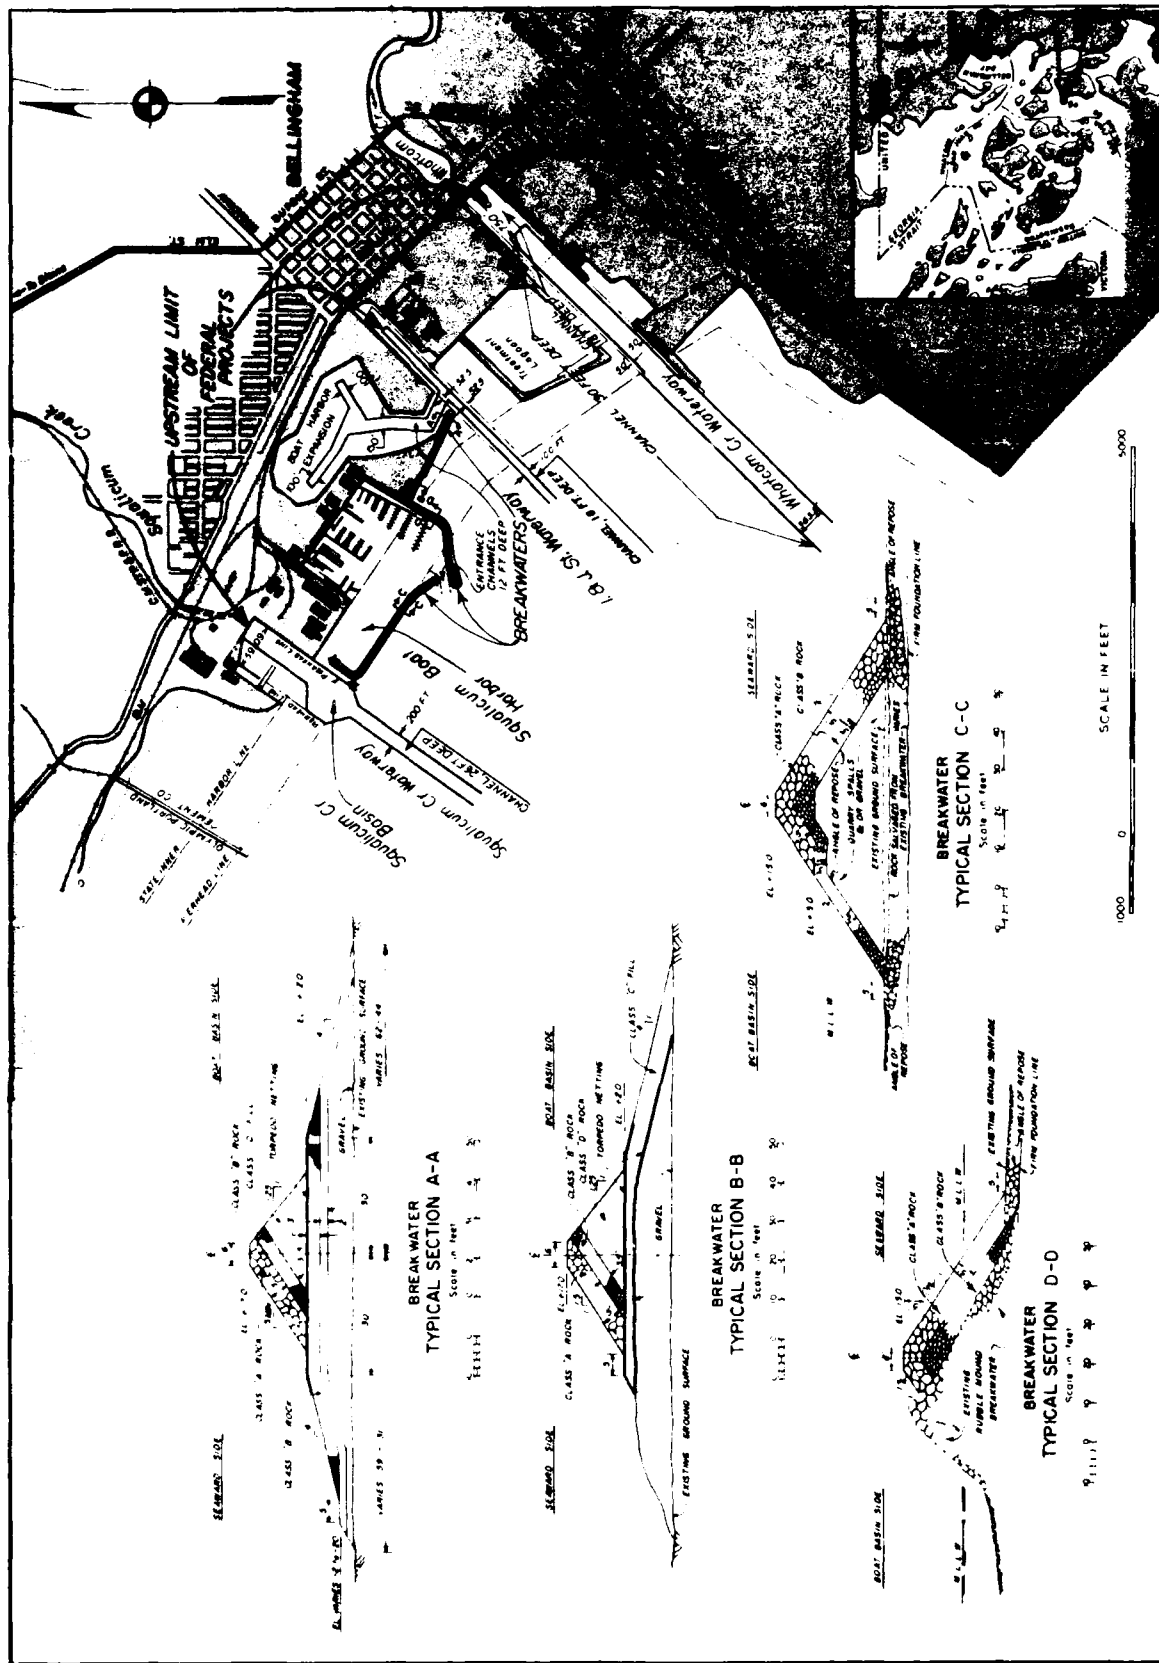
Figure 67. Site layout of Bellingham Harbor, Washington (revised 1982)

| <u>Date(s)</u> | <u>Construction and Rehabilitation History</u> |
|---|---|
| 1985 | The harbor and cross sections of the breakwaters are shown in Figure 67. There are no reports of needed repairs or rehabilitation for the breakwaters. |
