TECHNICAL REPORT REMR-CO-3

CASE HISTORIES OF CORPS BREAKWATER  
AND JETTY STRUCTURES

Report 6

NORTH PACIFIC DIVISION

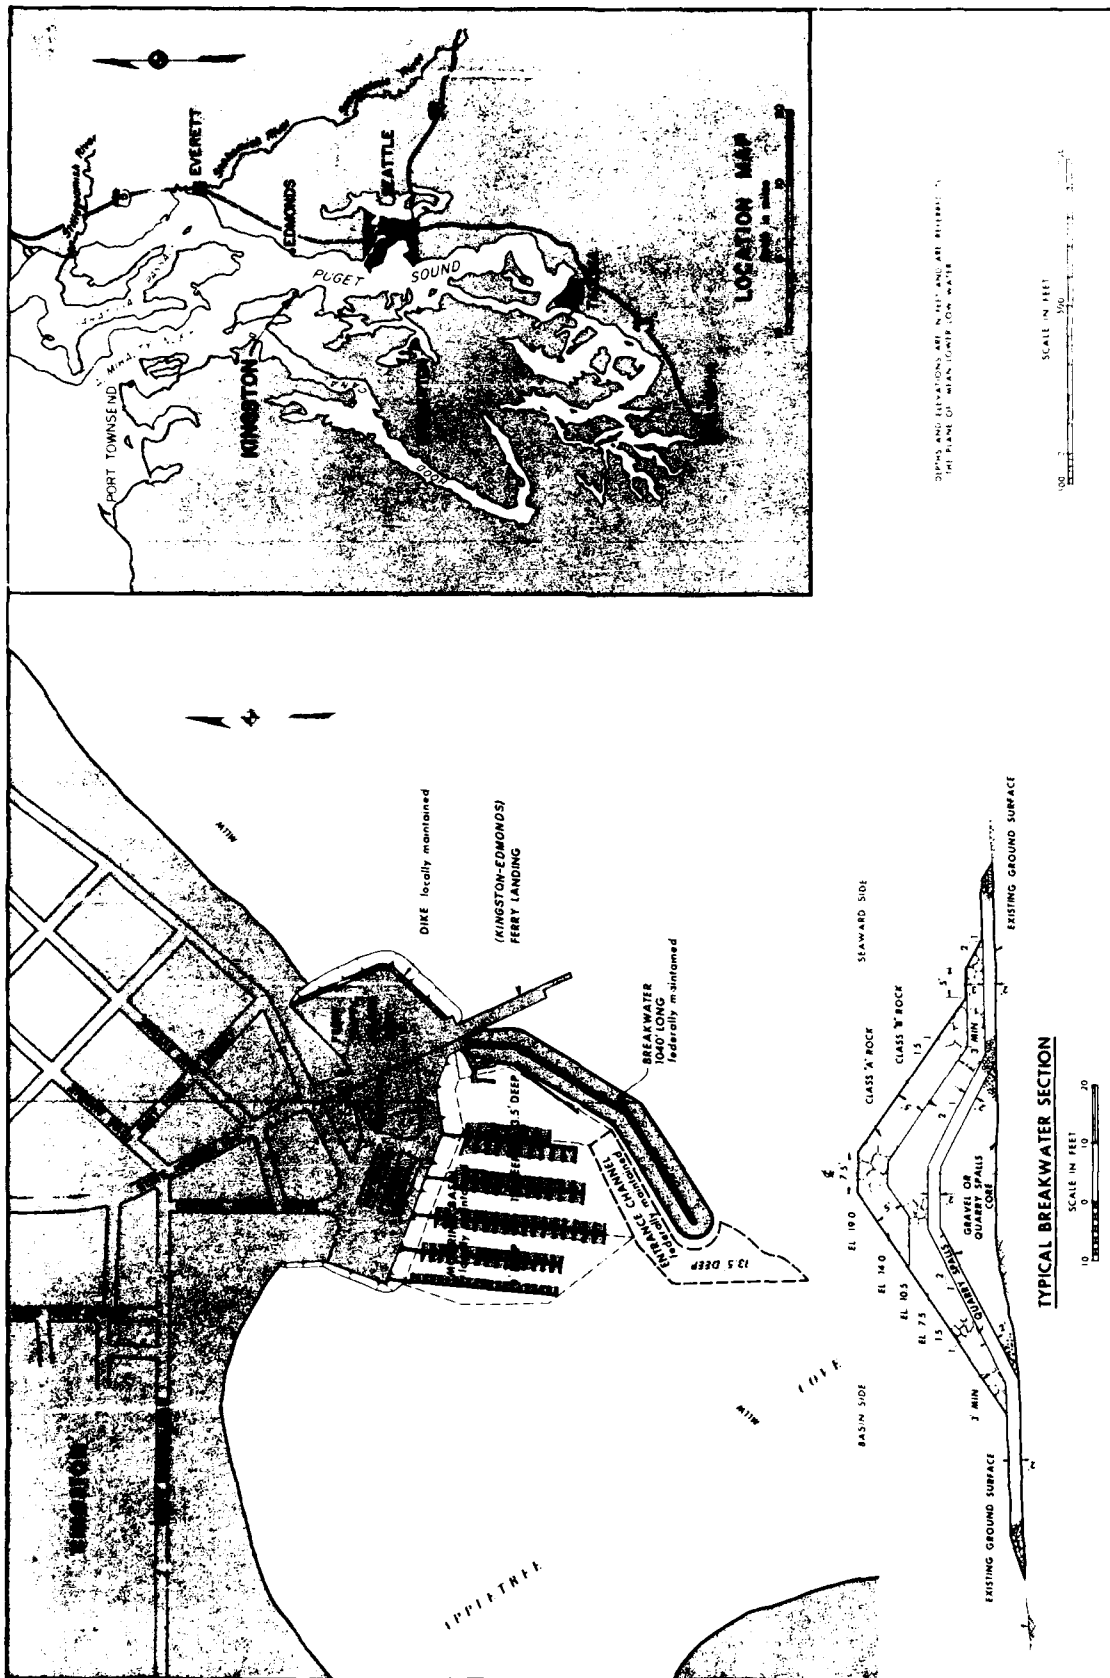
Figure 71. Site layout at Kingston Harbor, Washington (revised 1979)

| <u>Date(s)</u> | <u>Construction and Rehabilitation History</u> |
|---|---|
| 1985 | The harbor and cross section of the breakwater are illustrated in Figure 71. There are no reports of needed repairs or rehabilitation. |

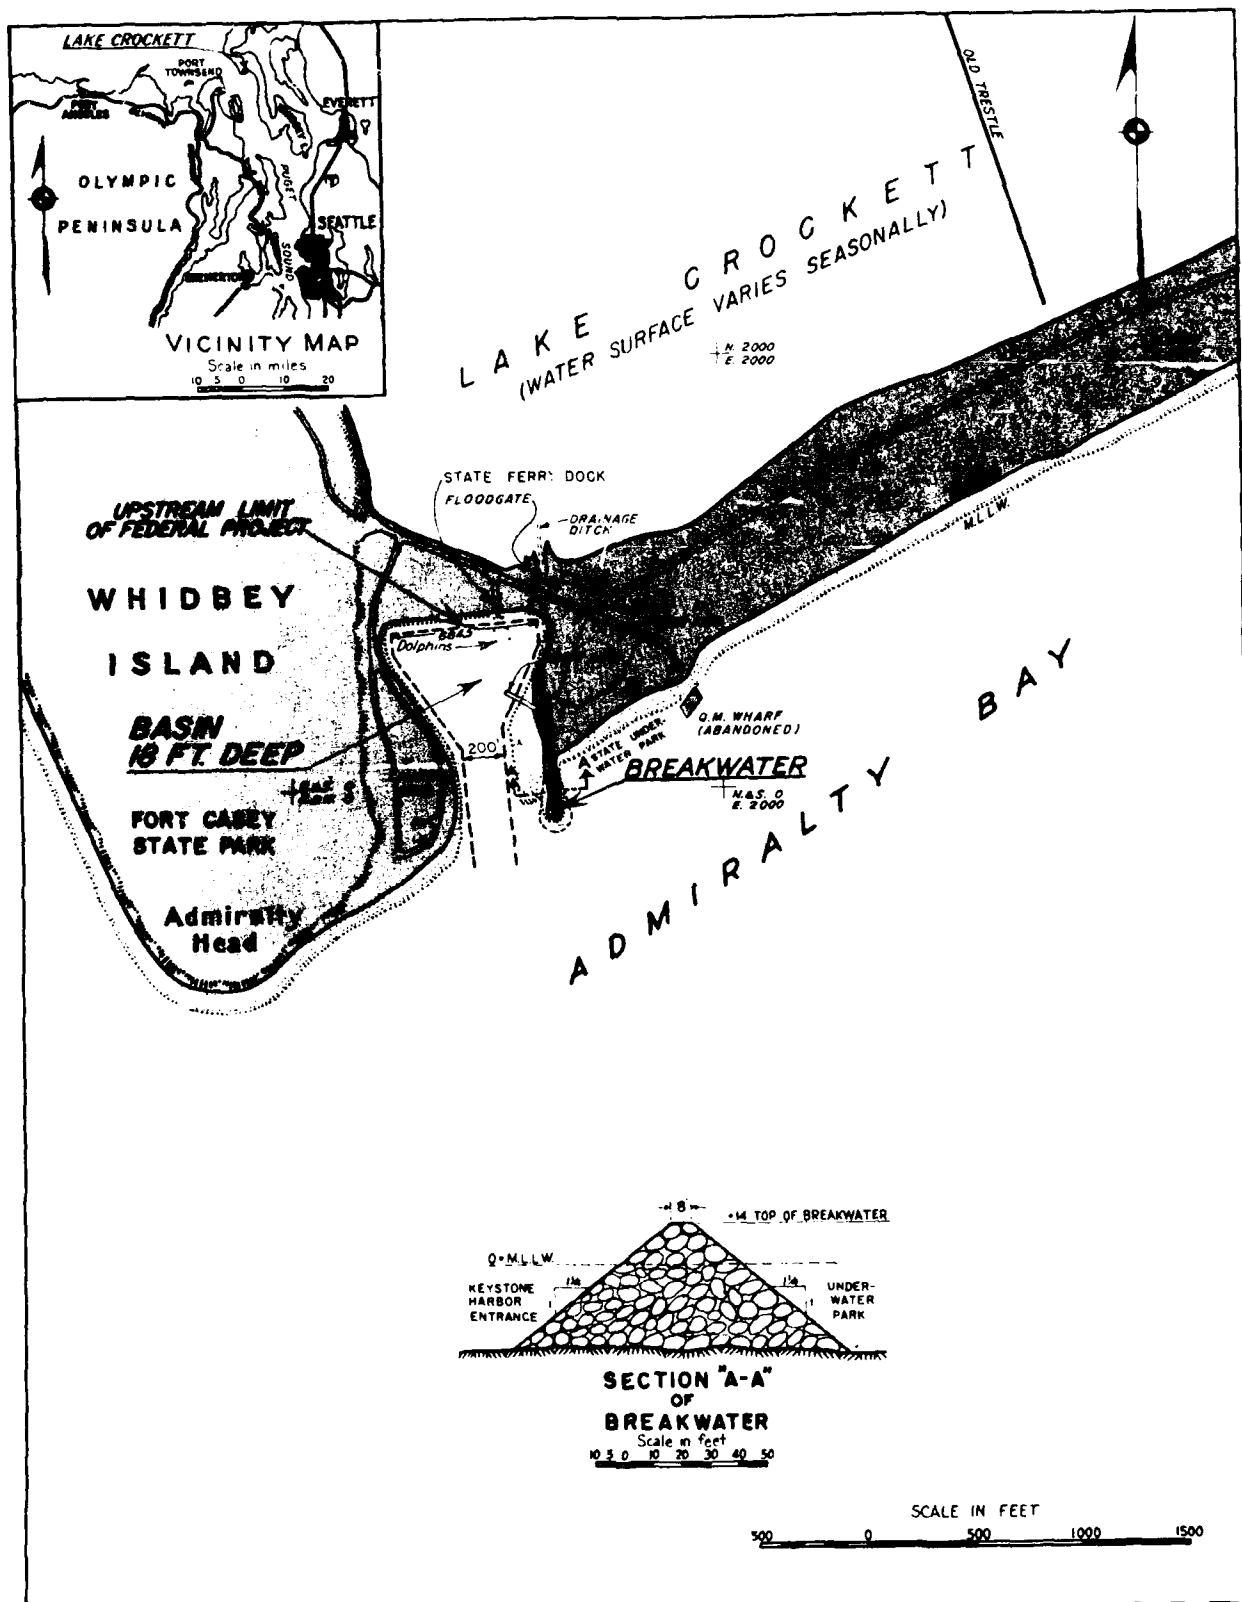
Figure 72. Site layout at Lake Crockett, Washington (revised 1979)

| Date(s) | Construction and Rehabilitation History |
|---|---|
| 1985 | The harbor and cross section of the breakwater are illustrated in Figure 72. No repairs or rehabilitation to the structure have been recorded since 1960. |

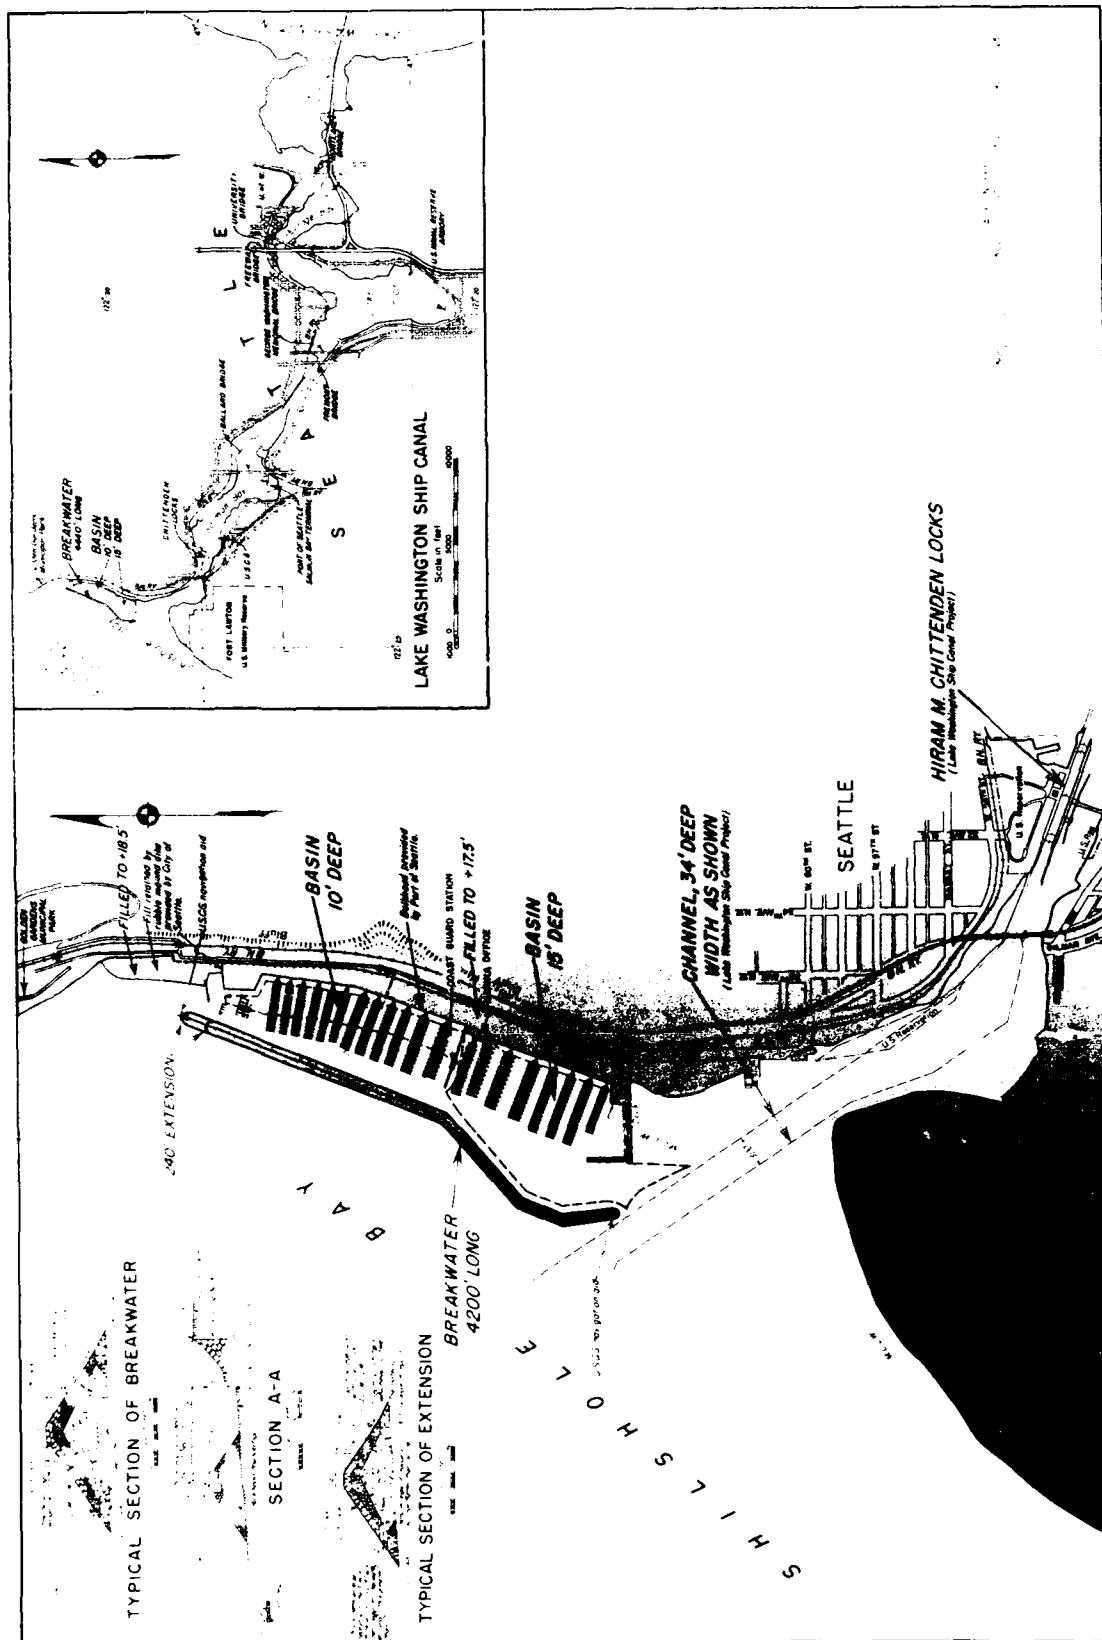
Figure 78. Site layout of Shilshole Bay, Washington (revised 1979)

| Date(s) | Construction and Rehabilitation History |
|---|---|
| 1985 | The harbor and cross sections of the breakwater are illustrated in Figure 78. There are no reports of needed repairs or rehabilitation. |

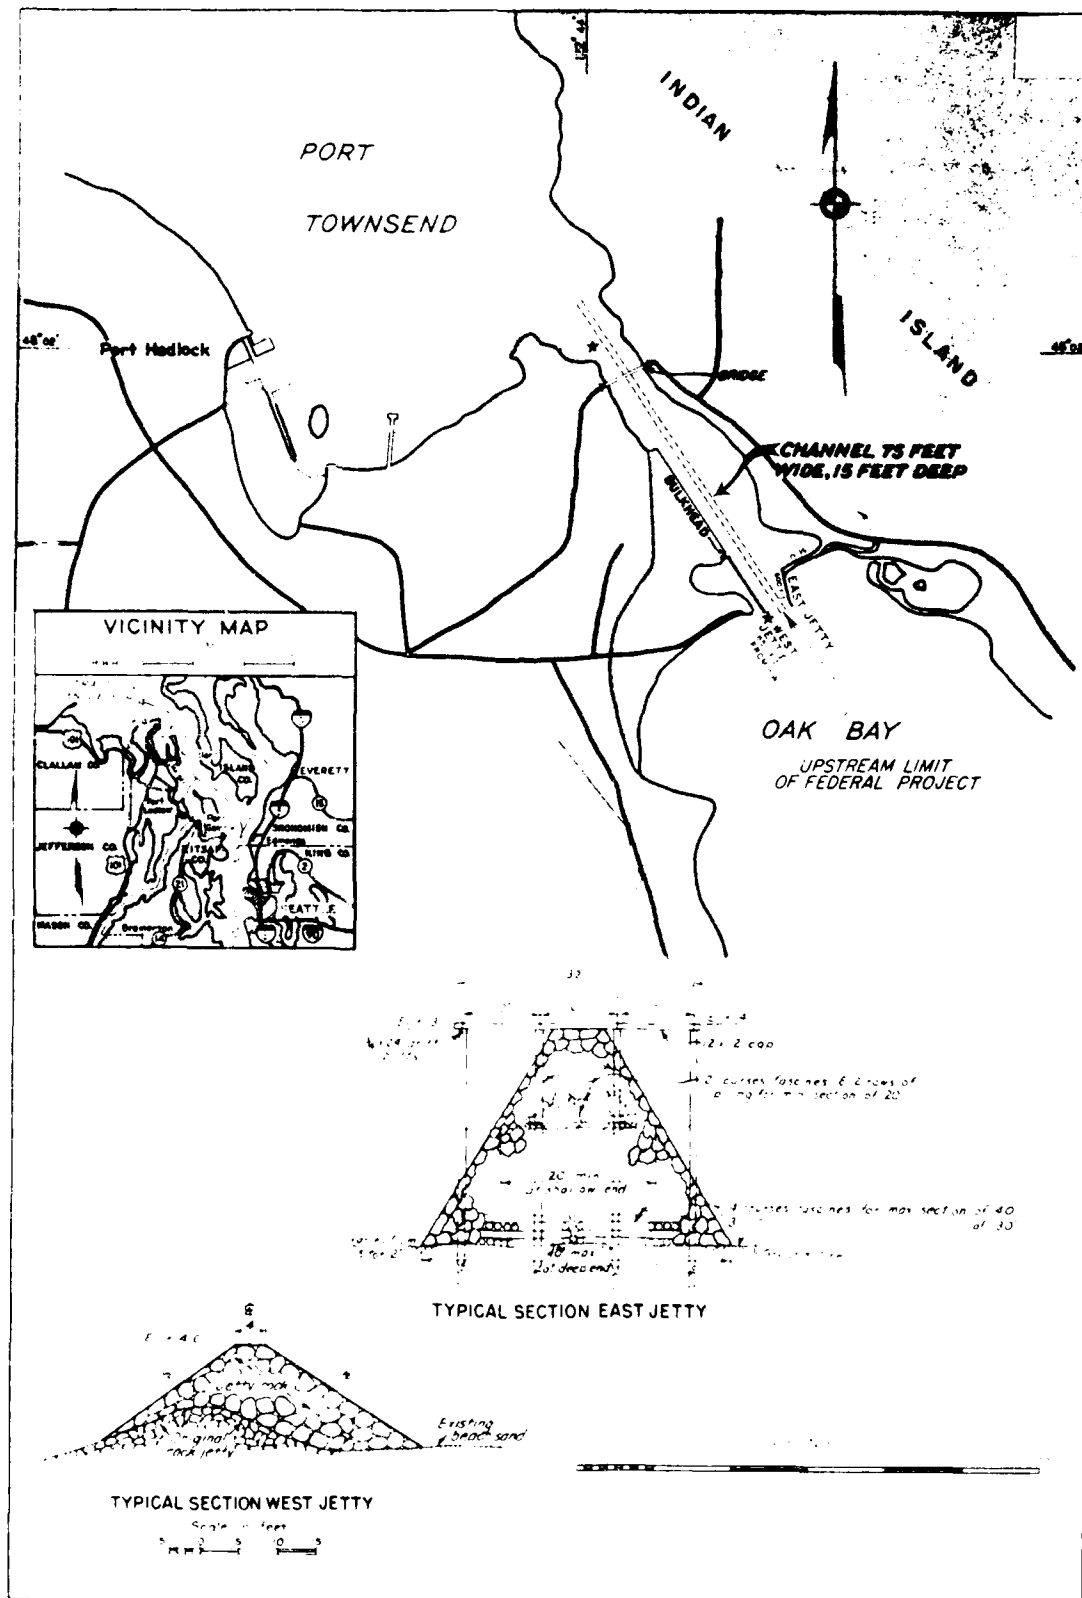
Figure 80. Site layout of waterway connecting Port Townsend and Oak Bay, Washington (revised 1979)

| <u>Date(s)</u> | <u>Construction and Rehabilitation History</u> |
|---|---|
| 1985 | The jetty layout and cross sections are illustrated in Figure 80. There is no record of repairs or rehabilitation since 1961. The west jetty is in good condition. The east jetty shows some deterioration but is stable and functional. |

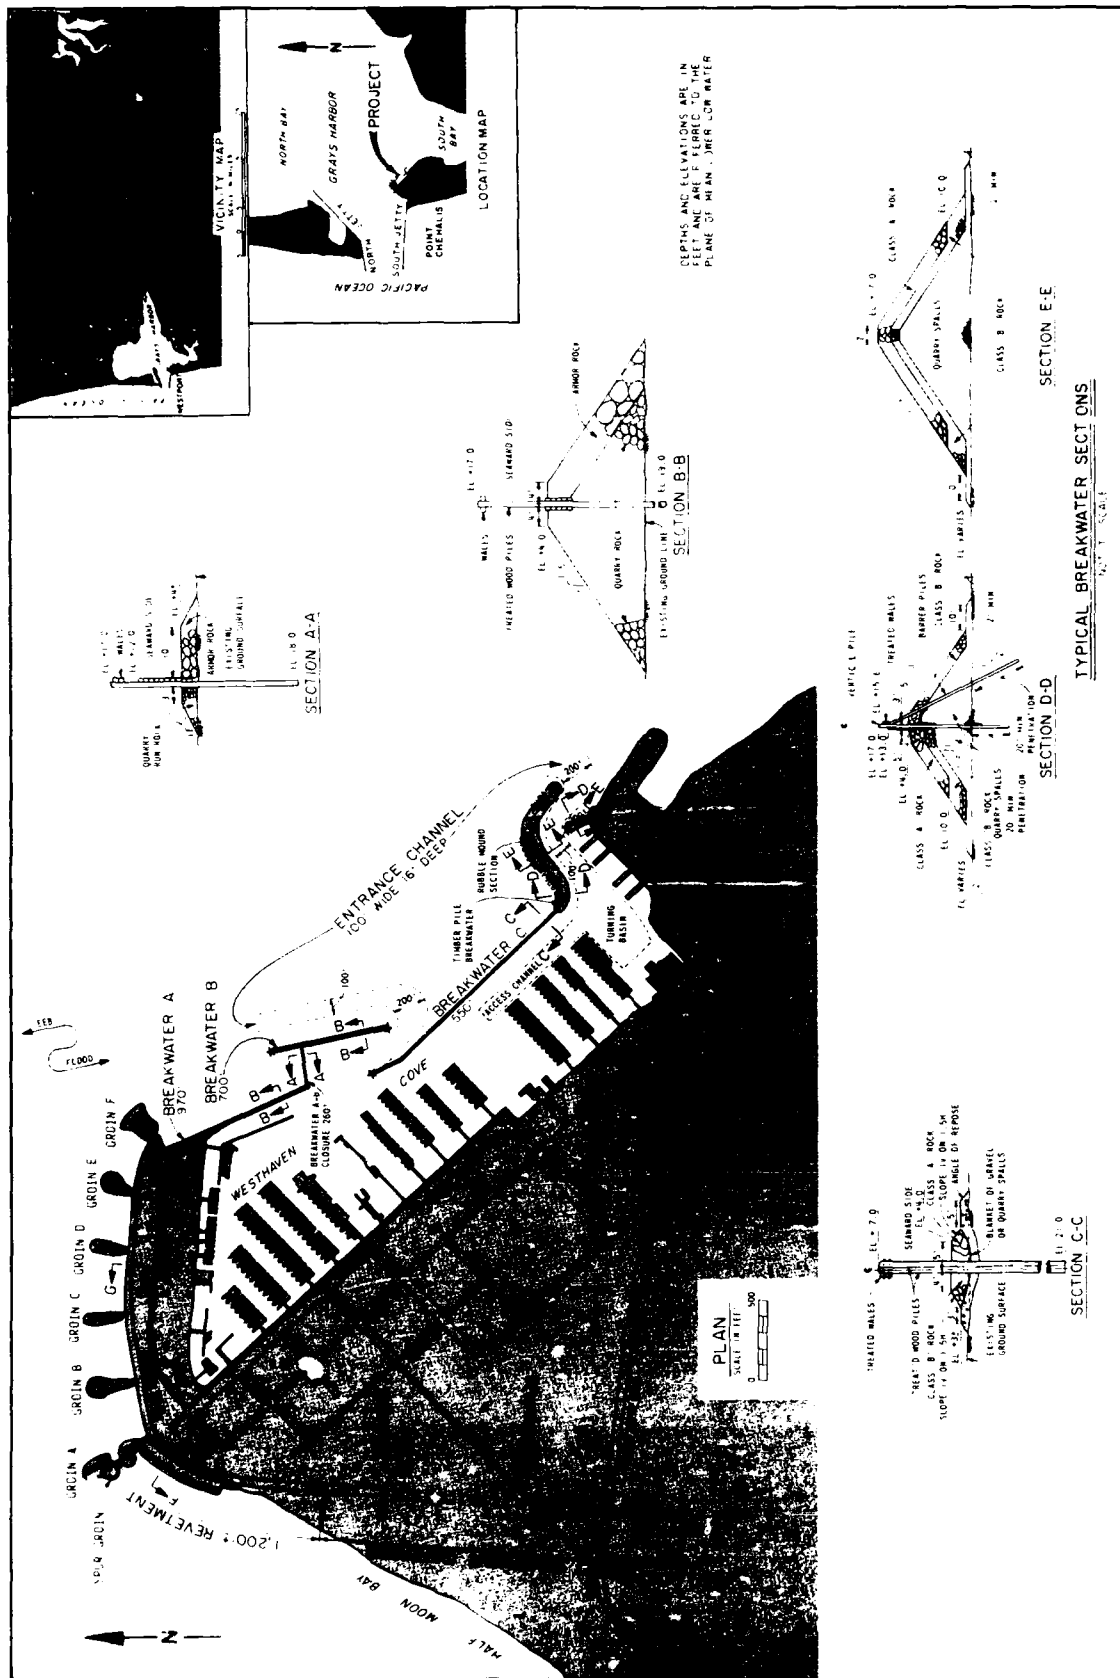
Figure 81. Site layout of Westhaven Cove Small-Boat Basin, Washington (revised 1979)

| <u>Date(s)</u> | <u>Construction and Rehabilitation History</u> |
|---|---|
| 1985 | The basin layout and cross sections of the breakwaters are illustrated in Figure 81. Breakwaters are in reasonably good repair and appear to be functioning properly. |

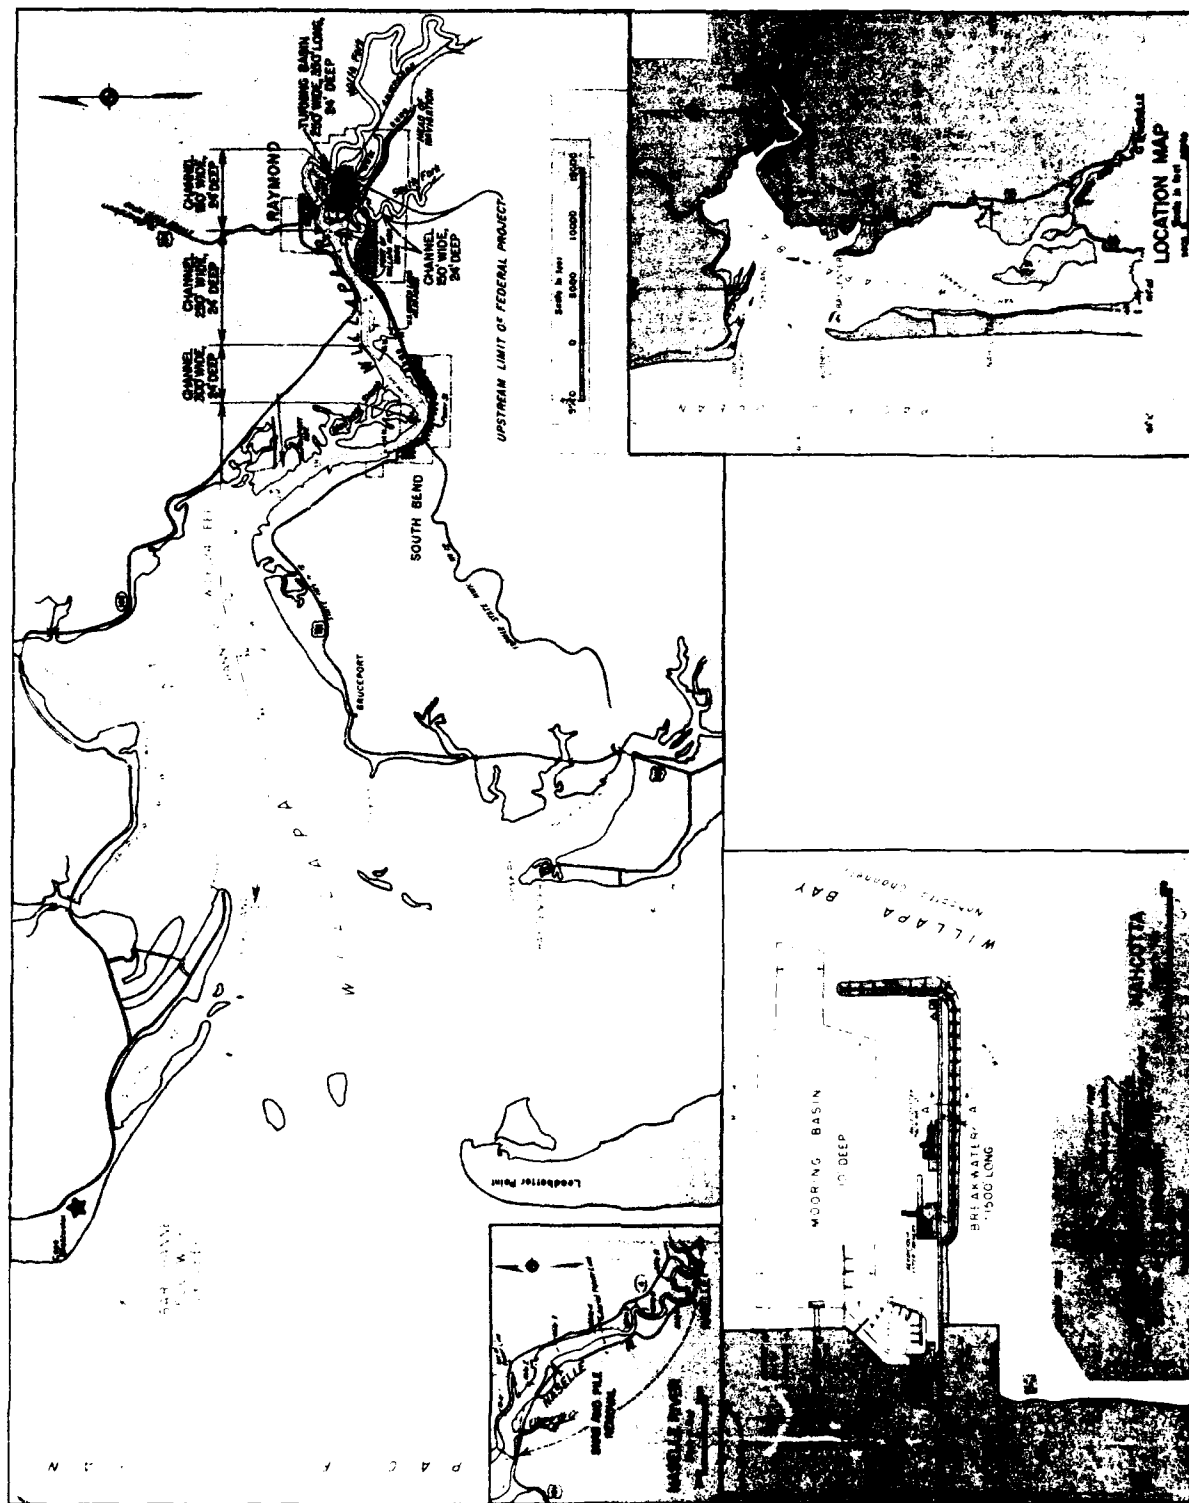
Figure 82. Site layout of Willapa River and Harbor and Naselle River, Washington (revised 1979)

| Date(s) | Construction and Rehabilitation History |
|---|---|
| 1985 | The harbor layout and breakwater cross sections are illustrated in Figure 82. There are no reports of needed repairs or rehabilitation for the breakwater. |
