TECHNICAL REPORT REMR-CO-3

CASE HISTORIES OF CORPS BREAKWATER  
AND JETTY STRUCTURES

Report 7  
NEW ENGLAND DIVISION

January 1989

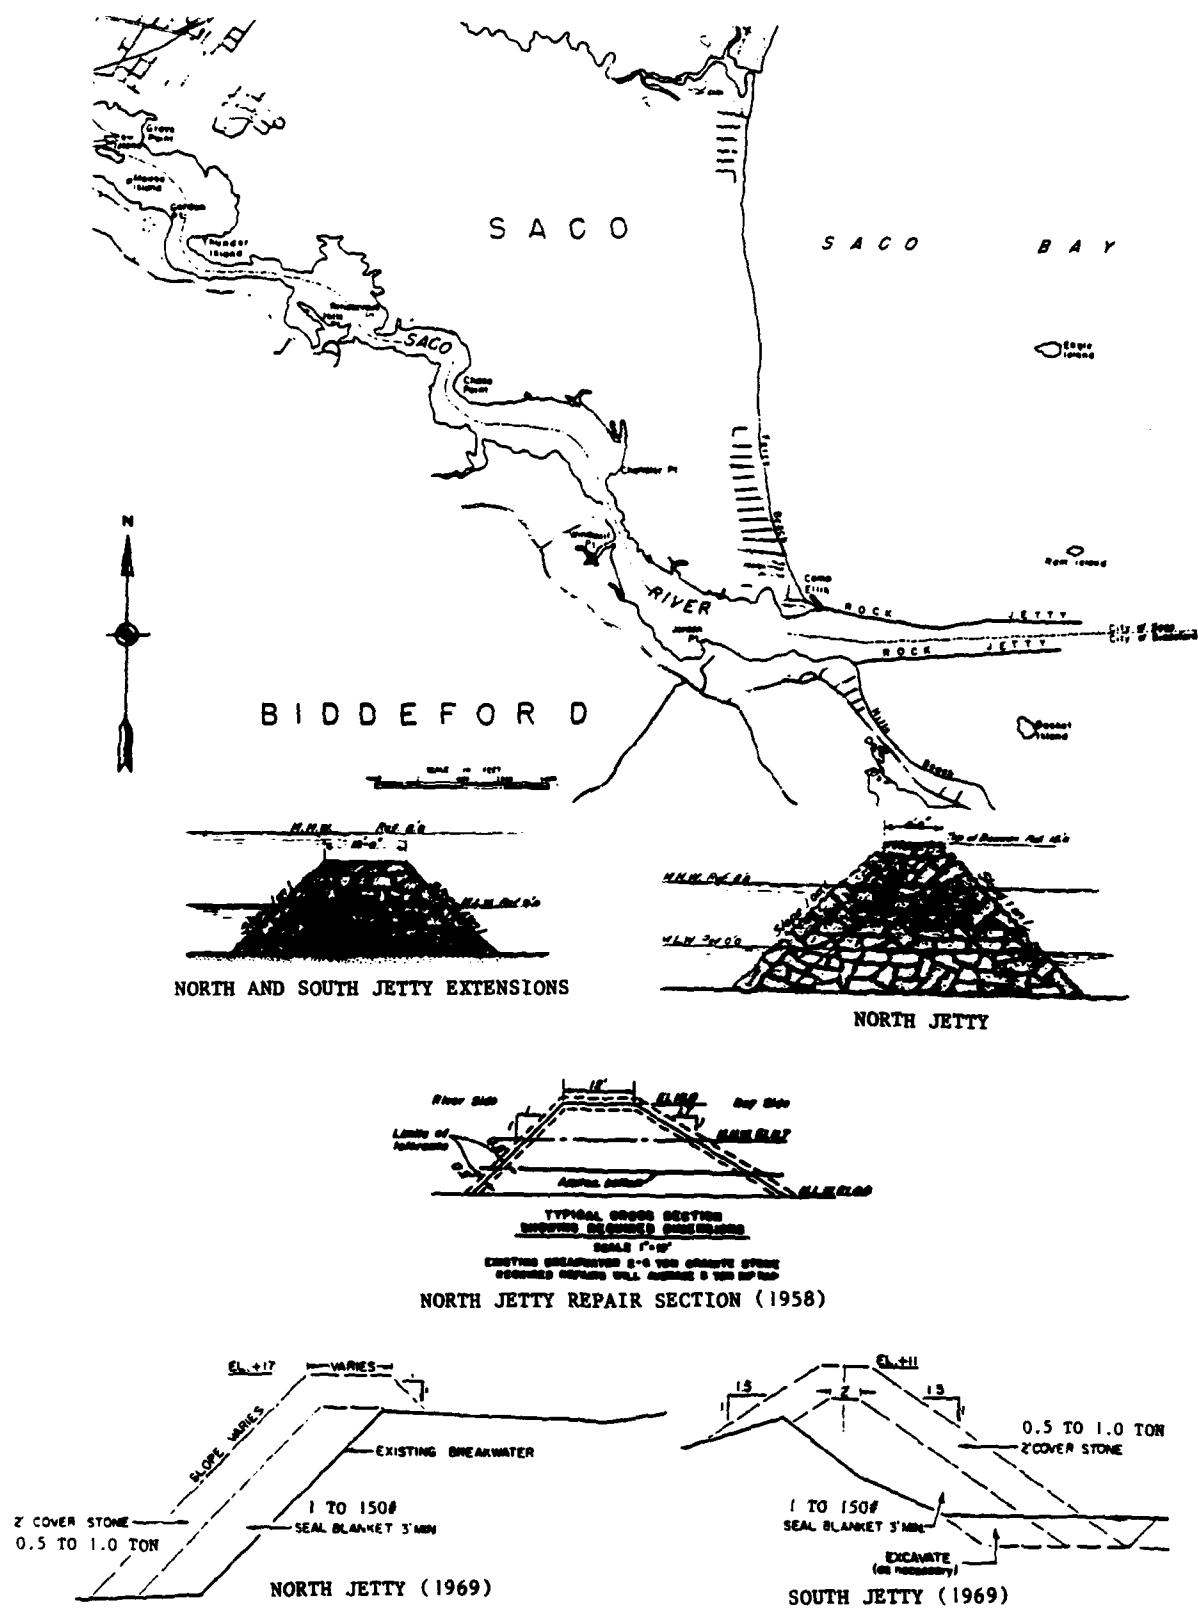
Figure 12. Plan view and typical sections of Saco River Jetties, Saco, Maine

| <u>Date(s)</u> | <u>Construction and Rehabilitation History</u> |
|---|---|
| 1983 | An inspection indicated the south jetty was in good condition. The 1968 north jetty repair section was in good condition, but the remainder of the jetty was in poor condition. |

| Date(s) | Construction and Rehabilitation History |
|---|---|
| 1958 | The landward 700 ft of the north jetty were repaired to a crown elevation of +15 ft mlw, a 12-ft crown width, and slopes of 1V:1H and 1V:1.7H on the channel and bay sides, respectively. Stone size varied from 0.5 to 7 tons or more, with 75 percent of the stone averaging more than 5 tons apiece. Prior to the repairs, existing center-line elevations varied from +9 to +15 ft mlw. A total of 5,100 tons of stone was placed for a cost of \$38,000. |
| 1969 | Repairs were made at the landward ends of the jetties by placing a seal blanket of 1- to 150-lb stone and 0.5- to 1.0-ton cover stone. Repair sections were 1,000 and 1,100 ft in length on the north and south jetties, respectively. The repair geometry was placed on the bayside slope of the existing jetty sections, with a minimum blanket thickness of 3 ft and a 2-ft cover layer. The north jetty design geometry had a +17 ft mlw crown elevation, various crown widths from 3 to 12 ft, a variable bayside slope matching the existing slope, and a 1V:1H channel side slope. The south jetty design geometry consisted of a +11 ft mlw crown elevation, 3-ft crown width, and 1V:1.5H side slopes. The cost for placing 16,600 tons of stone was \$199,000. |

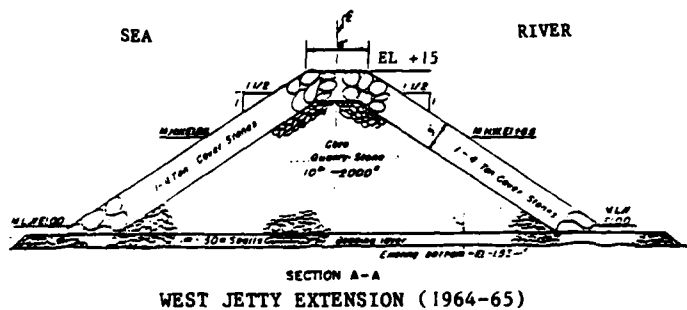
Figure 13. Plan view and typical cross sections of Kennebunk River jetties, Kennebunk, Maine

| Date(s) | Construction and Rehabilitation History |
|---|---|
| 1977-<br>1978 | <p>Visual inspections indicated the jetties were in poor condition. On the east jetty the seaward side of the head (stone pier) was severely damaged, void spaces in the seaward slope armor stone were evident, and the channel side toe was in a deteriorated state due to undermining. On the west jetty extension the outer 150 ft had large amounts of displaced cover stone with typical elevations from +6 to +13 ft mlw. The remainder of the extension was in considerably better shape with only minor displacement and settlement of the armor stone.</p> |

| Date(s) | Construction and Rehabilitation History |
|---|---|
| 1981 | <p>The jetties were repaired with armor stone along the damaged sections observed on previous inspections and a topographic survey. The channel side of the east jetty, from 1+66 to 3+80, was repaired with 5- to 8-ton stone placed to an elevation of +12 ft mlw, a 1V:1H side slope, and a top width varying from 0 to 4 ft. The east jetty's seaside was repaired between 4+20 and 5+24 using 5- to 8-ton stone</p> |

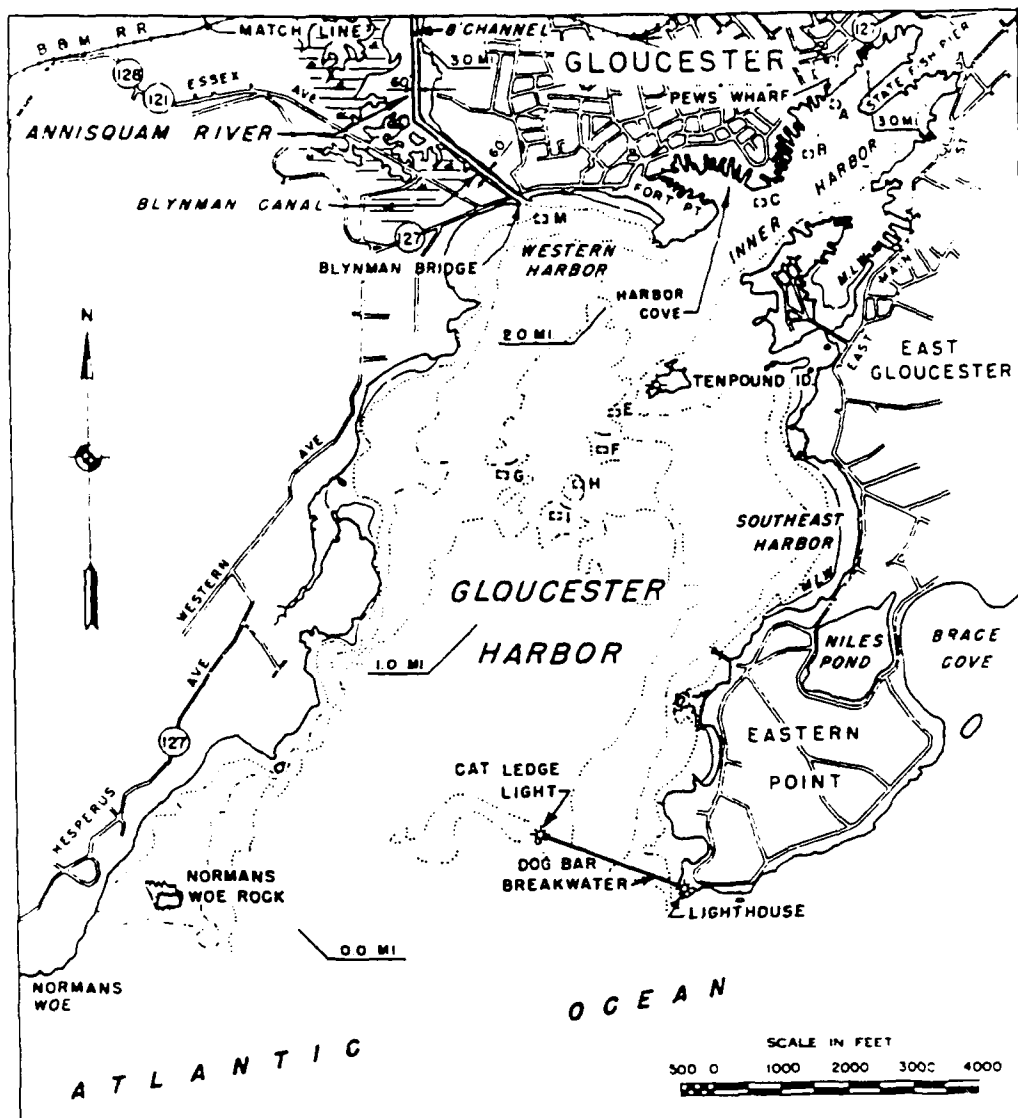
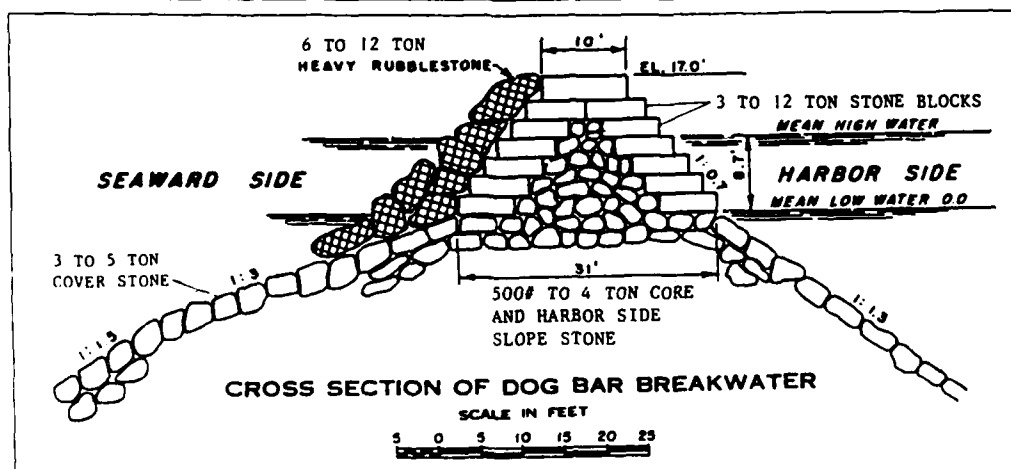
Figure 23. Plan view and typical section of Dog Bar breakwater at Gloucester Harbor, Mass.

| <u>Date(s)</u> | <u>Construction and Rehabilitation History</u> |
|---|---|
| 1967-<br>1978 | Breakwater inspections, taken over this period, showed a gradual deterioration of the sea-side armor stone at several locations. Most of the damage was on the outer half of the breakwater. |

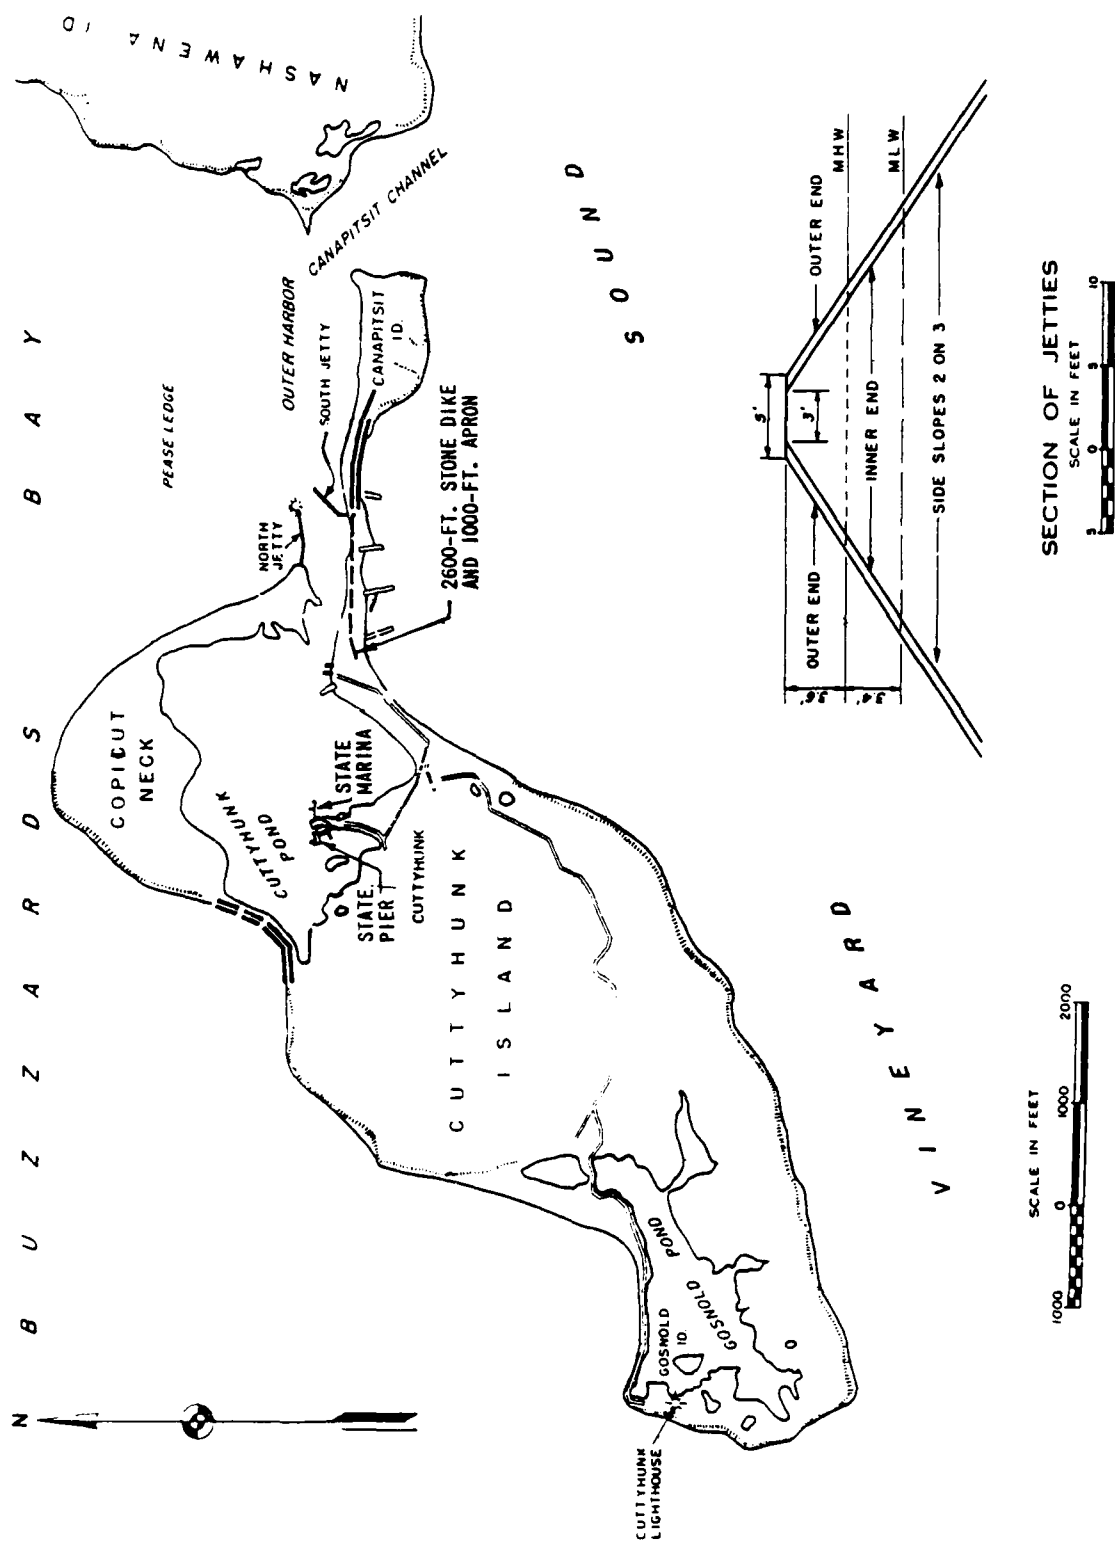
Figure 35. Jetties at Cuttyhunk Harbor, Mass.

| Date(s) | Construction and Rehabilitation History |
|---|---|
| 1962-<br>1977 | Visual inspections indicated the north jetty was in good condition, and the south jetty was in very poor condition. During the early 1960's recommendations were made which included repair of the south jetty, and subsequent repairs were made. |

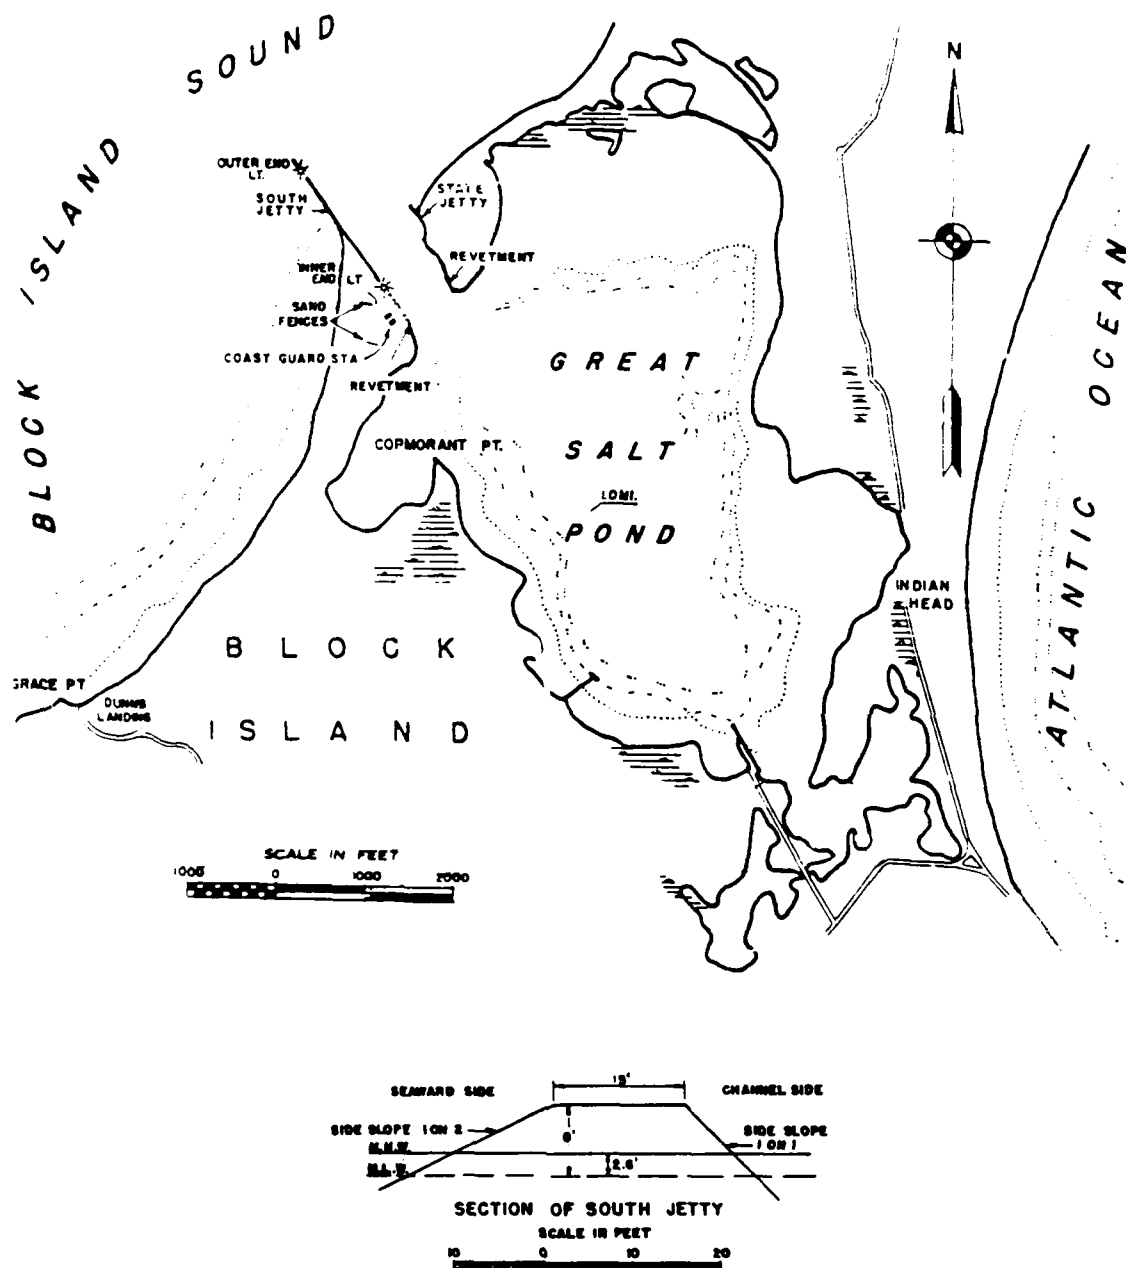
Figure 42. Plan view and cross section of south jetty at Great Salt Pond, Block Island, R.I.

| <u>Date(s)</u> | <u>Construction and Rehabilitation History</u> |
|---|---|
| 1965-<br>1977 | Visual inspections indicated the jetty was in poor to fair condition and in need of repairs. The outer half of the jetty had many void spaces and areas of displaced stone. Subsequent repair work was performed. |

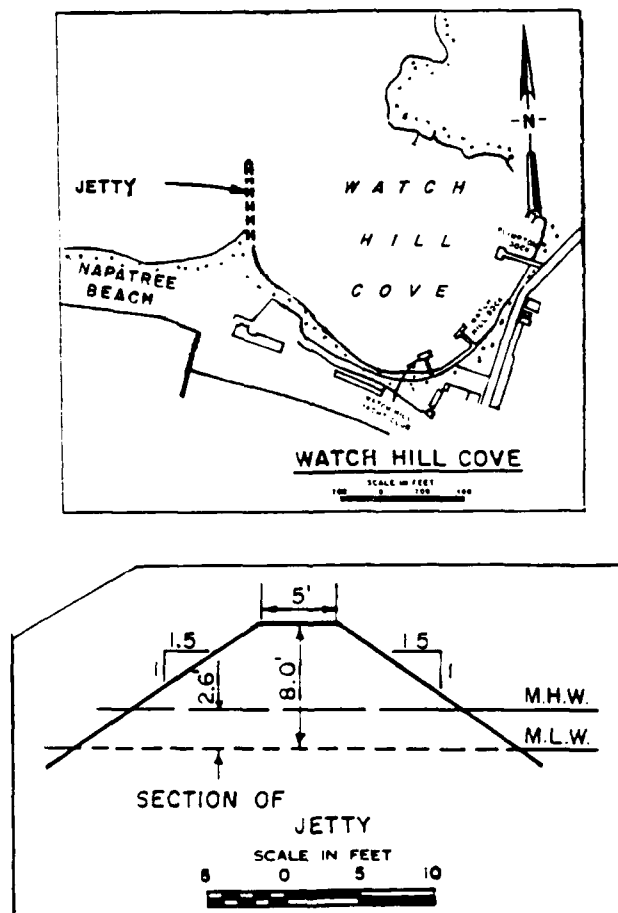
Figure 43. Jetty at Watch Hill Cove, R.I.

| Construction and Rehabilitation History | |
|---|---|
| 1974 | The jetty was in good condition, with only minor displacement of stone noted along its outer 150 ft. |
