DISC-E-95GP-0301

REPORT OF FINDINGS: ENGINEERING PRACTICES STUDY ON FAILURE ANALYSIS OF NSN 5340-00-136-9872 GROOVED COUPLING CLAMP

Bohdan Hasiuk  
Defense Industrial Supply Center  
DISC-ECM  
700 Robbins Avenue  
Philadelphia, PA 19111-5096

3 October 1988

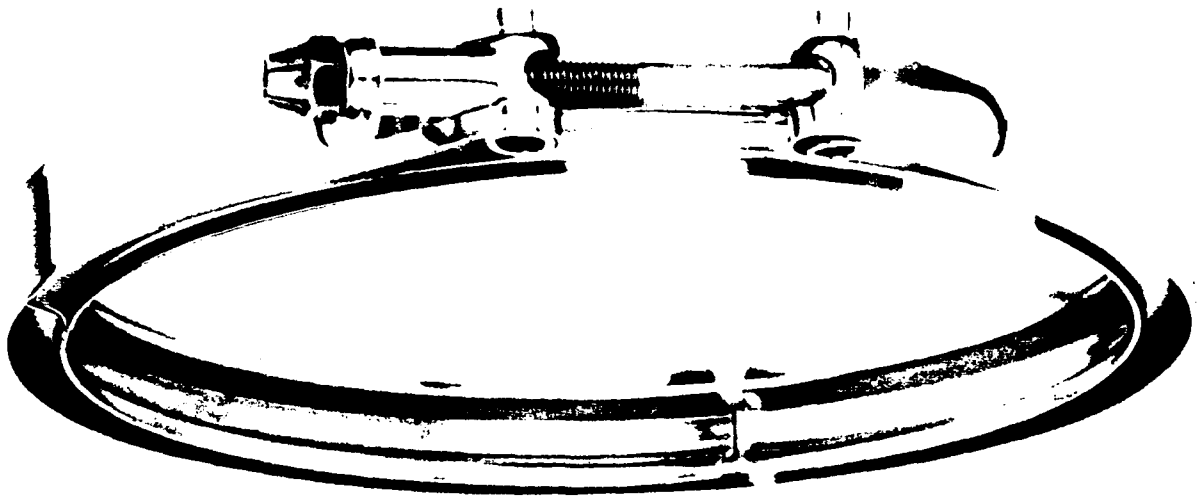
Figure 2. An isometric of the NSN 5340-00-136-9872 V-Band Coupling Clamp made by National Utilities Corporation to Dwg: 4606AC.

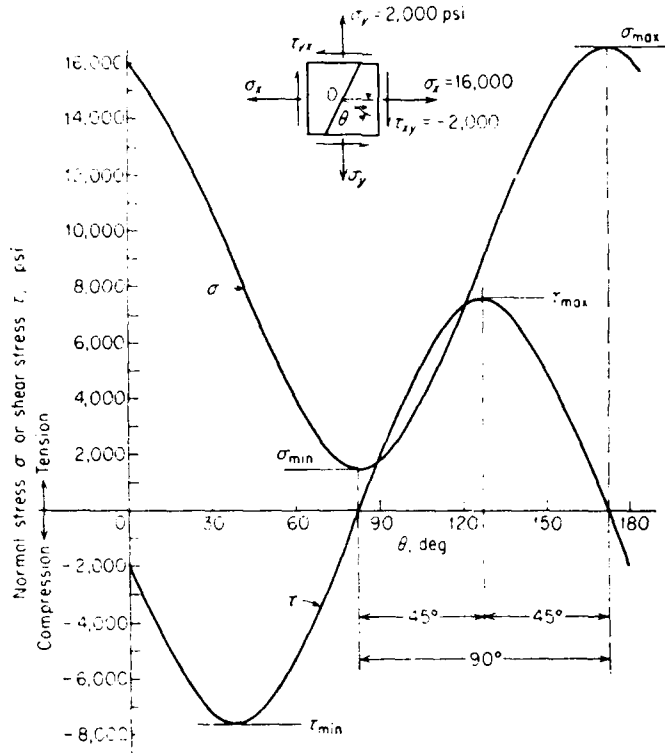
As the tail pipe heated up, the clamp band began to experience thermal tensile stresses, (superimposed on the normal mechanical tensile/bending stresses) as was stated heretofore: the outside surface of the clamp was in (thermal) tension and the inside surface in (thermal) compression. Because of the clamp band geometry a two dimensional (plane stress) state of stress can be applied to this situation (8). The normal stresses in this state of stress are maximum in the longitudinal (circumferential) direction and minimum (in this situation close to zero) in the transverse (90 degrees to the longitudinal) direction. In such a state of stress the maximum shear stress will be at 45 degrees to the maximum normal stress. This is graphically portrayed in figure 9.

Looking at figure 9, the following conclusions can be made:

Figure 9. Variation of normal (tensile) stress  $\sigma$  with shear stress  $\tau$ . The shear stress is at a maximum  $45^\circ$  away from the maximum normal (tensile) stress. (Dieter, George E. Jr. mechanical metallurgy, p. 21)
