# CHEMICAL AND SURFACE CHARACTERIZATION OF TOW MISSILE CASES

SIN-SHONG LIN and WAI K. CHIN  
MATERIALS SCIENCE BRANCH

December 1988

US ARMY  
LABORATORY COMMAND  
MATERIALS TECHNOLOGY LABORATORY

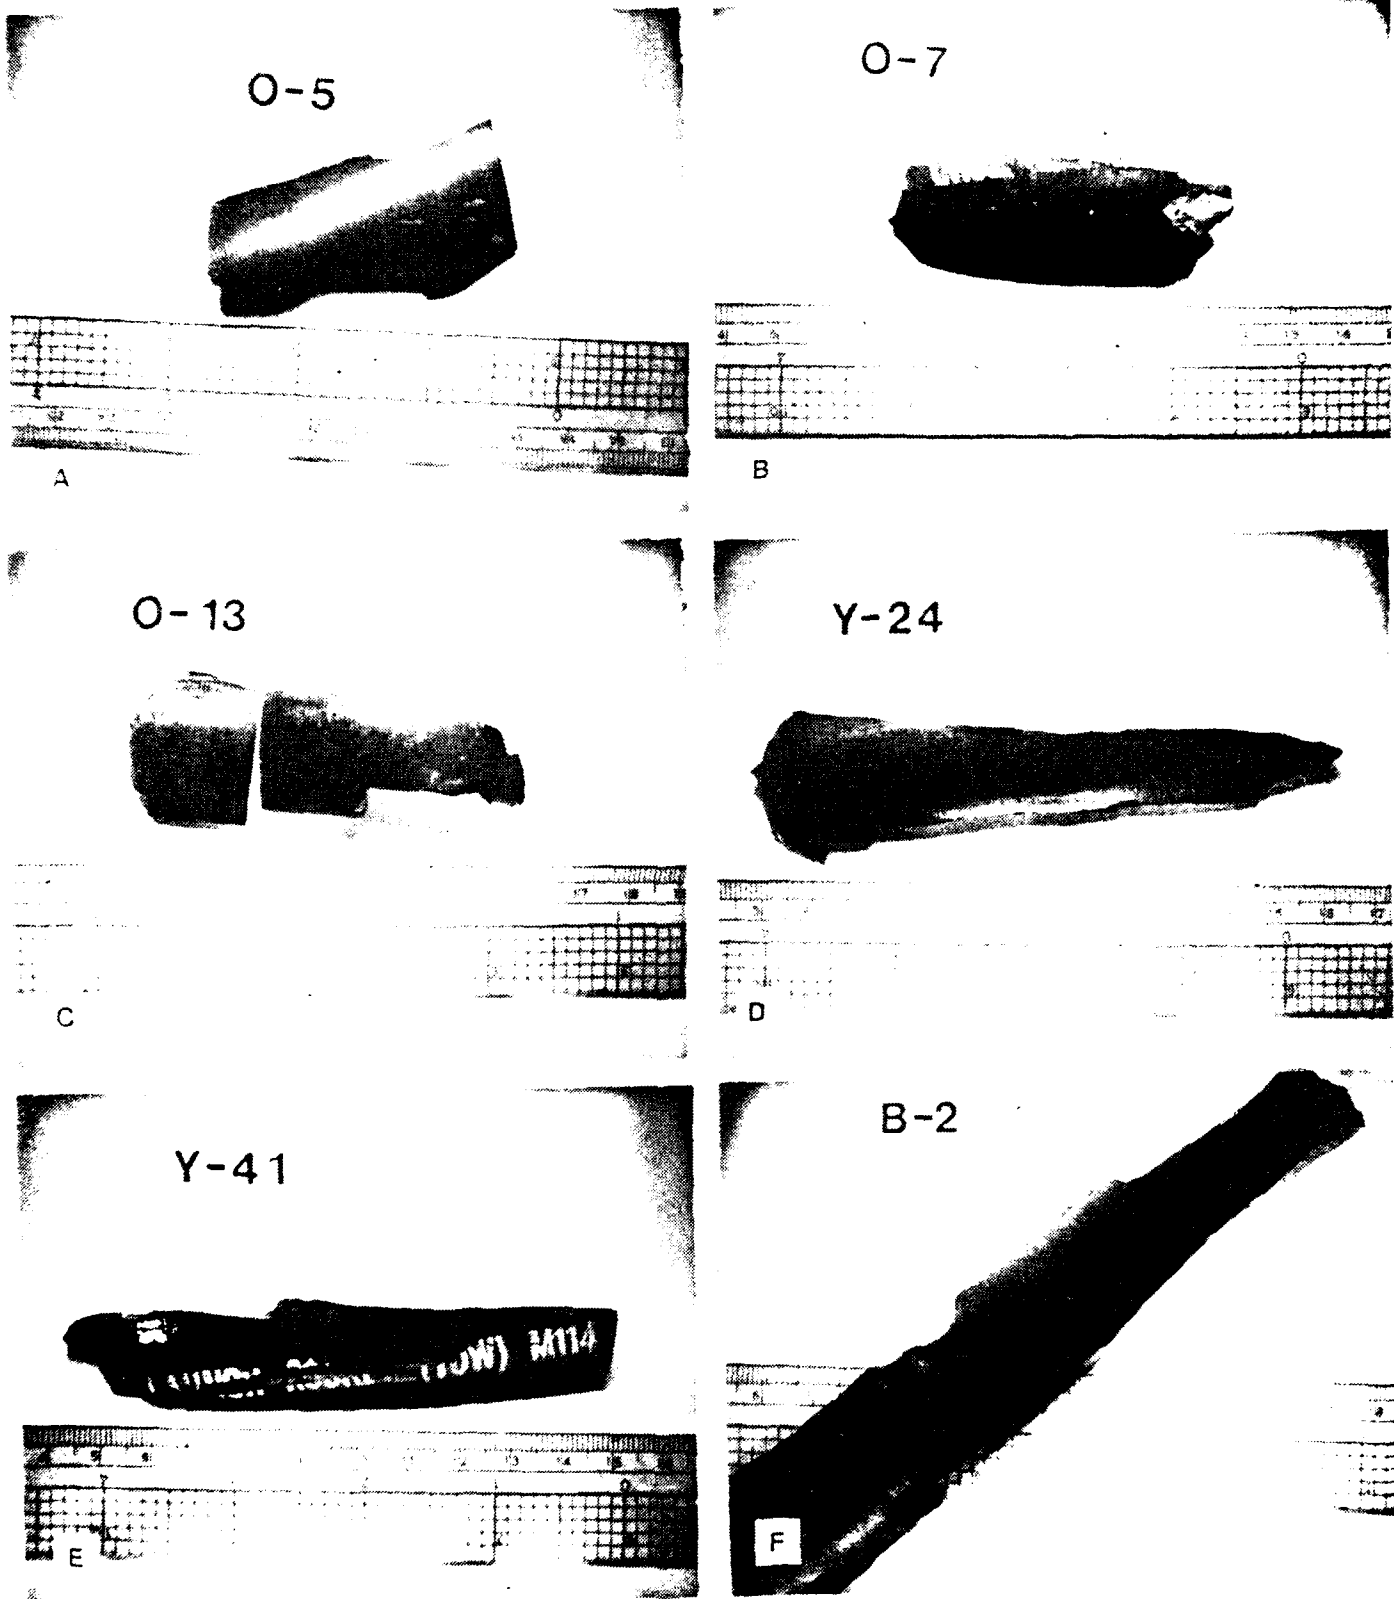
Six fragments from the failure missile cases were received (through the POC). The pieces were about 2 mm thick and 10 to 20 sq cm, weighing 15 to 30 g, and identified as O-7, O-5, O-13 (Oahu failure); Y-24 and Y-41 (Yakima failure); and B-2 (Blanket test, reference). The sizes and shapes of these pieces are shown in Figure 1.

Figure 1. Fracture pieces from missile case failure. Six samples were received from three sources: Cahu, Yakima and Blanket test reference). (a) #O-5 (b) #O-7 (c) #O-13 (d) #Y-24 (e) #Y-41
