EGG-HWP-8128  
August 1988

**Idaho  
National  
Engineering  
Laboratory**

FINAL REPORT

DISMANTLEMENT OF BUILDING 666 AND INDUSTRIAL  
WASTEWATER TREATMENT PLANT NO. 4

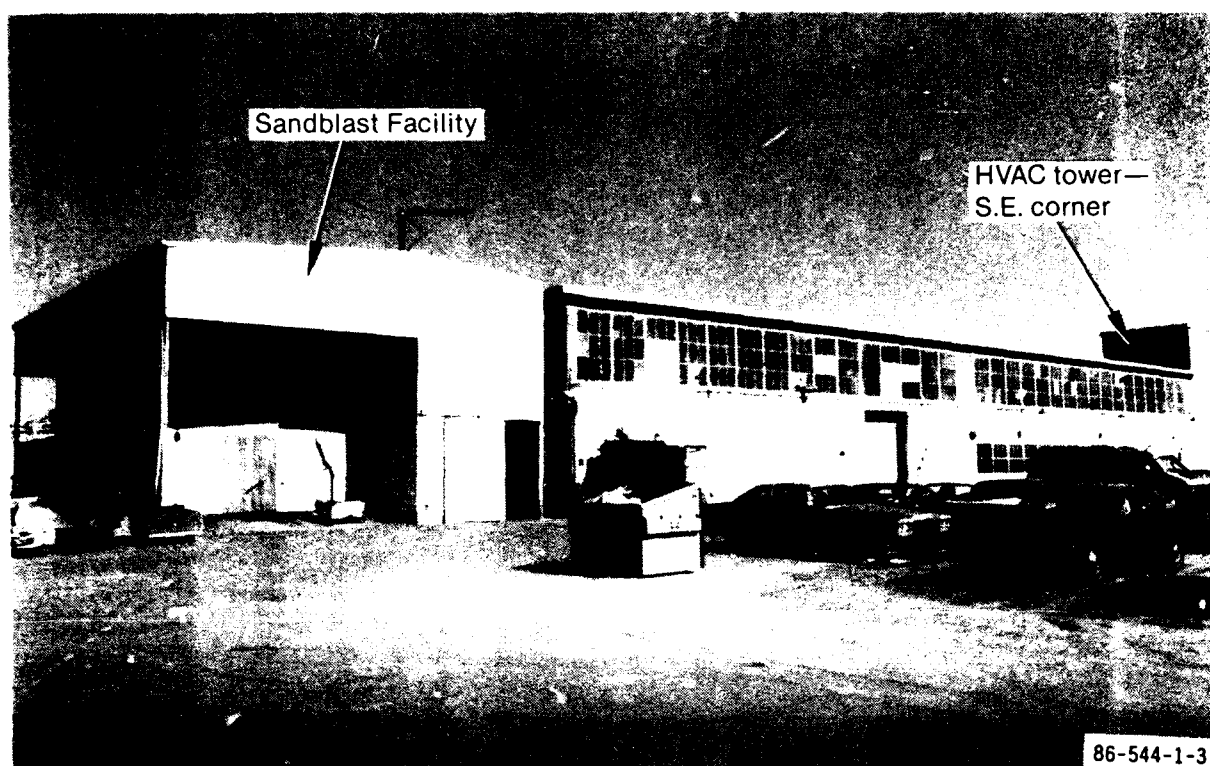
Figure 4. Building 666 south side with Sandblast Facility at left.

Building 666 had broken windows, open windows, open doors, and louvers in the three HVAC towers which, if not closed, would have allowed airborne contamination to leave the building once work began inside the building. All these openings were closed before activities started inside the building (see Figures 23 and 24).

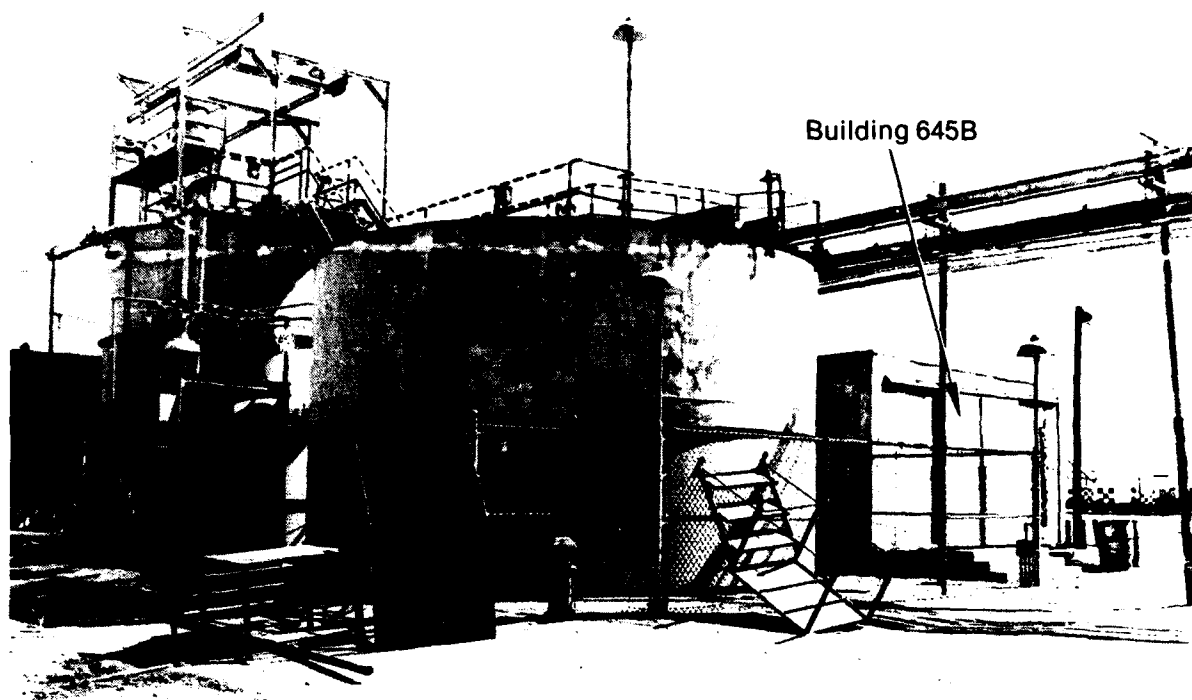
Figure 14. South section of IWTP No. 4 with Building 666 in background.

Most of the tanks were carbon steel with painted exteriors and appeared to be in good condition. Exceptions were tanks 541, 526, and 527. Tank 541, a dilute chromic acid tank, appeared to have been painted with dark gray paint, which was peeling and flaking extensively. The vinyl liners in tanks 526 and 527, treated cyanide wastes retention tanks, were coming loose from the tank interiors. The liner in Tank 526 had pulled away from the north half of the tank wall and had torn and collapsed inside the tank. No tank leakage was visible.

Figure 15. IWTP No. 4 north section.
