TECHNICAL REPORT REMR-CO-3

CASE HISTORIES OF CORPS BREAKWATER  
AND JETTY STRUCTURES

Report 5

NORTH ATLANTIC DIVISION

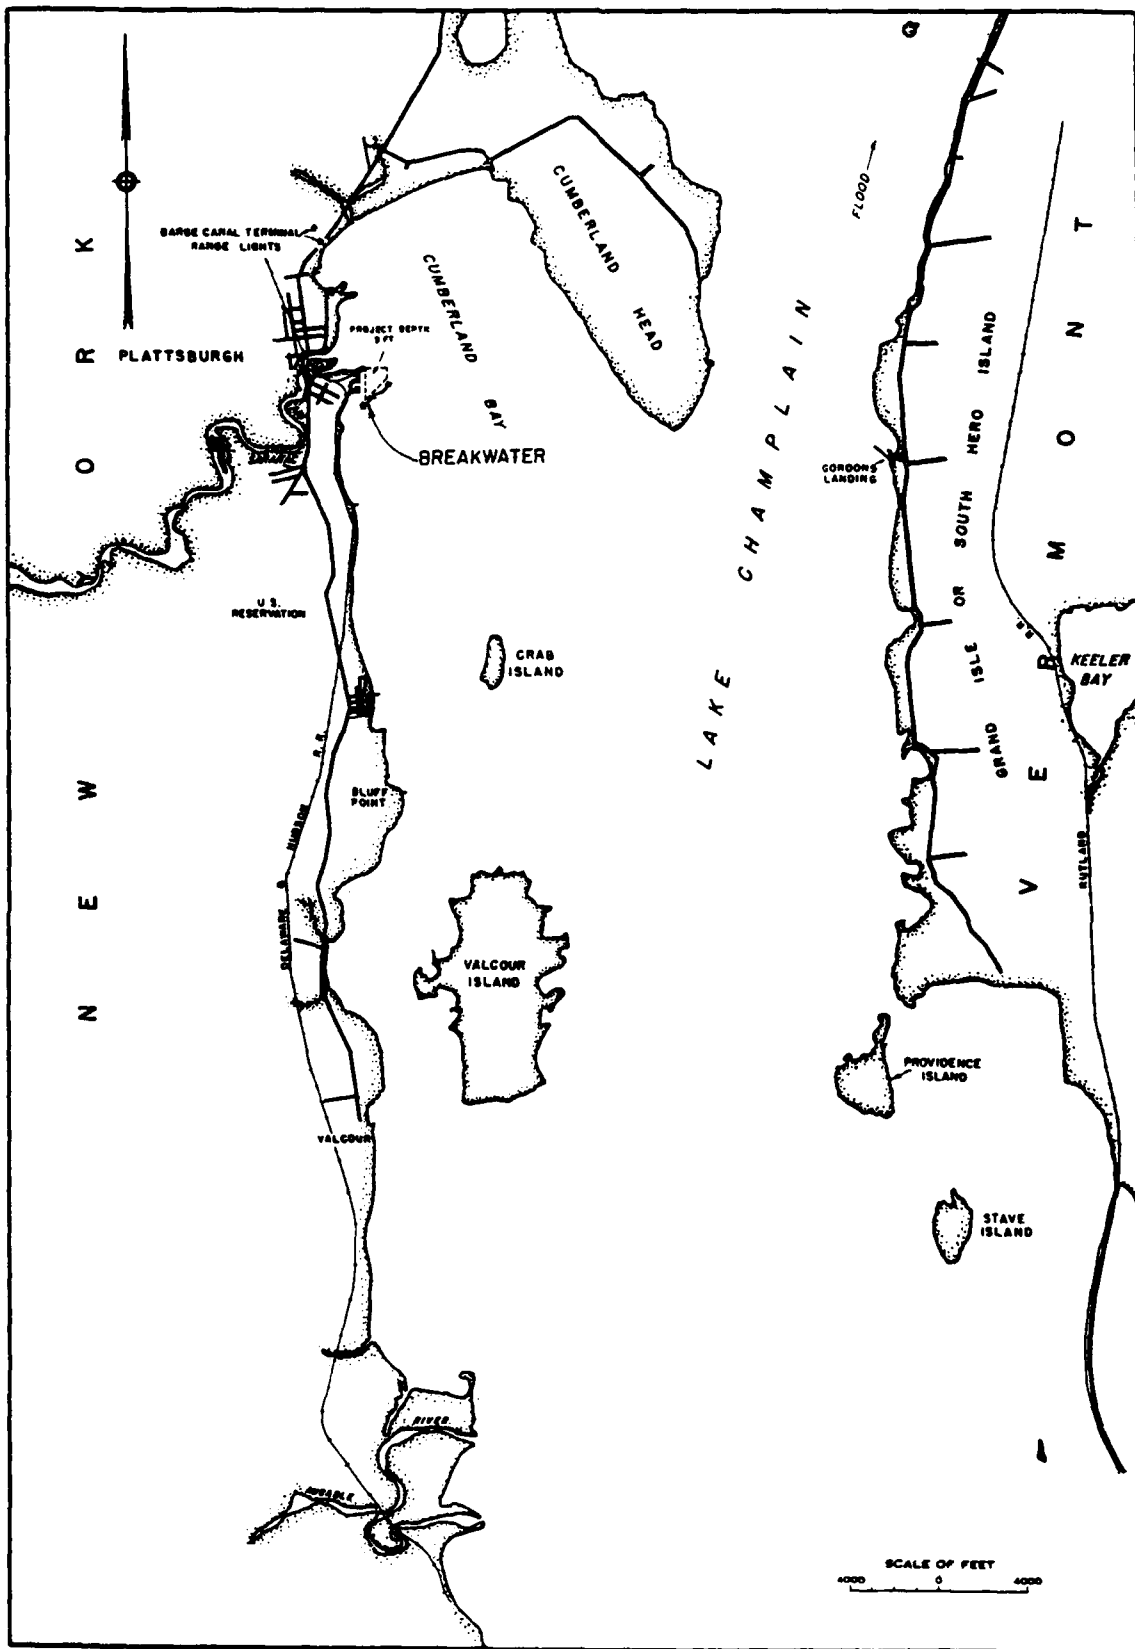
Figure 7. Plattsburgh Harbor, New York

| <u>Date(s)</u> | <u>Construction and Rehabilitation History</u> |
|---|---|
| 1949 | A survey indicated the breakwater was in good condition except at the ends. |

| <u>Date(s)</u> | <u>Construction and Rehabilitation History</u> |
|---|---|
| 1971 | Repairs were made to the north end of the breakwater at a cost of \$118,000. |

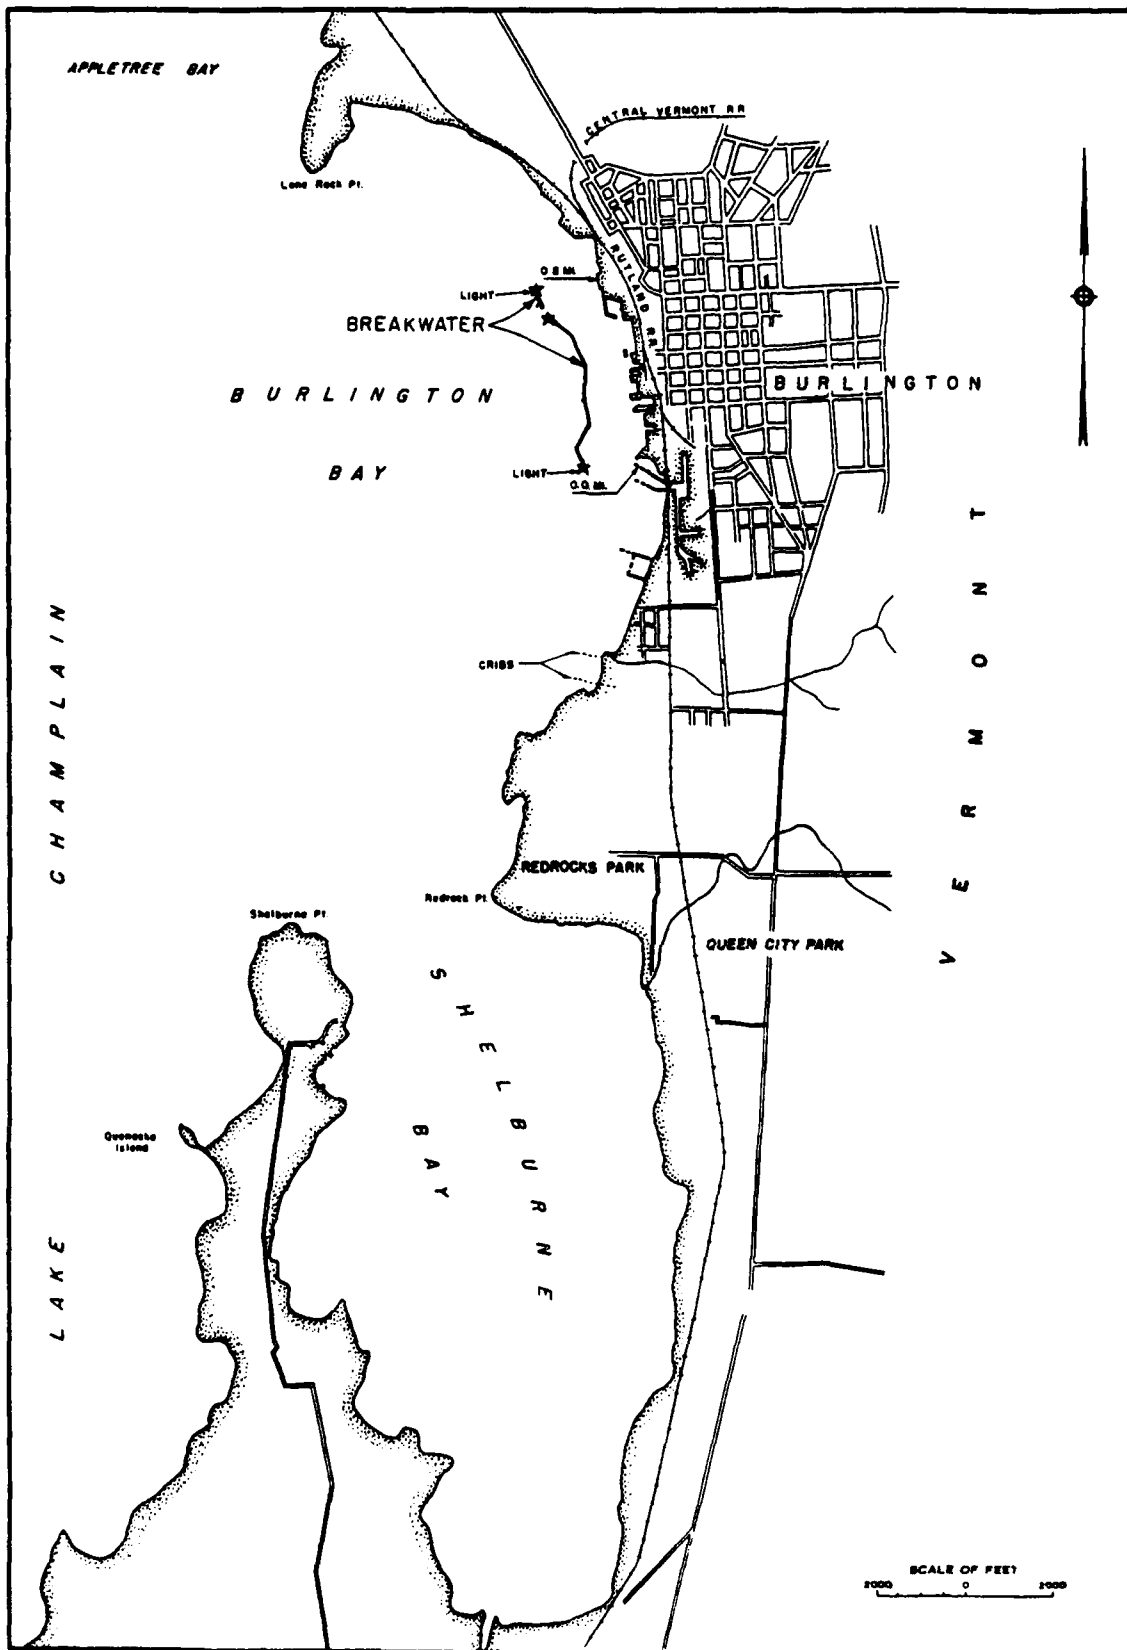
Figure 8. Burlington Harbor, Vermont

| <u>Date(s)</u> | <u>Construction and Rehabilitation History</u> |
|---|---|
| 1960 | A survey indicated the existing structure had settled 1.0 to 3.0 ft along the entire length. Deterioration of sections of the timber fasteners left unconnected sections and caused timber displacement and leaning of the structure lakeward. Deterioration was believed to be caused by wave action and ice conditions over long periods of time. Approximately 550 lin ft of the stone superstructure was undermined. Eighty feet of the structure was breached. |

| <u>Date(s)</u> | <u>Construction and Rehabilitation History</u> |
|---|---|
| 1948 | The breakwater was repaired. Stone was placed on the lakeside at weakened sections. |
| 1962-<br>1965 | The breakwater was rehabilitated using 16,573 tons of stone at a cost of \$381,000. |

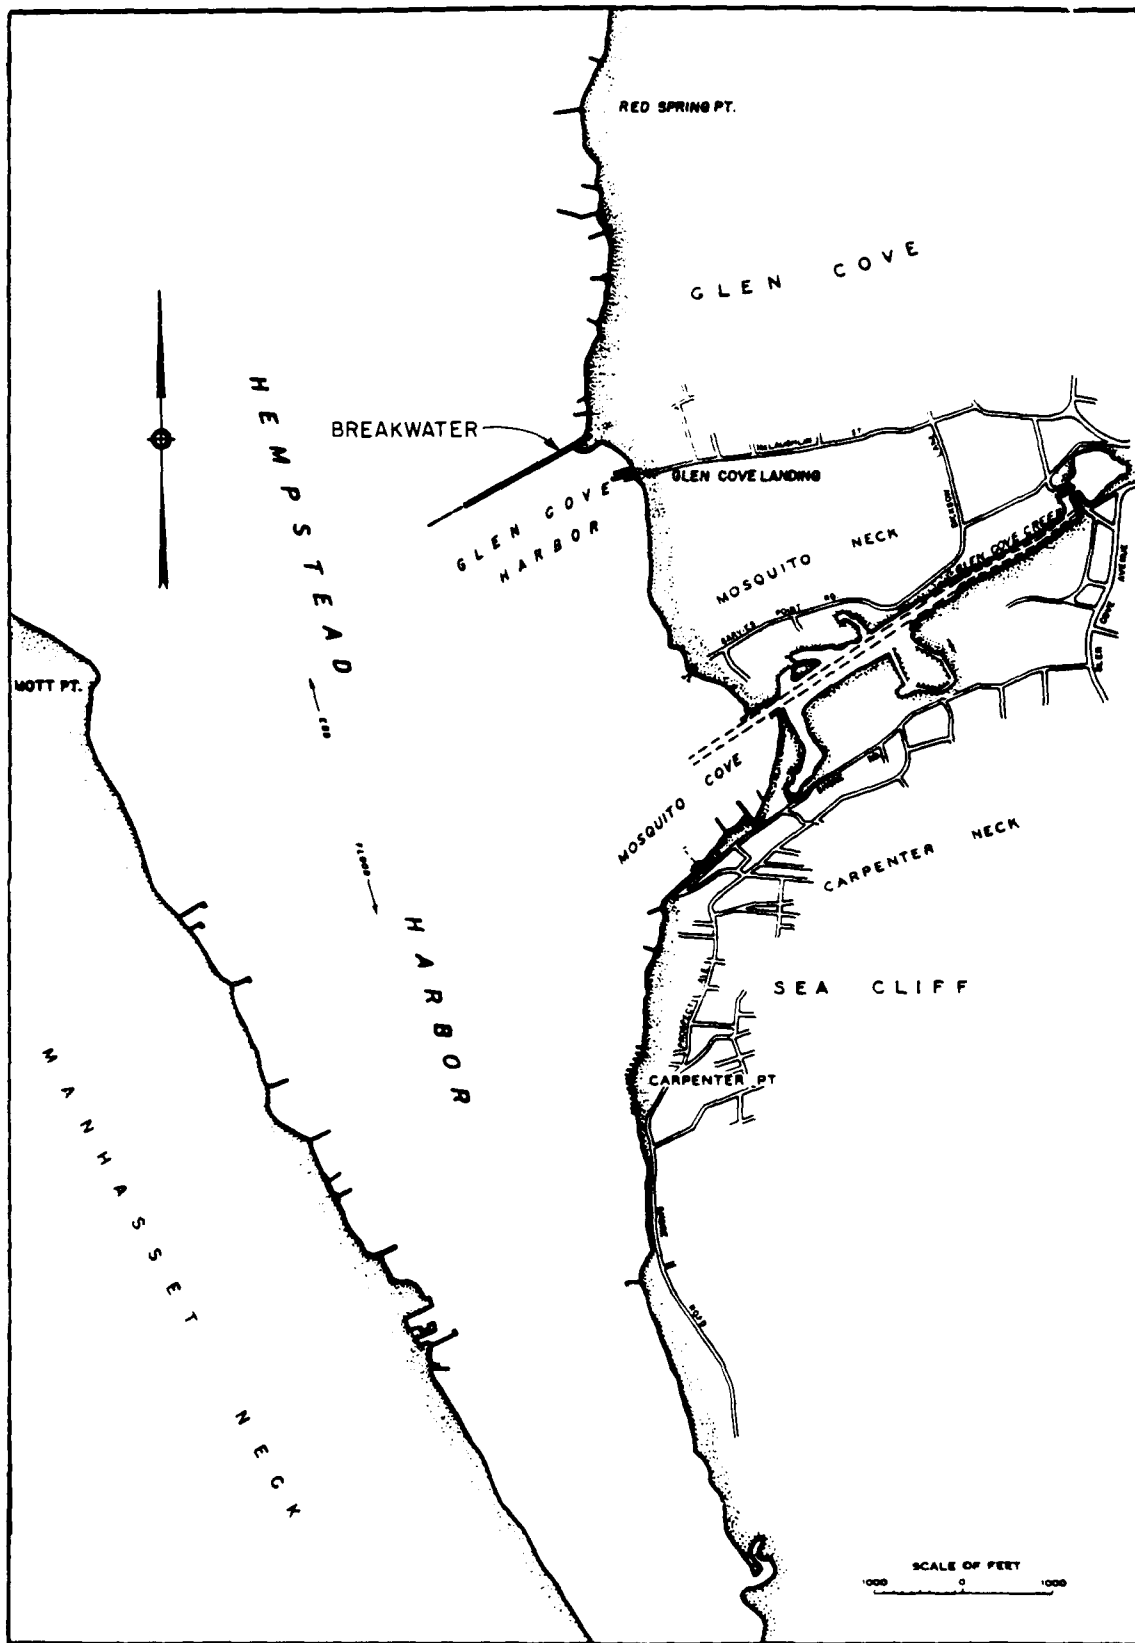
Figure 11. Glen Cove Harbor, New York

| <u>Date(s)</u> | <u>Construction and Rehabilitation History</u> |
|---|---|
| 1964 | A survey of the breakwater revealed that the offshore portion had deteriorated and the outer half had settled 3.0 ft. Crest elevation varied from +5.0 to +10.4 ft mlw, and side slopes varied from 1:1 to 1V:2H. Stones were displaced due to undersized stone. Over 50 percent of the breakwater was submerged at high tide. The breakwater was considered stable with no breach along the entire length. |

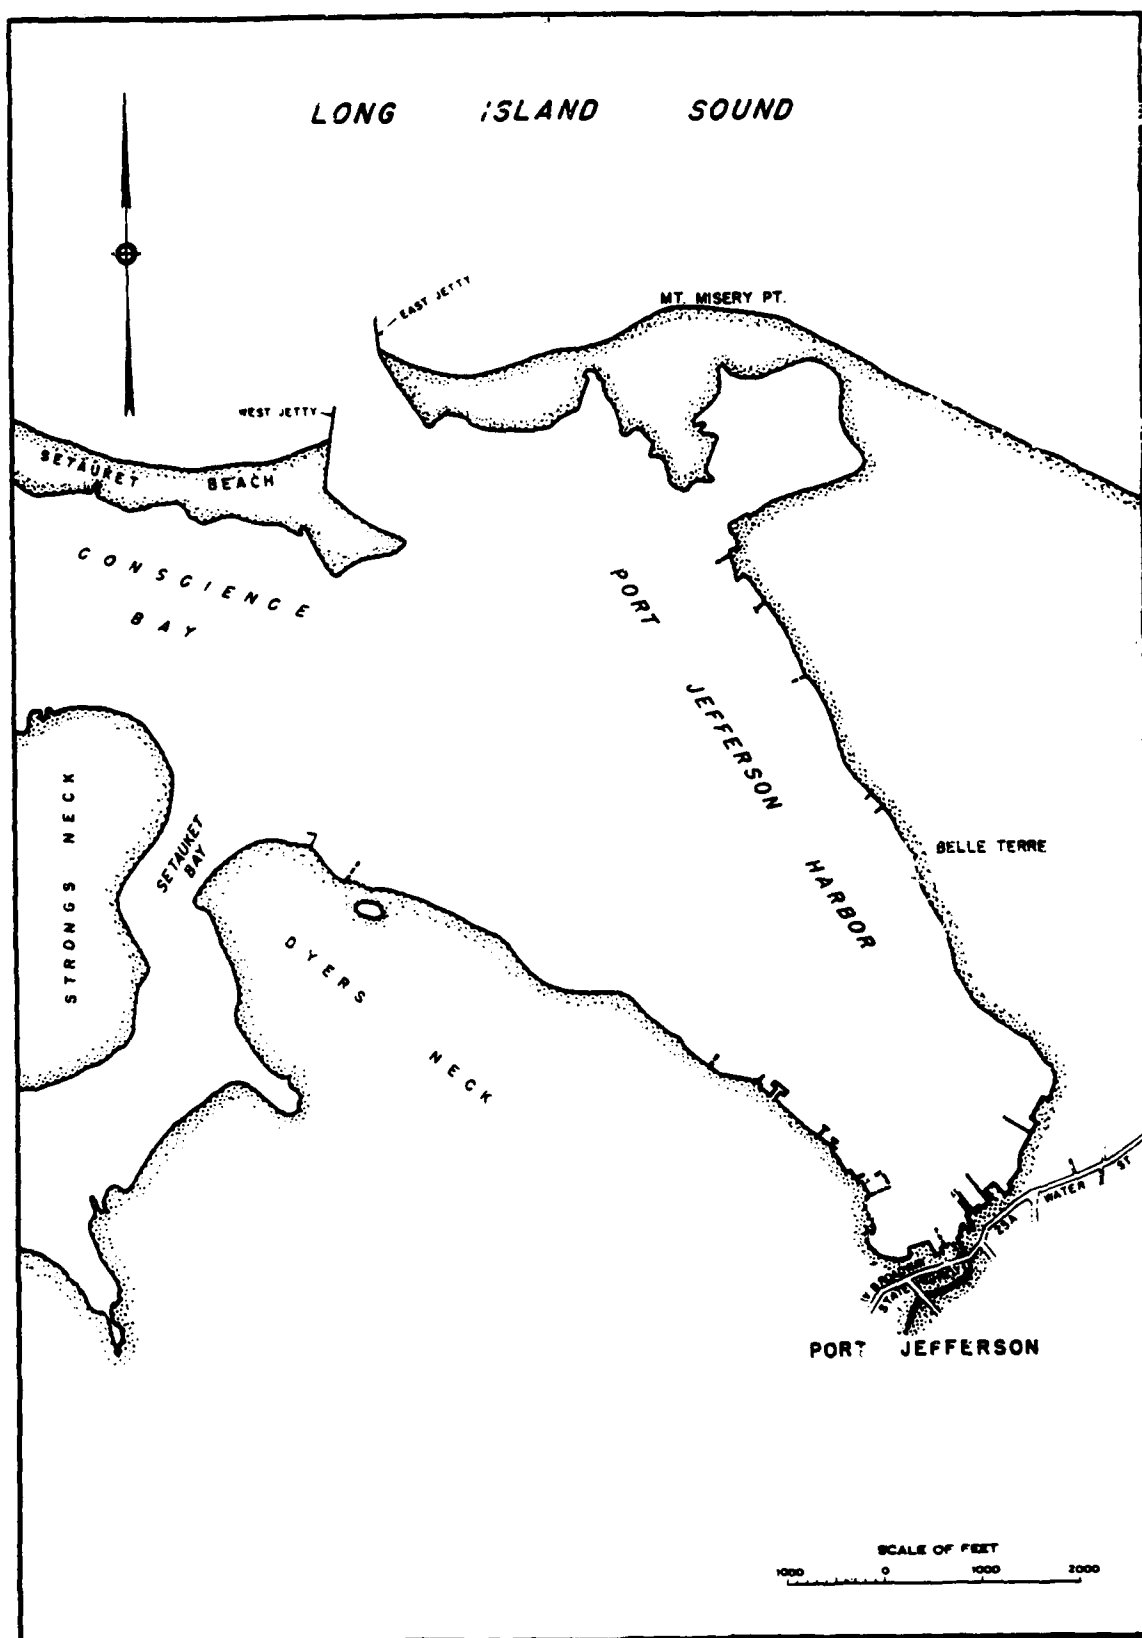
Figure 12. Port Jefferson Harbor, New York

| <u>Date(s)</u> | <u>Construction and Rehabilitation History</u> |
|---|---|
| 1964 | A survey indicated the jetties were in poor condition. |

| <u>Date(s)</u> | <u>Construction and Rehabilitation History</u> |
|---|---|
| 1891 | The east jetty was repaired over 600 ft with 1,464 tons of stone. |

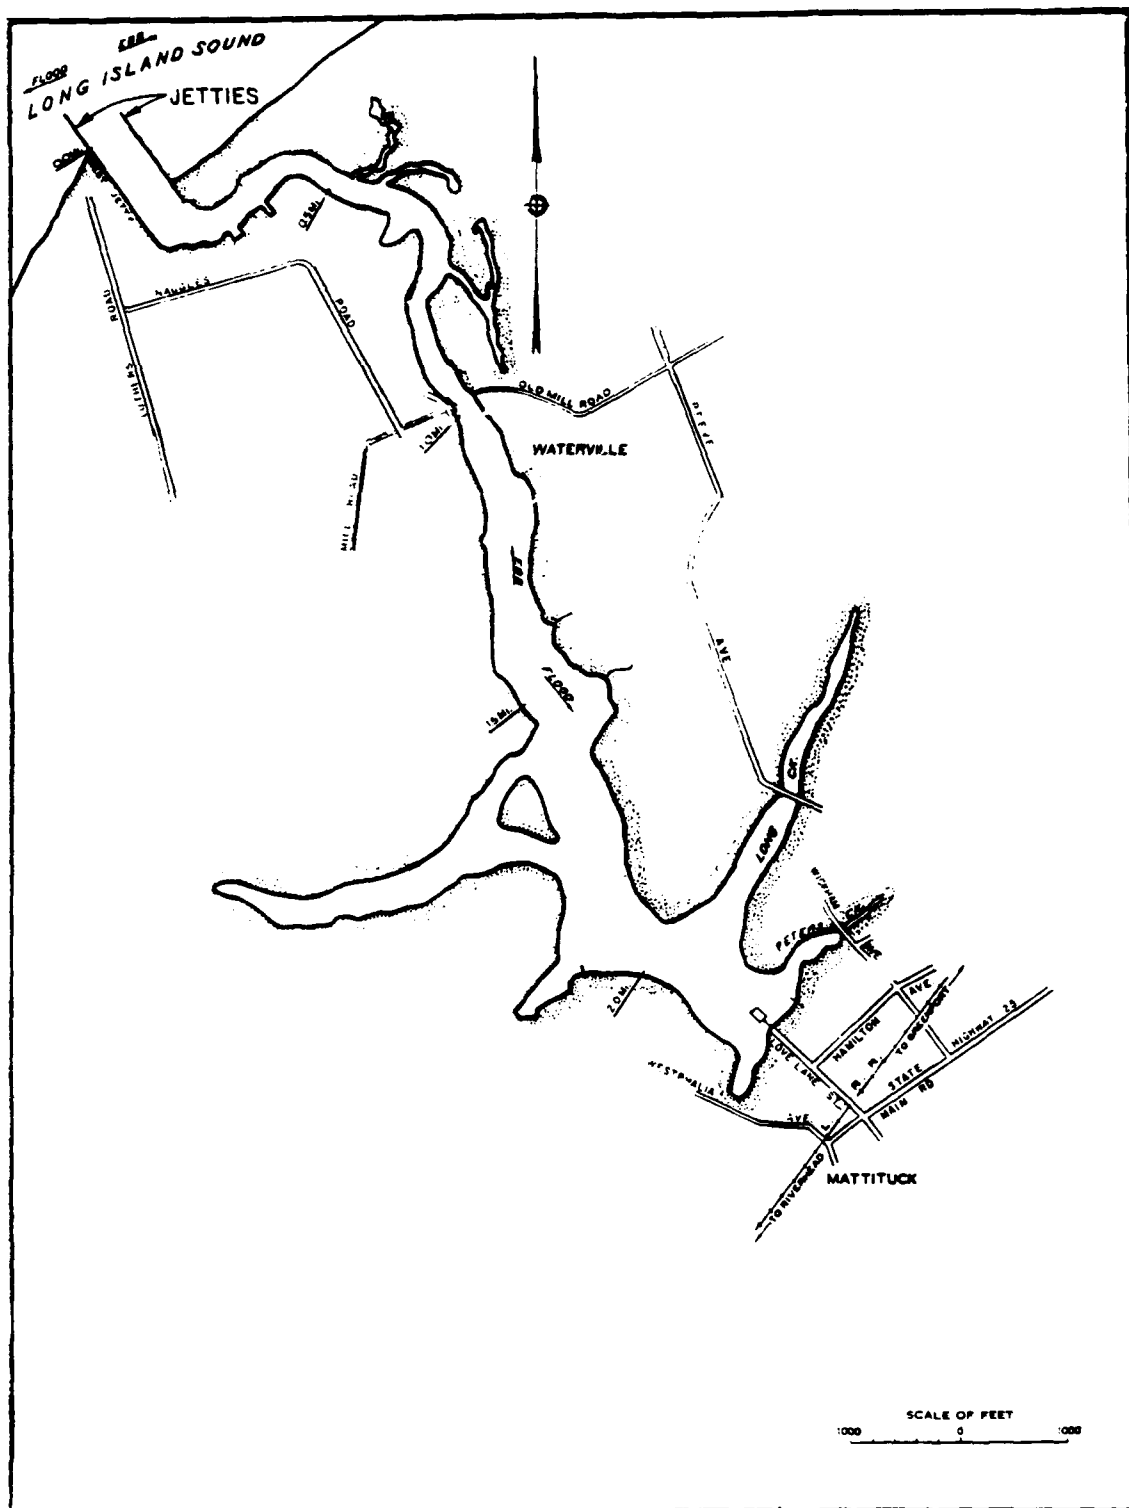
Figure 13. Mattituck Harbor, New York

| <u>Date(s)</u> | <u>Construction and Rehabilitation History</u> |
|---|---|
| 1910 | The landward 680 ft of the east jetty and 485 ft of the west jetty were repaired and made sand tight at a cost of \$6,158. Seaward portions of the jetties were in need of repair and sand tightening. |

| <u>Date(s)</u> | <u>Construction and Rehabilitation History</u> |
|---|---|
| 1975 | Both jetties were repaired using \$10,670 tons of stone. The cost of repairs was \$385,000. |

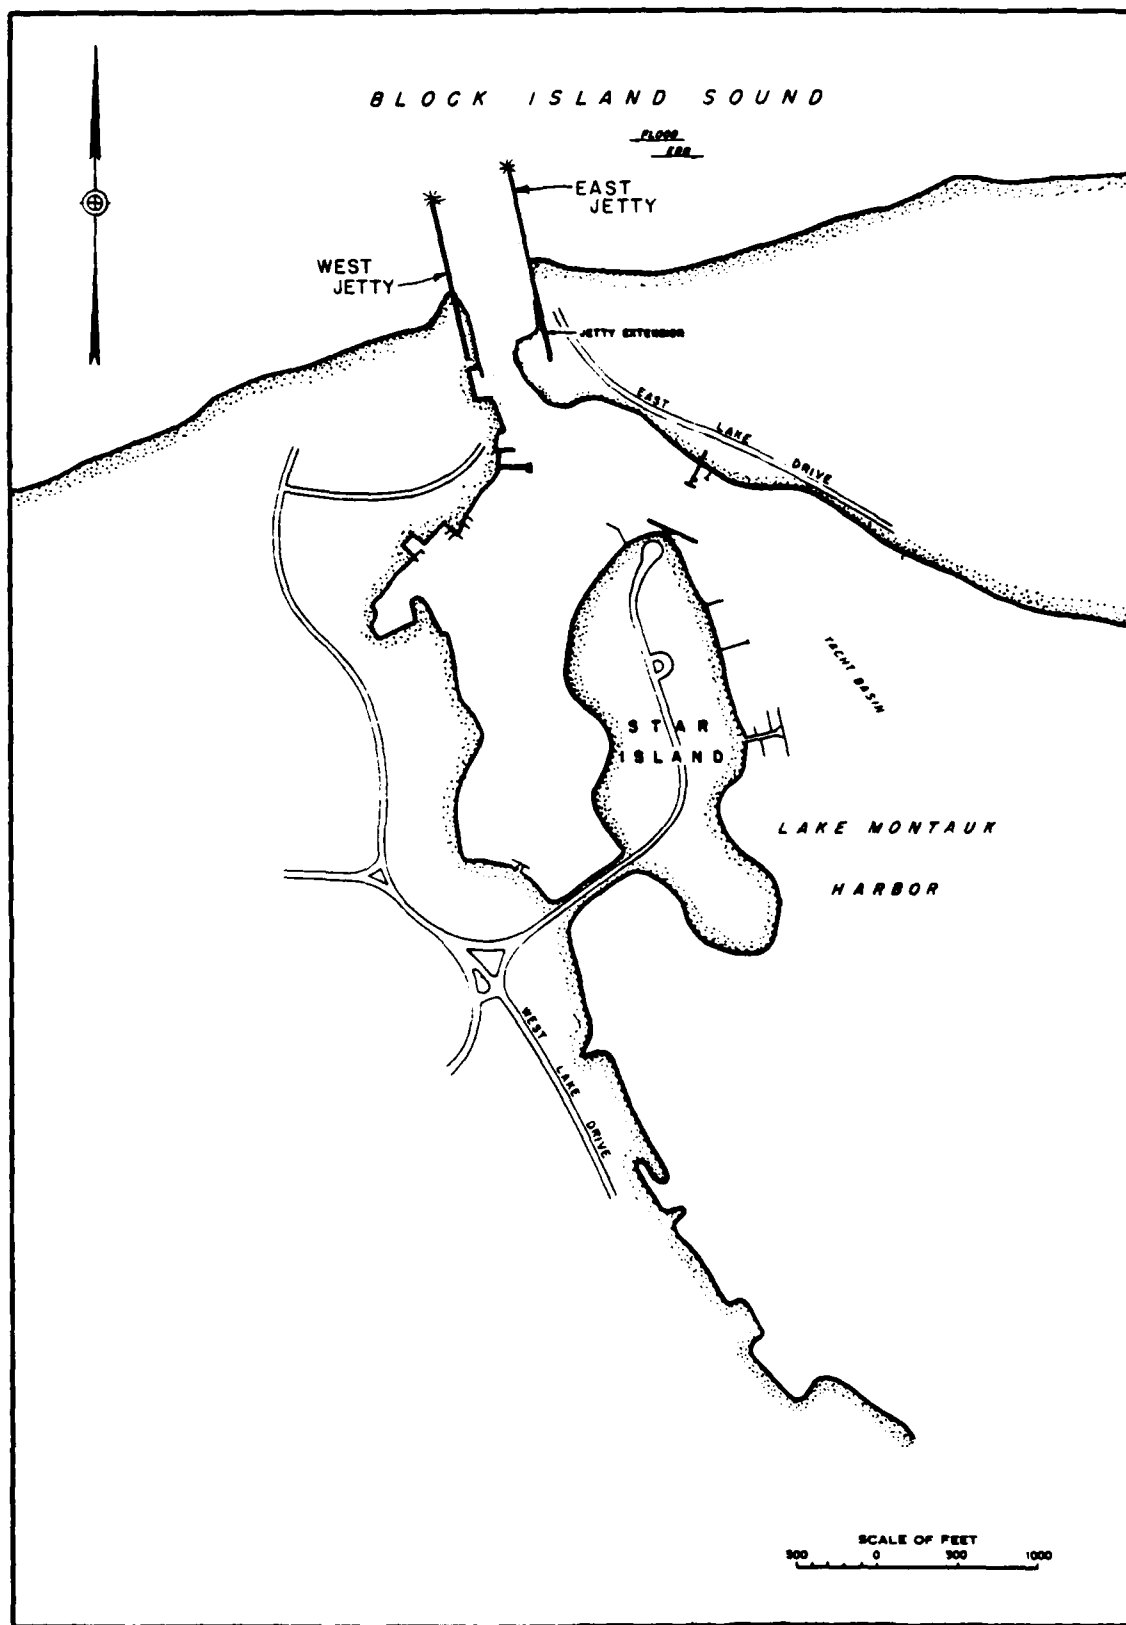
Figure 16. Lake Montauk Harbor, New York

| <u>Date(s)</u> | <u>Construction and Rehabilitation History</u> |
|---|---|
| 1967 | A survey indicated the jetty was in poor condition. Proposals were made to repair and extend the jetties using a design wave of 16.0 ft and 5.8 sec. |

| <u>Date(s)</u> | <u>Construction and Rehabilitation History</u> |
|---|---|
| 1968 | The jetties were repaired, and the east jetty was extended 350 ft. The cost of repairs and the extension was \$526,600, and 18,400 tons of stone were used. |

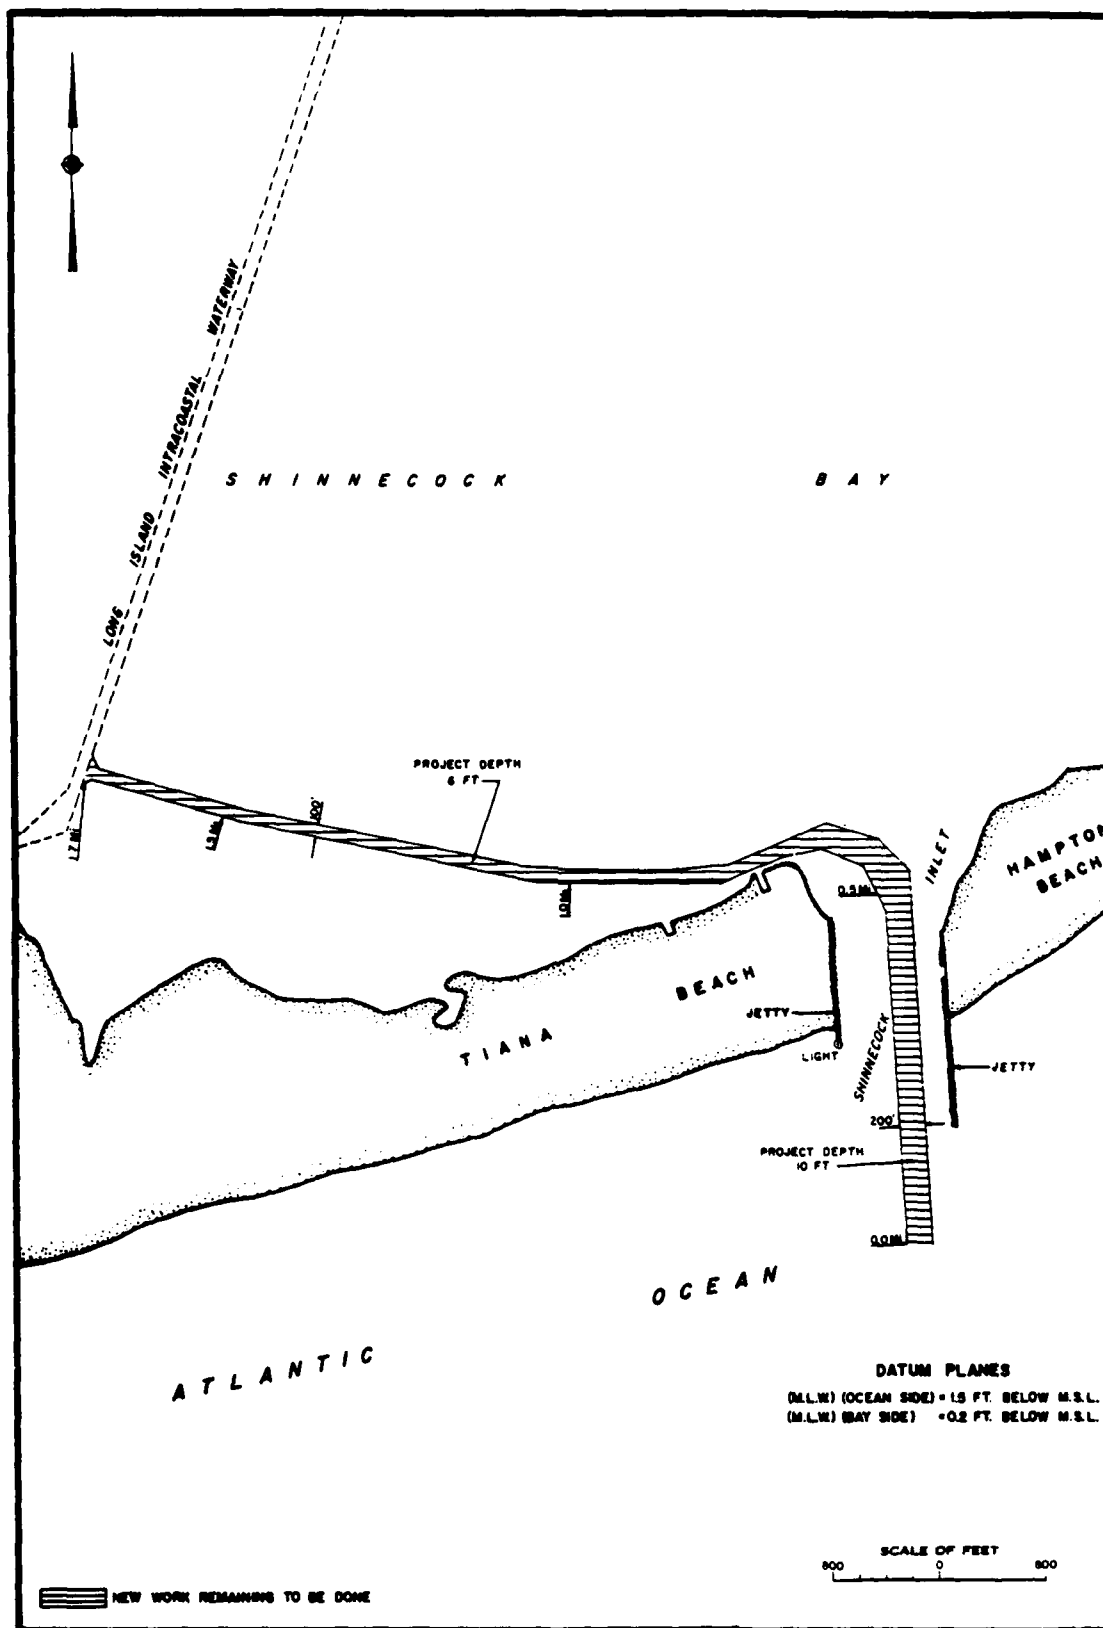
Figure 17. Shinnecock Inlet, New York

| <u>Date(s)</u> | <u>Construction and Rehabilitation History</u> |
|---|---|
| 1956 | A survey revealed that the east jetty had suffered severe damage. Capstones and slope stones had slipped and were disarranged in numerous spots. Core stones were washed out in several places. Capstones and core stones were washed out in four locations totaling 150 ft. The outer 250 ft of the jetty was partly washed out. Beach and dunes adjacent to the jetty eroded, and waves rode over the dunes and flanked the jetty. The west jetty was in fair condition with minor slips and disarrangement in five spots. The inlet was in a shoal condition. Most of the damage was due to a hurricane in 1954. |
| 1985 | A survey revealed that the reconstructed portion of the west jetty was in good condition. The seaward 200 ft of the west jetty had unraveled and capstones were scattered. The west jetty head had not maintained design configuration. Stones on the inlet side of the east jetty had sloughed in some sections, but stones on the beach side had retained their original position. Two areas on the northern end were completely deteriorated. Erosion of sand caused undermining of the east jetty with continual loss of sand undermining it further. |

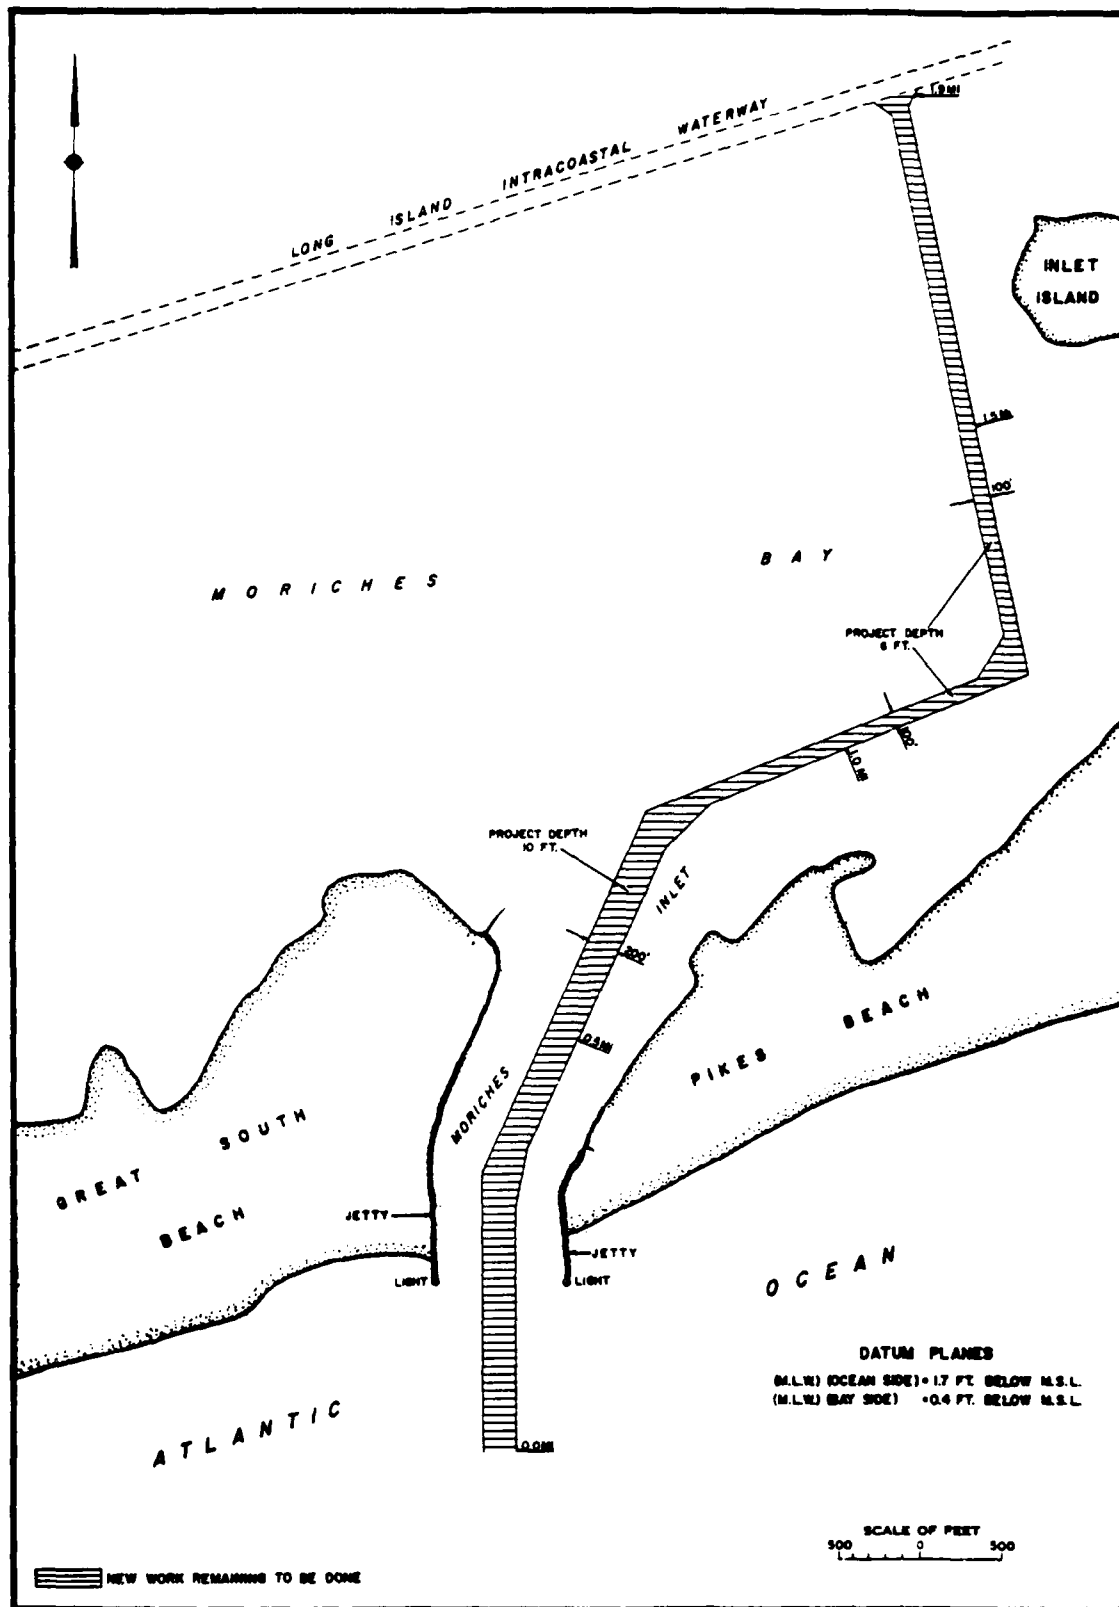
Figure 19. Moriches Inlet, New York

| <u>Date(s)</u> | <u>Construction and Rehabilitation History</u> |
|---|---|
| 1956 | An inspection of the jetties was conducted. Stone on the inlet side of both jetties had slipped at numerous locations. Slope stones and capstones had unraveled at the outer end of the east jetty. Approximately 300 ft of the west jetty had settled 2.0 to 3.0 ft. The jetties had undergone severe wave attack since their construction, and most of the damage was attributed to the hurricane of August 31, 1954. |
| 1983 | A survey indicated the jetties were in a good, stable condition. The jetties had settled approximately 2.0 ft over 65 ft on the east jetty and 130 ft on the west jetty. The jetties did not meet Corps of Engineers standards for armor stone layer thickness, weight, or elevation, and it was determined that it would be more economical to maintain the jetties on an annual basis than by rehabilitation. Potential damage was anticipated to increase. |

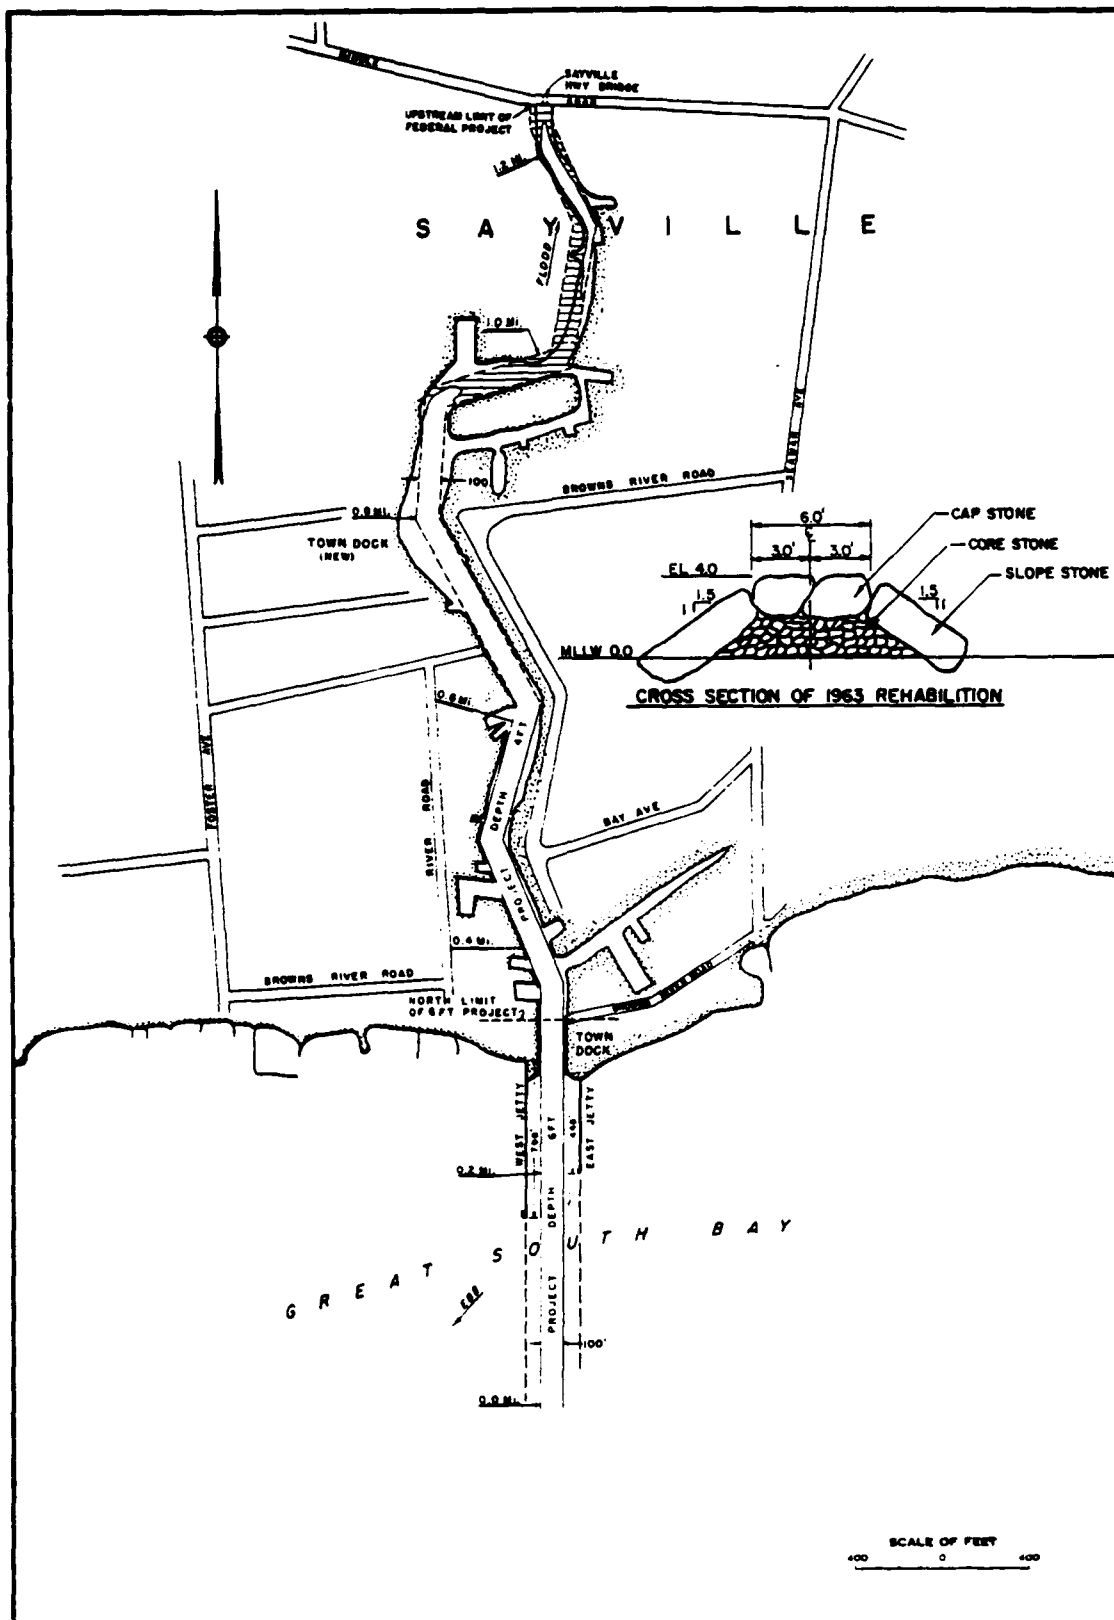
Figure 20. Browns Creek, New York

| <u>Date(s)</u> | <u>Construction and Rehabilitation History</u> |
|---|---|
| 1962-<br>1963 | A survey indicated the jetties were deteriorated. Almost all stones were displaced on the west jetty, and there were numerous openings in the structure. Most of the stones were shifted out of place on the east jetty. Almost half of the jetty was breached and was not visible at mean low water. The jetties were rehabilitated over the entire lengths in 1963 using 4,000 tons of stone at a cost of \$71,000. Crest elevations were +4.0 ft mlw, crown width was 6.0 ft, and side slopes were 1V:1.5H (Figure 20). Three-ton cap and slope stone, and 15-lb to 1.5-ton core stone was used. The design wave was 5.0 sec, 6.0 ft. |

| <u>Date(s)</u> | <u>Construction and Rehabilitation History</u> |
|---|---|
| 1927 | The west jetty was repaired and extended 208 ft (Figure 20). Elevation of the extension was +3.0 ft hw. Nine hundred eighty one cubic yards of rock was used for repair and extension. |
| 1935 | The outer 213 ft of the west jetty was repaired. Minimum capstone and slope stone was 2.0 tons, and core stone was 15 lb to 1.5 tons. The crest elevation was raised over the entire jetty to +4.0 ft mlw, crown width was 4.0 ft, and side slopes were 1V:1.5H. |

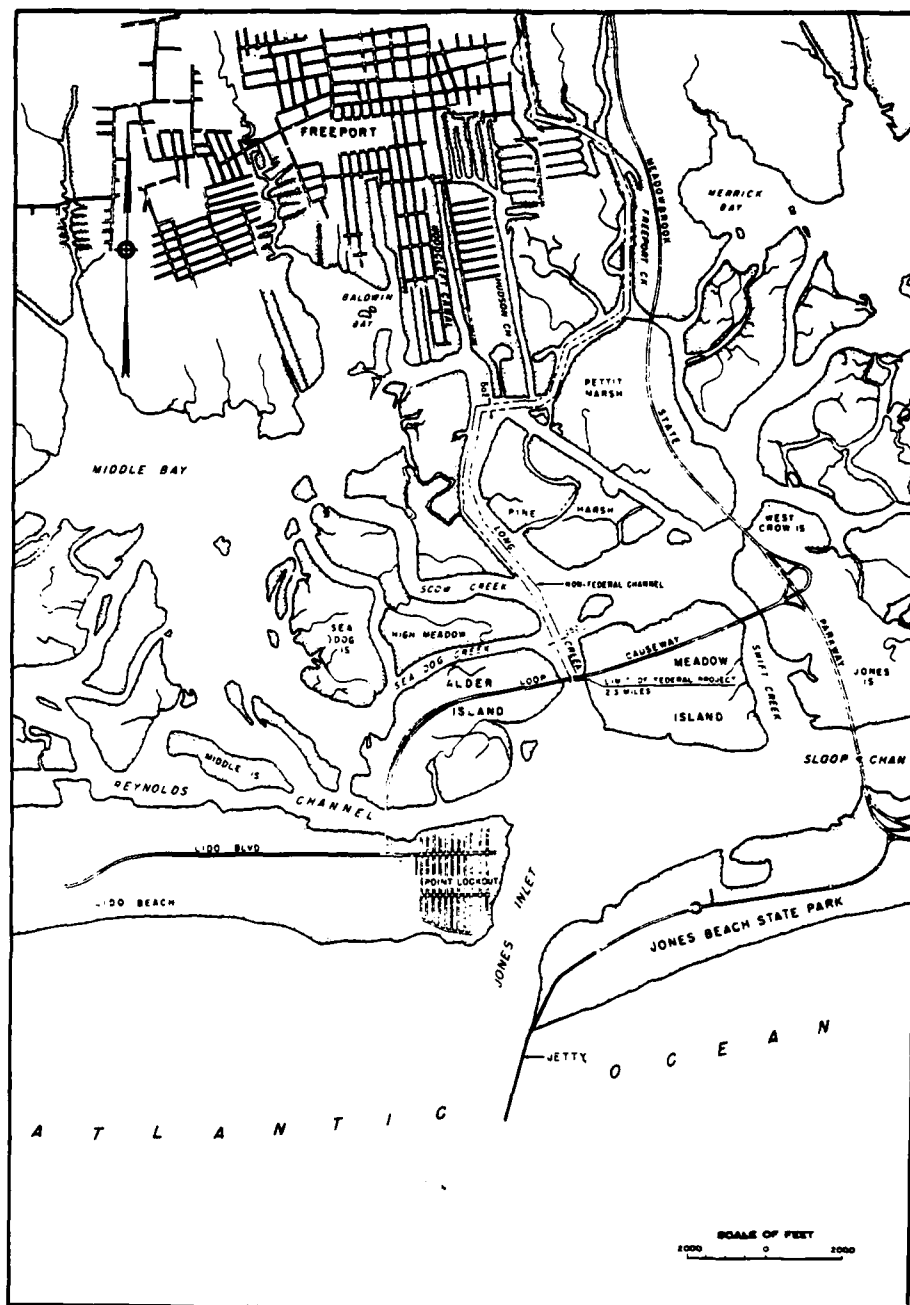
Figure 22. Jones Inlet, New York

| <u>Date(s)</u> | <u>Construction and Rehabilitation History</u> |
|---|---|
| 1985 | The jetty had nearly reached impoundment. Sand was bypassing the jetty, mostly through large voids at the jetty-shoreline intersection. The apron had settled approximately 7.0 ft at the seaward end due to sand loss through voids in the apron. |

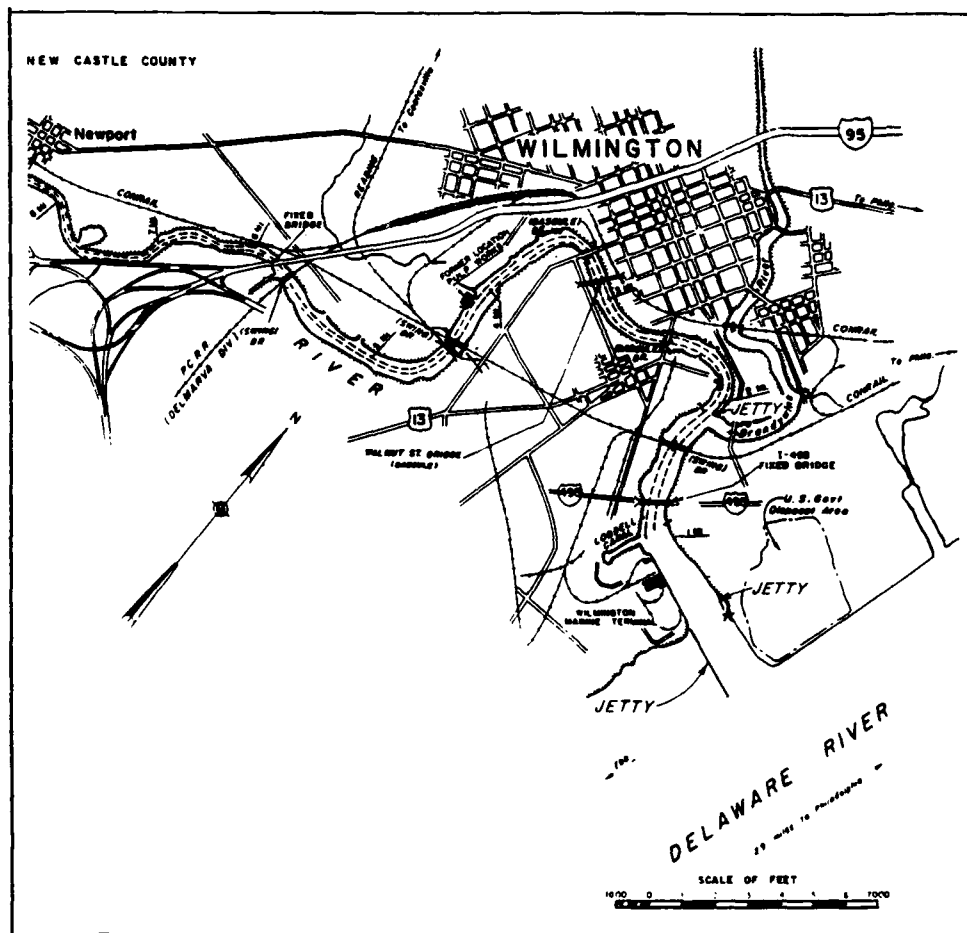
Figure 31. Wilmington Harbor, Delaware

| Date(s) | Construction and Rehabilitation History |
|---|---|
| 1962 | 275 ft of buttressed steel sheet-pile wall failed during an extremely low tide and was eventually repaired. |
| 1985 | The Christina south jetty is in good condition. |

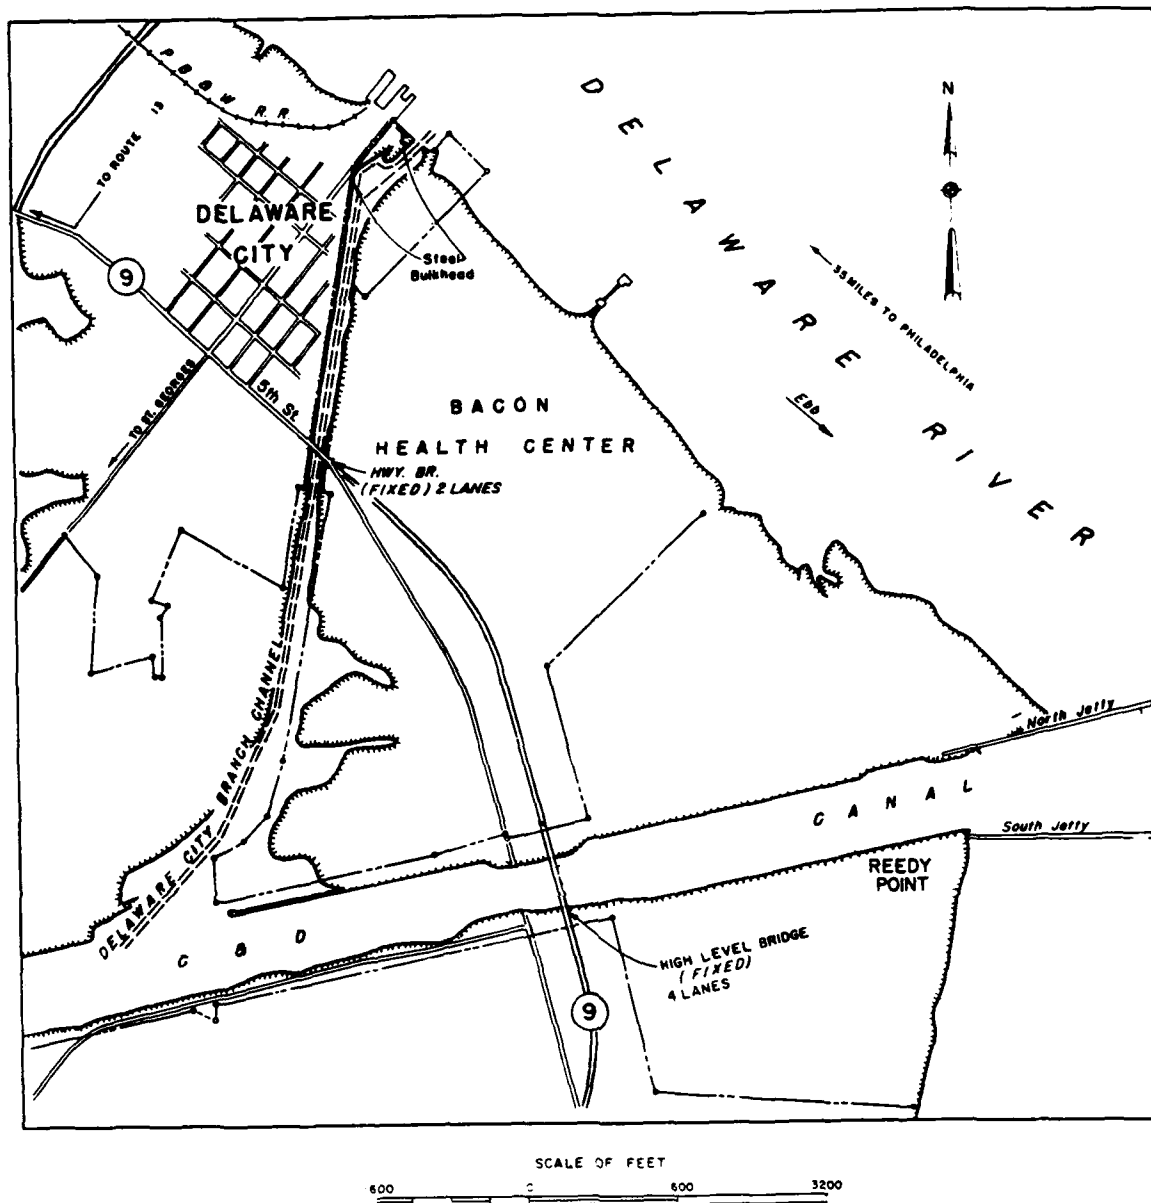
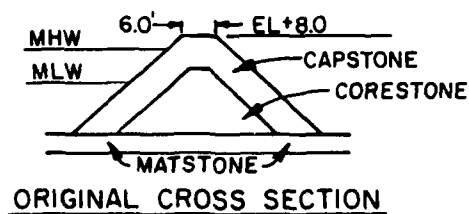
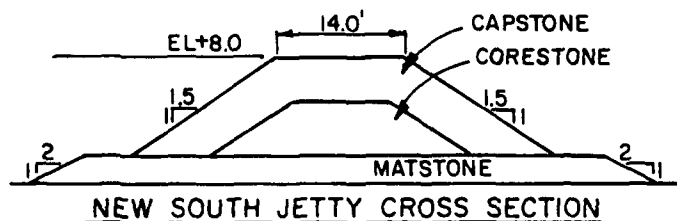
Figure 32. Delaware River and Chesapeake Bay Canal, Delaware

| <u>Date(s)</u> | <u>Construction and Rehabilitation History</u> |
|---|---|
| 1985 | The north jetty has subsided, lost stone, and the toe has scoured. |
