TECHNICAL REPORT REMR-CO-3

CASE HISTORIES OF CORPS BREAKWATER  
AND JETTY STRUCTURES

Report 5

NORTH ATLANTIC DIVISION

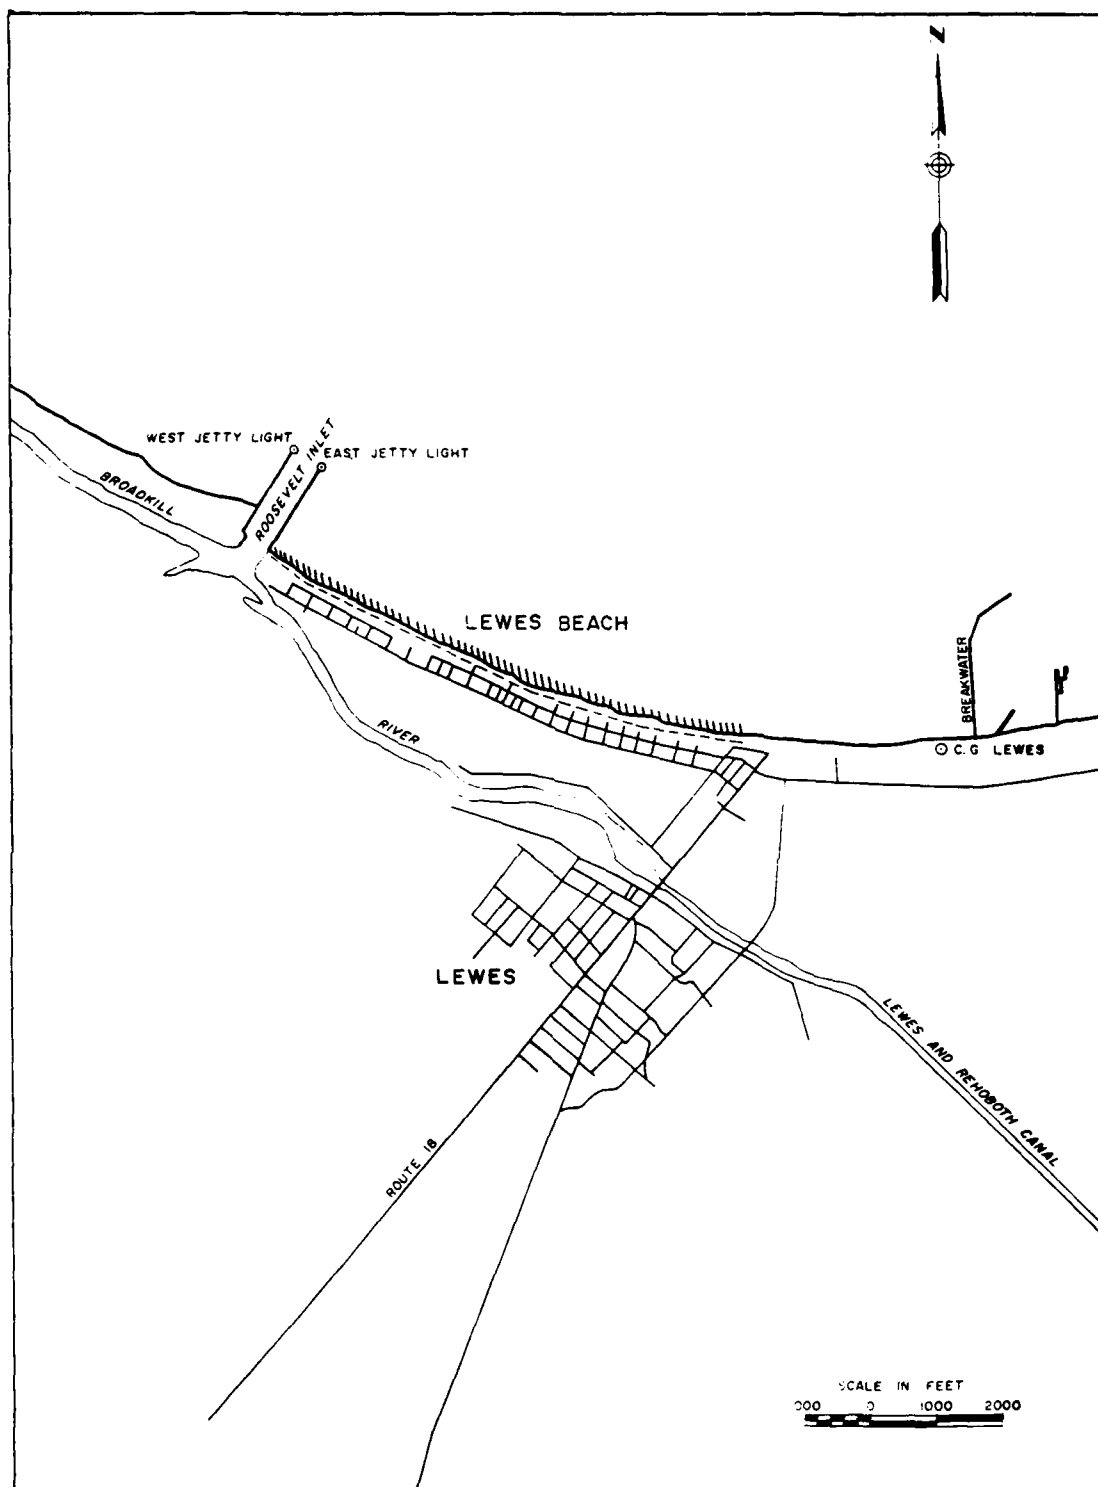
Figure 36. Roosevelt Inlet, Delaware

| <u>Date(s)</u> | <u>Construction and Rehabilitation History</u> |
|---|---|
| 1944 | The jetties were flanked and rubble was placed along the east bank. The additional rubble extended the east jetty shoreward 400 ft. The possibility of the west jetty becoming completely flanked was determined to be remote; therefore, no rubble was placed on the west bank. Seaward ends of both jetties were repaired due to deterioration by corrosion. |
| 1985 | The jetties are in poor condition and are ineffective. They are considered a navigation hazard and are to be removed. |

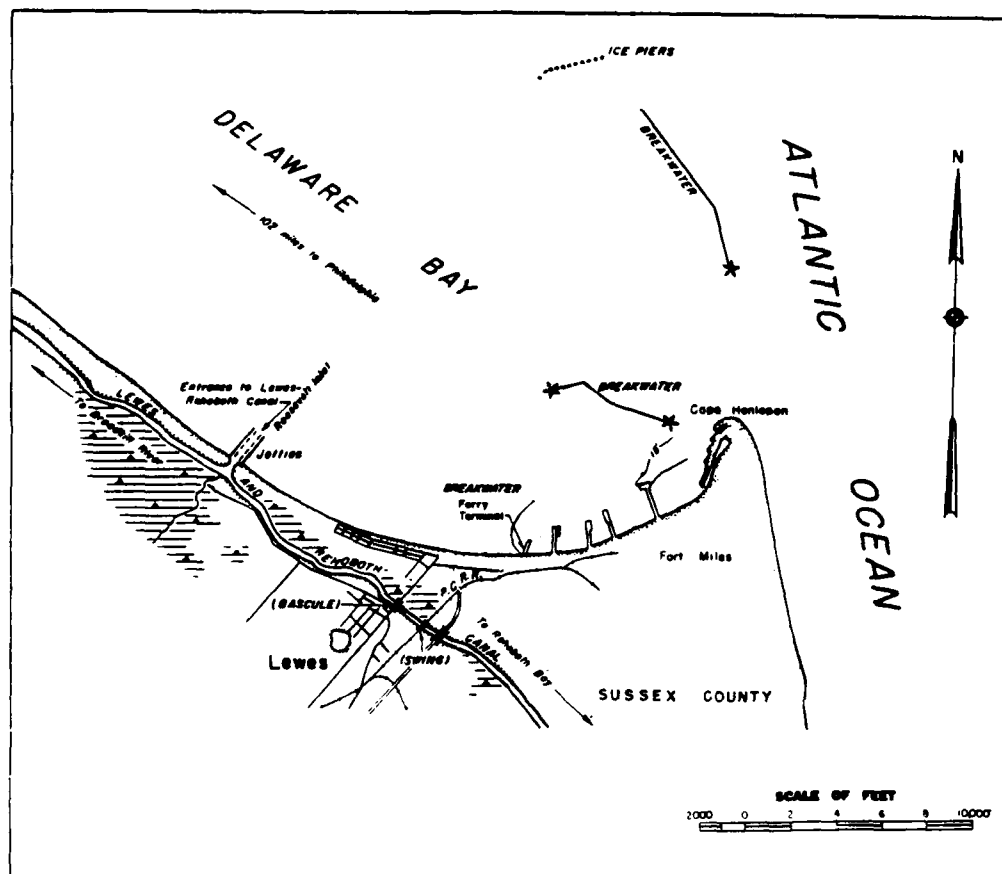
Figure 37. Delaware Bay Harbor of Refuge, Delaware

| Date(s) | Construction and Rehabilitation History |
|---|---|
| 1901 | Construction was completed on a second detached breakwater to provide harbor protection from northwest storms (Figure 37). The structure began at a point 6,000 ft north of Cape Henlopen and extended northwest 7,500 ft. The rubble-mound breakwater was constructed with 1,475,276 tons of stone at a cost of \$2,239,000. |
| 1985 | The breakwaters have no history of repairs and have survived remarkably well. The structures are outdated and would not be repaired if damaged. They no longer serve their intended purpose because of changes in the shipping industry. |

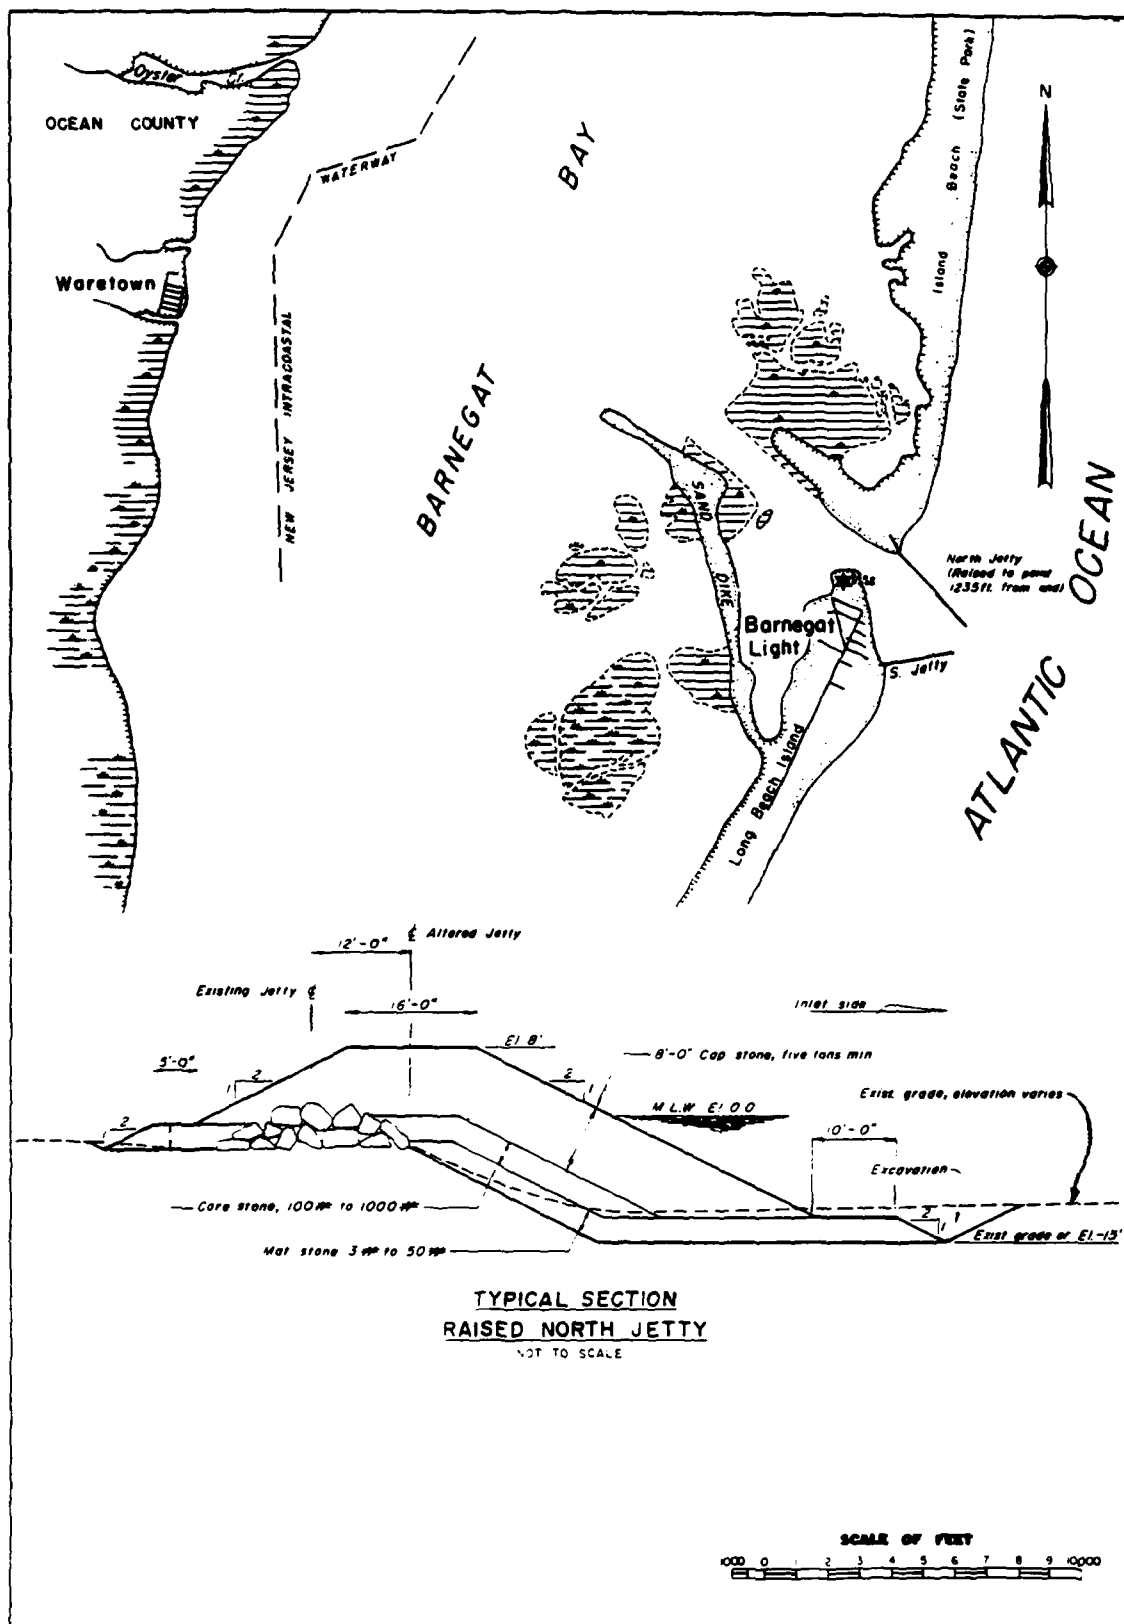
Figure 40. Barnegat Inlet, New Jersey

| <u>Date(s)</u> | <u>Construction and Rehabilitation History</u> |
|---|---|
| 1940 | Two converging stone jetties were constructed north and south of the inlet for channel protection. The north jetty was 4,675 ft long, and the south jetty was 2,820 ft long (Figure 40). Design crest elevation was +2.0 ft mlw. |
| 1972-<br>1974 | To prevent sand passing through and waves overtopping the north jetty, the shoreward 3,700 ft was raised to +8.0 ft mlw and made impermeable. The center line of the section repaired was offset 12.0 ft toward the inlet from the existing section (Figure 40). |

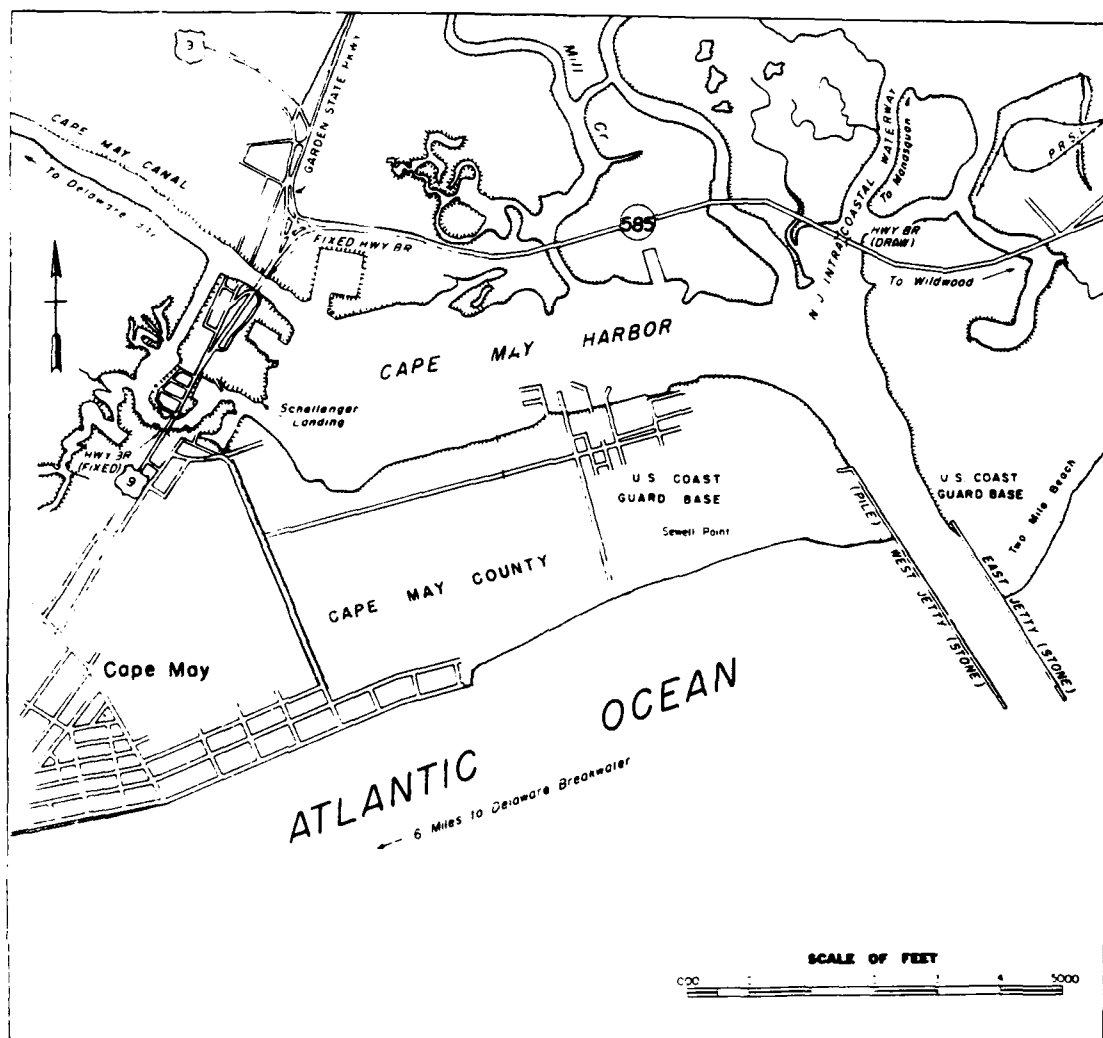
Figure 46. Cold Spring Inlet, New Jersey

| <u>Date(s)</u> | <u>Construction and Rehabilitation History</u> |
|---|---|
| 1911 | Construction was completed on two parallel jetties 850 ft apart, on the east and west sides of the inlet. Lengths were approximately 4,548 ft and 4,410 ft east and west, respectively (Figure 46). Crest elevations were +10 ft mlw, crown widths varied from 6.0 to 15.0 ft, and side slopes were generally 1V:1.5H. A total of 326,049 tons of stone was used. Shoreward wing lengths were 750 ft and 297 ft east and west, respectively. Wings of both jetties and the shoreward 2,000 ft of the west jetty were constructed of stone-filled pile and timber. The remainder of the west jetty and the entire east jetty were rubble mound. |

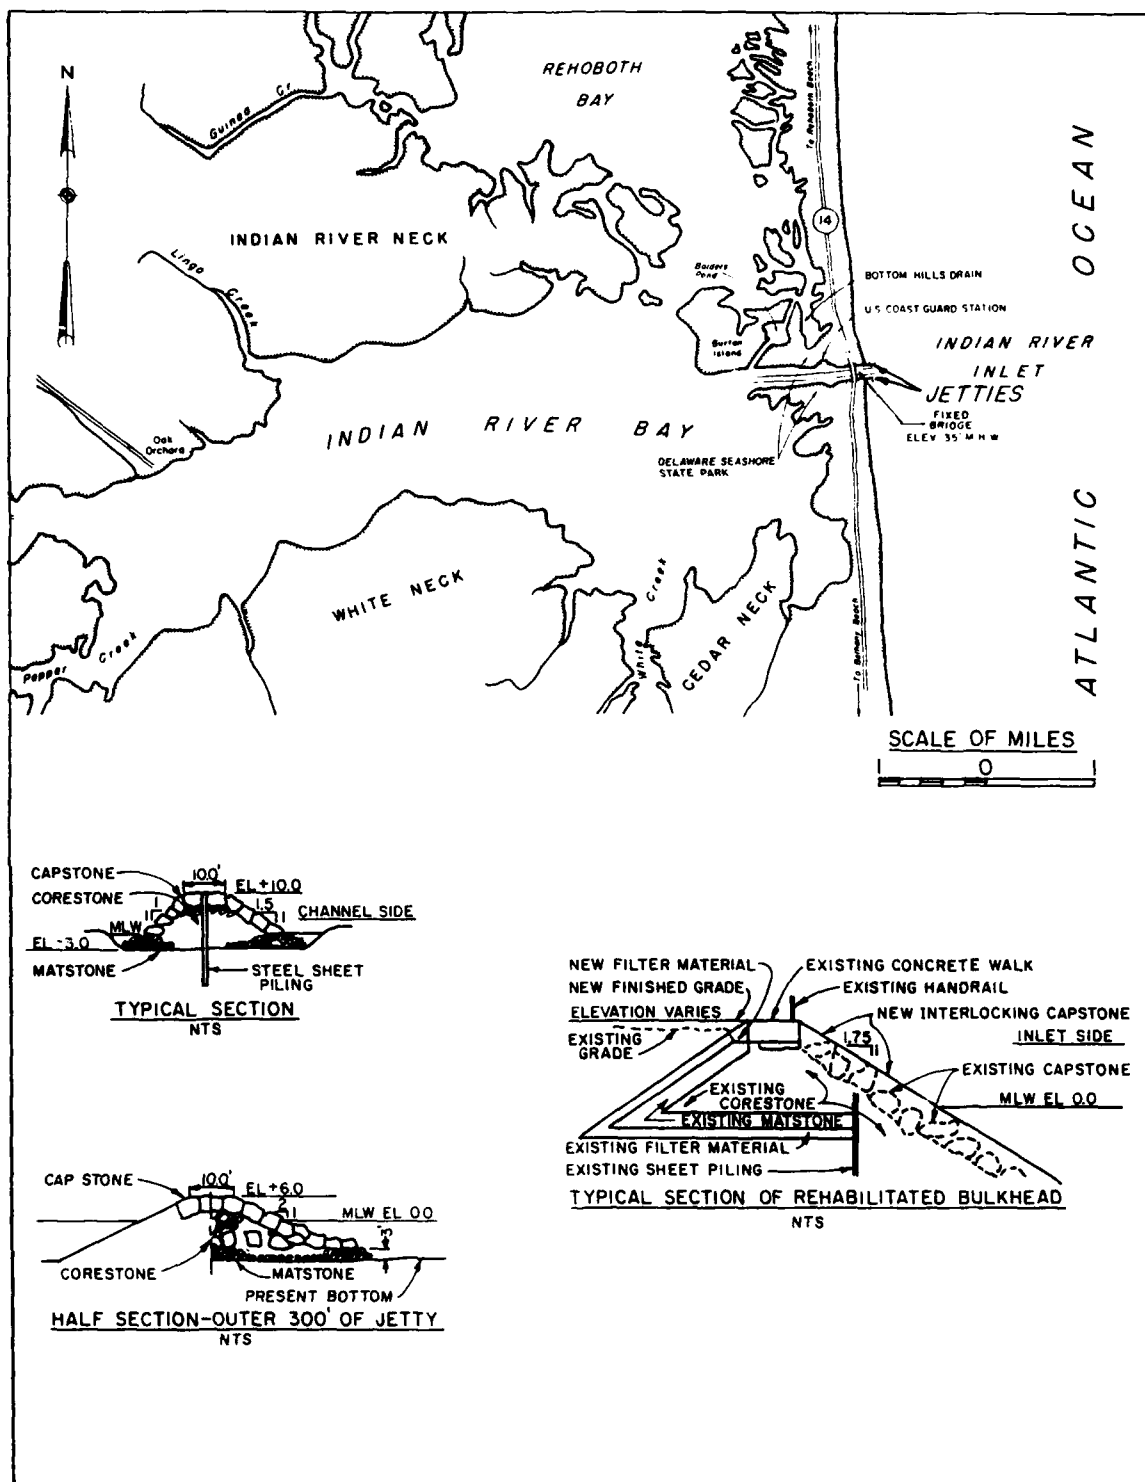
Figure 49. Indian River Inlet, Delaware

| <u>Date(s)</u> | <u>Construction and Rehabilitation History</u> |
|---|---|
| 1939 | Two parallel jetties were completed to provide inlet protection. The jetties were 1,566 ft long and 500 ft apart. The shoreward 904 ft and 890 ft of the north and south jetties, respectively, were constructed of steel sheet pile, and the seaward portions were constructed of stone. The stone jetties had a crest elevation of +6.0 ft mlw, a crown width of 10.0 ft, and side slopes of 1V:1.5H (Figure 49). |
| 1957 | The north jetty was repaired because of storm damages and was extended shoreward 320 ft because of shoreline recession and deterioration of the sheet pile (Figure 49). |

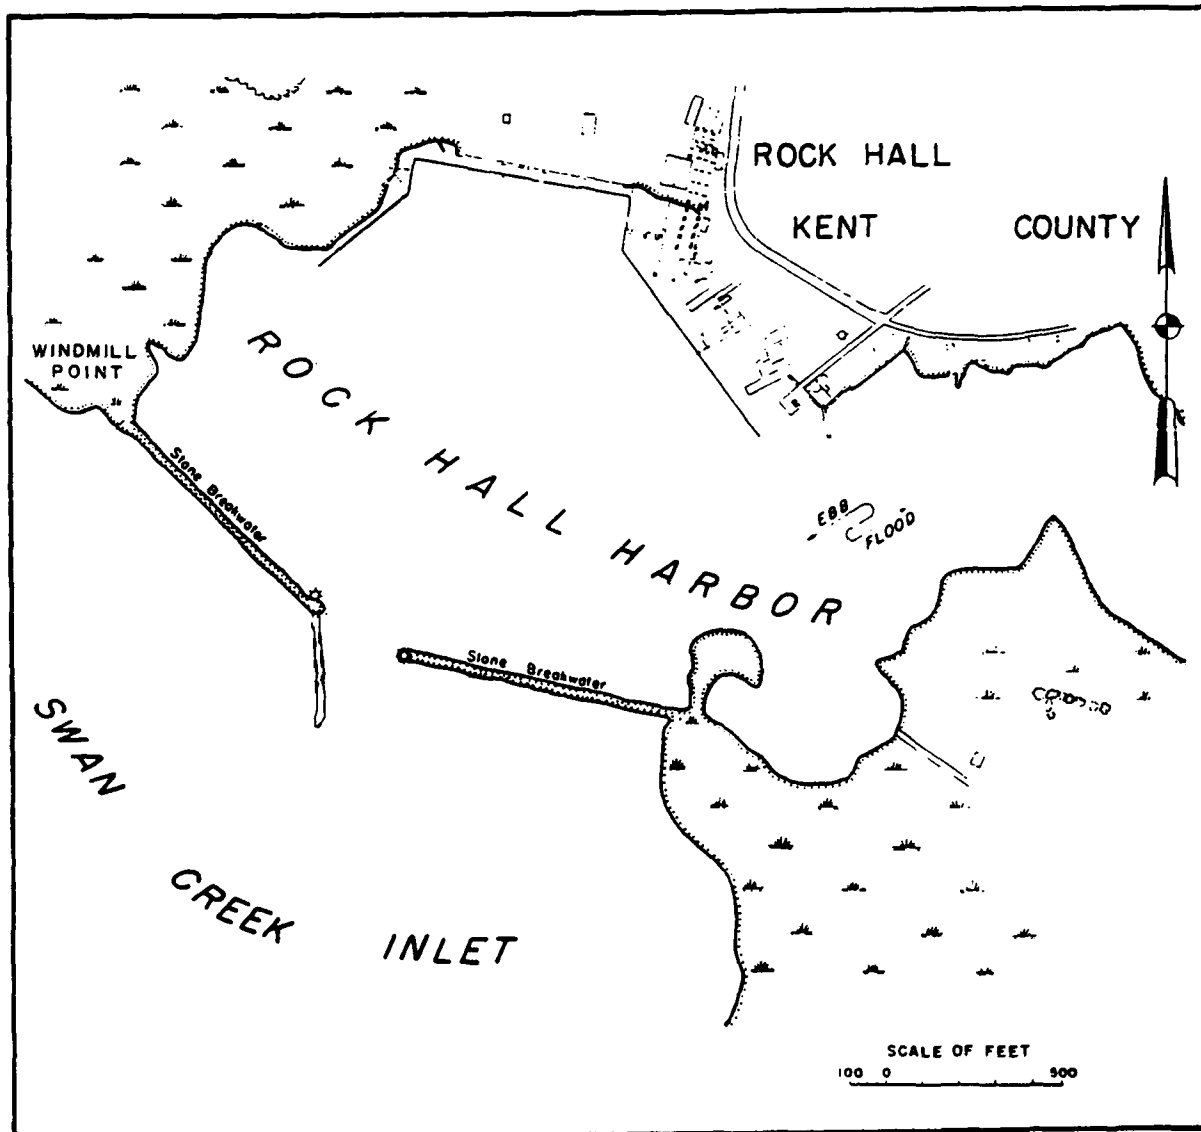
Figure 51. Rock Hall Harbor, Maryland

| Date(s) | Construction and Rehabilitation History |
|---|---|
| 1939 | Two breakwaters were constructed with 8,400 tons of stone. Lengths of the breakwaters were 850 ft and 700 ft east and west, respectively (Figure 51). Elevations of the breakwaters were +4.0 ft mhw, with a single capstone, crown width of 4.0 ft, and side slopes of 1V:1.5H. |

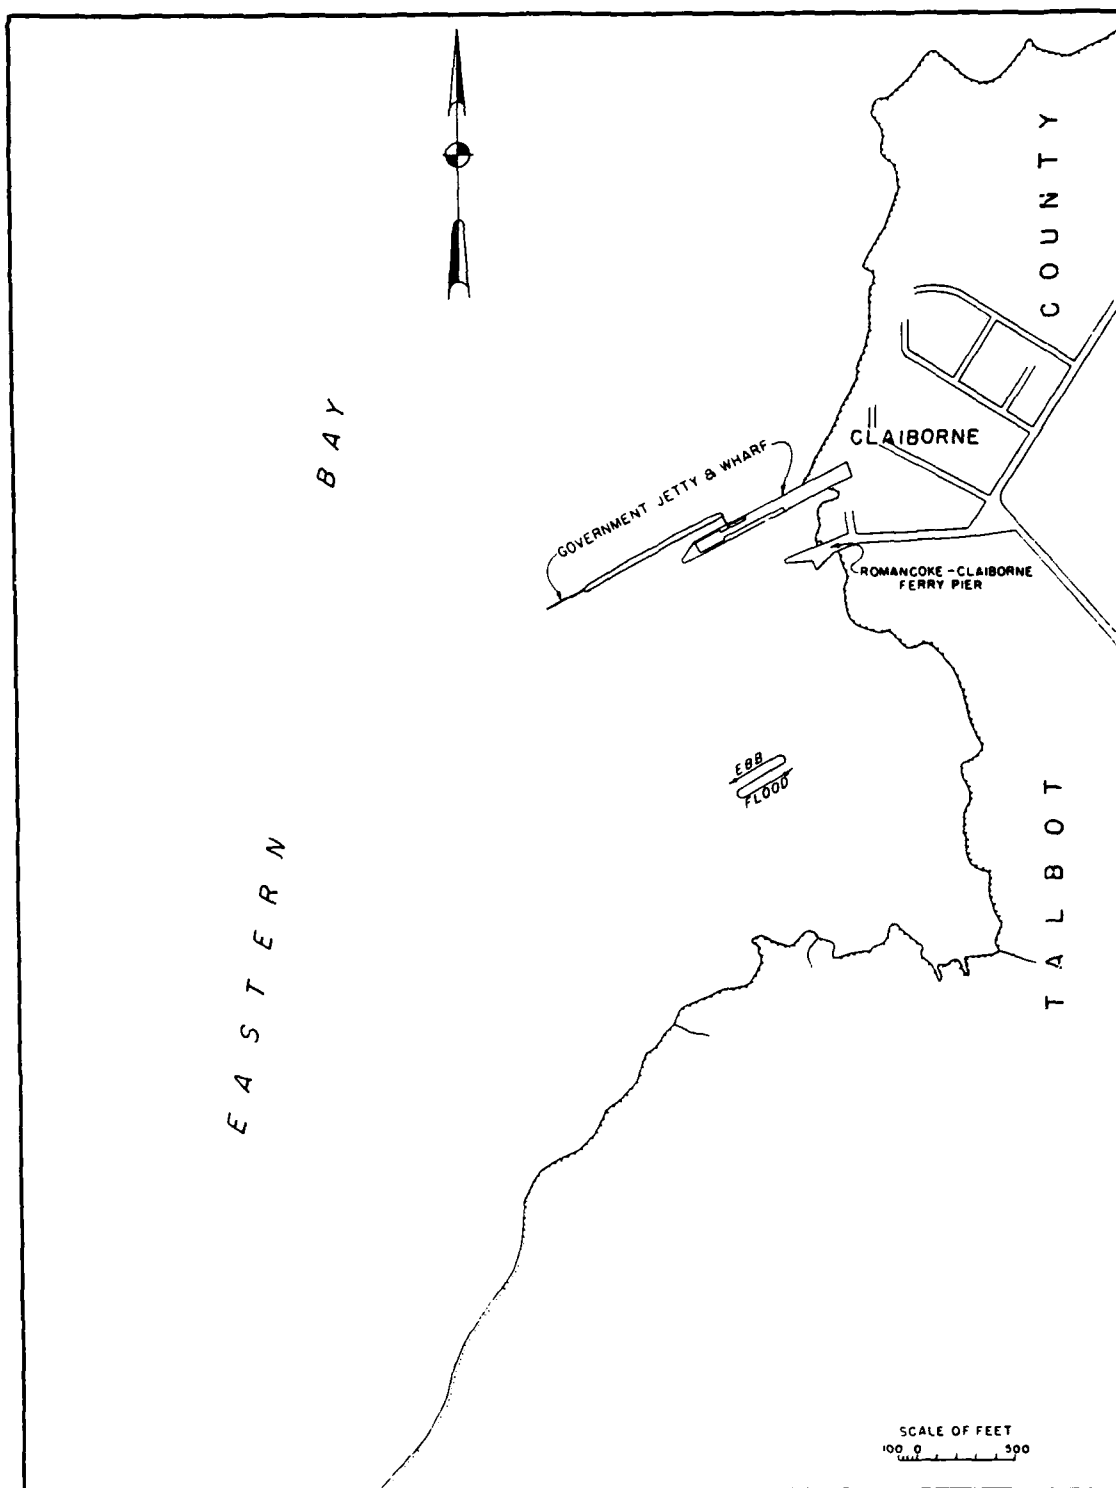
Figure 53. Claiborne Harbor, Maryland

| <u>Date(s)</u> | <u>Construction and Rehabilitation History</u> |
|---|---|
| 1912 | The jetty was extended 250 ft seaward as part of the federal project and was constructed of timber piles (Figure 53). |

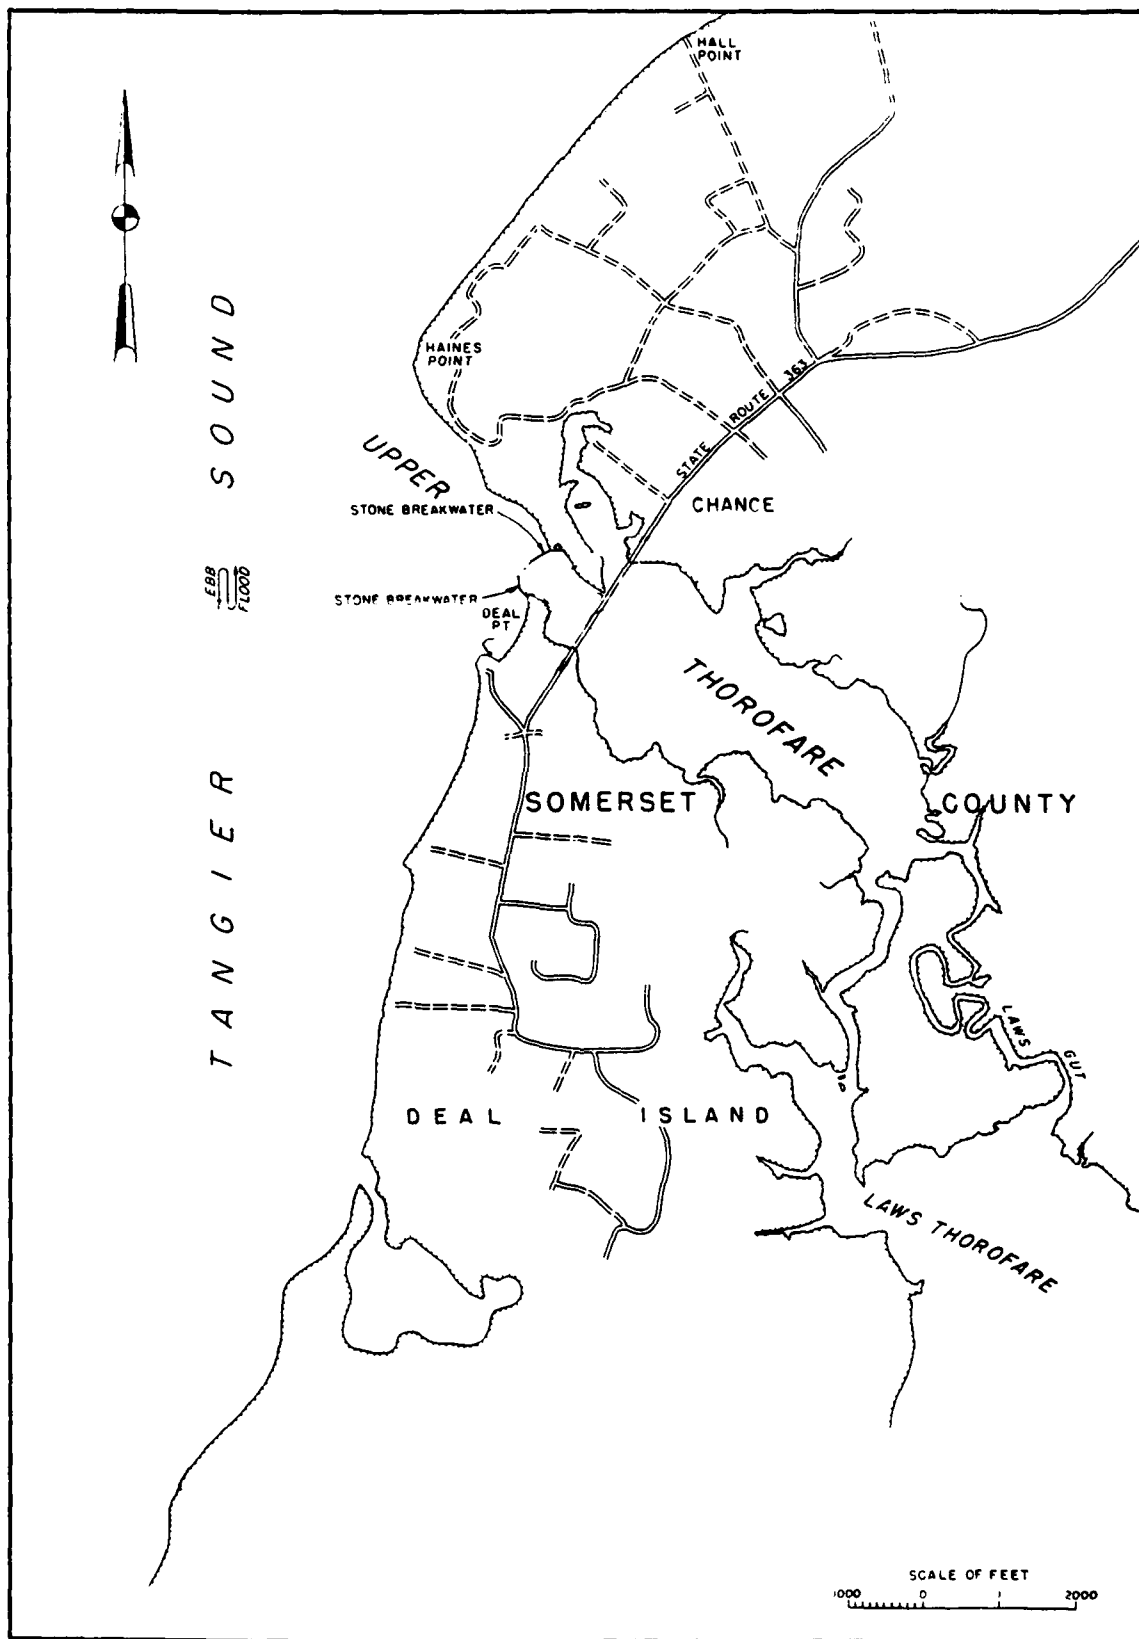
Figure 60. Upper Thorofare, Maryland

| Date(s) | Construction and Rehabilitation History |
|---|---|
| 1934 | Two stone breakwaters were constructed with 3,650 tons of stone at an estimated cost of \$9,000. The north breakwater was 410 ft long. The south breakwater was 310 ft long. The seaward ends were 180 ft apart (Figure 60). Crest elevations were +7.0 ft mlw, except the landward 142 ft of the south breakwater which was from +5.0 to +6.5 mlw. Crown width was 4.0 ft, and side slopes were 1:1. |

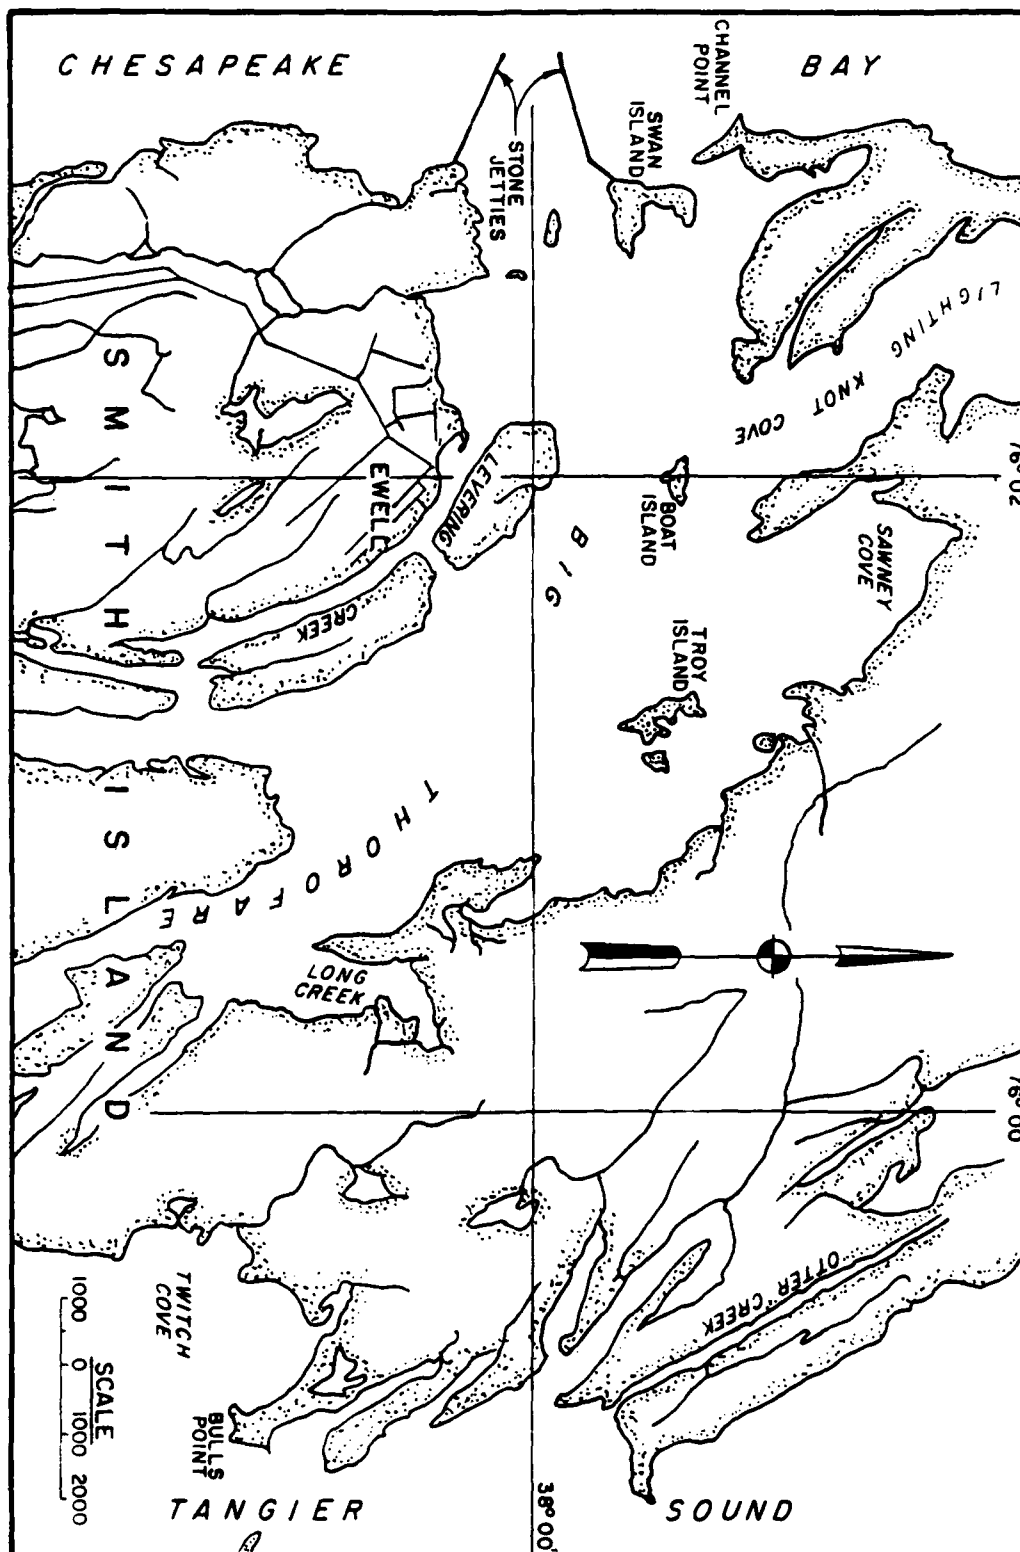
Figure 61. Twitch Cove and Big Thorofare River, Maryland

| Date(s) | Construction and Rehabilitation History |
|---|---|
| 1940 | Two converging stone jetties were constructed with 23,000 tons of stone at a cost of \$112,000 (Figure 61). The north jetty was 2,070 ft long, and the south jetty was 1,800 ft long. The design section included a crown elevation of +4.0 ft mlw, a crown width of 2.0 ft with the exception of the seaward 120 ft of the north jetty which was 4.0 ft, and side slopes of 1V:2H, except for the bay side of the north jetty which was designed for 1:1 along the landward 1,950 ft. No stone size details were given; however, a 1981 survey indicated the side slope stone was approximately 1.5 tons, and the core was of similar stone. The survey also revealed the single cap-stone ranged from 2.0 to 3.0 tons. No apron or bedding was placed during construction or subsequent repairs. |

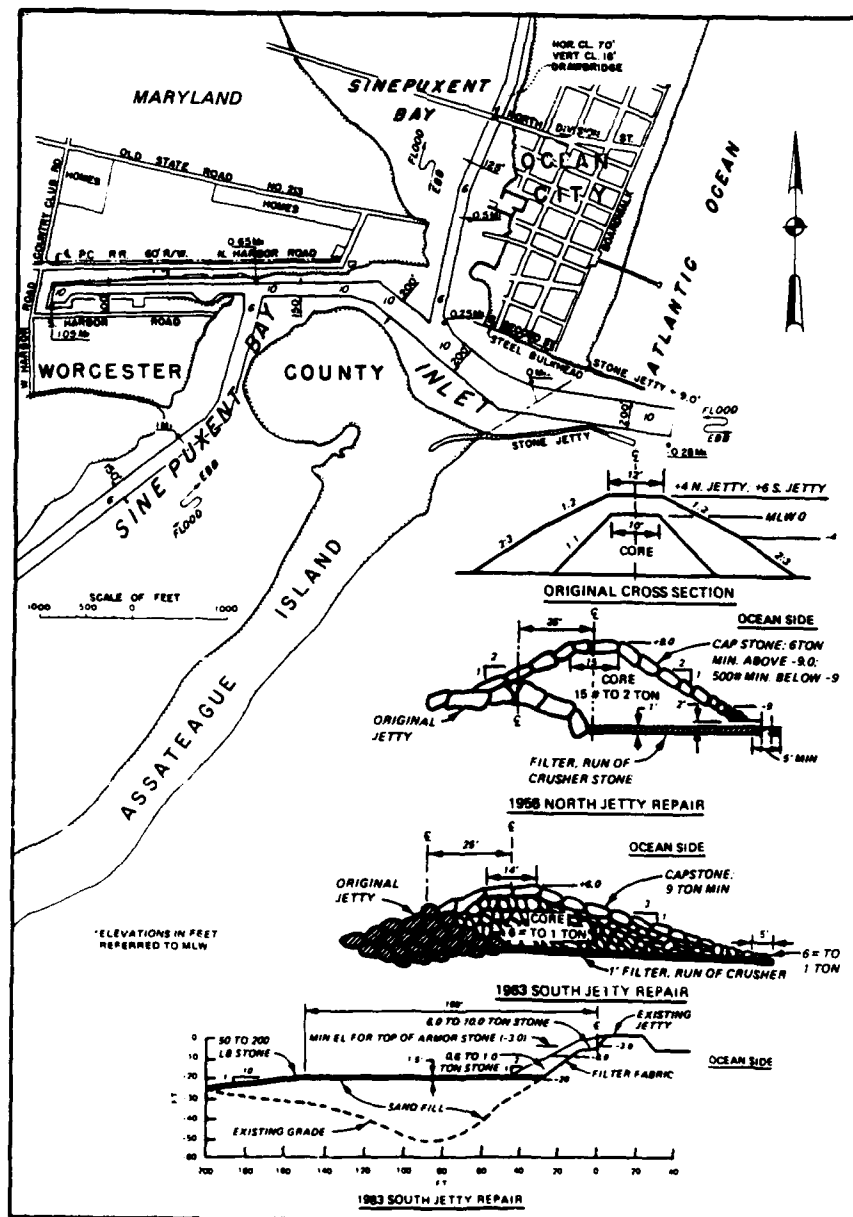
Figure 62. Ocean City Inlet, Maryland

| Date(s) | Construction and Rehabilitation History |
|---|---|
| 1934 | A 1,100-ft-long jetty was constructed on the north side of a newly formed inlet at Ocean City (Figure 62). Crest elevation was +4.0 mlw, crown width was 12.0 ft, and side slopes were 1V:2H from the crest to -4.0 mlw and 1V:1.5H from -4.0 mlw to the bottom. |

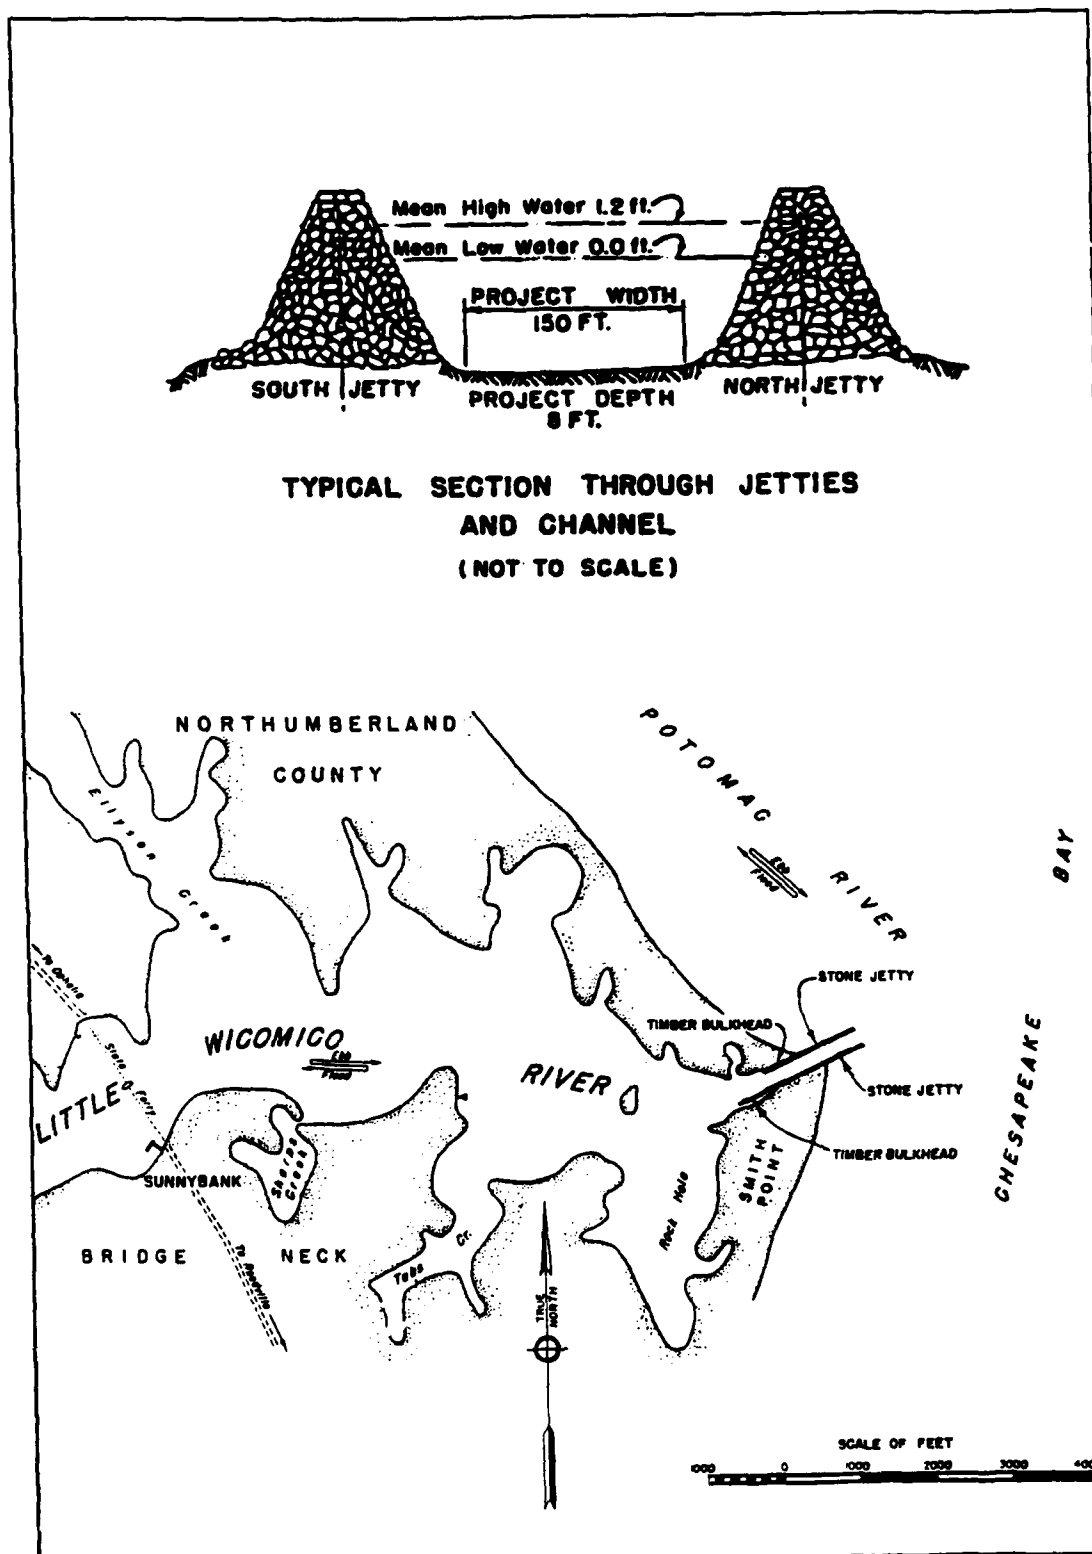
Figure 67. Little Wicomico River, Virginia

| Date(s) | Construction and Rehabilitation History |
|---|---|
| 1937 | Two stone jetties were constructed to lengths of 1,000 and 1,300 ft north and south, respectively (Figure 67). Timber pile jetties were also placed at the landward ends of the stone jetties. Lengths of the timber piles were 357 ft north and 650 ft south. |
