HISTORIC STANDING STRUCTURE  
INVESTIGATION OF THE SOURIS RIVER  
BASIN PROJECT RURAL IMPROVEMENTS

HISTORICAL RESEARCH ASSOCIATES

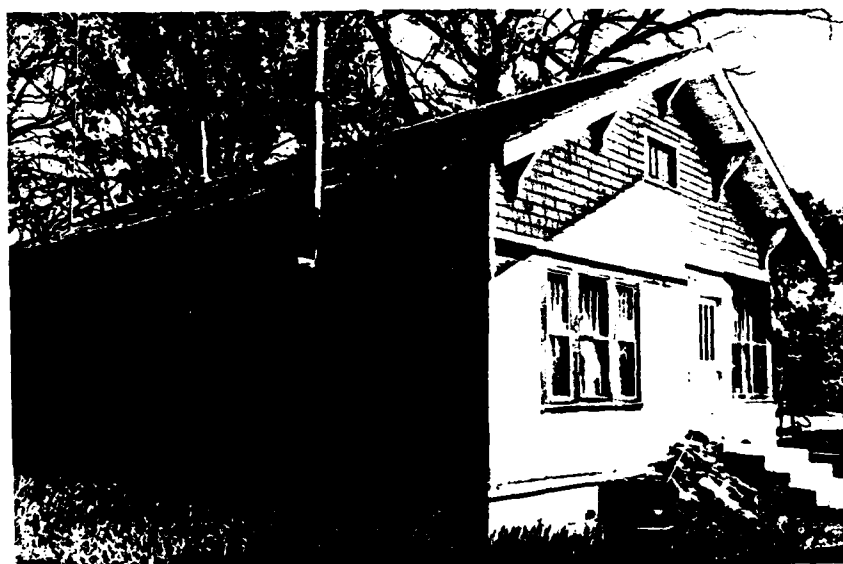
Feature 1 is a one story dwelling with a gable roof, wood shingles, and concrete foundation (Figure 9). Exterior siding materials are stucco on the lower two-thirds of the sides, and wood shingles on the remaining one-third. There is a metal stovepipe near the northern end in the center of the roof, and a metal woodstove pipe that exits near the southwest corner on the west exterior wall. On the west elevation are one 3/1 double-hung window, two three-lite fixed-pane windows, and one 3/1 double-hung window. The main entrance on south elevation has a single-entry door. On the west side of the door are three 3/1 double-hung windows and east of the door are two 3/1 double-hung windows. The east elevation of the structure has five 3/1 double-hung windows and one small 3/1 double-hung window. The north elevation has a single-entry door and two 3/1 double-hung windows. The feature was moved onto the site in the early 1970s. Thus, it has no integrity of association.

Figure 9. Looking northeast at Feature 1 of 32MH32 (HRA 121).

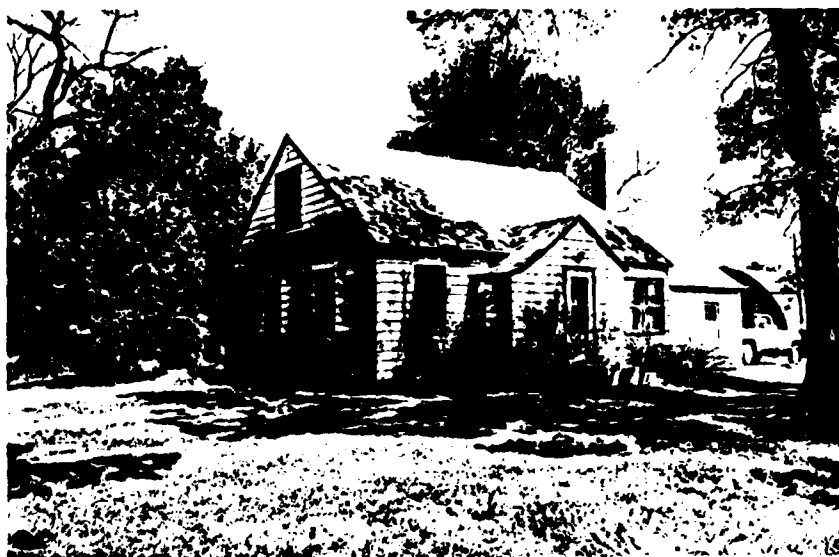
Feature 2 is a one and one-half story, gable-roofed residence with asphalt shingles and a one story gable-roofed addition on the east elevation (Figure 10). There is also a gable-roofed entry on the south elevation. The sides are covered with aluminum siding. Windows are 6/1 double-hung, with two on the west and three on the south elevations. There also is a single-entry door on the south elevation. There are two 6/1 double-hung windows on the east elevation of the main structure and two 6/6 double-hung windows on the south elevation of the addition. There is a single-entry door on the east elevation of the addition. There are two 6/6 double-hung windows on the north elevation of the addition and one 6/1 double-hung window on the north corner of the east elevation of the main structure. The south elevation of the main structure has two 6/1, one 1/1, and one 6/6 double-hung windows. The feature sits on a concrete pad foundation. Feature 2 was constructed in the early 1950s and has been extensively altered. Thus, it lacks integrity of association and does not meet the age requirements for listing on the National Register of Historic Places.

Figure 10. Looking northeast at Feature 2 of 32MH32 (HRA 121).

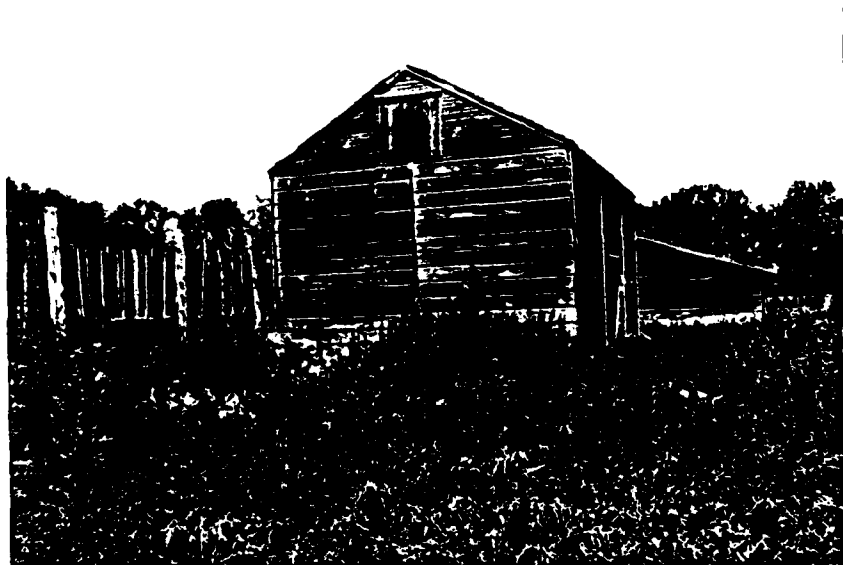
Feature 7 is a one and one-half story, frame granary (Figure 11). It has 1x4 tongue and groove siding and wood shingles on the roof. There is no foundation. There is a loading door on the south elevation near the top. Recently, a single-entry door on the east has been cut into the side. The feature is not architecturally significant.

Figure 11. Looking north at Feature 7 of 32MH32 (HRA 121).

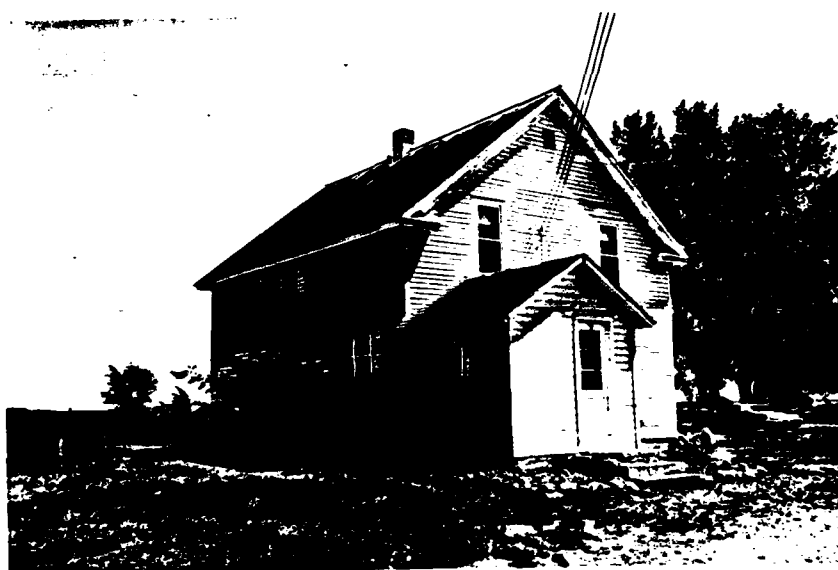
Figure 21. Looking southeast at Feature 1 of 32MH44 (HRA 232).

hung window on the lower floor, one single-entry doorway into the mud room, and one four-lite fixed-pane window on the southwest elevation of the mud room. The north elevation has one single-lite fixed-pane window on the upper floor, and three Anderson windows with aluminum storms. The feature has been extensively altered and no longer maintains integrity of association.

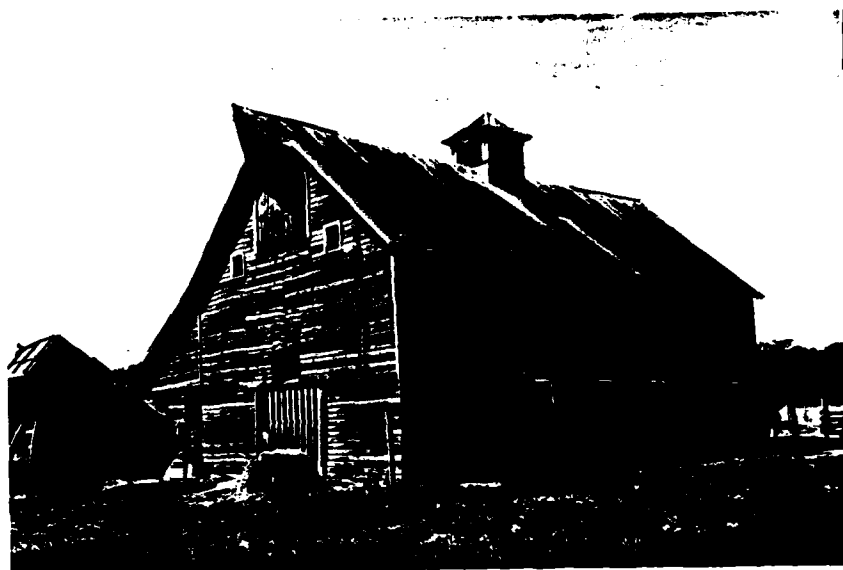
Figure 22. Looking northwest at Feature 4 of 32MH44 (HRA 232).

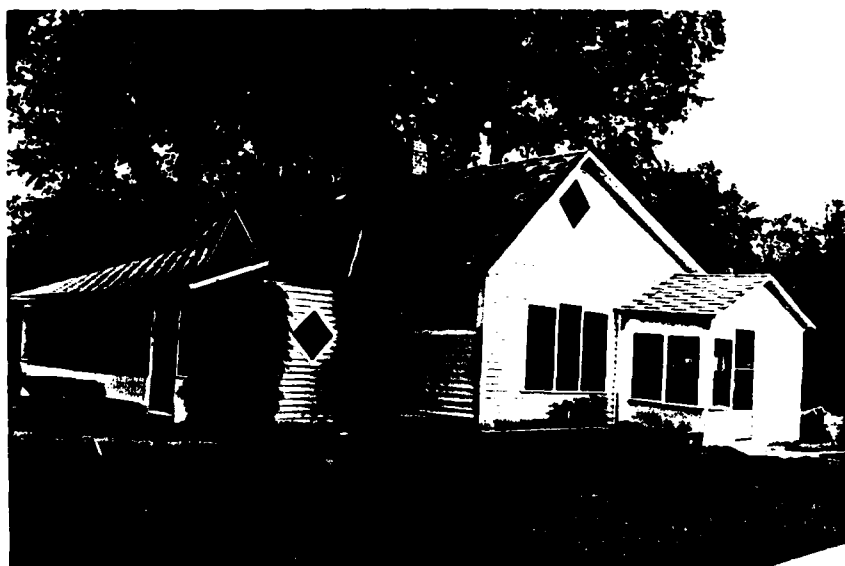
Figure 25. Looking southeast at Feature 2 of 32MH36 (HRA 320).

shaped single-pane window and two 1/1 double-hung windows on its north elevation, and a 1/1 double-hung window on its west elevation. The west elevation of the house has three 1/1 double-hung windows, and a diamond-shaped window under the eave of the roof. The south elevation has two 1/1 double-hung windows and two 6/1 double-hung windows. All windows in the house have wood-framed storm windows or screens. The original portion of the house probably was built between 1910 and 1920, but the additions were constructed in the 1930s. The building is in good condition. The feature has been extensively altered and no longer maintains integrity of association.

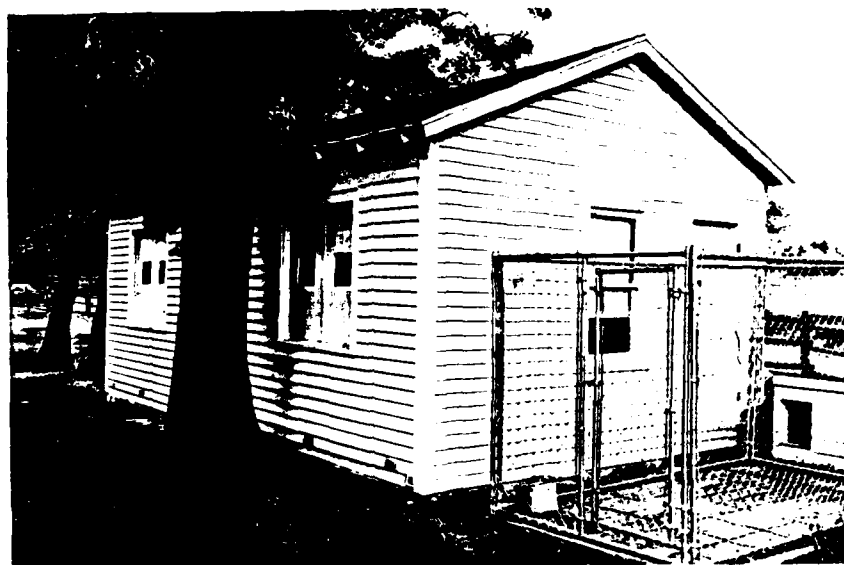
Figure 26. Looking northwest at Feature 5 of 32MH36 (HRA 320).

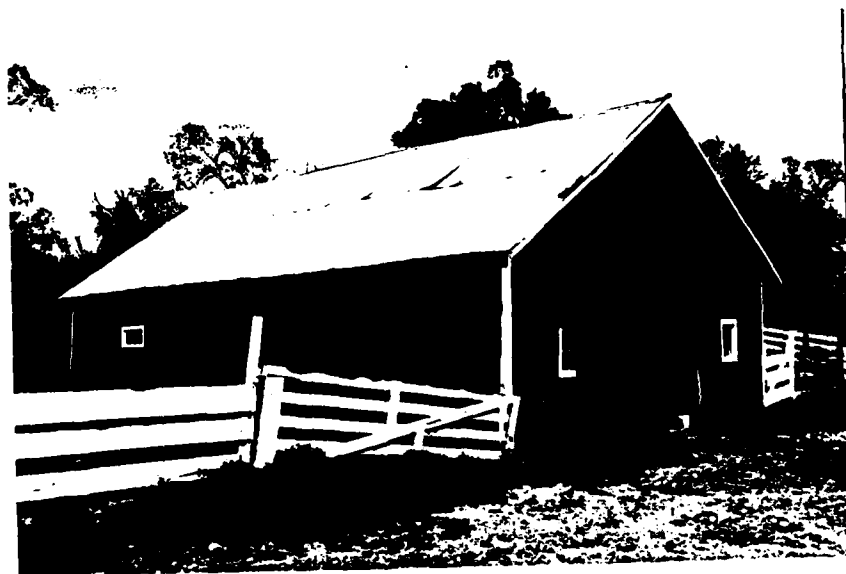
Figure 27. Looking northwest at Feature 6 of 32MH36 (HRA 320).

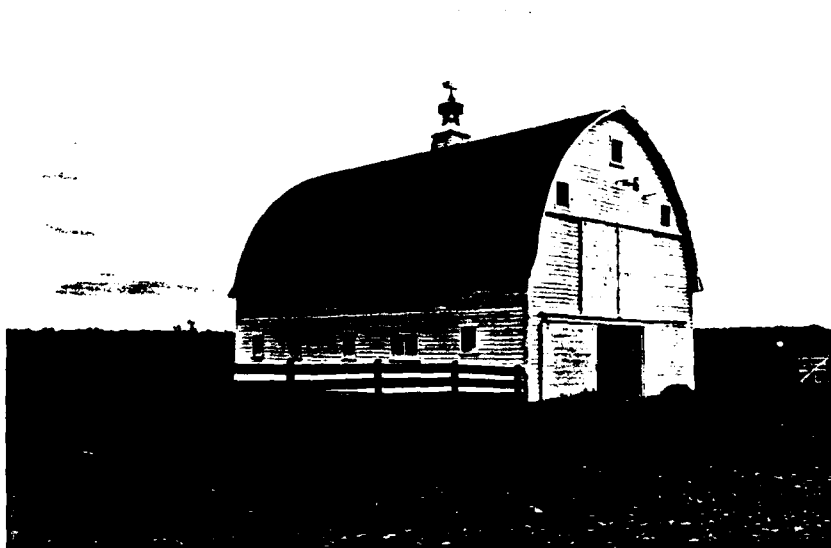
Feature 7 is a three story, wood frame barn with a vaulted, bellcast roof (Figure 28). There is a frame hip-roofed vent in the center of the roof. The building has asphalt shingles on the roof, 1x4 tongue and groove siding, and rests on concrete footers. There are two four-lite fixed-pane windows and a double-entry doorway with a sliding wooden door on the north elevation. The east elevation has seven four-lite fixed-pane windows. The west elevation has six four-lite fixed-pane windows. There are three four-lite fixed-pane windows on the upper floor of the south elevation, a large hay loading entry with two sliding doors on the middle floor, and a single vehicle entry with a sliding door on the ground level. The barn was probably built between 1915-1930 and is in good condition. The addition of other features that are less than fifty years old has compromised the integrity of this feature.

Figure 28. Looking southwest at Feature 7 of 32MH36 (HRA 320).

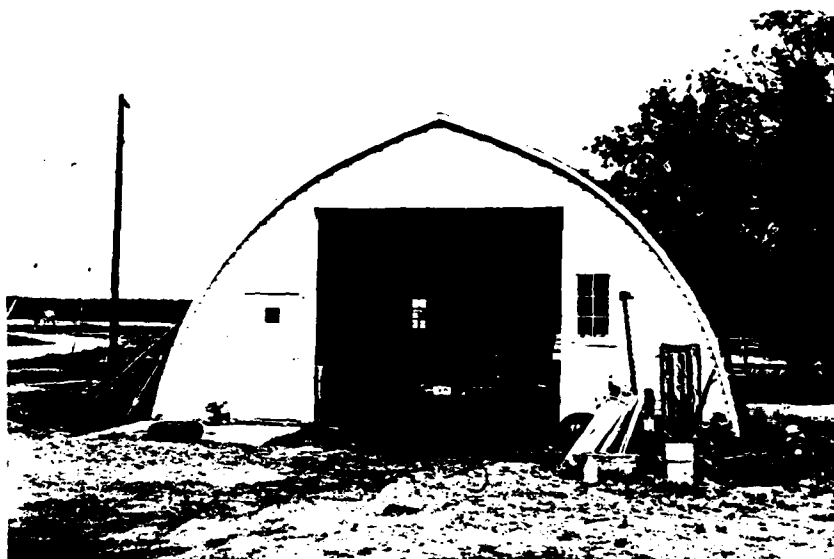
Figure 30. Looking east at Feature 9 of 32MH36 (HRA 320).

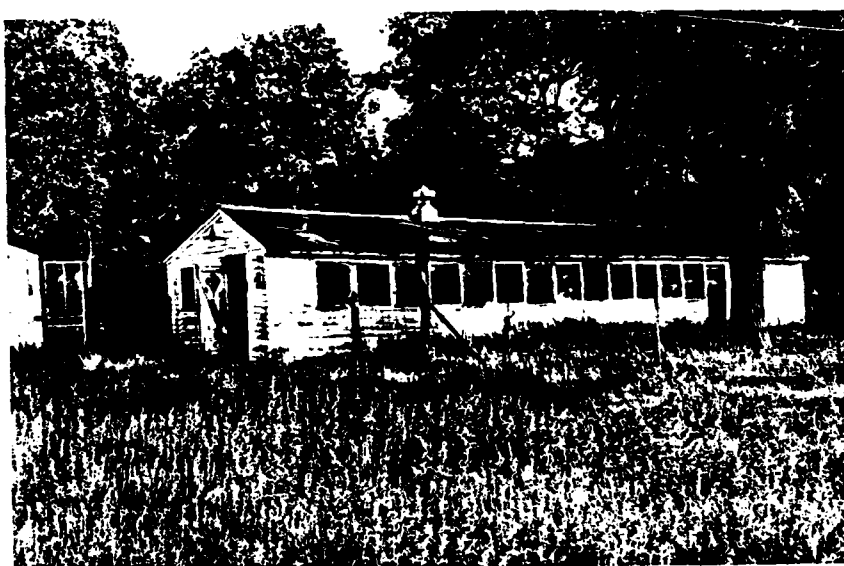
Figure 33. Looking northeast at Feature 3 of 32MH37 (HRA 420).

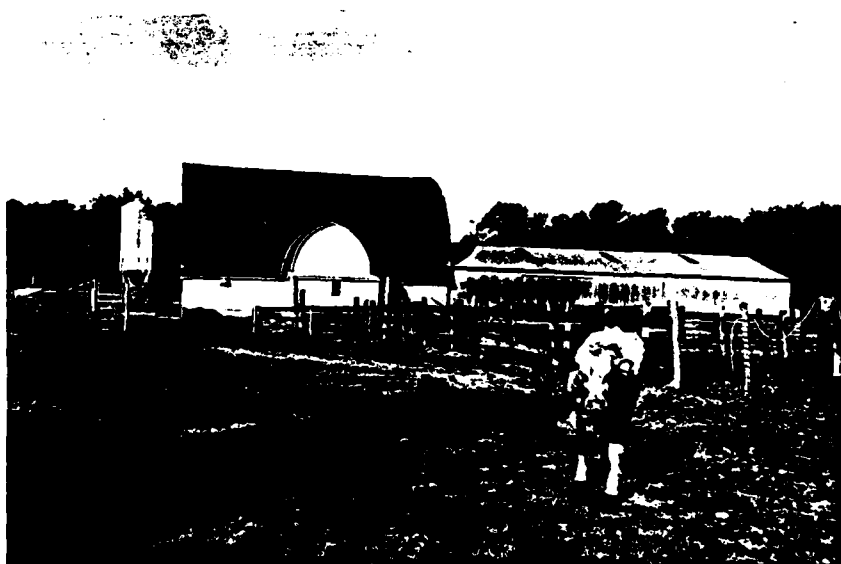
Feature 5 is a three story barn with a vaulted or arched roof (Figure 34). On the east elevation is a two story addition with a vaulted or arched roof. A one story shed-roofed addition

Figure 34. Looking west at Feature 5 of 32MH37 (HRA 420).

is attached to the east elevation of the two story addition. There is a long, two story, corrugated metal, machine shed attached to the north elevation of the feature. With the exception of the metal machine shed, the roofing material used throughout the feature is asphalt shingles, and the exterior siding is 1x4 tongue and groove. The foundation is concrete. The south elevation of the original part of the feature has two six-lite fixed-pane windows flanking the barn door on the first level. Immediately over the barn door is a hay opening. Two window openings are located above the hay opening. On the south elevation of the additions is a single-entry door and two 4/1 double-hung windows. A 1/1 double-hung window is located on the east elevation of the feature's one story addition. The north elevation has 20 four-lite fixed-pane windows. Located on the west elevation of the original part of the feature are five six-lite fixed-pane windows, a single-entry door, and a boarded up window opening. The metal shed addition has a wide metal door on its west elevation. The feature is in good condition. The feature has been extensively altered and no longer maintains integrity of association.

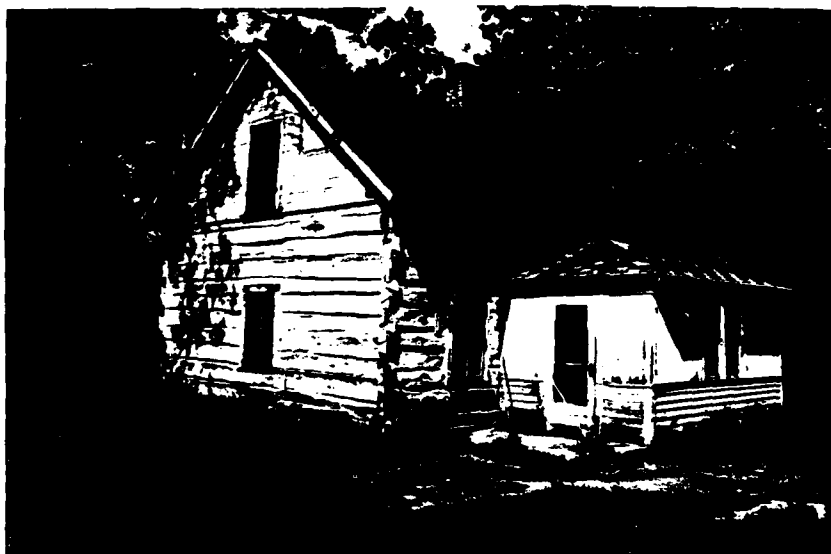
Figure 37. Looking west at Feature 1 of 32MH43 (HRA 430).

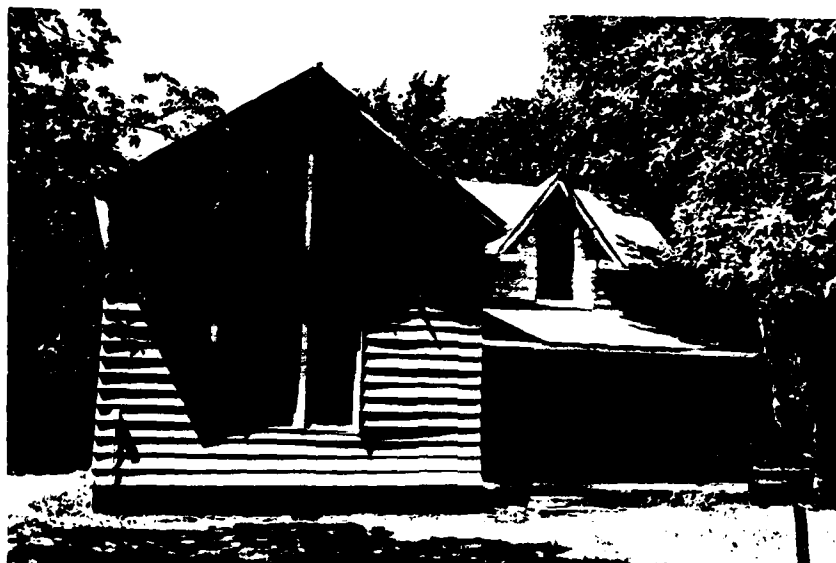
Feature 1 is a two story, gable-roofed, frame residence with two additions: a two story gable-roofed addition to the north elevation of the original structure, and a one story addition to the two story addition (Figure 41). There is a shed-roofed porch on the east elevation, which is screened from floor to roof. There is a shed-roofed mud room on the north elevation of the feature. The original part of the feature is the original residence of the Espeseth family, who built it in 1889. The two story, northern addition was built in 1916. The roof line of the original portion of Feature 1 has an east/west orientation. The roof line of the two story addition has a north/south orientation and an interior brick chimney. The one story addition has a gable roof with an east/west orientation. This addition also has an interior brick chimney on the north side of the roof. The roofing material for all of the feature is asphalt shingles. The entire feature has aluminum exterior siding. The foundation is concrete. On the north elevation are four windows: a 2/1-lite double-hung, a 4/4-lite double-hung, a 1/1-lite double-hung, and a 2/2-lite double-hung. On the east elevation are two single-entry doors, one of which leads into the screened porch and the other into the mud room. There are a total of five 2/2-lite double-hung windows on the east elevation. On the south elevation of the two story part of the feature, there is a single-entry door and two 2/2-lite double-hung windows. There are two 2/2-lite double-hung windows on the east elevation of the first story addition. On the west elevation there is a cellar entrance and a 2/2-lite double-hung window. Feature 1 is in good condition. The feature has been extensively altered and no longer maintains integrity of association.

Figure 41. Looking west at Feature 1 of 32MH34 (HRA 451).

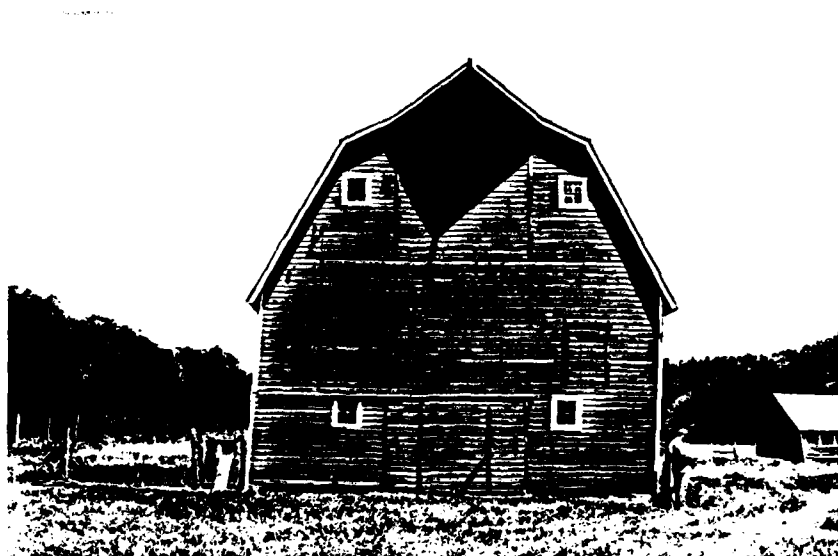
Figure 43. Looking north at Feature 4 of 32MH34 (HRA 451).

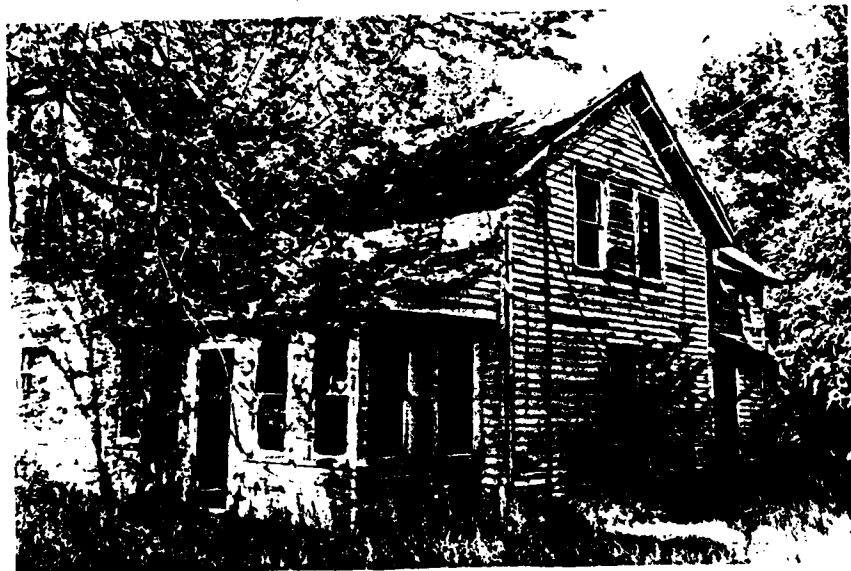
Feature 4 is a two story, wood frame, gable-roofed dwelling with numerous additions (Figure 47). It is roofed with wood shingles, built with 1x4 shiplap siding, and rests on a concrete foundation. There are brick chimneys near the southeast and southwest corners of the house. The original portion of the structure is rectangular, with gables on the east and west elevations. The gables display decorative shingles. The west elevation of this portion has one 2/2 and one 1/1 double-hung window on the second floor and a 1/1 double-hung window centered on the ground floor. The south elevation has two 1/1 double-hung windows on the ground floor only. The east elevation has two 1/1 double-hung windows on the second floor and a three-lite fixed-pane window on the ground floor. There is a two story addition on the north elevation, with gabled roof, two 1/1 double-hung windows on the second floor, and a two-lite fixed-pane window on the ground floor. The west and east elevations are adjoined by a second two story addition and a shed-roofed addition, respectively. The second two story addition has a gable but no windows or doors on the west elevation, a gabled 1/1 double-hung window on the second floor of the south elevation, two 2/2 double-hung windows on the ground floor, and a gabled 1/1 double-hung window on the second floor of the north elevation. There is a shed-roofed addition on a porch foundation in the southeast corner, with a single-entry door and four 1/1 double-hung windows on the east elevation and two 1/1 double-hung windows on the south elevation. A smaller shed-roofed addition on the north elevation has a single-entry doorway with an aluminum screen door. The house was built apparently between 1915 and 1930, and is now vacant. The feature has been extensively altered and no longer maintains integrity of association. The feature is in poor condition and the lack of maintenance has resulted in deterioration of the building, thus compromising its integrity.

Figure 47. Looking southwest at Feature 4 of 32MH42 (HRA 452).

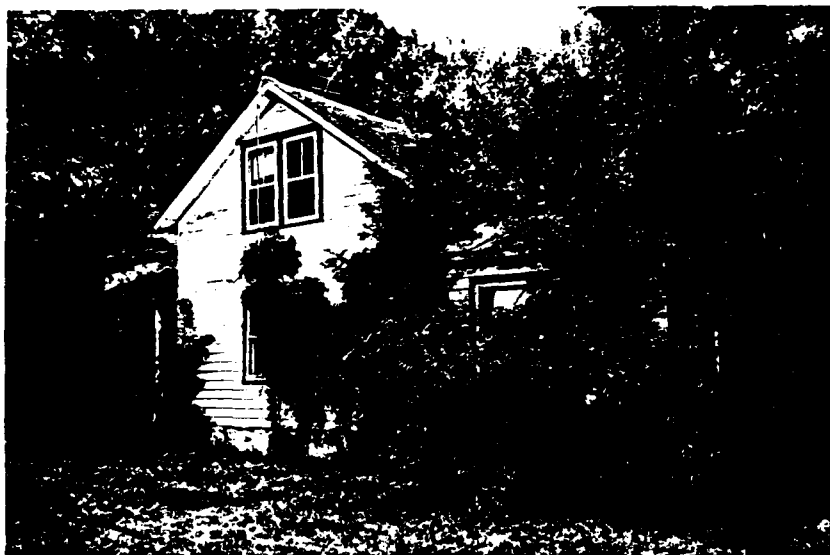
Feature 1 is a gable-roofed, two story residence with an east/west orientation, and a north/south addition on the east elevation (Figure 51). The west elevation has an open porch with

Figure 51. Looking northwest at Feature 1 of 32MH35 (HRA 454).

a shed roof and the east elevation has an enclosed porch with a shed roof, which was made into a kitchen. The main roof is constructed of wood shingles, while the shed roofs have asphalt shingles. The house has a rock and mortar foundation, a center-set brick chimney in the main portion, and another brick chimney in the shed-roofed addition. The main portion was built with logs in 1904, but the exterior is currently covered with decorative metal siding. The north elevation has three 2/2 double-hung windows with four-lite fixed-pane storm windows on each, and a single-entry door into the shed-roofed addition. The east elevation has one 2/2 double-hung window with a four-lite fixed-pane storm window and a single-entry door. The south elevation has a large one-lite picture window in the shed-roofed addition, four 2/2 double-hung windows in the main north/south-oriented addition, and one single-entry door and a 2/2 double-hung window in the east/west-oriented portion. The west elevation has two 2/2 double-hung windows. The building is in fair condition. The feature has been extensively altered and no longer maintains integrity of association.

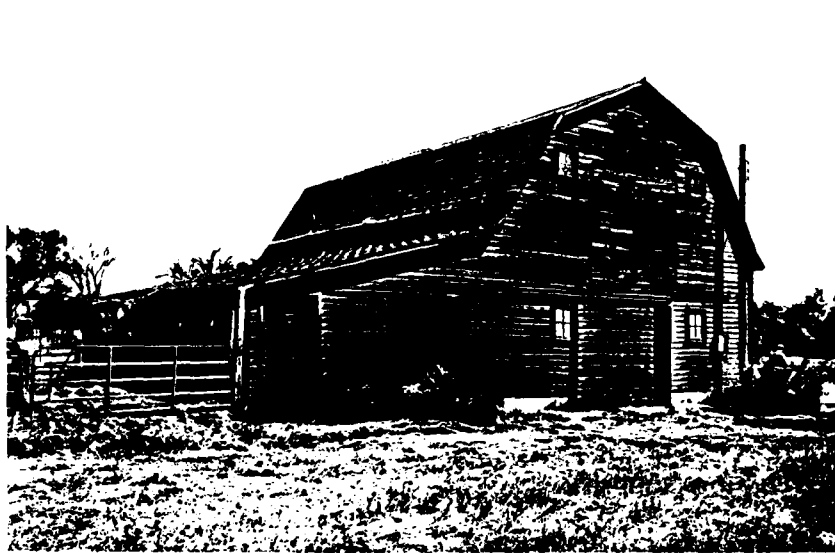
Feature 6 is a two and one-half story, gambrel-roofed barn with a large, shed-roofed addition on the west elevation (Figure 52). The barn is a wood frame structure with tongue and groove siding. It rests on a concrete foundation. There is a vehicle entry with a sliding door on the ground level of the south elevation, and an opening with two hinged doors for loading hay on the second floor. There are four four-lite fixed-pane windows on the main wall of the south elevation and a single-entry door in the shed-roofed addition. The north elevation of the barn is identical to the south elevation. There are no windows or doors in the east elevation. The shed-roofed addition on the west elevation is half open. The barn was built in the 1930s. It is in good condition. The feature was moved onto the site in 1961 or 1962 and therefore lacks integrity of association.

Figure 52. Looking northeast at Feature 6 of 32MH35 (HRA 454).

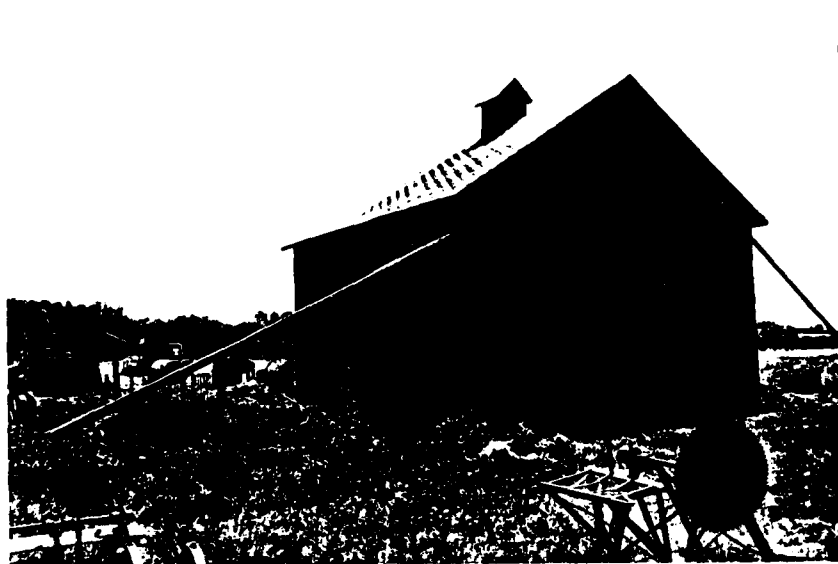
Feature 9 is a two story, quonset-roofed, metal frame work shop on a concrete foundation (Figure 53). The south elevation has an equipment entrance, six fixed-pane windows, and a single-entry door. The building is of recent construction, and is in good condition. The feature is less than fifty years old and does not maintain historic association.

Figure 53. Looking southwest at Feature 9 of 32MH35 (HRA 454).

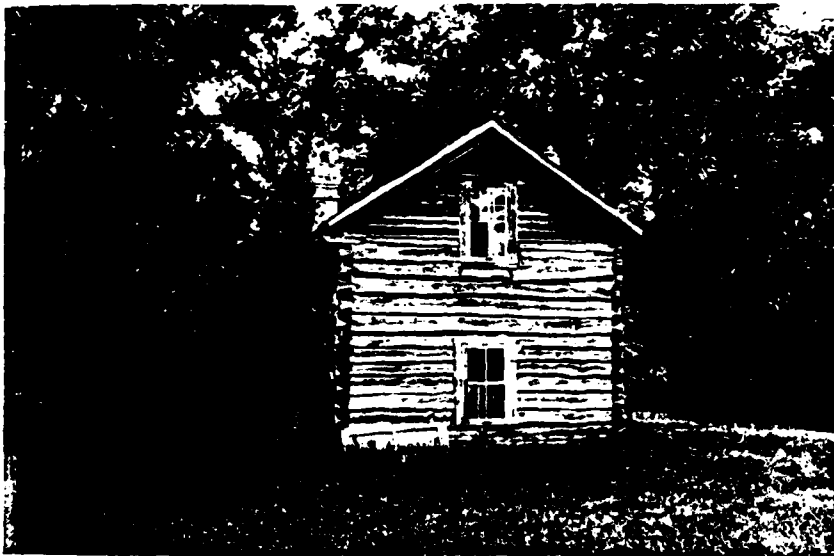
Feature 2 is a two story log cabin with a gable roof (Figure 61). The roofing material is wood shingles. There is a brick chimney on the southwest corner of the roof. The exterior walls consist of logs, fourteen courses high, that were fitted by dovetail notching. The chinking is mostly gone and only some mortar remains. The foundation is stone. There are no windows or doors on the north elevation. On the east elevation there are two window openings. The windows were apparently 6/6 double-hung with four-lite fixed-pane storms. Most of the glass is missing on the windows and the storm windows. There is a single-entry door on the south elevation. On the second floor of the west elevation is one small window opening with no glass. On the first floor of the west elevation is a window opening similar to the window frames on the east elevation. The feature is in fair condition. The addition of other features that are less than fifty years old has compromised the integrity of this feature.

Figure 61. Looking west at Feature 2 of 32MH39 (HRA 485).

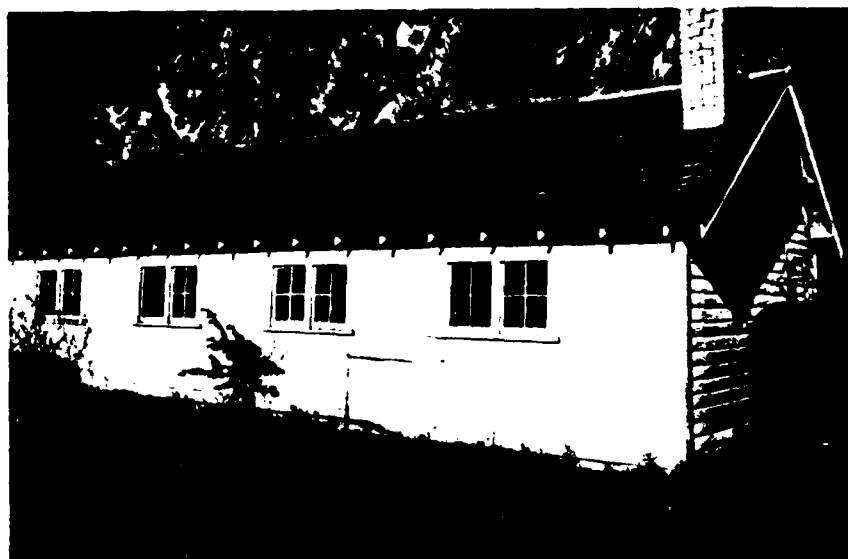
Feature 2 is a one story, wood frame, gable-roofed garage on a concrete foundation (Figure 65). The garage has wooden shingle roofing and 1x4 tongue and groove siding. There is a brick chimney in the north elevation of the roof. The south elevation has a single vehicle opening with no door, and the east elevation has eight four-lite fixed-pane windows. The garage was built in the 1920s and was moved to the site around 1940. It is in good condition. The feature is not architecturally significant.

Figure 65. Looking southwest at Feature 2 of 32MH38 (HRA 525).

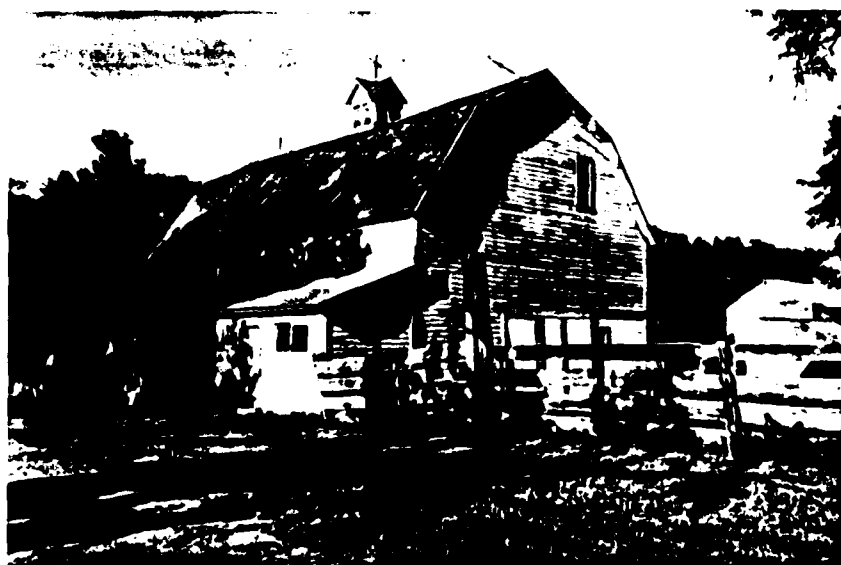
Feature 5 is a two and one-half story, wood frame barn with a gambrel roof (Figure 66). The roofing is asphalt shingles and the walls have 1x4 tongue and groove siding. There is no visible foundation. The barn has two shed-roofed additions on the east elevation, the older one extending three-quarters of the length of the building and the narrower, more recent one covering the rest. Both additions have corrugated metal roofs and stand on a concrete pad. There is a hip-roofed wooden vent on the top of the barn. The west elevation of the building has a single-entry door, two four-lite fixed-pane windows, and two window apertures without windows. The south elevation has two 4/4 double-hung windows on the uppermost half story, a double hay loading door with two sliding doors on the second floor, and a double door with one sliding door on the ground level. The shed-roofed addition has a double entry with a sliding door on its south elevation, and a single-entry door and five fixed-pane windows (four four-lite and one one-lite) on the east elevation. The north elevation of the barn has two 4/4 double-hung windows on the uppermost half story. On the ground level are a single-entry doorway with sliding door, and two window openings, one boarded up and one with a four-lite fixed-pane window. The barn was built in 1925, and is in fair condition. The addition of other features that are less than fifty years old has compromised the integrity of this feature.

Figure 66. Looking southwest at Feature 5 of 32MH38 (HRA 525).

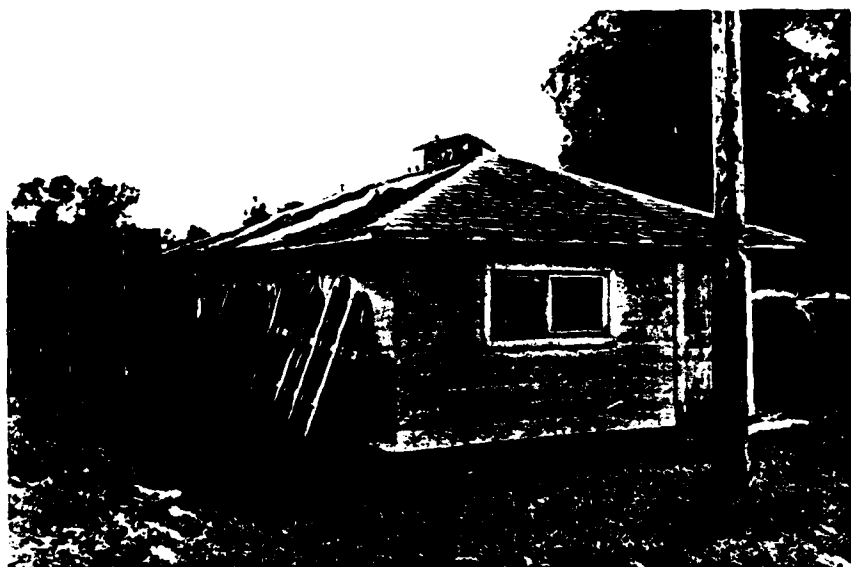
Feature 6 is a one story, frame, milk house with a hip roof (Figure 70). It was built in 1920. The roofing material is wood shingles. The exterior siding is metal with a "fake block" design. The feature is located on a concrete pad. A one-lite window and a two-lite window are located on the west elevation. A single-entry door and a two-lite fixed-pane window are located on the north elevation. A two-lite fixed-pane window is located on the east elevation. There is a single-entry door on the south elevation. The feature is in fair condition. The addition of other features that are less than fifty years old has compromised the integrity of this feature.

Figure 70. Looking southwest at Feature 6 of 32MH41 (HRA 580).

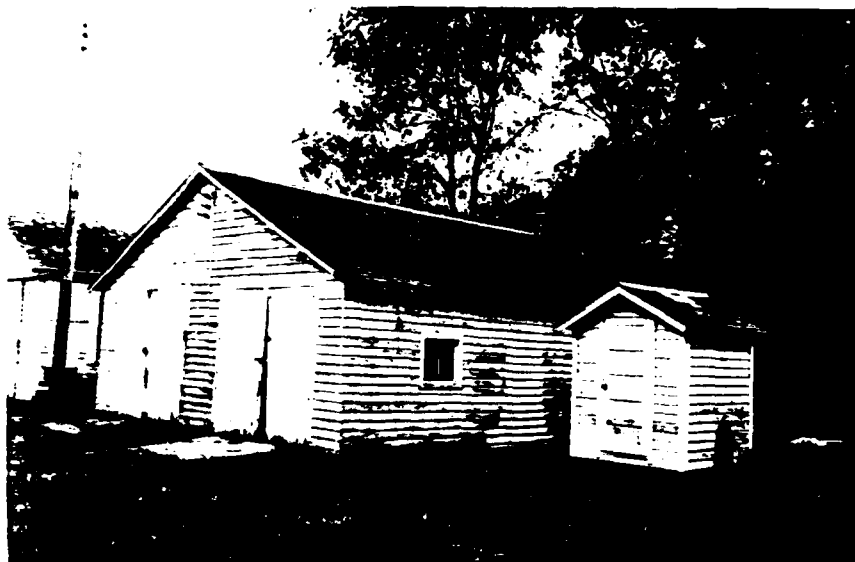
Figure 72. Looking southwest at Feature 9 (right) and 10 (center) of 32MH41 (HRA 580).

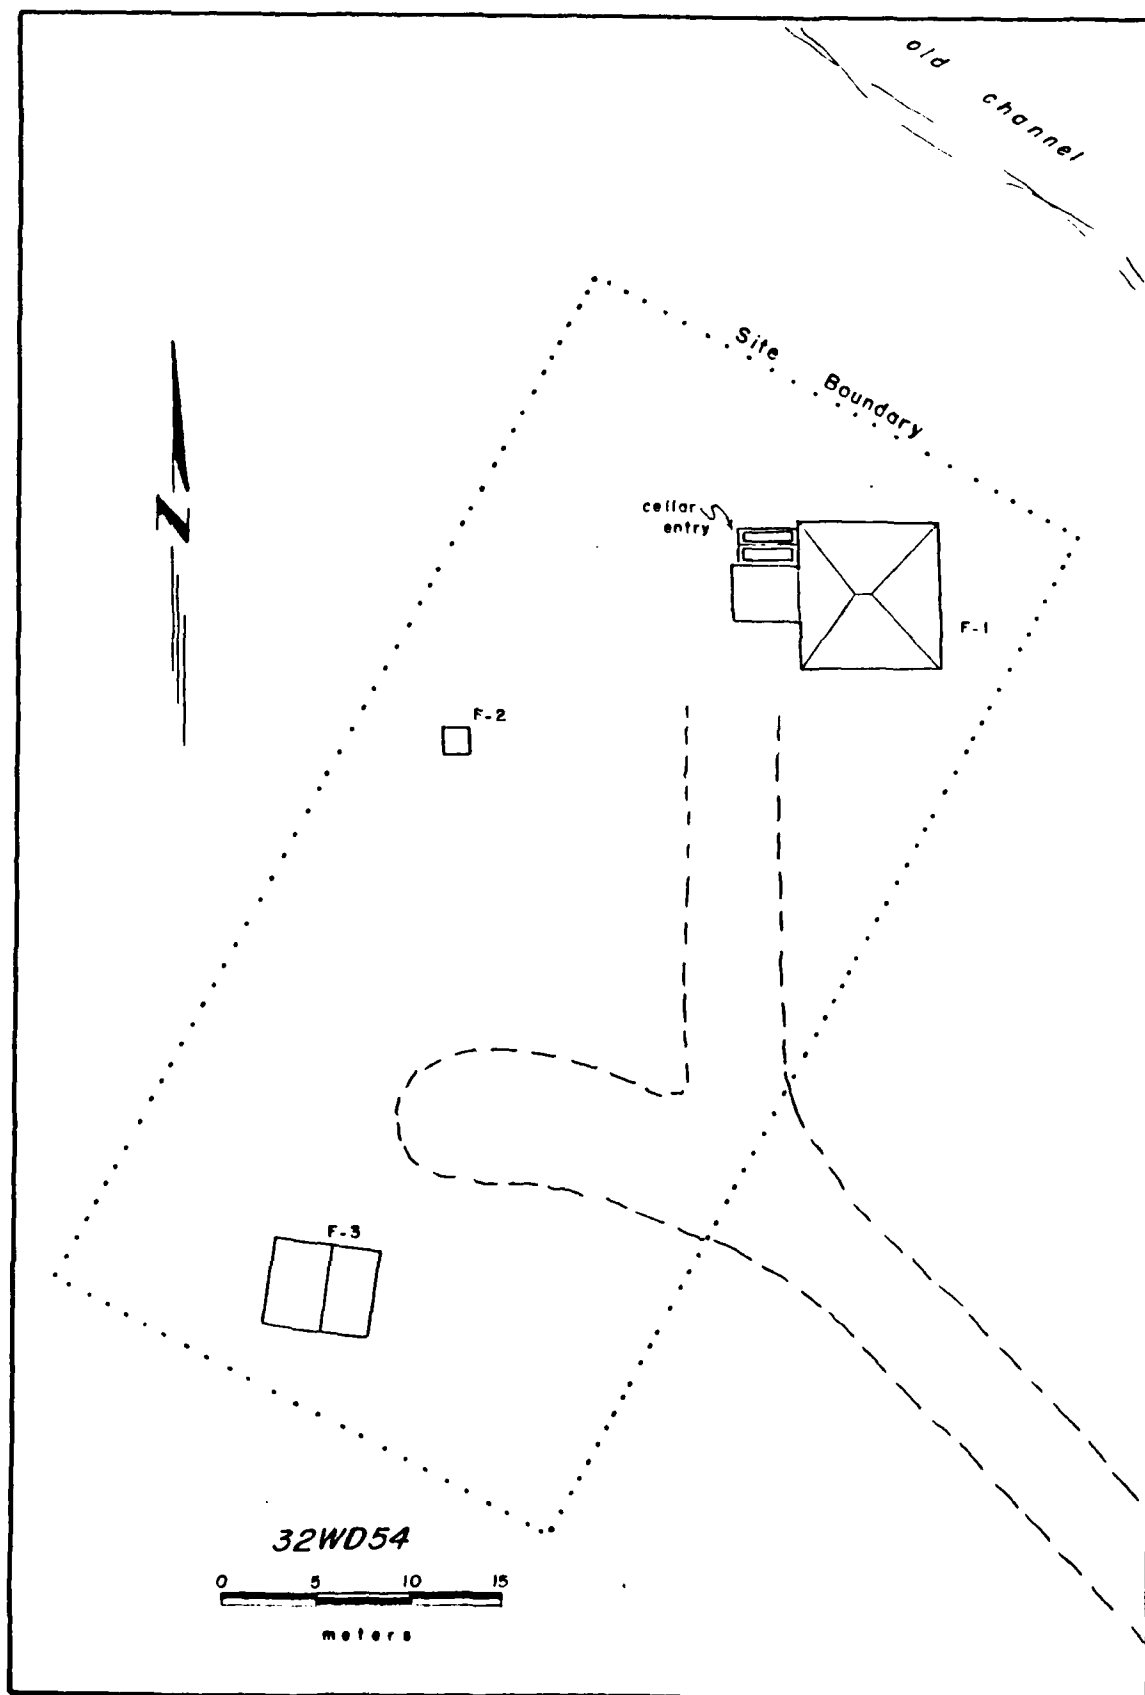
Figure 74. Plan map of 32WD54 (HRA 1090).

The MacGregor farmstead covers 1800 square meters and is located on a bench approximately ten meters from the Souris River (Figure 73). The view from the site is obstructed to the east, west, and south by cottonwood, elm, and oak trees. To the north is an open, cultivated field that extends to the banks of the river. The site consists of three features (Figure 74) and is presently occupied by a renter. None of the structures are significant.

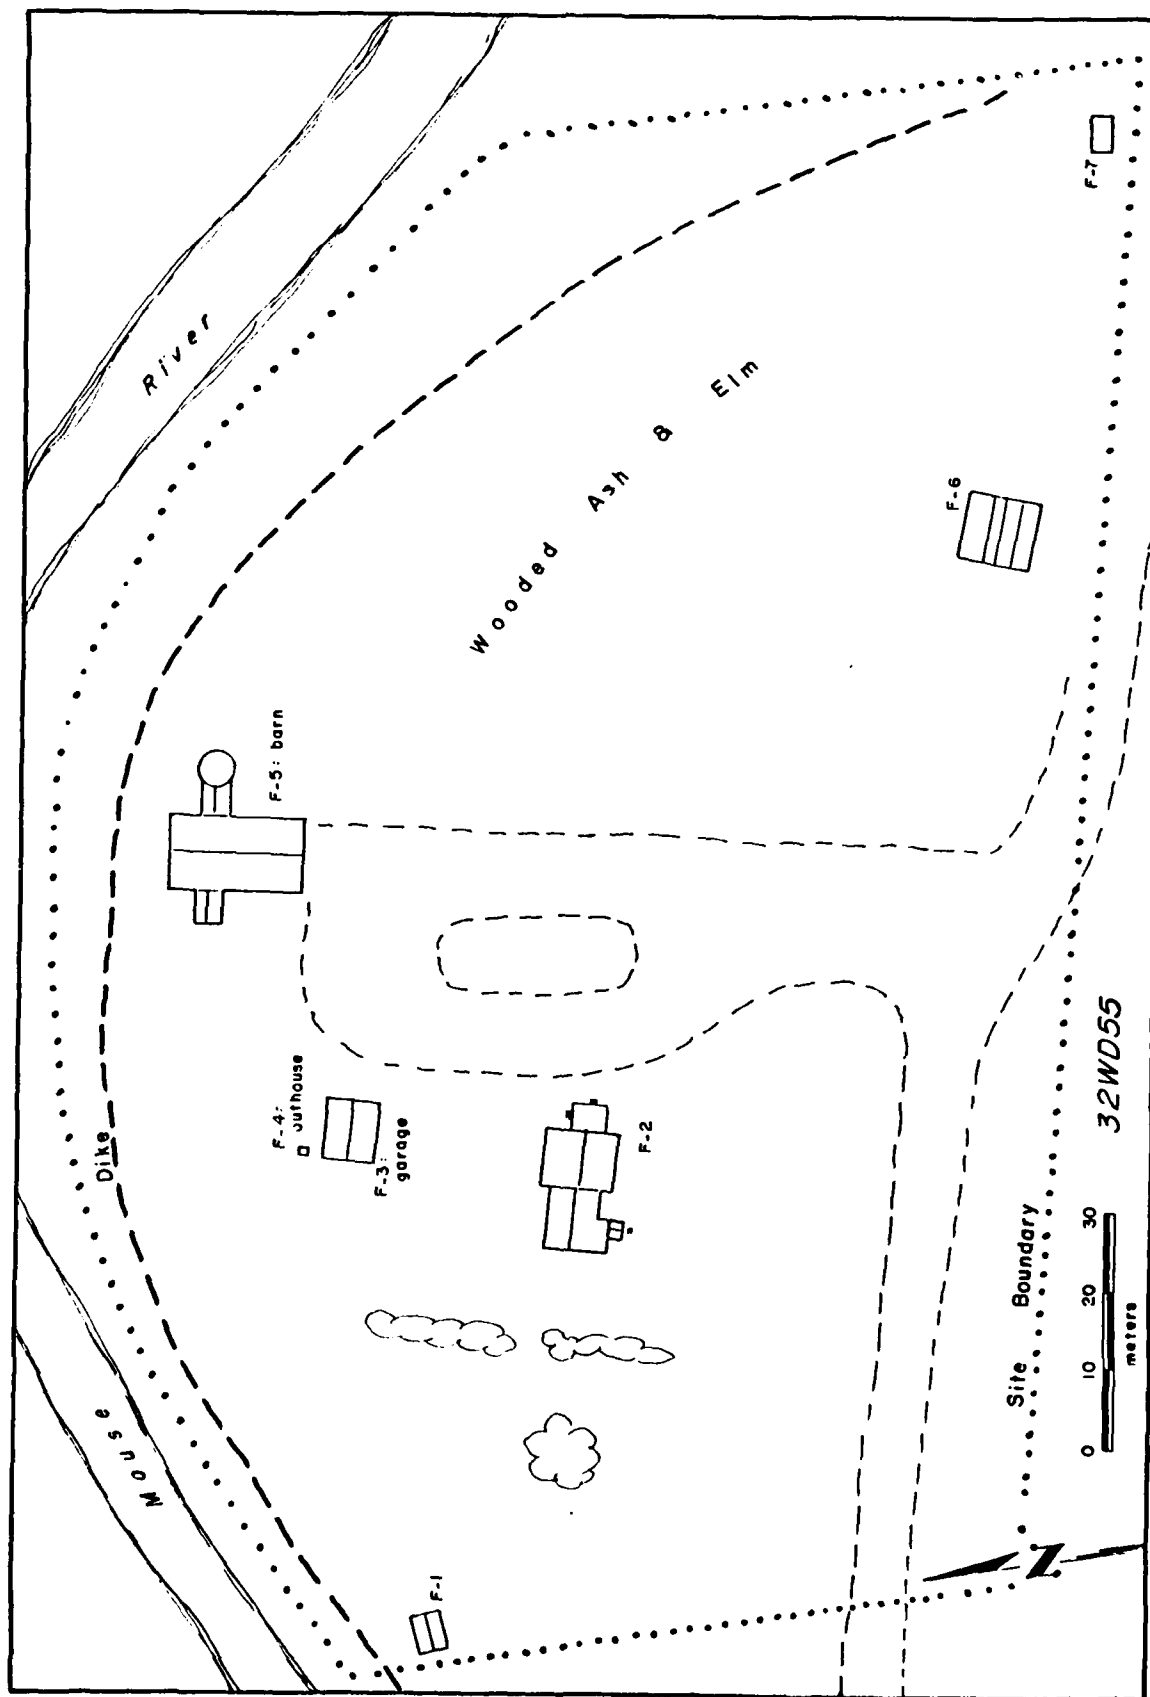
Figure 77. Plan map of 32WD55 (HRA 1130).

The site is located on the south bank of the Souris River (Figure 76). The view from the site is obscured by deciduous trees on the west, north, and east, but the view is open for over one hundred meters on the south. There are seven features on the site, consisting of a residence, a log cabin, a barn, a garage, a granary, a storage building, and an outhouse (Figure 77). Most of the features are in good condition but they have been altered significantly.

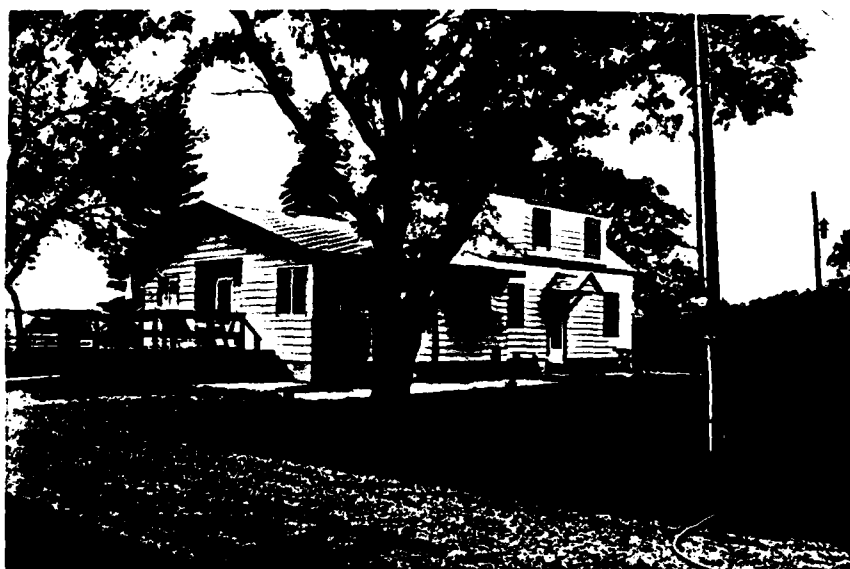
Feature 2 is a two story, wood frame, gable-roofed residence on a concrete foundation (Figure 79). Roofing material is asphalt shingles. The building has a dormer on the south and north sides of the roof. There is a one story, hip-roofed

Figure 79. Looking southwest at Feature 2 of 32WD55 (HRA 1130).

addition and a wooden deck on the east elevation. The addition has aluminum siding. The south elevation of Feature 2 has three 3/1 double-hung windows and a single-entry door that opens into a 1x1 meter porch. The dormer has four 3/1 double-hung windows with aluminum storms. The south elevation of the addition has two two-lite Anderson windows. The west elevation of Feature 2 has one 3/1 double-hung window with an aluminum storm on the upper story, and two 3/1 double-hung windows with aluminum storms on the first floor. The north elevation has two 3/1 double-hung windows with aluminum storms and one single-entry door on the first level. The dormer has two 3/1 double-hung windows with aluminum storms. The north elevation of the addition has a 2/1-lite and a 1/1-lite Anderson window. The east elevation of the addition has two two-lite Anderson windows and a single-entry doorway inset into the east elevation. The feature has been extensively altered and no longer maintains integrity of association.
