HISTORIC STANDING STRUCTURE  
INVESTIGATION OF THE SOURIS RIVER  
BASIN PROJECT RURAL IMPROVEMENTS

HISTORICAL RESEARCH ASSOCIATES

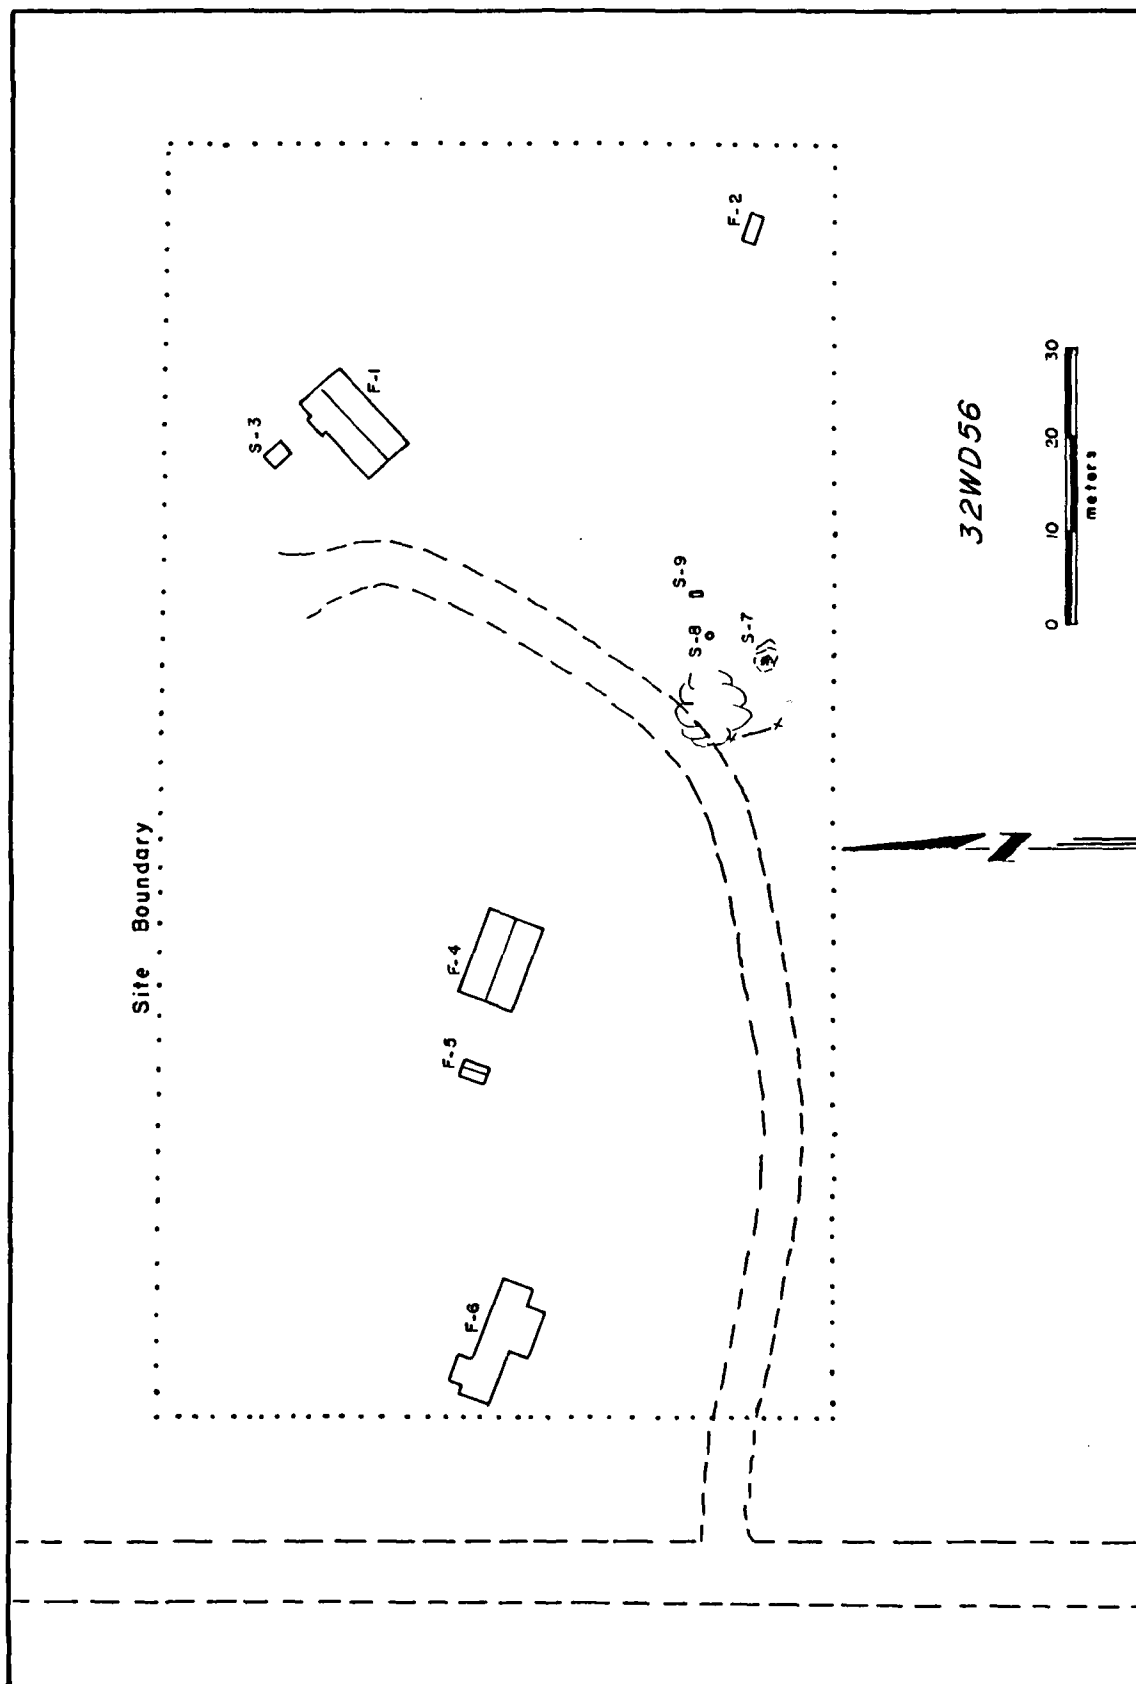
Figure 83. Plan map of 32WD56 (HRA 1421).

The site is located on the south bank of the Souris River, on the outskirts of Minot, North Dakota. The features are all located on a low bench within fifty meters of the river (Figure 82). The site consists of five features and four structures (Figure 83). The features include a log cabin, garage, trailer house, privy, and a metal storage shed. The structures are a concrete grill, monument, flag pole, and a water pump.
