TECHNICAL REPORT REMR-CS-21

IN SITU REPAIR OF DETERIORATED CONCRETE  
IN HYDRAULIC STRUCTURES:  
A FIELD STUDY

Final Report

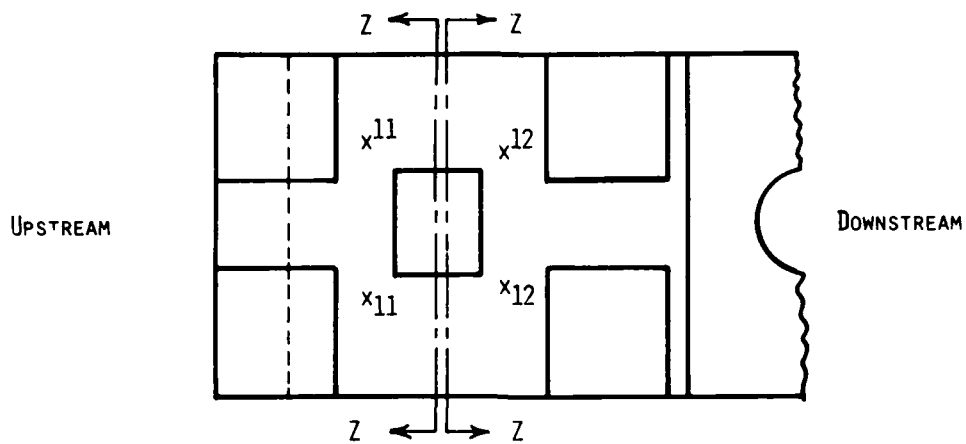
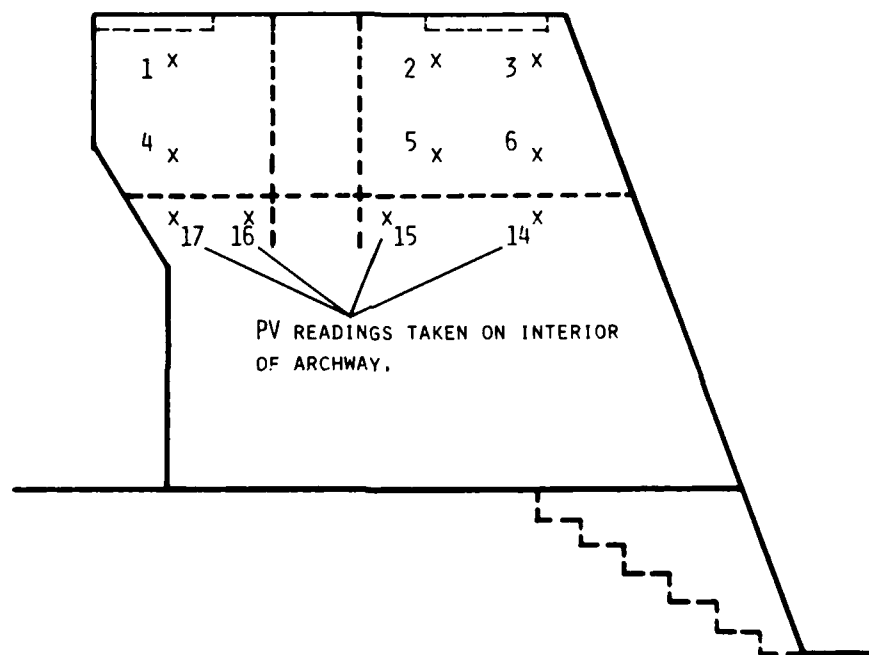
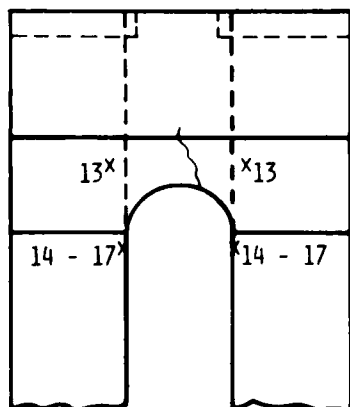
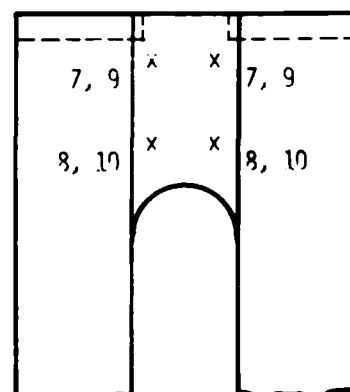
Figure 17. Locations of ultrasonic pulse velocity measurements

41. Preliminary ultrasonic pulse velocity data were taken between opposite points at six locations on the Illinois and Missouri faces of the pier stem using the direct transmission method. Readings also were taken between selected points on the faces of the stairwell, the top of the pier stem, the upstream face of the pier stem and the archway ceiling using the indirect transmission method. However, these readings were used only to supplement the data obtained from the direct transmission method, since the indirect method generally is considered less accurate than the direct method.\* Primary emphasis was based upon the pulse velocity values obtained using the direct transmission method. The general locations of the pulse velocity readings are illustrated in Figure 17, and the readings are summarized in Table 1.

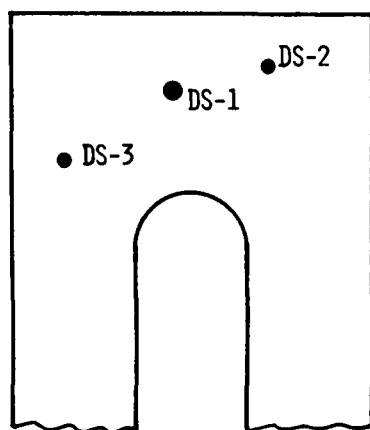
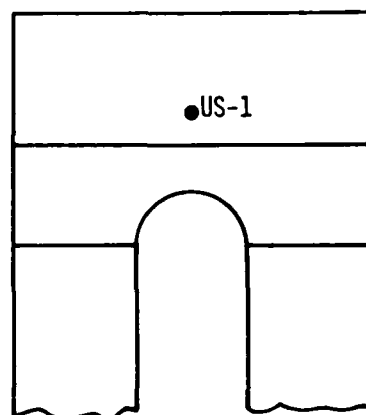
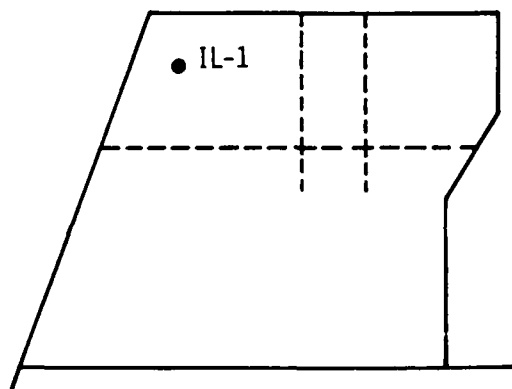
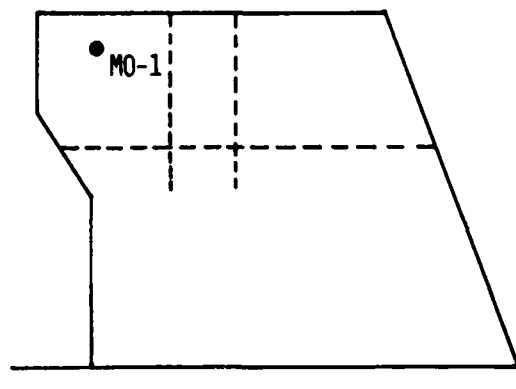
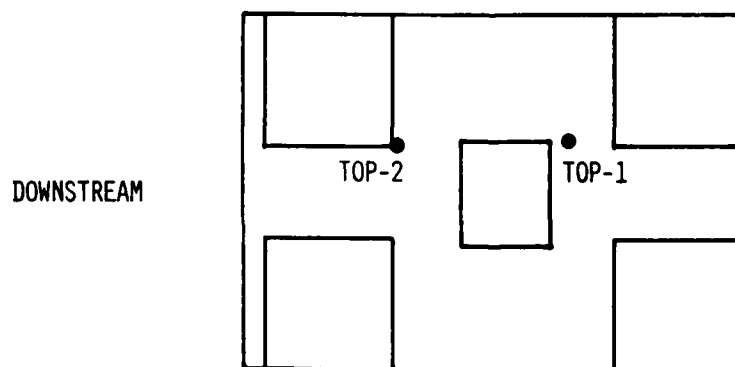
Figure 24. Locations of concrete cores

4-in.-diam cores and one 6-in.-diam core were removed from Pier No. 27 by personnel from the US Army Engineer District, Rock Island. The core locations are shown in Figure 24, and the drilling logs are presented in Appendix A.
