MISCELLANEOUS PAPER HL-89-4

SCOUR PROTECTION FOR MORGANTOWN DAM MONONGAHELA RIVER, WEST VIRGINIA

Hydraulic Model Investigation

August 1989

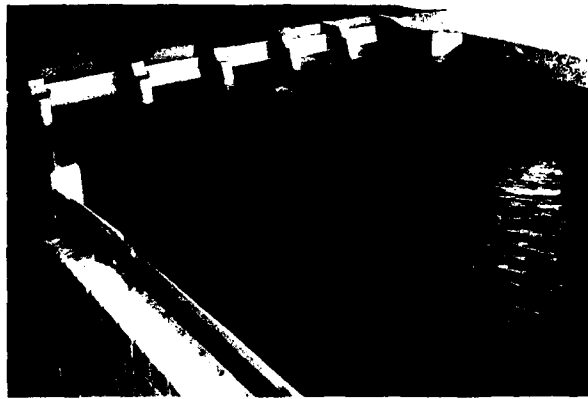
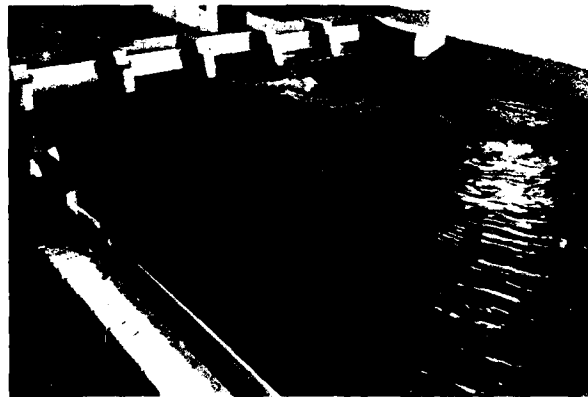
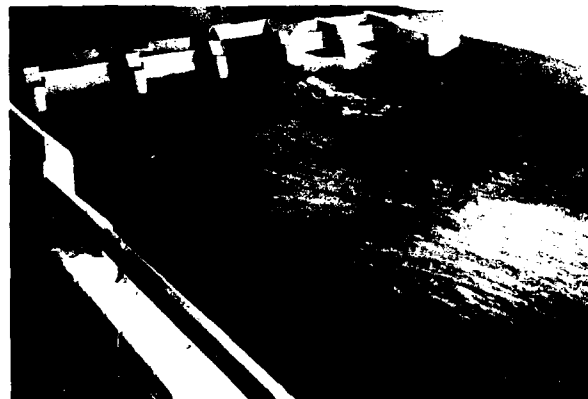
Photo 8. Flow conditions with no scour protection downstream of structure; normal pool el 814, minimum tailwater el 797

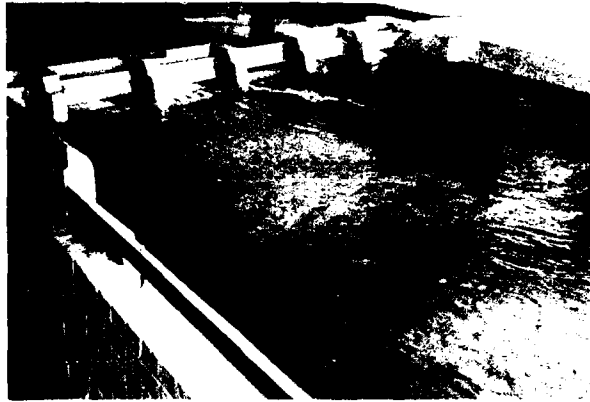
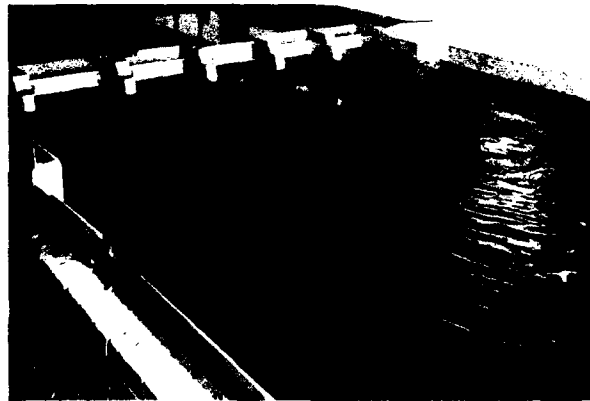
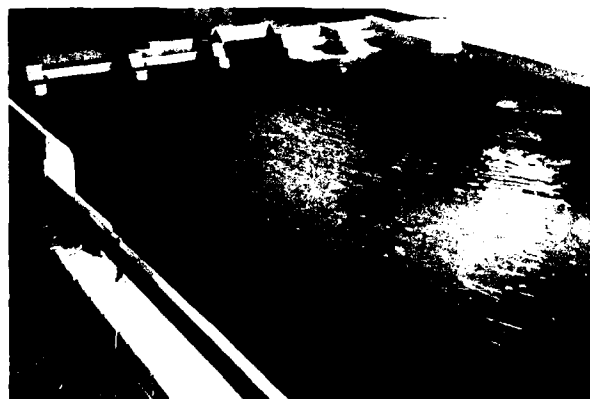
Photo 9. Flow conditions with no scour
protection downstream of structure;
normal pool el 814, normal
tailwater el

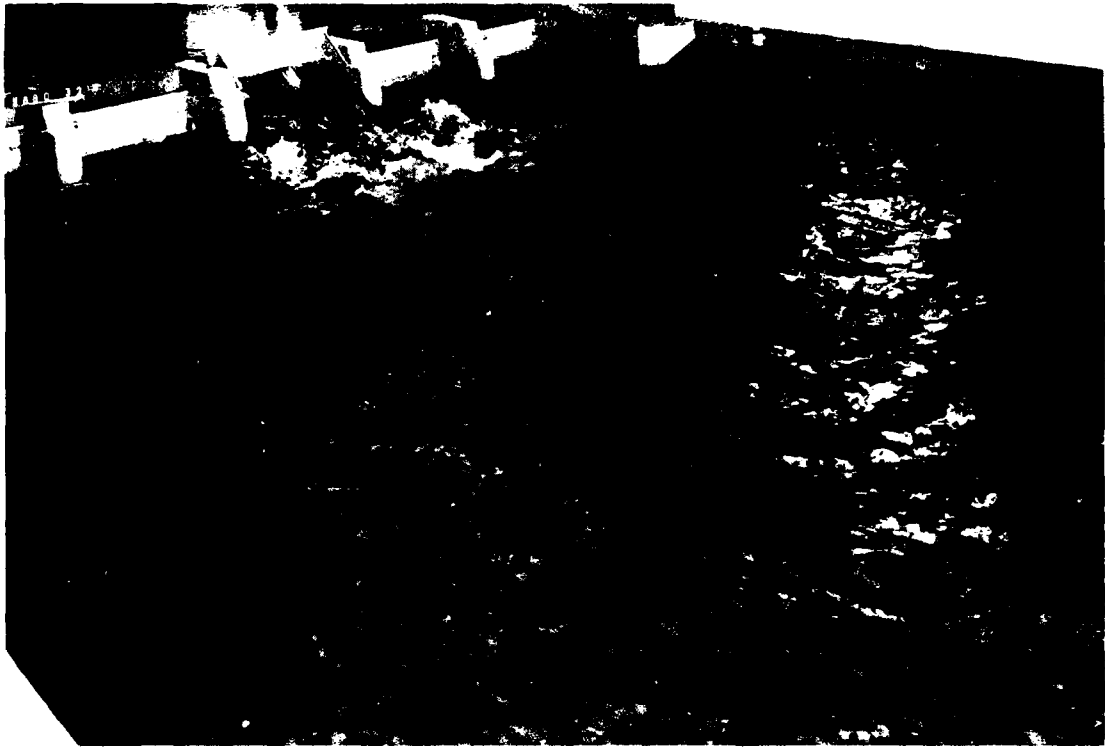
Photo 20. Flow conditions, type 15 scour protection plan,
normal pool el, gate 3 open full

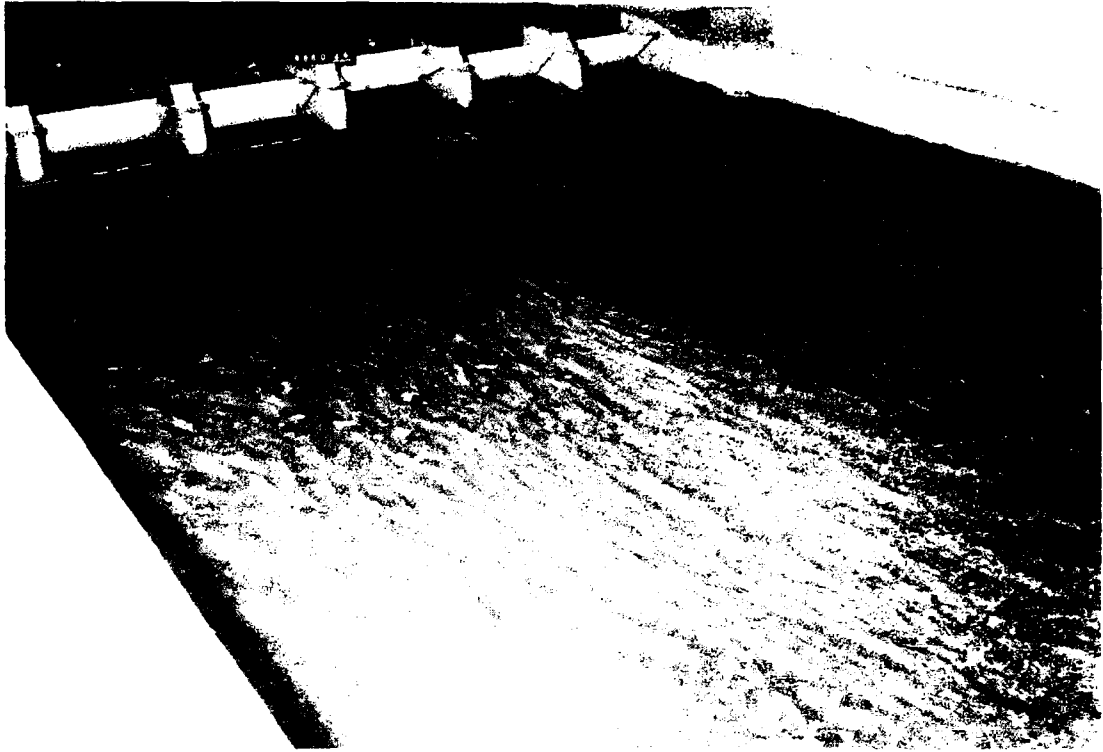
31. The walls between the first and second barges were lowered to 9 ft with the remaining walls 6 ft high to form the type 24 scour protection plan shown in Plate 24. A test was conducted for 5 hr with gate 3 opened 6 ft, normal upper pool and minimum tailwater and scour in the exit channel after completion of the test is shown in Photo 33a. The stones failed due to displacement by the flow conditions shown in Photo 34a. Results from another test conducted with the normal tailwater of 803.6 are shown in Photo 33b and indicate the stones failed again. Flow conditions during the test are shown in Photo 34b.

Photo 34. Flow conditions with type 24 scour protection plan, normal pool el 814, gate 3 open 6 ft

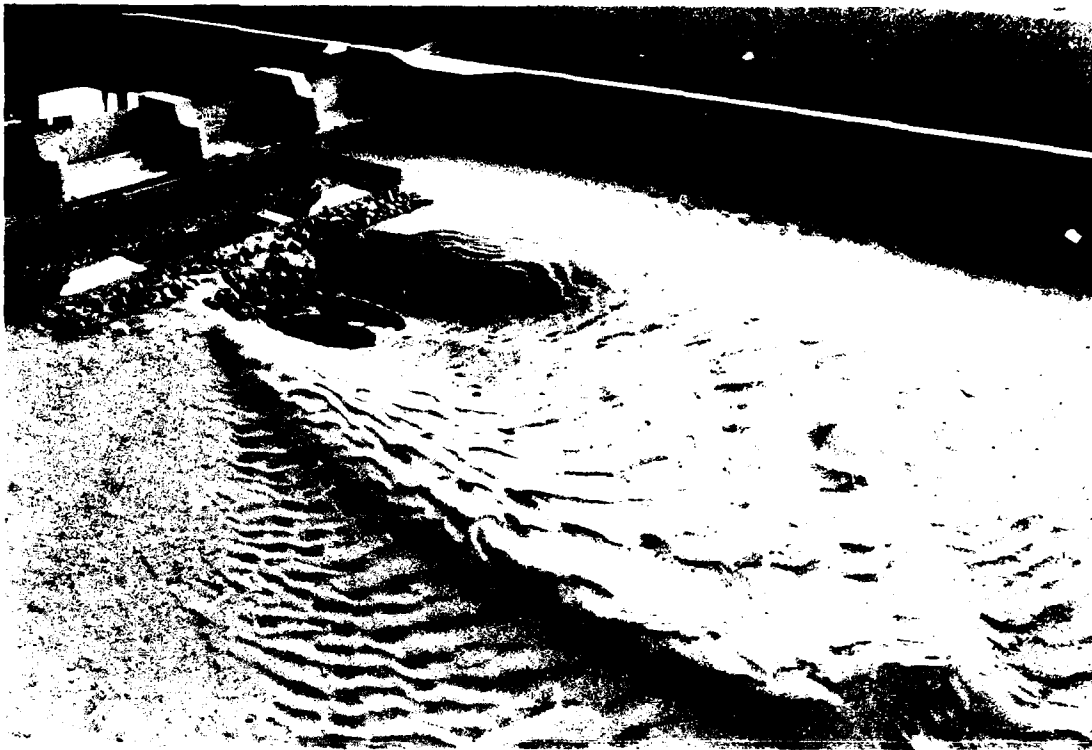
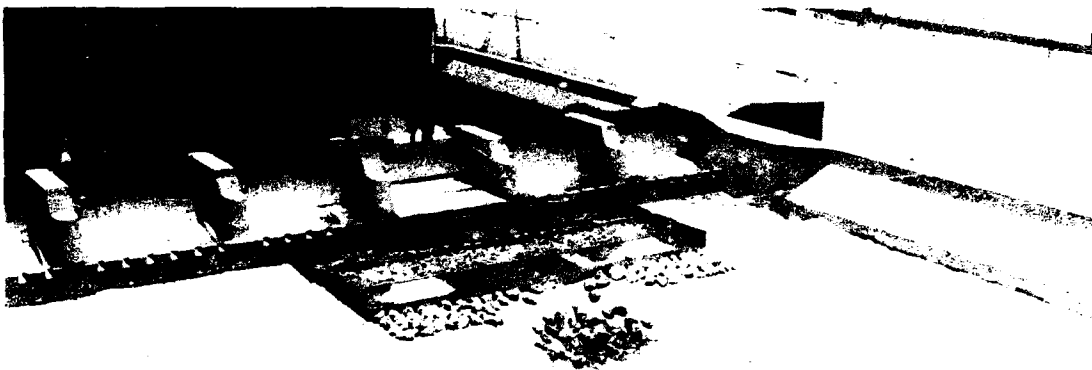
32. The 3-ft-high sill at the end of the existing structure improved energy dissipation in the barges, but it was not considered a feasible modification. The walls between all the barges and the downstream wall of the last barge were lowered to 6 ft. This modification is shown in Plate 25 and was noted as the type 25 scour protection plan. Tests were conducted with gate 3 opened 6 ft, normal upper pool, and tailwaters of 797 and 803.6. Results from the test with a tailwater of 797 are shown in Photo 35a and indicate failure of the stones. Flow conditions during the test are shown in Photo 36a. Scour in the exit channel after 5 hr of operation with a normal tailwater of 803.6 is shown in Photo 35b and indicate stone protection failed during this test. Flow conditions during the test are shown in Photo 36b.

Photo 35. Scour downstream of type 25 scour protection plan after 5 hr of operation; normal upper pool el 814, gate 3 open 6 ft

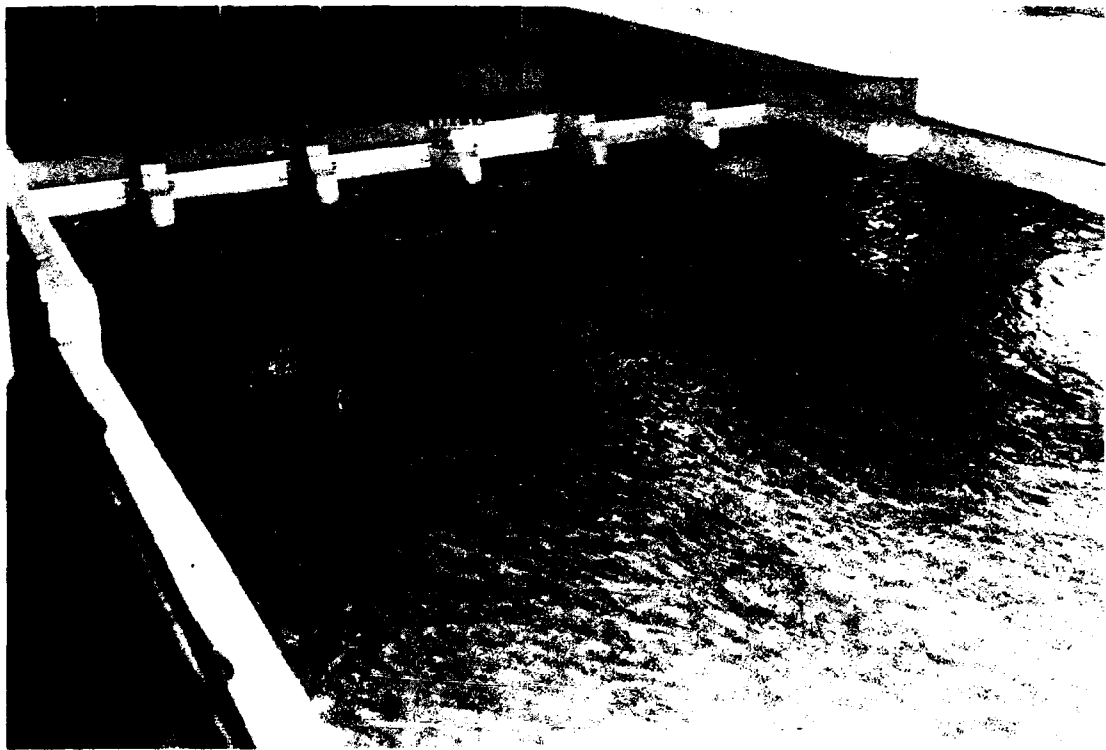
Photo 36. Flow conditions with type 25 scour protection plan, normal upper pool el 814, gate 3 open 6 ft
