# NONCONVENTIONAL ROOF SYSTEMS FOR IN-HOUSE INSTALLATION AT AIR FORCE BASES

W.B. ROSE  
D.M. BAILEY

CONSTRUCTION ENGINEERING RESEARCH LABORATORY  
PO BOX 4005  
CHAMPAIGN, ILLINOIS 61824-4005

JULY 1989

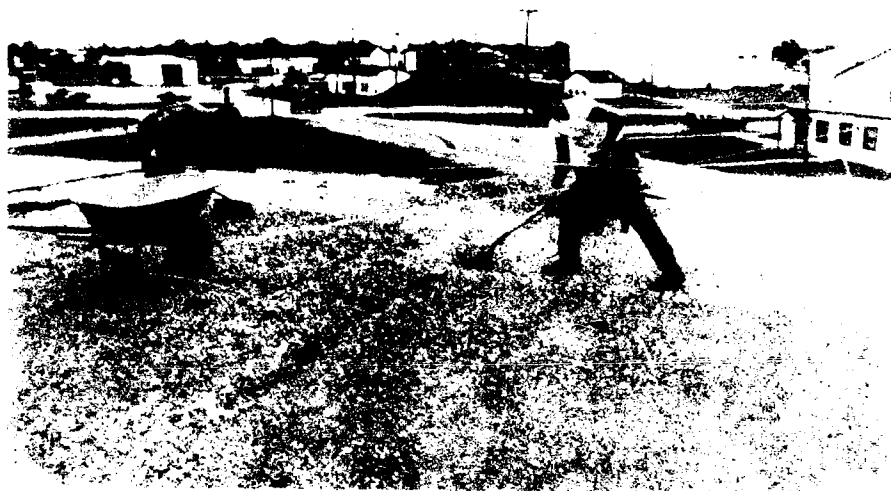
The existing roof was a gravel-topped BUR over high density fiberglass board insulation. The gravel was swept from the roof (Figure 11). A mechanical cutter was leased so the roof could be cut into sections and removed (Figure 12). The cutter was unreliable and was not used after the second breakdown. Further cutting was done by hand. Disposal of roofing materials was a problem. The quantity of gravel and other debris was much more than estimated. The dumpster was filled faster than it was emptied. The tearoff took much more time than expected.

Figure 11. Gravel being removed by shoveling and brooming.

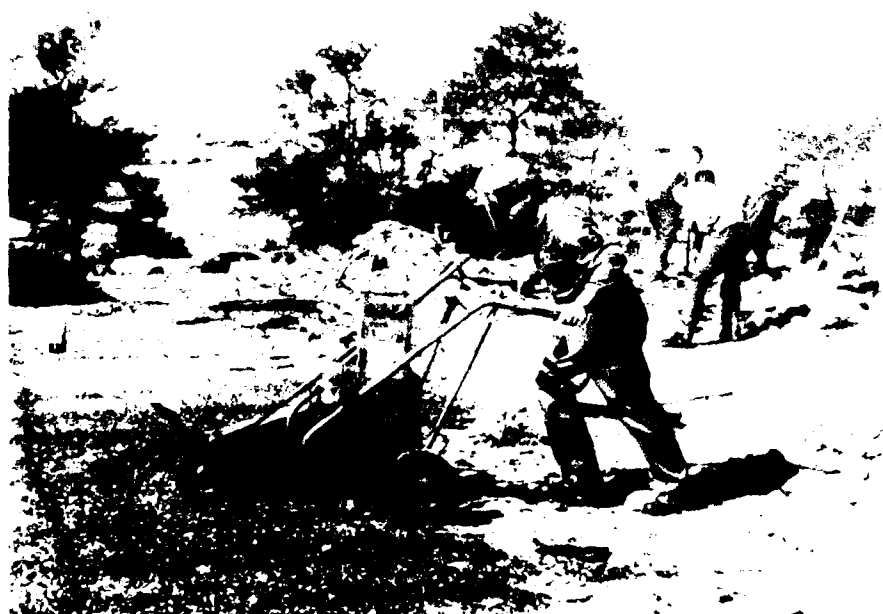
Figure 12. Mechanical cutter being used to separate sections of old BUR.

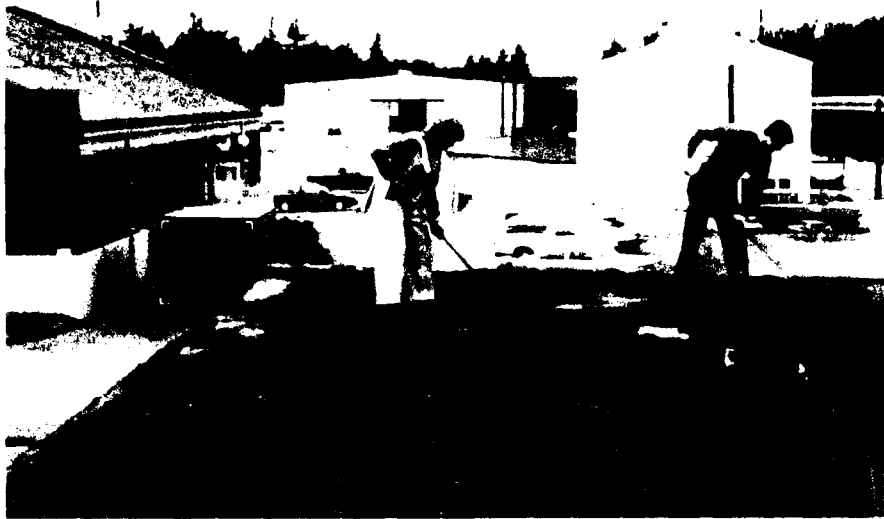
Figure 56. Loose gravel is spudded off the existing BUR.

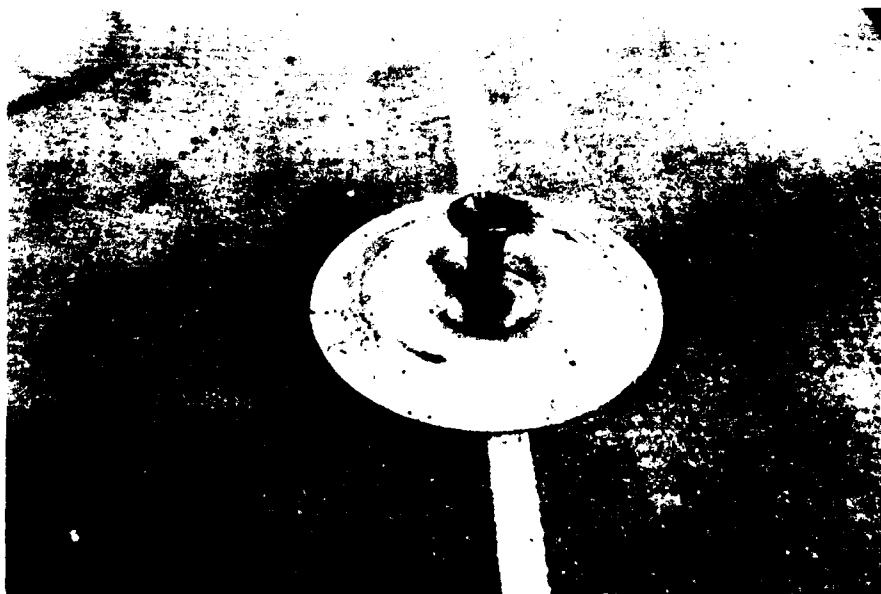
An early difficulty in getting the fastening screws to seat properly in the deck material was overcome by using a standard screw gun, rather than a hammer screw gun.

Figure 61. Proper tools must be used to install fasteners.

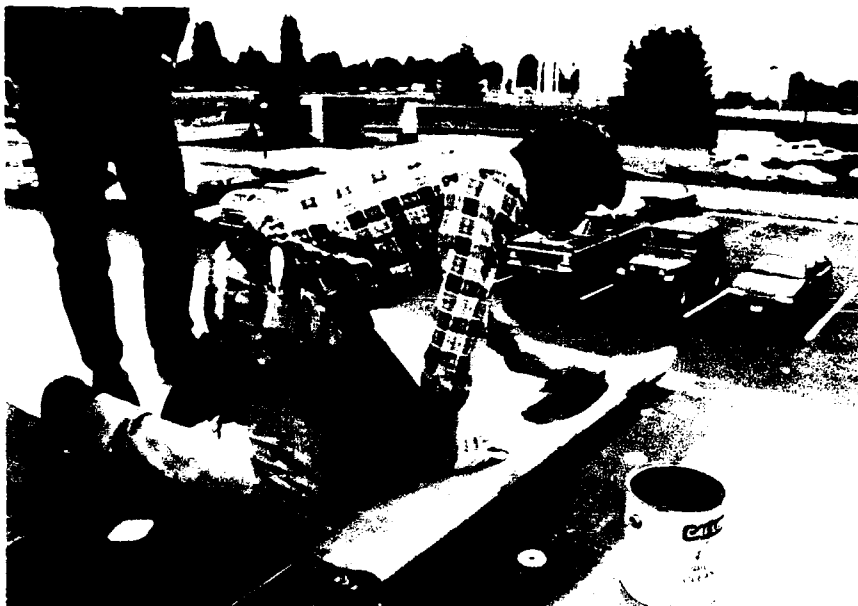
1. Lay the membrane in place
2. Fasten the edge to the deck (Figure 60)
3. Install fasteners so that no burrs protrude from the metal (Figure 61)
4. Carefully clean the surfaces to be mated (Figure 62)
5. Apply an even amount of splicing cement and let it dry correctly (Figure 63)
6. Apply the in-seam sealant per the manufacturer's directions (Figure 64)
7. Carefully lay the membrane in place to avoid wrinkles (Figure 65)
8. Seal the trailing edge and "butter" the sealant (Figures 66 and 67). It is important that the edges be properly "buttered" to prevent the reinforcing scrim from wicking water into the membrane.

**Figure 62.** The first step in proper seaming involves cleaning the two mating surfaces to remove all talc from the membrane.
