REPAIR, EVALUATION, MAINTENANCE, AND  
REHABILITATION RESEARCH PROGRAM

TECHNICAL REPORT REMR-CS-22

MONOLITH JOINT REPAIRS: CASE HISTORIES

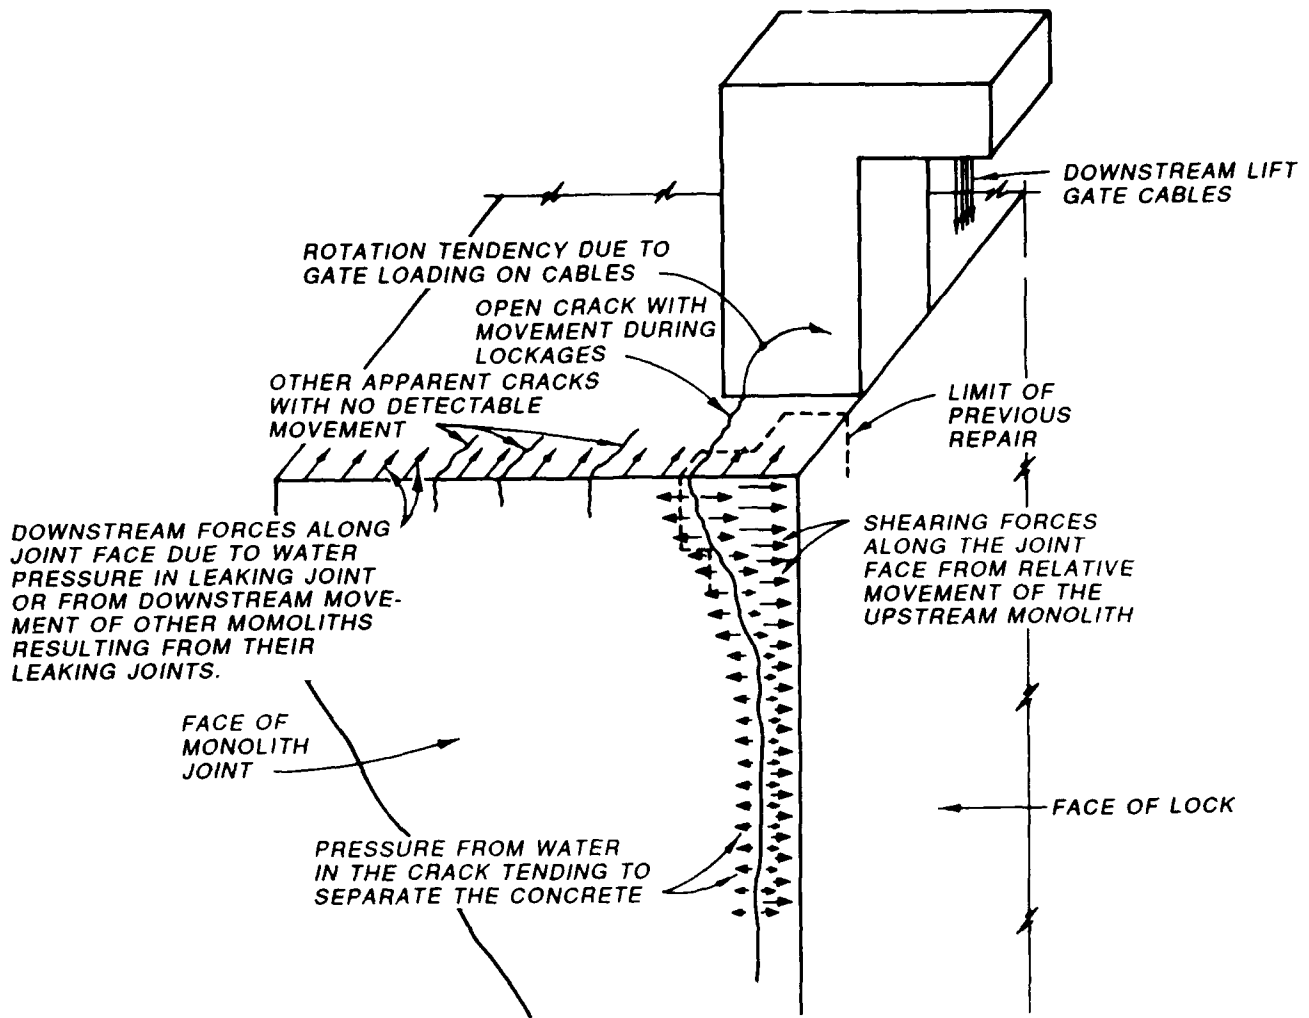
Figure 3. Forces acting on gate monolith, Lower Monumental Lock and Dam

10. Periodic Inspection Reports No. 4 (USAED, Walla Walla, 1973) and No. 5 (USAED, Walla Walla, 1975), documented the continued deterioration of the concrete adjacent to these joints. The deterioration extended from el 420\* to 460 on monolith 26 and el 480 to 537 on monolith 28. The cause of the deterioration (Figure 3) was described in Periodic Inspection Report No. 5 (USAED, Walla Walla, 1975) as follows:

Damage is caused by relative movements of adjacent monoliths from hydraulic loading during lockages. These movements are much more significant during the cold winter months when the concrete has contracted and there is less friction along the monolith joint. When the locks are emptied the upstream monoliths 25 and 26 move inward relative to the larger downstream monoliths 27 and 28, thereby causing a tearing action along the joint surface. This action spalls the concrete through repeated shearing and continued crack propagations.

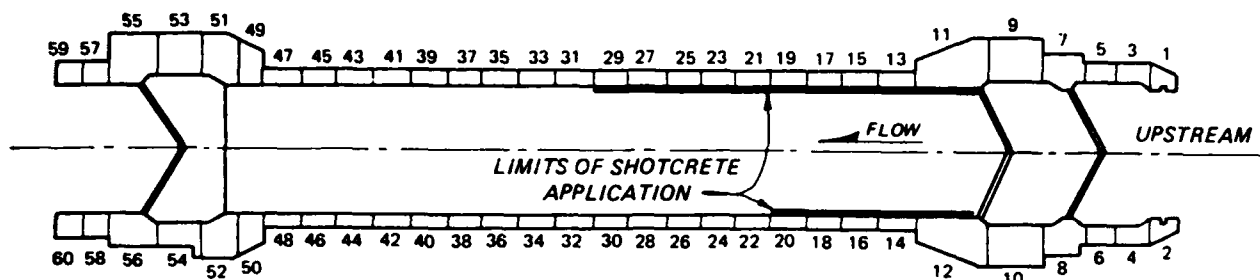
Figure 11. Limits of 1954 repair, Dresden Island Lock and Dam

14. In 1954 the upstream half of the lock chamber was resurfaced with shotcrete. Resurfacing extended over the even numbered monoliths 12 through 20 for the land wall and over the odd numbered monoliths 11 through 29 for the river wall (Figure 11). This repair was described in detail in Technical Report REMR-CS-13 (McDonald 1987).

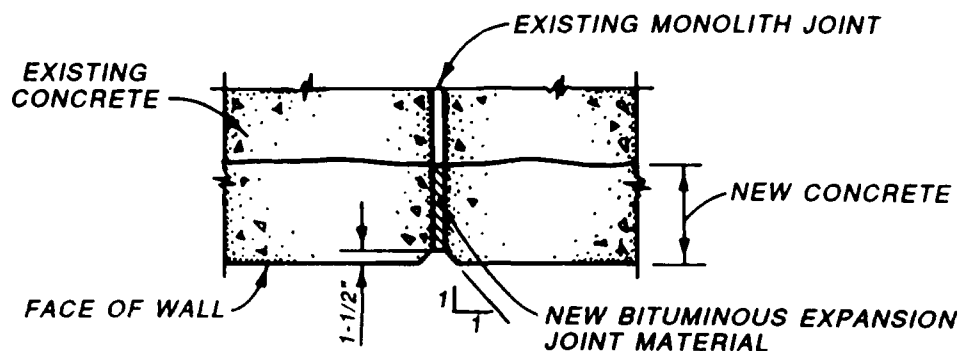
Figure 34. Conventional concrete-refacing monolith joint repair details, Emsworth Locks

35. The conventional concrete-refacing repairs began with the use of explosives to remove the deteriorated concrete to a depth of 1 ft. This repair technique is described in detail in Technical Report REMR-CS-13 (McDonald 1987) and summarized here. The reinforced concrete was designed to have a compressive strength of 3,000 psi at 28 days, a maximum water-cement ratio of 0.50, and a 1-1/2-in. maximum size coarse aggregate. The only special treatment given to the monolith joints during the concrete repairs was the addition of a bituminous expansion joint material and a 45-deg chamfer on each side of the 1-1/8-in.-deep joint (Figure 34).

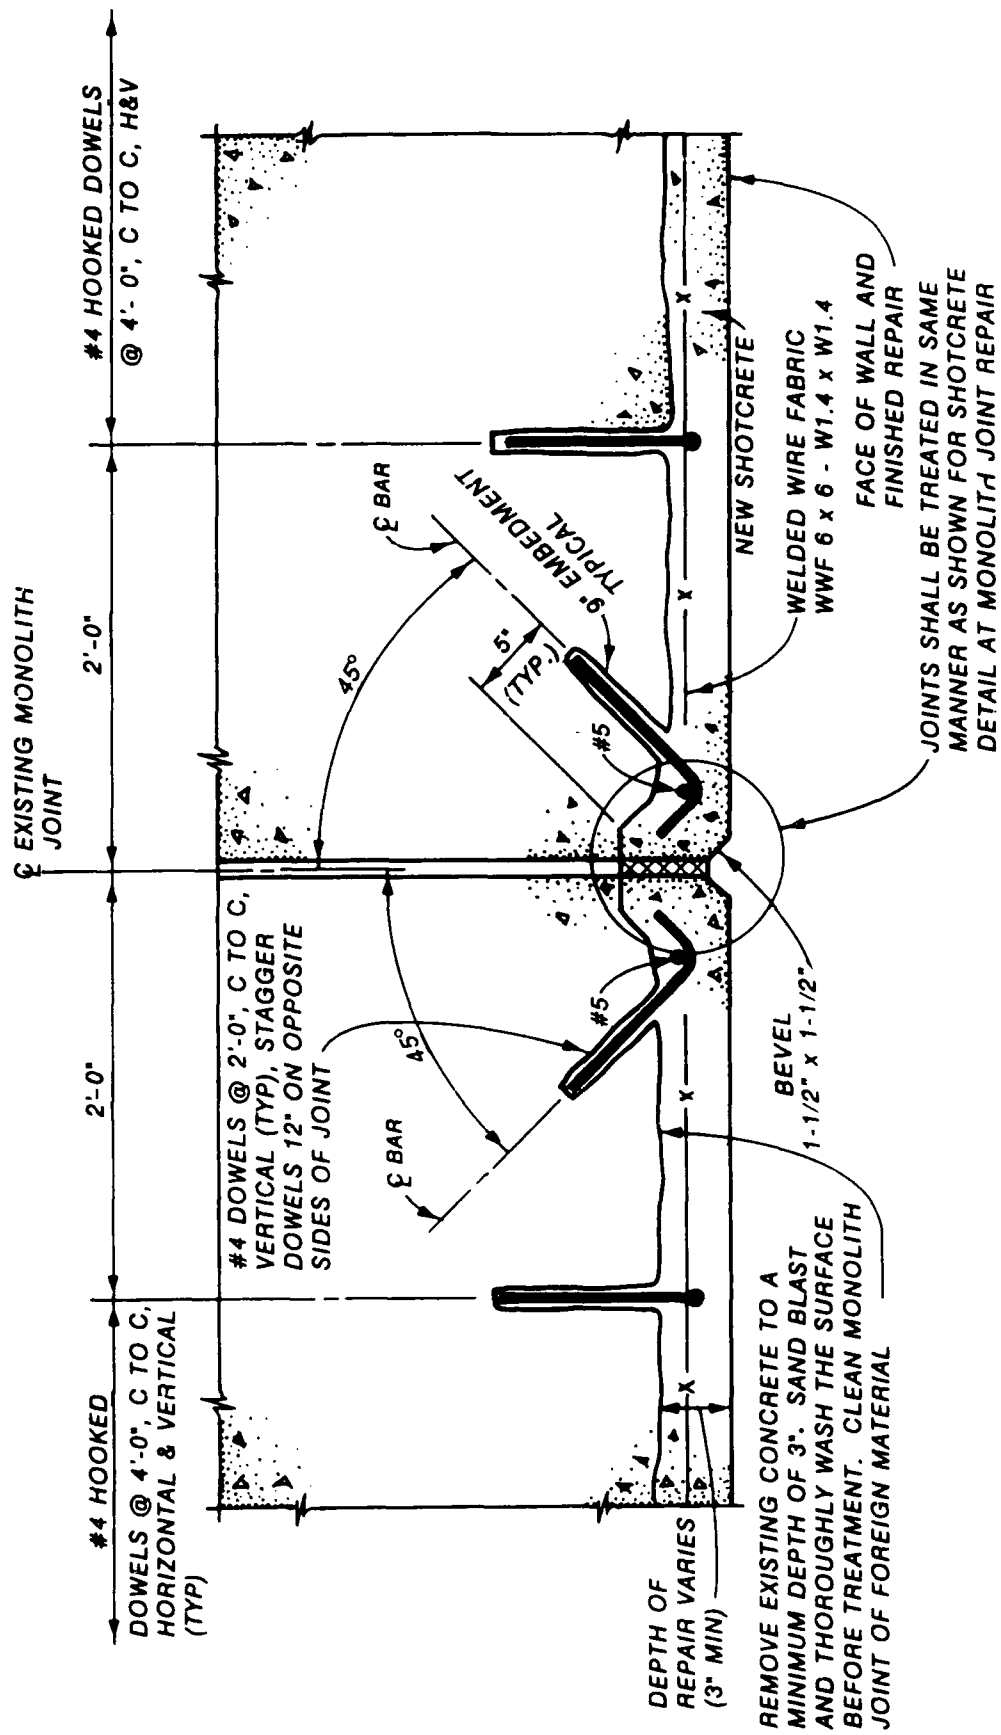
Figure 35. Shotcrete resurfacing monolith joint repair details, Emsworth Locks

accelerator was used to minimize sagging. Hooked dowels were installed on both sides of the monolith joint. A bituminous expansion joint material was placed at the joint and the corners were beveled (Figure 35).

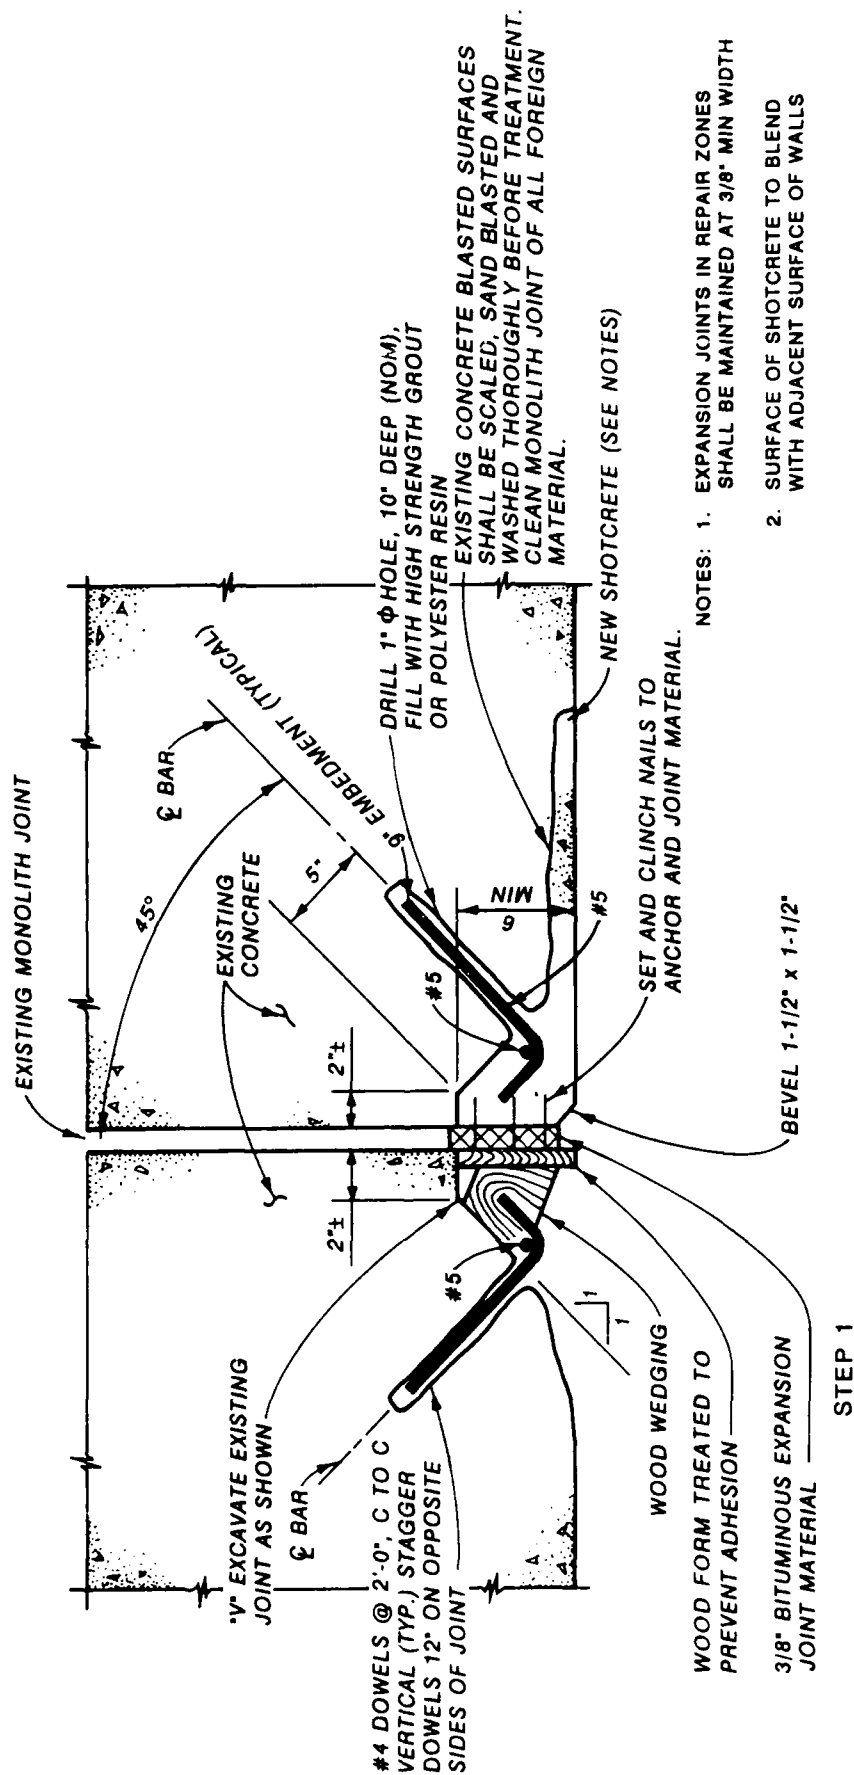
Figure 36. Shotcrete monolith joint repair details, Emsworth Locks

37. Some areas received a shotcrete 3/4-in.-thick coating, while other areas had only the monolith joints repaired. At these monolith joints, 6 in. was the minimum removal depth (Figure 36). Hooked dowels were grouted on both sides of the joint with polyester resin. Expansion joint material was installed and the joint was filled leaving a 45-deg bevel, 1-1/8-in. deep on both sides of the joint (Figure 37).

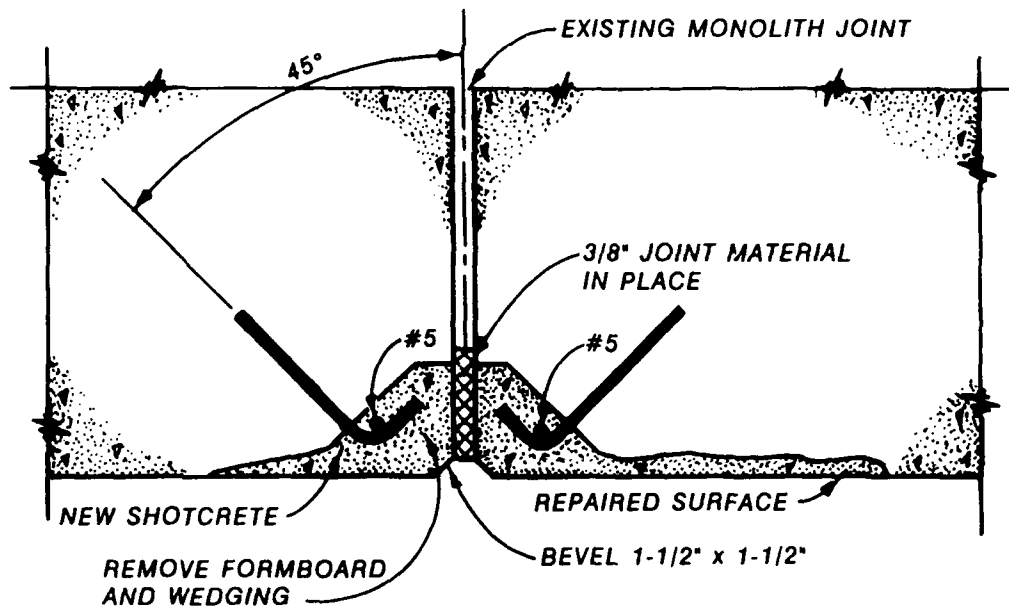
Figure 37. Shotcrete monolith joint repair details,  
Emsworth Locks

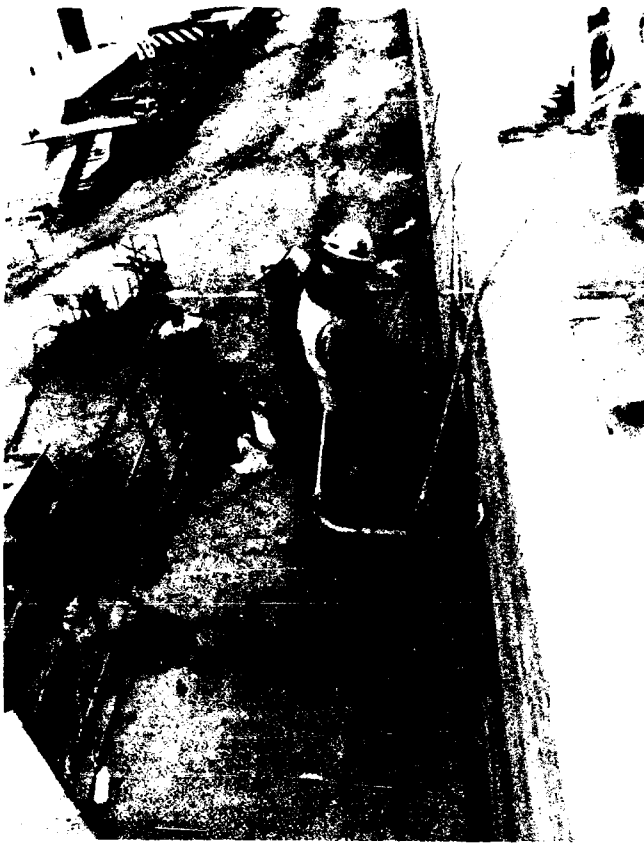
Figure 42. Removing deteriorated concrete, Lock and Dam No. 2

involved the installation of new operating machinery and controls. Repairs to the lock wall were completed in Stage I when the project was dewatered during the 1986-1987 winter. Work began with the identification and removal of the deteriorated concrete around the joints. (Identification was made by visual examination and the use of a sounding hammer.) A 1-1/2-in.-deep saw cut was made a minimum distance of 4 in. from the joint. The cut was angled from the joint to "lock" the repair into the existing concrete, except for the top joint which was cut perpendicular to the face of the wall. The deteriorated concrete was removed with hand-held jackhammers which allowed the mechanics to actually feel the deterioration beyond the minimum removal depth of 2 in. (Figures 42 and 43). The original joint was filled with 18 in. of asphalt-impregnated foam rubber secured with nails. Of a variety of methods, an electric chain saw was determined to be the best tool to remove joint material. Mechanical anchors 1/2 in. in diameter were installed on 9-in. centers on both sides of the joint. Mechanical anchors were selected because their full strength was realized immediately after they were set. After the anchors were set, all loose materials were blown or brushed from the surface to be patched. Because the temperatures were well below freezing, special provisions were made to protect the concreting operations (Figure 44). The cement and polymer were stored inside a heated enclosure; the aggregate was stored in a heated stockpile, and the scaffolding around each joint was enclosed and heated (Figure 45). The FRAPMC was placed in 7-ft lifts and consisted of a modified cement, liquid polymer, 3/8-in. granite aggregate, and 2-1/4-in. polypropylene fibers. The cement and polymer were in prepackaged units which made mixing very simple. Each unit had a volume of 1/2 cu ft to which 30 lb of aggregate and 1 oz of fibers were added. To get a self-leveling mixture that could easily be placed and consolidated, 25 to 30 percent more polymer had to be added. Because FRAPMC would adhere to a wooden form coated in form oil, the forms required a 6-mil polyethylene lining. Even with a form release agent specifically designed for use with acrylic modified concrete, the FRAPMC still bonded to the form if polyethylene was not used. After only 2 hr, the form was removed and used for the next lift. The joint was recessed from the face of the lock wall with a bevel 3-1/2 in. by 1/2 in. and a 45-deg chamfer at the joint edge (Figures 46 and 47). The 1/2-in. gap between monoliths was maintained during placement with the use of gatorboard (a styrofoam core with a thin plastic face on both sides). After the FRAPMC had cured sufficiently for

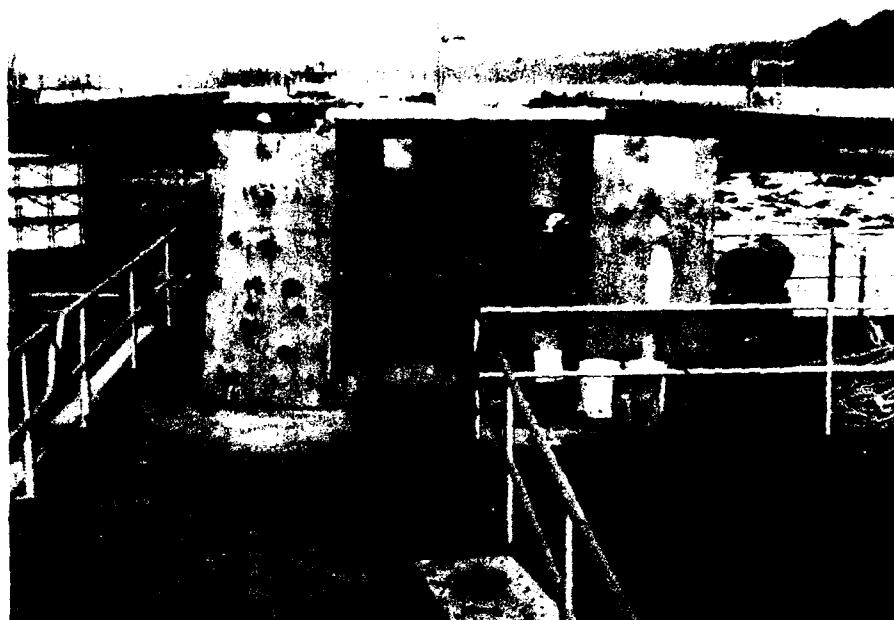
Figure 44. Heated concrete-mixing shelter,  
Lock and Dam No. 2

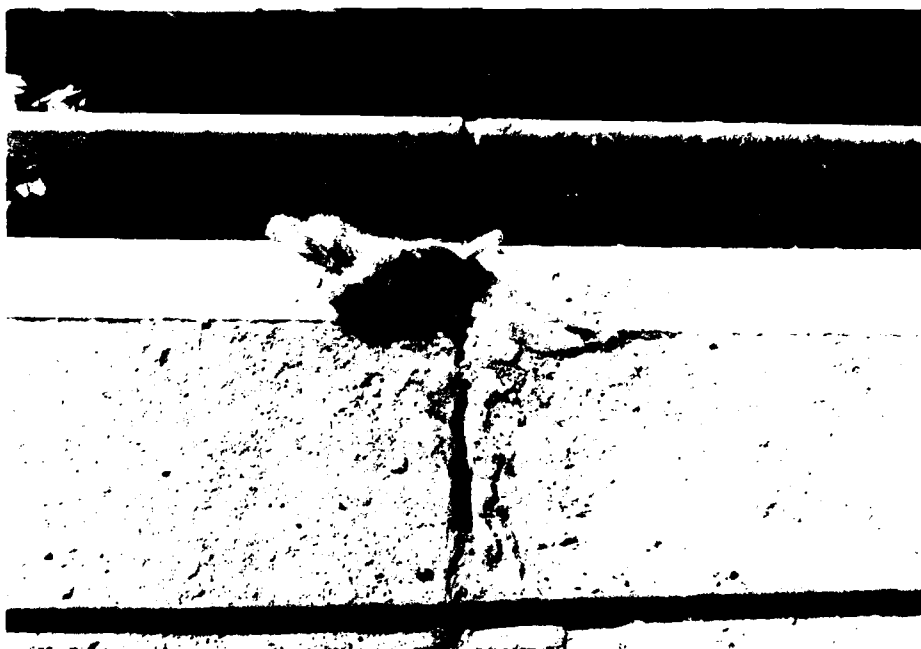
Figure 48. Backing material and oakum in place before  
grouting, Lock and Dam No. 2

the gatorboard to be removed, the soft styrofoam center was removed and the plastic faces, previously coated with form oil, released easily. The expansion joint was filled with a water-activated polyurethane foam grout and sealed with a polyurethane joint sealant (Figures 48 through 50).

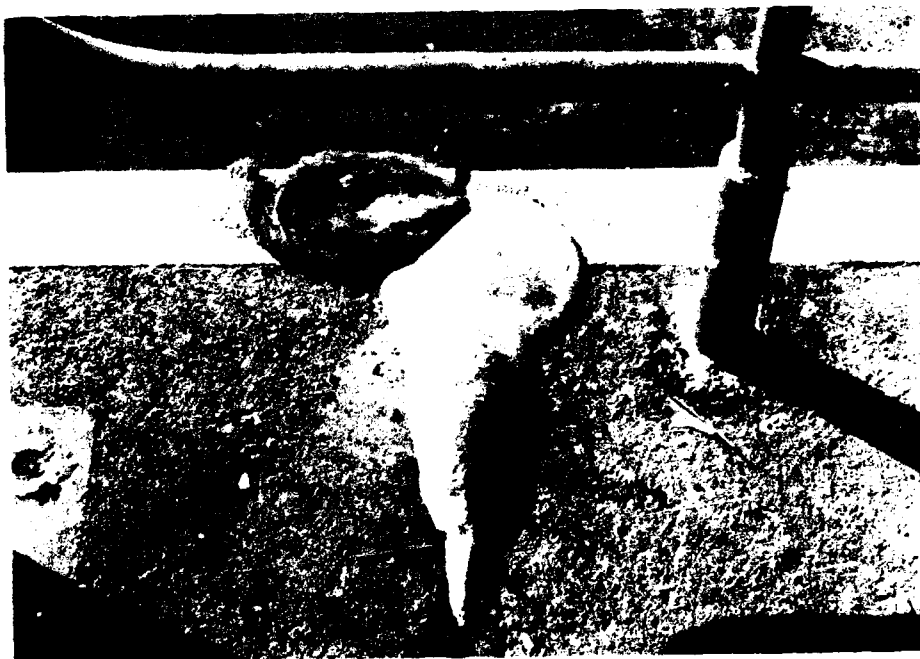
Figure 50. Expanded grout, Lock and Dam No. 2

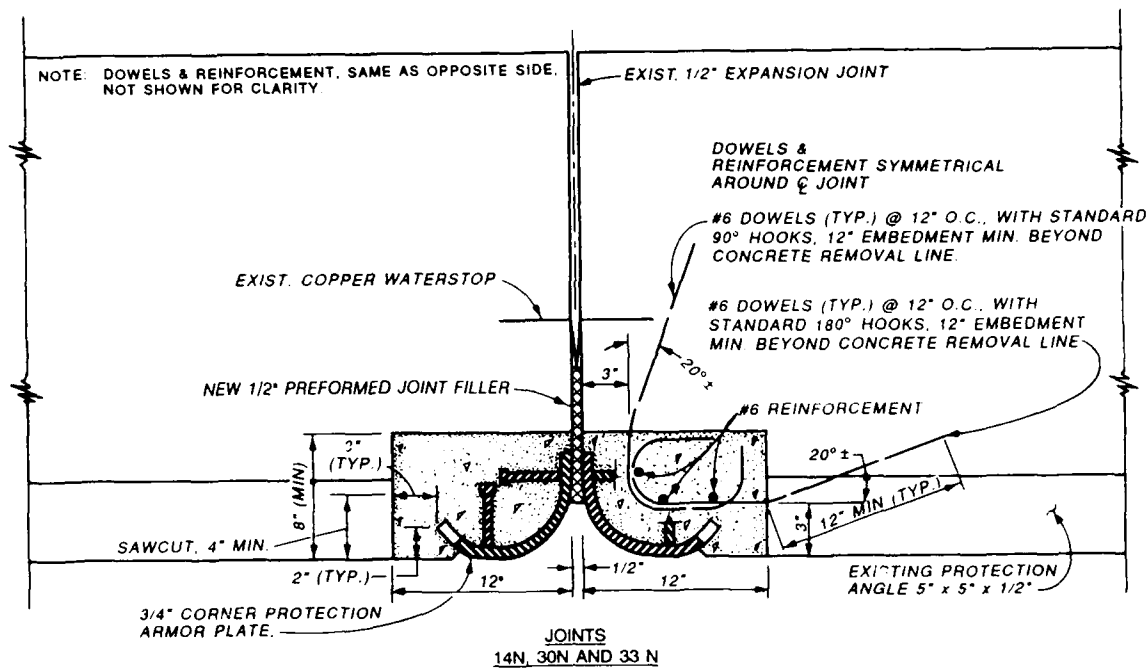
Figure 53. Monolith joint repair details for joints 14N, 30N, 33N, Algiers Lock

48. The procedure for the first repair method began with the removal of the deteriorated concrete around the joint. The contractor used a system of scaffolding hung over the side of the lock as well as scaffolding mounted on a pontoon barge to gain access to the work area. A minimum 4-in.-deep saw cut was made 12 in. on each side of the joint. Concrete was removed a minimum depth of 8 in. with jackhammers. A final removal surface tolerance of plus or minus 1/2 in. was required. Two No. 6 dowels were installed on 12-in. vertical centers on both sides of the joint (Figure 53). One dowel had a standard 90-deg hook and the other had a standard 180-deg hook. All dowels were installed with an epoxy grout. Three No. 6 dowels were installed vertically the entire height of the repair. The concrete surface was prepared by wet sandblasting. No bonding agent was used. Next, the 1/2-in. preformed joint filler was installed. This step was followed by the installation of the 3/4-in.-thick armor with stud anchors along with the formwork. A 3-in. polyvinyl chloride tremie was used to place the new concrete in one continuous 20-ft lift. The concrete was designed to have a 0.45-water-cement ratio and a 90-day compressive strength of 3,000 psi. The 90-day strength requirement was based on the contractor's use of fly ash. After the initial strength had been developed, the formwork was stripped and the concrete was moist cured for 7 days. The armor was coated with a coal tar epoxy paint, and the joint sealant was installed.

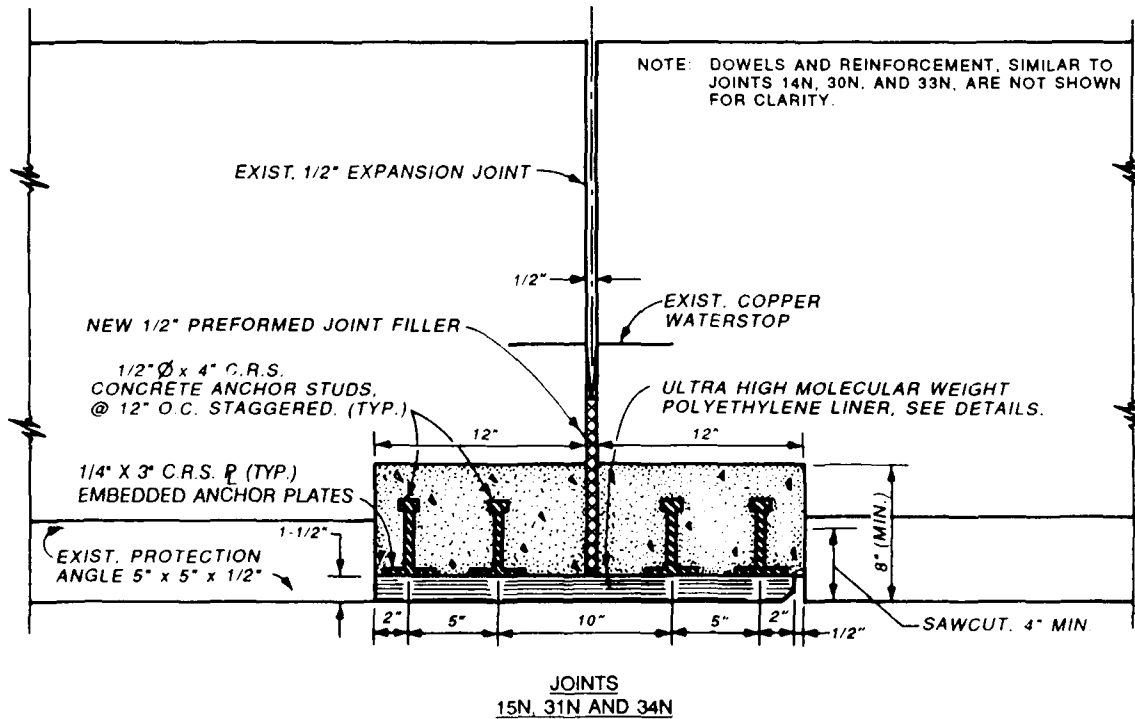
Figure 54. Monolith joint repair details for joints 15N, 31N, and 34N, Algiers Lock

49. The second repair technique used the same procedures for removing concrete and surface preparation. After the surface was prepared, the 1/2-in. preformed joint filler was installed. The ultra-high-molecular weight polyethylene liner was then coated with form-release oil and installed on the inside of the formwork. Simultaneously, the stainless steel studs which had been welded to the concrete anchor plates were placed on 12-in. vertical centers (Figure 54). Again a tremie was used to place the new concrete in one 20-ft lift. After the forms were stripped, the new concrete was moist cured for 7 days. The liner was fixed on one side and free on the other side to compensate for thermal expansion and contraction (Figure 55).

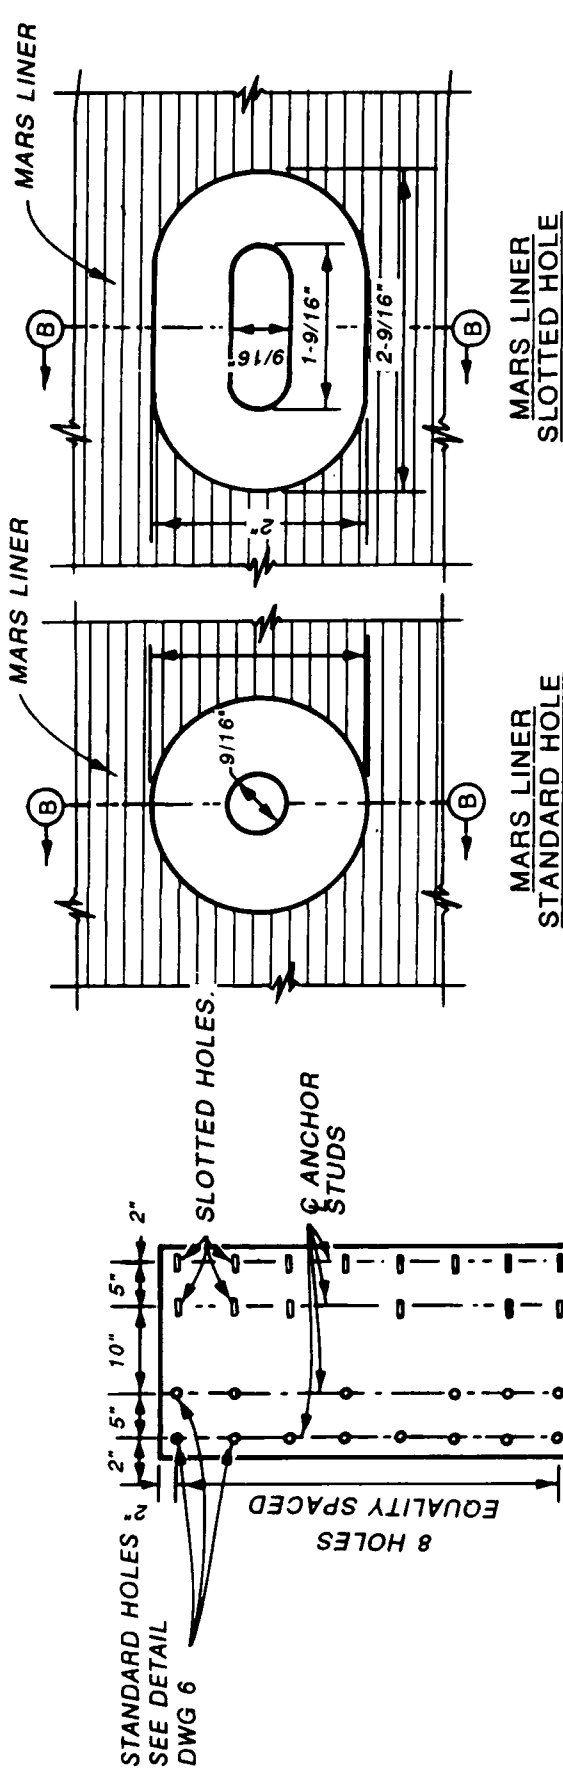
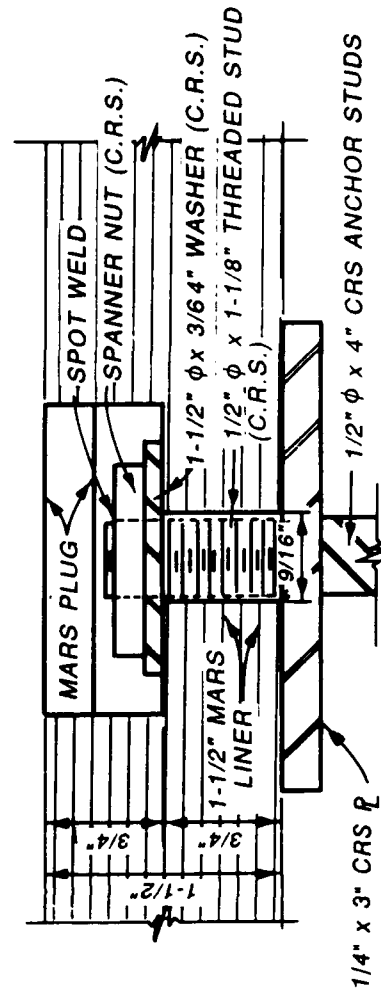
Figure 55. Ultra-high-molecular weight polyethylene liner details, Algiers Lock

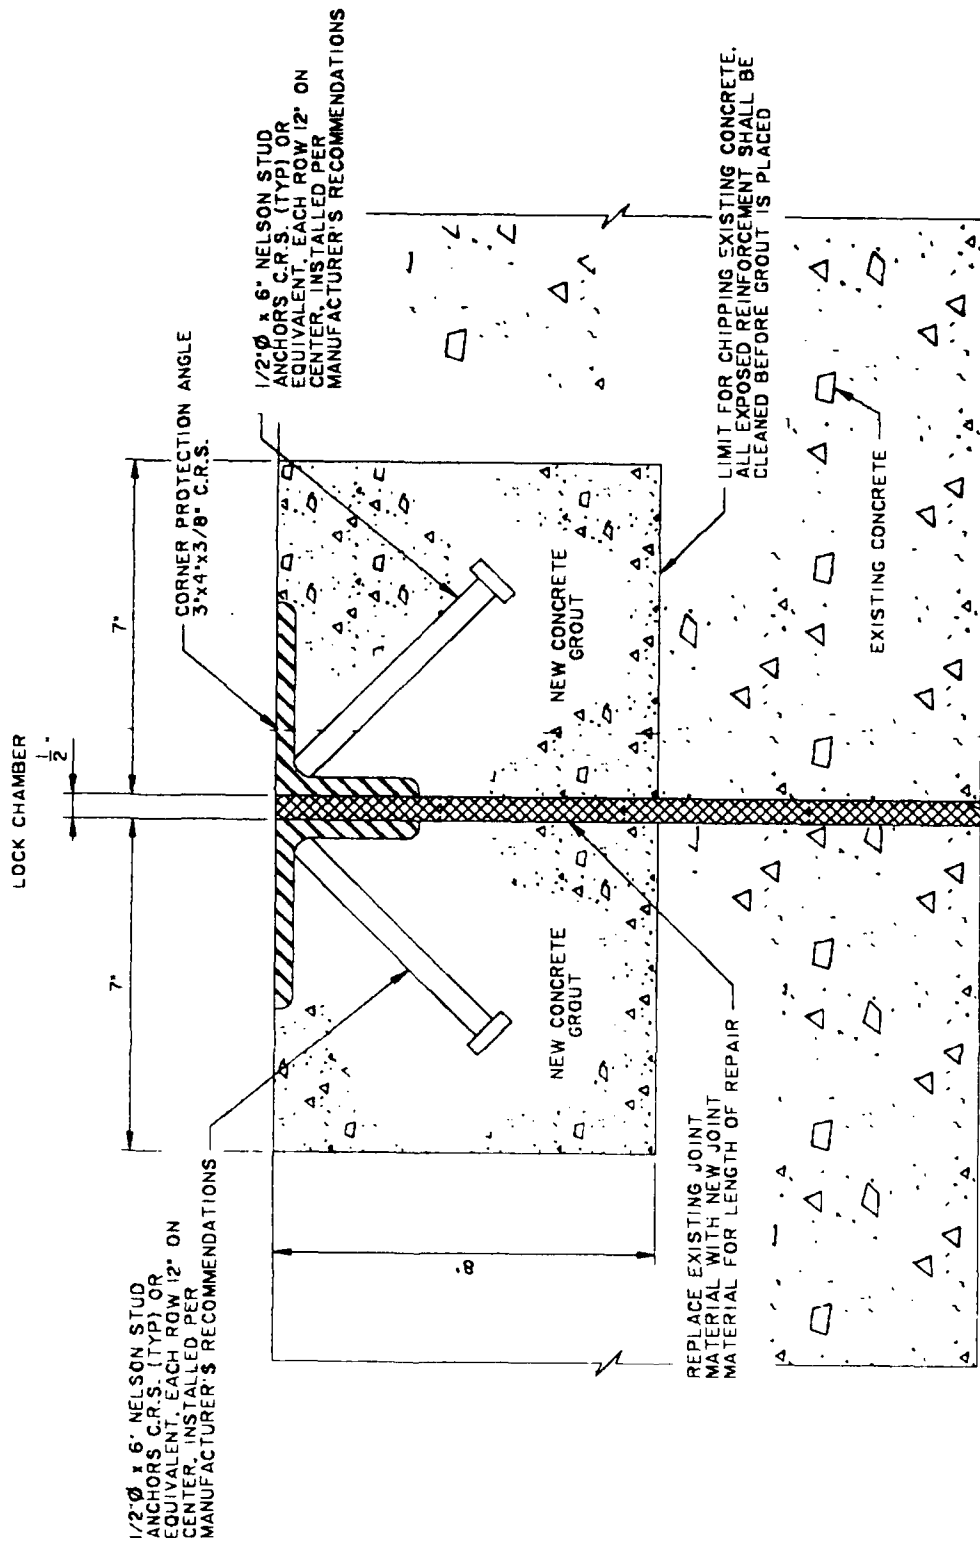
Figure 58. Monolith joint repair details (not final), Bayou Sorrel Lock

# DETAIL I TYPICAL VERTICAL JOINT REPAIR

53. The repair technique for the monolith joints consists of removing the deteriorated concrete a minimum depth of 8 in. (Figure 58) and then preparing the surface. The formwork would be installed with corner protection angles and Nelson stud anchors attached. New joint filler would be installed the length of the repair, and the repair material would be placed and cured.
