Final Report  
for the Period  
September 1984  
to July 1989

# Pulsed Plasma Mission Endurance Test

Authors:  
R.J. Cassidy

Rocket Research Company  
Olin Defense Systems Group  
11411 Willows Road NE  
Redmond WA 98073-9709

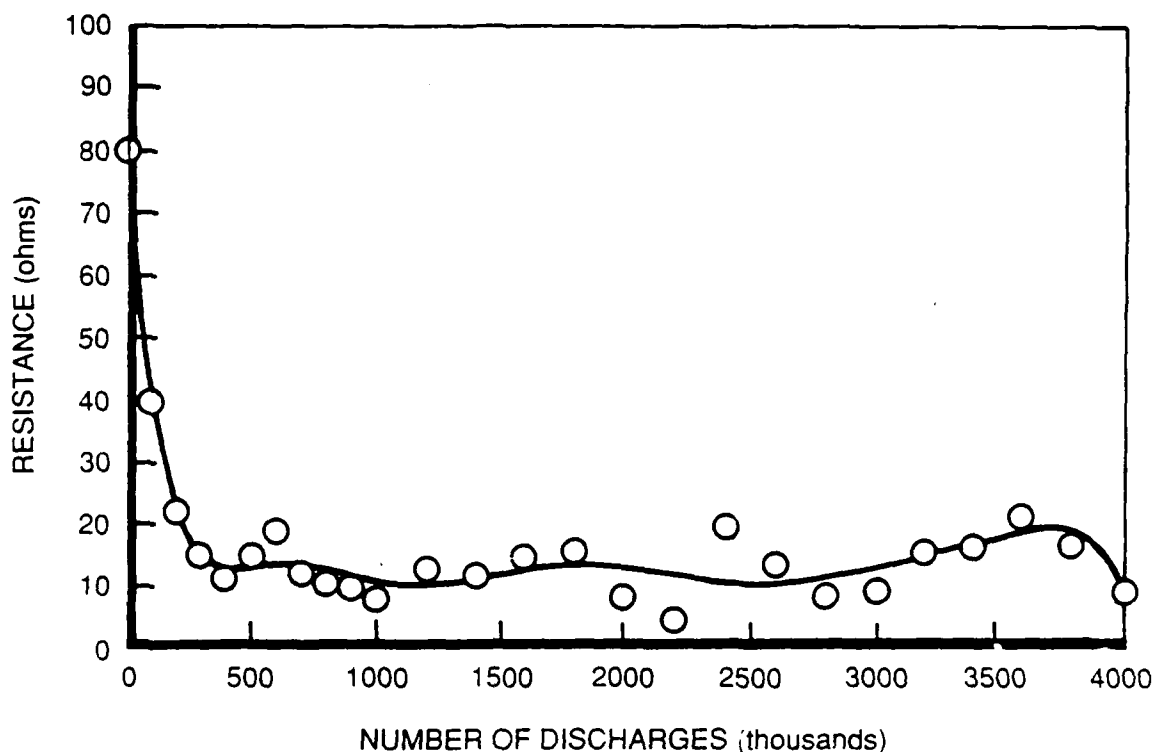
**Fig. 4. Igniter Plug Resistance as a Function of Number of Discharges**

At Fairchild, work was funded by AFAL to modify the existing DI circuit to include the coupling inductor. It was determined to be beyond the scope of the contract to incorporate the JPL DI circuit design, however. Several million discharges were run with the coupling inductor replacing the original coupling resistor. The results indicated an initial drop from 90 ohms to approximately 10 ohms in less than 200,000 pulses. The plug resistance then stabilized for the remainder of the 4 million discharges at between 5 and 20 ohms, as shown in Figure 4.

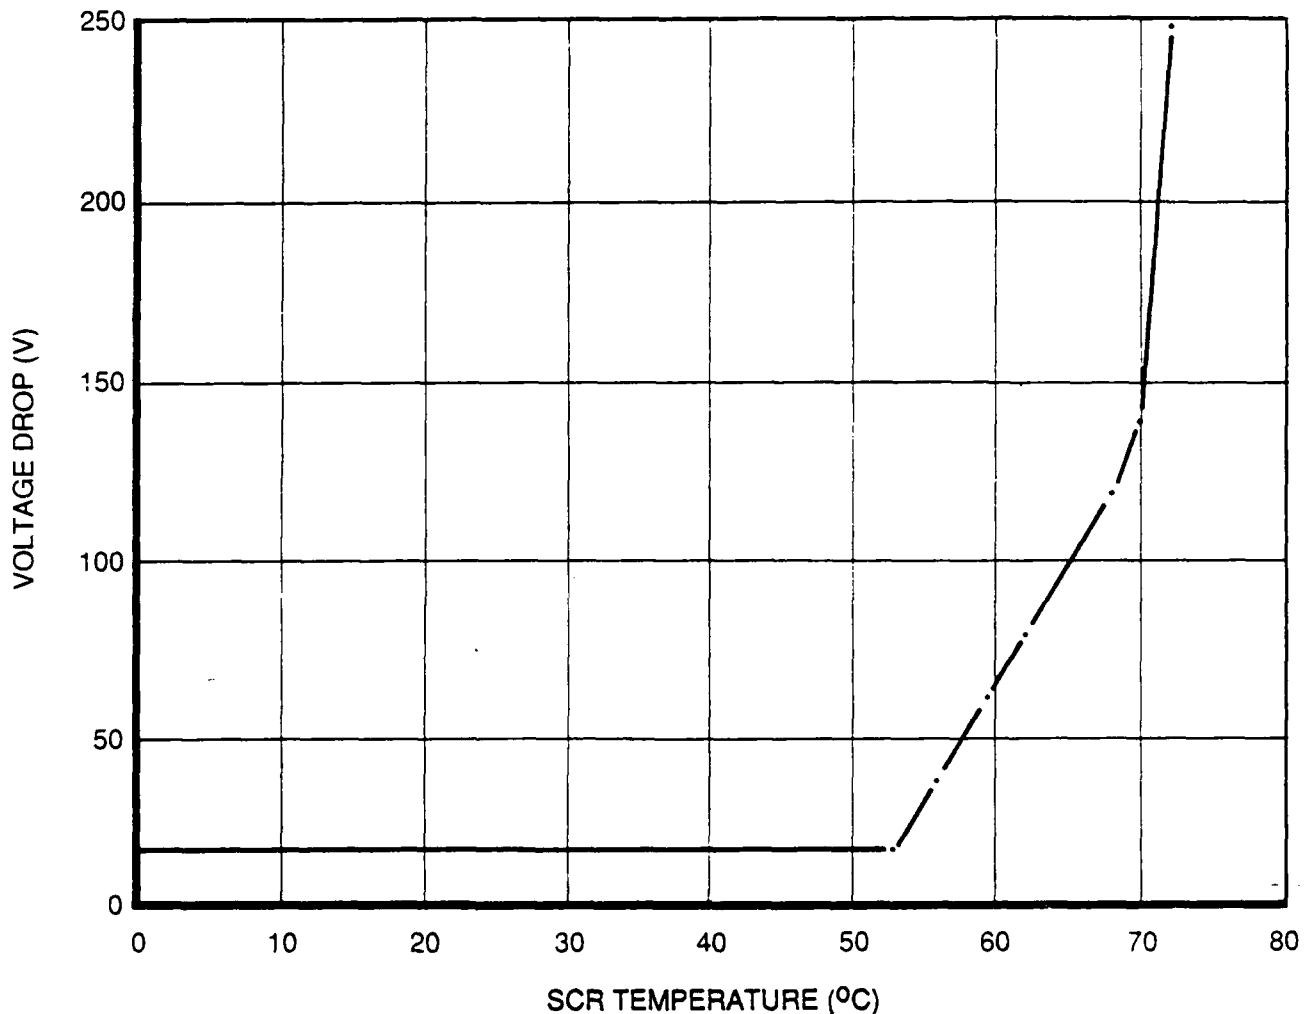
**Fig. 16. Storage Capacitor Voltage Drop as a Function of SCR Case Temperature for Operation at 80 Hz**

Figure 2 shows the SCR leakage current as a function of SCR case temperature as measured on the DI circuit. Figure 3 shows the voltage droop seen on the storage capacitor as a function of case temperature. The information in Figure 3 applies only to operation at 80 Hz, but we see that the SCR can heat to 55°C without affecting circuit performance.
