St. Marys River  
Shoreline Erosion and Shore Structure Damage  
1980 Closed Navigation Season

February 1981

Corps of Engineers  
U.S. Army Cold Regions Research and Engineering Laboratory  
Hanover, New Hampshire 03755

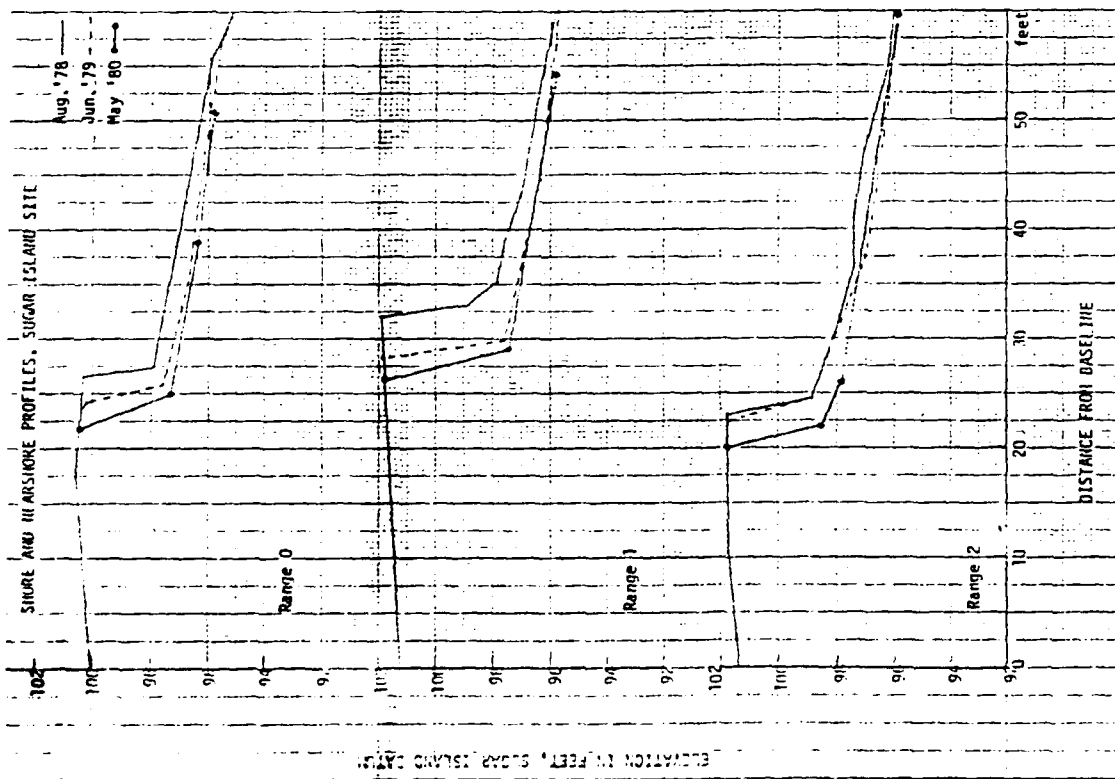
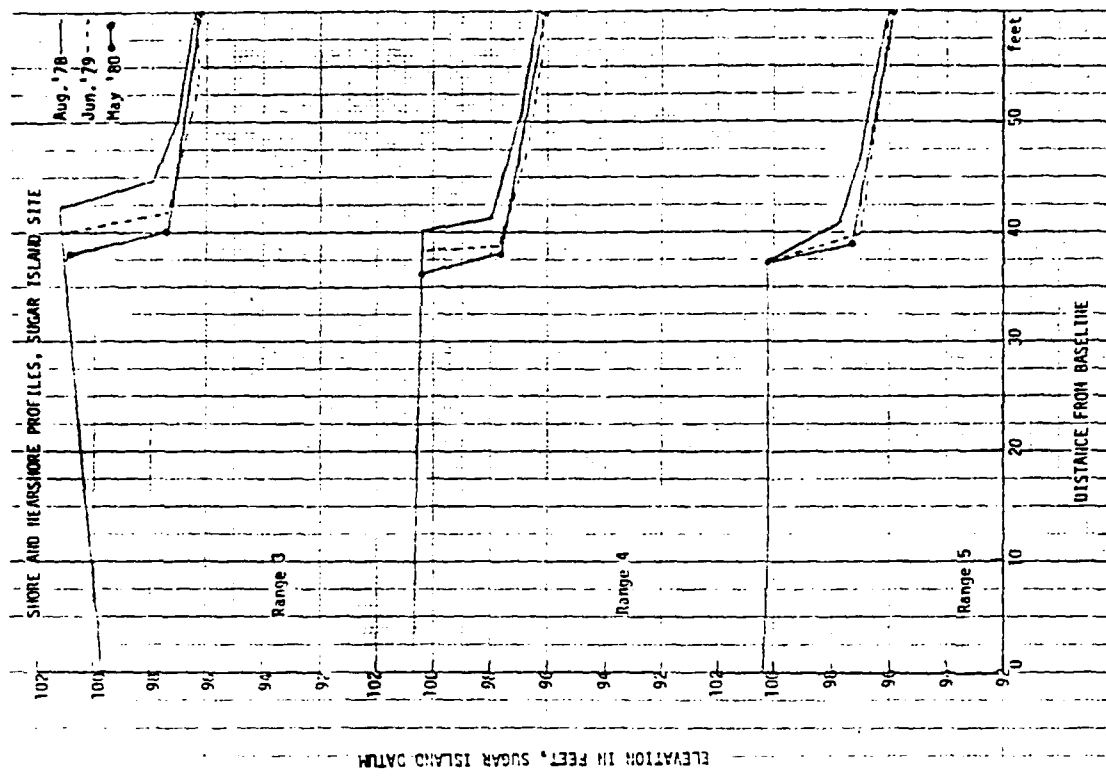
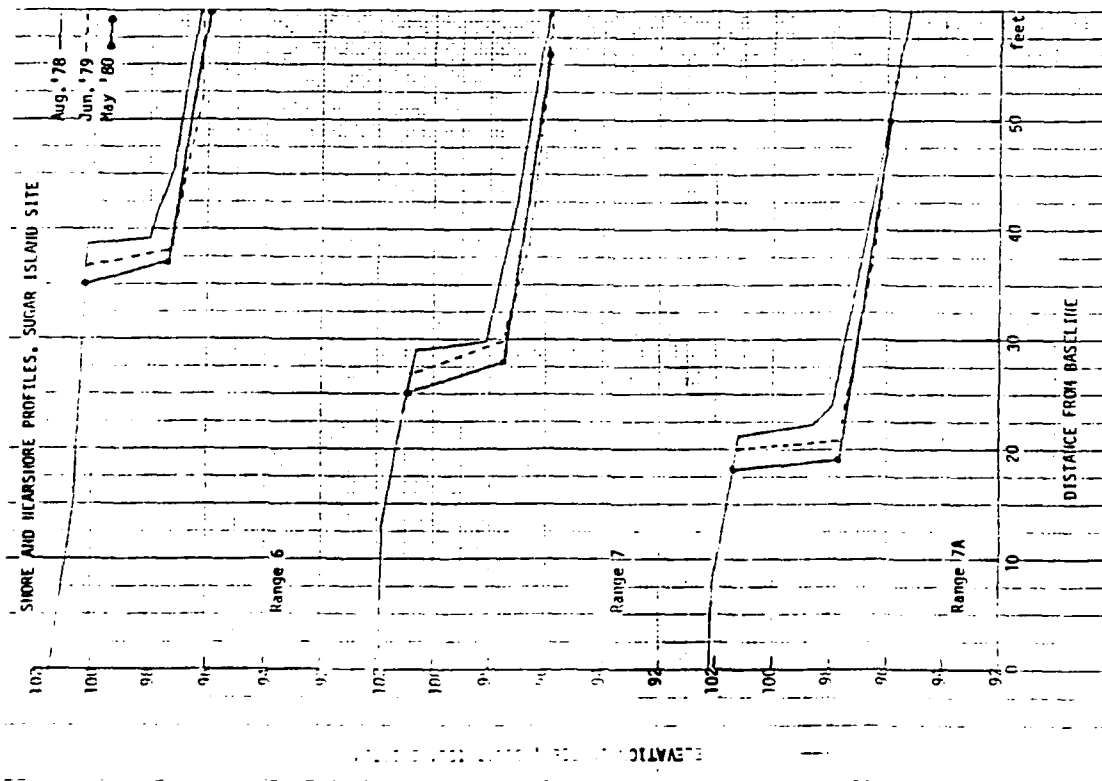
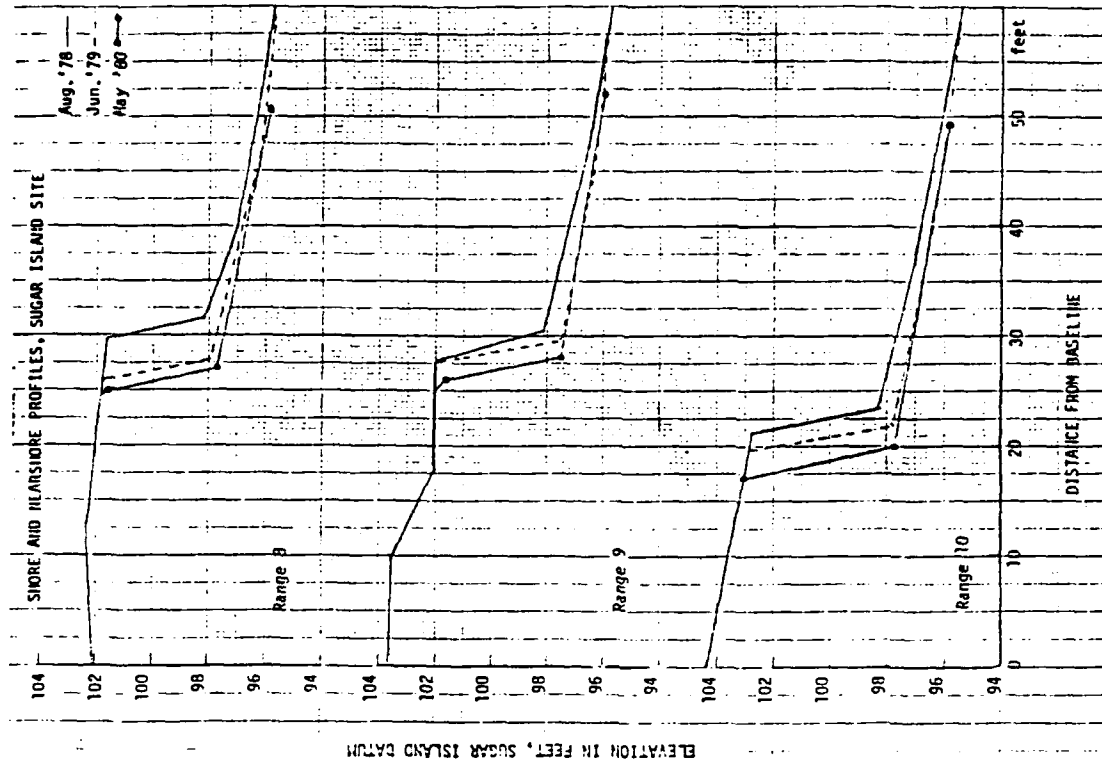
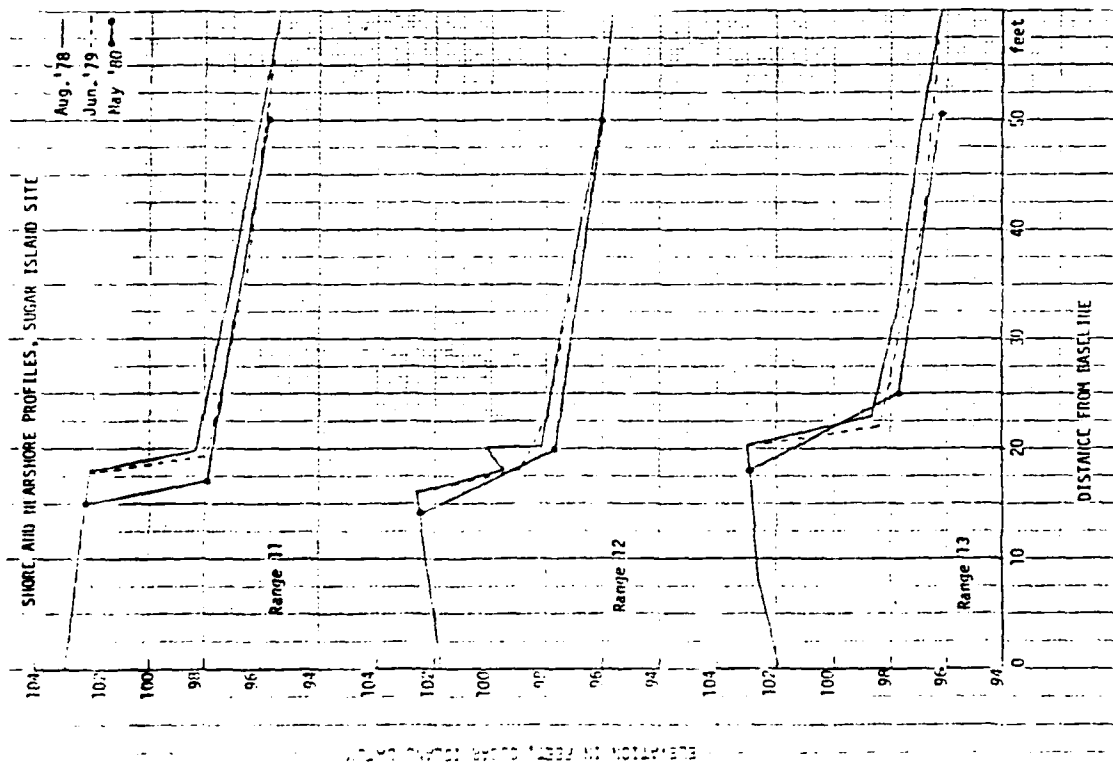
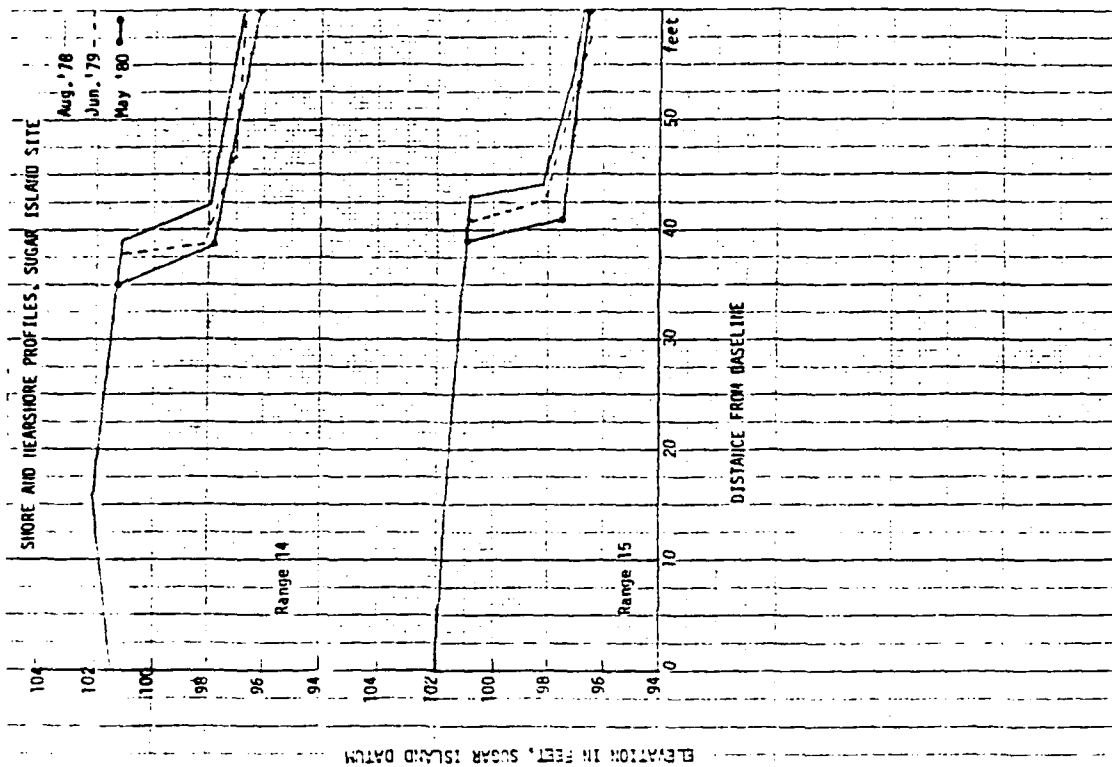
Nearshore profiles at the Sugar Island Site are reported in Figures 26 through 31 and all fifteen ranges located at this site. Bank and bluff recession is evident at all of the range locations. This site has been active in the past periods of study which might have led to suspicions of the effects due to winter navigation, however, these nearshore alterations appear to continue during a period with essentially no winter navigation.

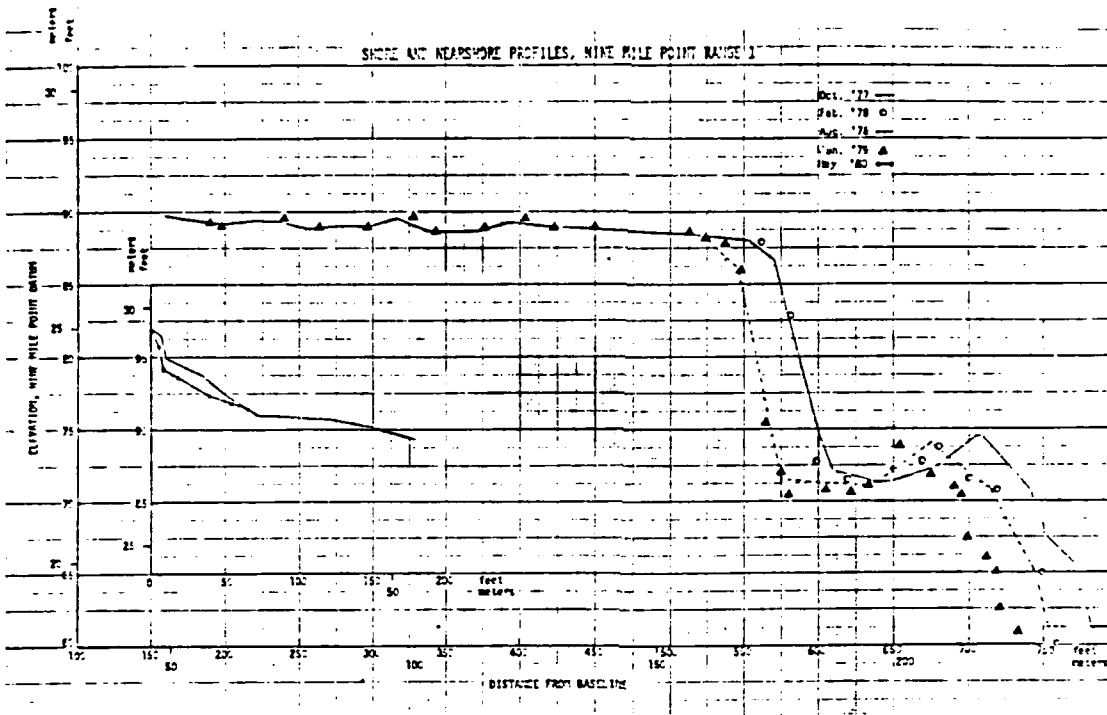
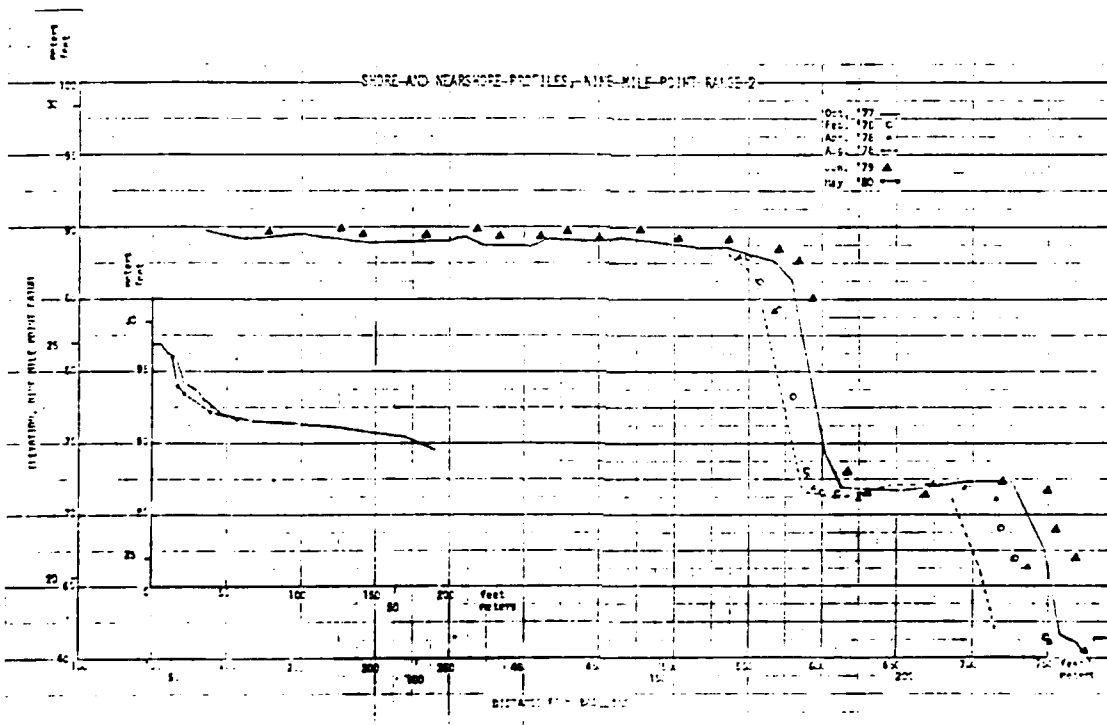
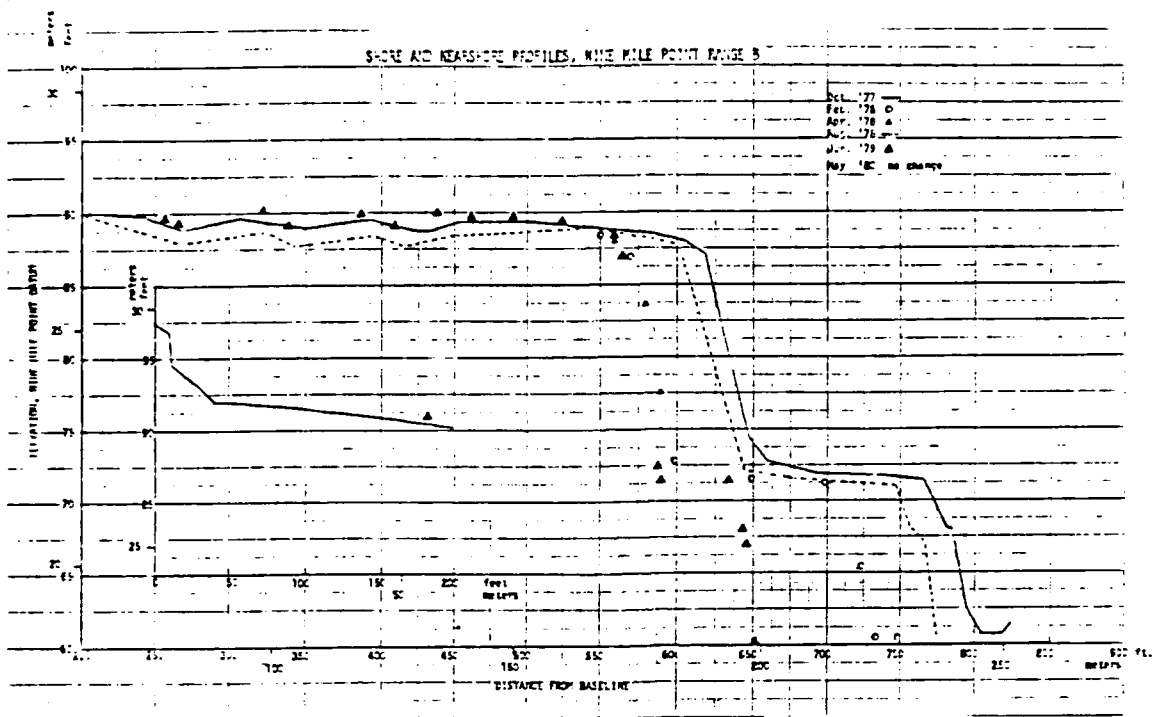
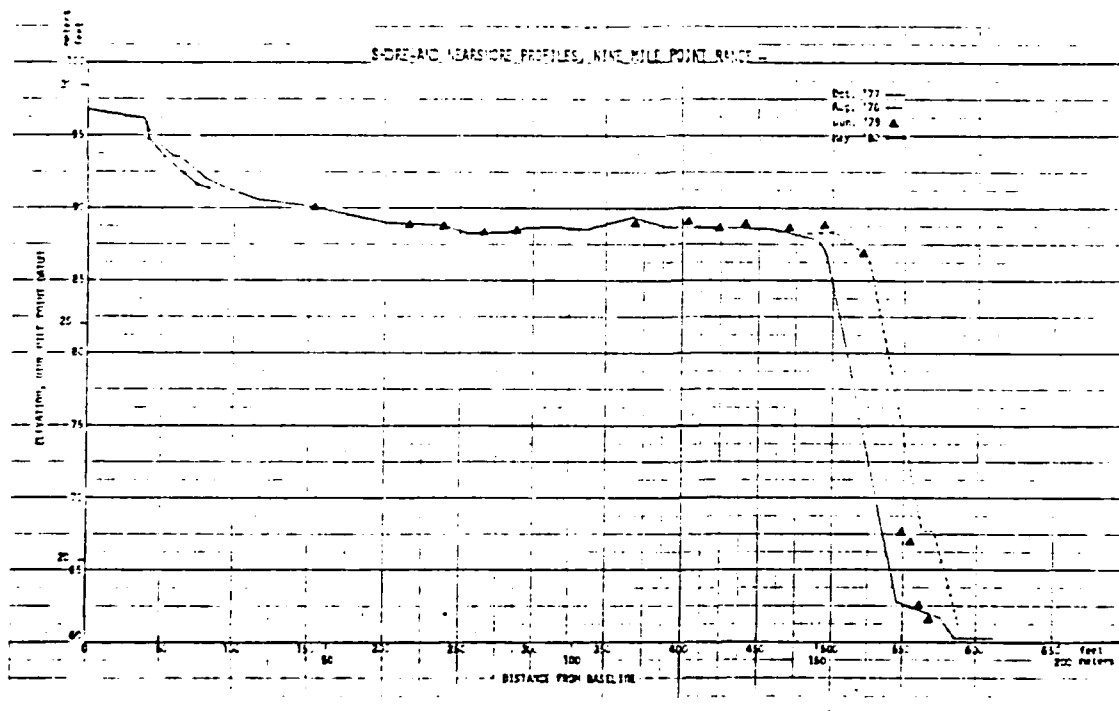
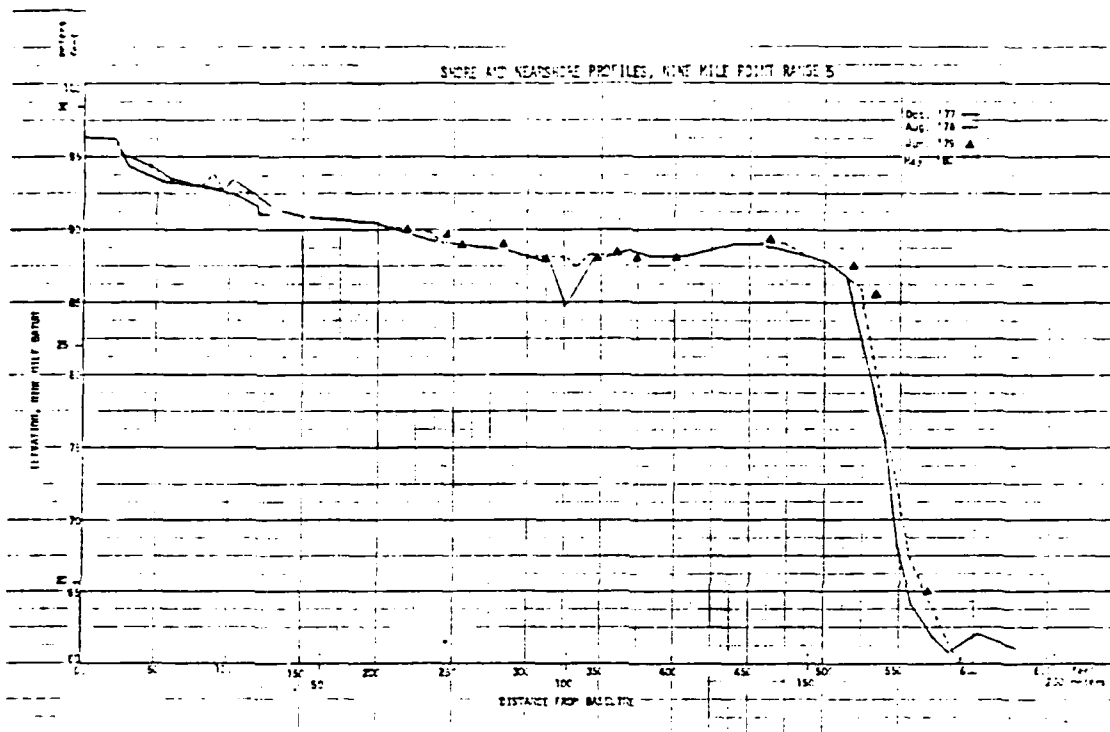
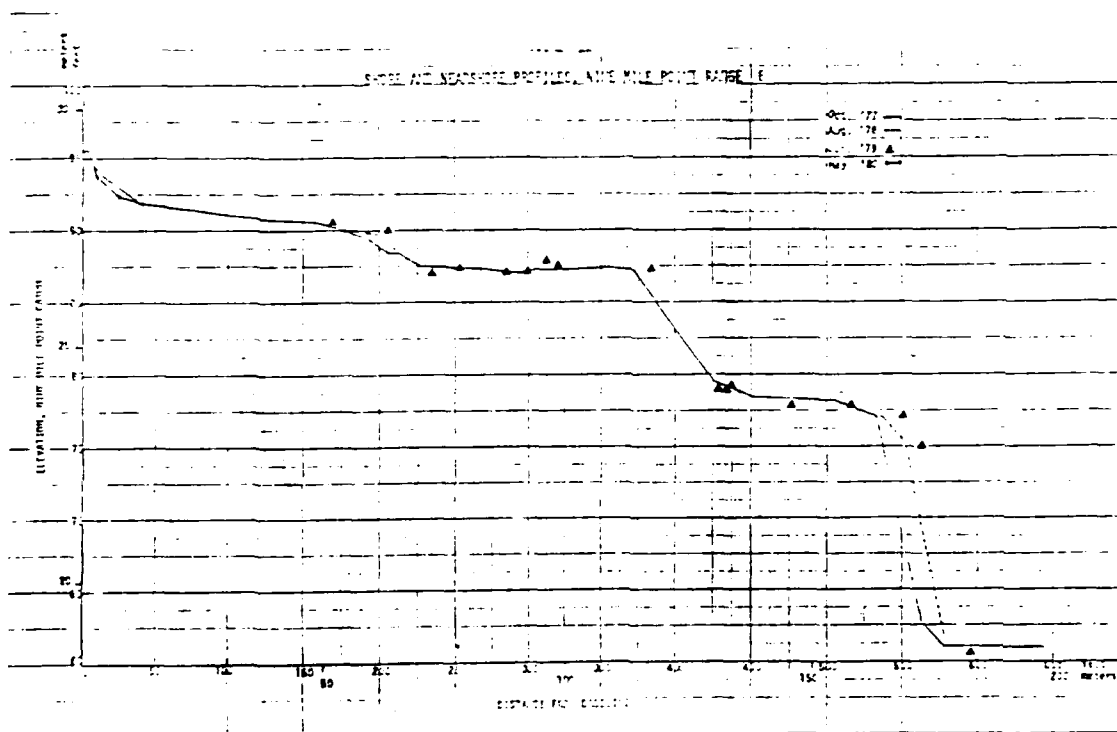
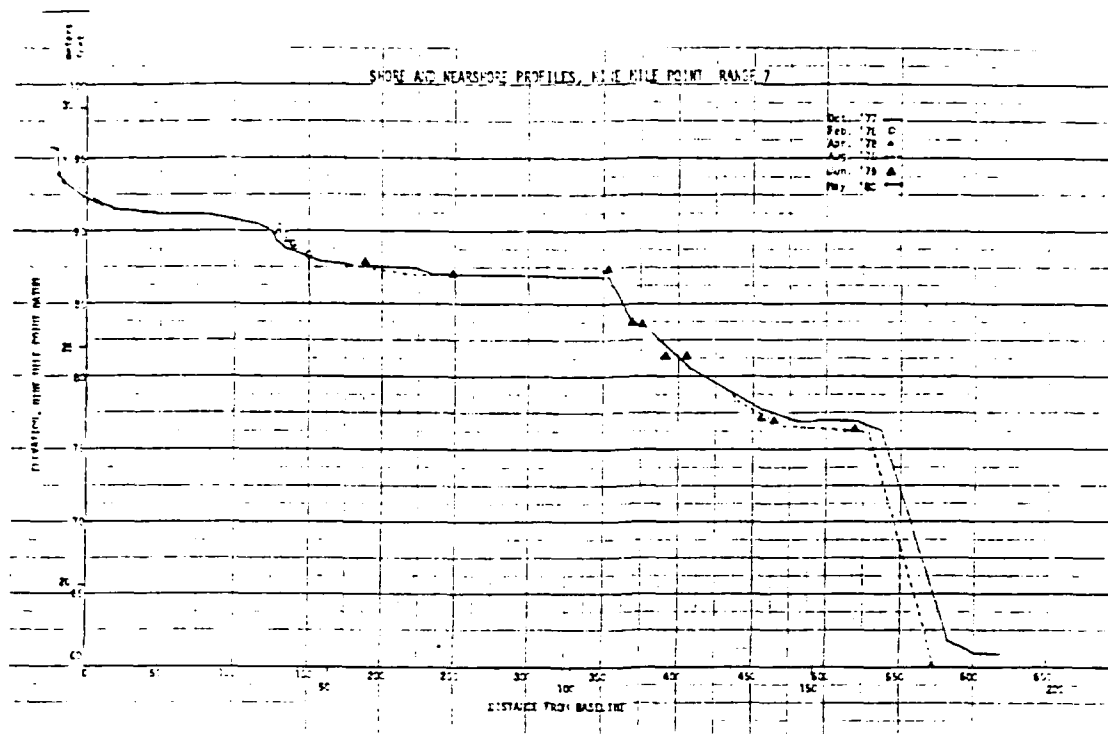
Profiles measured under this contract at the Nine Mile Point Site were compared with those reported in previous study periods. The profile measurements reported for earlier years have shown no change except for the inshore migration of a small berm near Range 5. The results of this study, however, showed nearshore alterations at all ranges except Range 3. These profiles are illustrated on Figures 32 through 38. Range 3 is protected with rip-rap and rock placed along the bluff and shoreline and no material nearshore alteration would be expected along this range. Ranges 1, 2, 4, 6, and 7 all show some recession of the shore area while Range 5 indicates some filling due to the migration of the sand berm located near this range. Water levels were high during the summer of 1979 and erosive forces would have been applied at higher elevations of the shore and bluff during this period.

It is interesting to note here that no material nearshore recession has been reported in the earlier years of study with winter navigation present while some recession did occur during this period of no winter navigation.

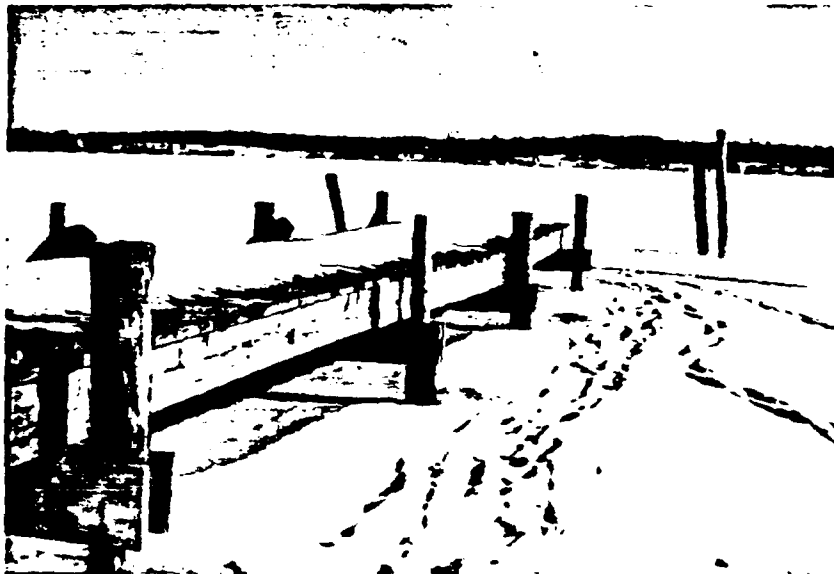
Figure 49. Dark Hole pile dock.

Prior to the 1978-79 winter navigation season, the Corps of Engineers had two demonstration docks installed at this site. One was a rock-filled timber crib as shown in Figures 47 and 48. The other shown in Figure 49 was a pile supported structure, with pile surfaces of various materials ranging from wood to plastic to steel. Both of these structures stood up

very well during both winters they were in place. The original Franklin Resort dock which can be seen on the left side of Figure 47 (9 February 1980) experienced no perceptible damage during the winter season.
