Bank Conditions and Recession Along the U.S. Shorelines
of the St. Marys, St. Clair, Detroit and St. Lawrence Rivers:
Ancillary Data

Lawrence W. Gatto
Earth Sciences Branch

February 1982

Prepared for the
U.S. Army Engineer District, Detroit

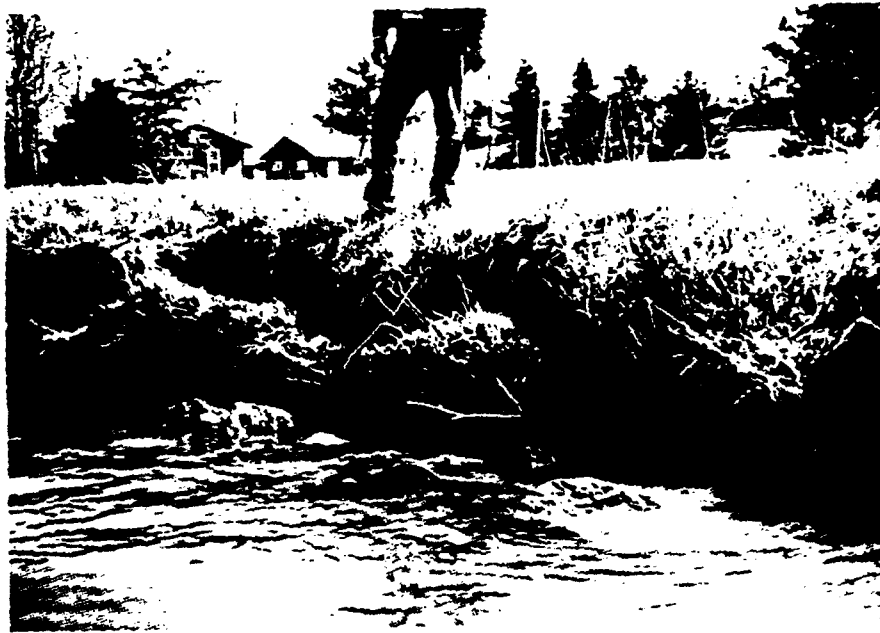
SMR reach 27b, 18 May 79

REMARKS SMR 27b is an old Corps of Engineers profile site. It was protected with boulder riprap between 1974 and 1977.

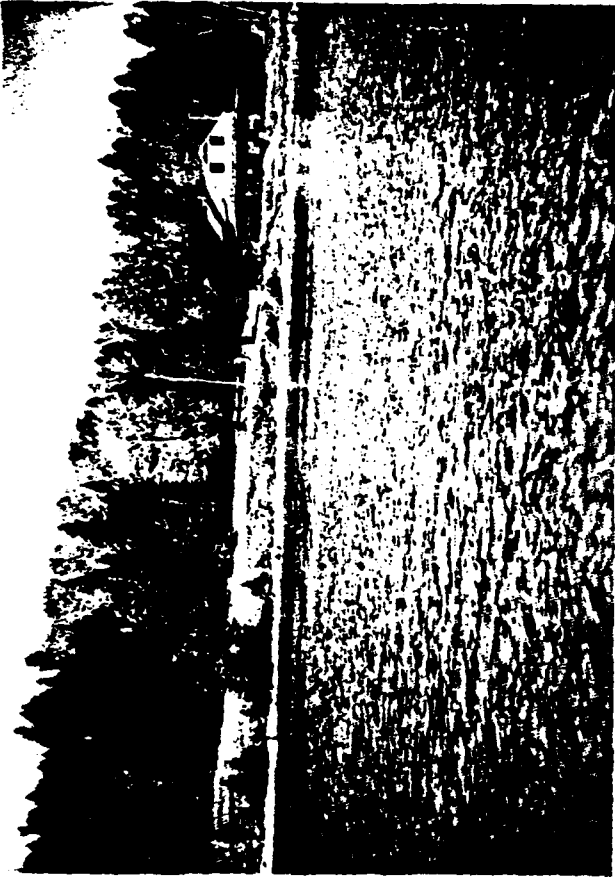
Figure D10. SMK reach 23b, 23 May 78.

BEACH	<input checked="" type="checkbox"/> Yes <input type="checkbox"/> No	Orientation NNE-SSW	Width 3-7	Texture Gravel to boulders	Remarks Fig. D10
	Photo No. _____				
BLUFF	<input checked="" type="checkbox"/> Yes <input type="checkbox"/> No	Height .5-7	Slope 30°-60°	Length 600	Evidence of Surface Runoff Rills <input type="checkbox"/> No Gullies <input type="checkbox"/> No
	Photo No. _____				Evidence of Groundwater Seepage Staining <input type="checkbox"/> No Damp Zone <input type="checkbox"/> No Vegetation <input type="checkbox"/> No Other <input type="checkbox"/> No
SOIL	<input checked="" type="checkbox"/> Collapsing <input type="checkbox"/> Stable	Vegetation Type Grasses	Remarks Grass covers bank on northern portion (Fig. D11)		
	<input checked="" type="checkbox"/> Artificial (fill) <input checked="" type="checkbox"/> Natural	Texture Sand with cobbles and boulders	Color Grey to tan	Structures None	Remarks Looks like till

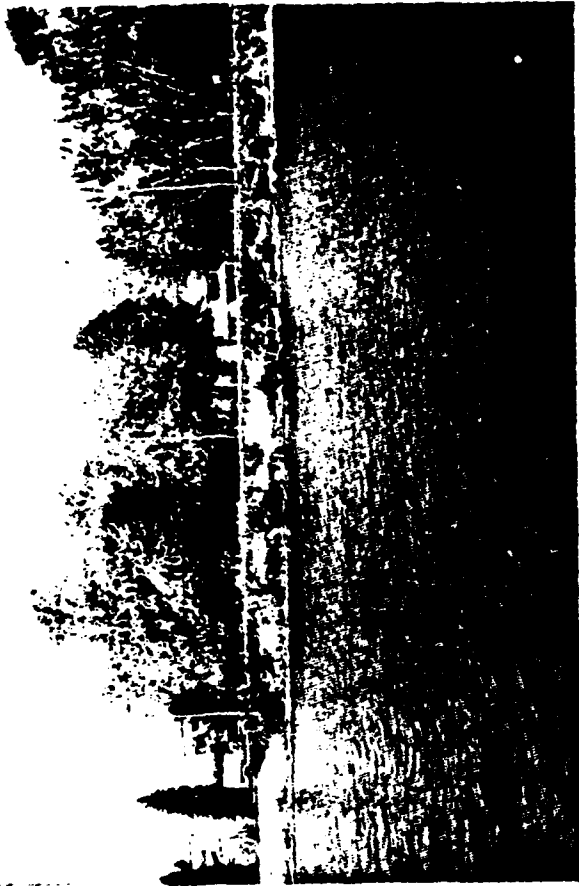
Figure D38. SCR reach 12b, 18 Oct 77.

BEACH		<input checked="" type="checkbox"/> Yes <input type="checkbox"/> No		Orientation		Width		Texture		Remarks	
Photo No. _____		NE-SW		NE-SW		0-3		Sand			
BLUFF		Orientation NE-SW		Slope 45°-60°		Length 400		Evidence of Surface Runoff Rills <input type="checkbox"/> Gullies <input type="checkbox"/>		Evidence of Groundwater Seepage <input checked="" type="checkbox"/> No Staining <input type="checkbox"/> Damp Zone <input type="checkbox"/> Vegetation <input type="checkbox"/> Other <input type="checkbox"/>	
Photo No. _____		Vegetation Collapsing Stable Type X (Fig. D37) Grass		Remarks Scattered riprap on south end; concrete slab on bluff face and blocks at bluff toe; brush and logs thrown on bluff; northern part appears more stable (Fig. D38).						Remarks When water level is high, waterline is at toe of bluff (Fig. D16)

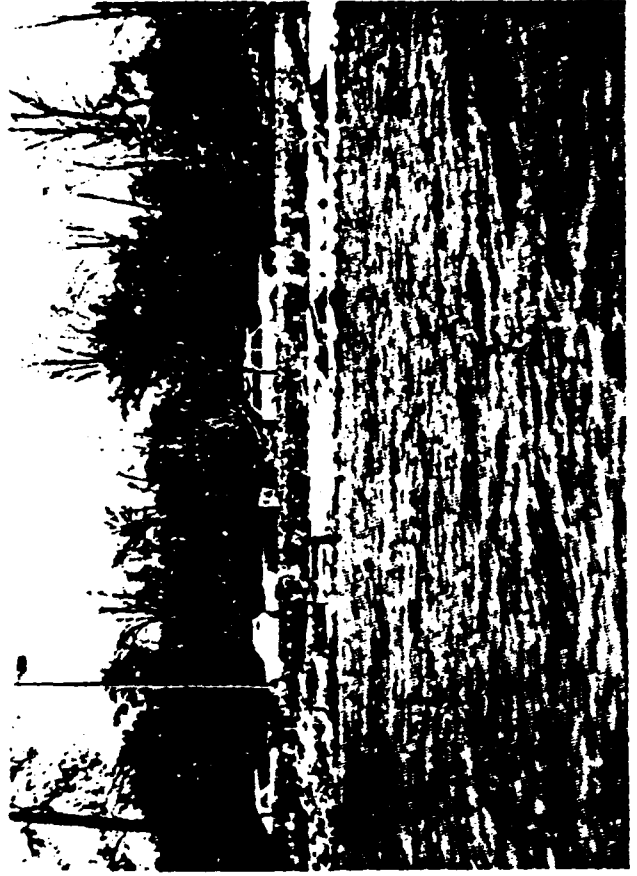
Figure D47. DR reach 2a, 20 May 79.

BEACH Photo No.	<input checked="" type="checkbox"/> Yes <input type="checkbox"/> No	Orientation NE-SW	Width 3-10	Texture Sand with gravel (Fig. D47)	Remarks Concrete slabs scattered along water line (Fig. D48)				
BLUFF Photo No.	<input type="checkbox"/> Yes <input checked="" type="checkbox"/> No	Orientation NE-SW	Height .5-2	Slope No distinct bluff (Fig. D47)	Length 300	Evidence of Surface Runoff Rills Gullies	Evidence of Groundwater Seepage Staining Damp Zone	Vegetation Other	Remarks Clumps of fallen grass
SOIL	Vegetation Collapsing <input type="checkbox"/> Stable <input checked="" type="checkbox"/> Type		Remarks						
NEARSHORE CONDITIONS	<input checked="" type="checkbox"/> Artificial (fill)	Crags Texture Sand	Color Grey	Structures None observable	Remarks				
	<input checked="" type="checkbox"/> Natural	Bathymetry Shelf <input type="checkbox"/> Drop off <input checked="" type="checkbox"/> (Fig. D58)	Texture Sand with scattered boulders	Redforms <input type="checkbox"/> No	Vegetation <input checked="" type="checkbox"/> No Type Density	Remarks

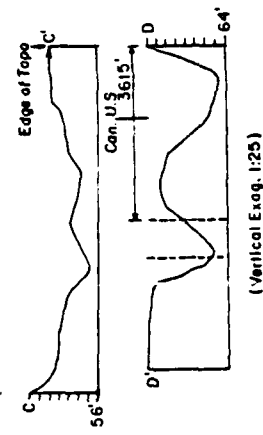
Figure D74. Generalized river cross-sections, sites 28 to 31, St.

Photo No.		Shelf Steep Shelf/Drop off (Fig. D74) X		Sand		Commercial Medium		Park			
		Sparse Medium Dense		Sparse Medium Dense		Slope		Nearshore Conditions		Remarks	
		Protective Structures		Vegetated Bluff		Grass		Similar			
		B.H. RR Gab Other X									
DOWNSTREAM CONDITIONS		Protective Structures		Vegetated Bluff		Slope		Nearshore Conditions		Remarks	
Photo No.		B.H. RR Gab Other X				Grass		Similar

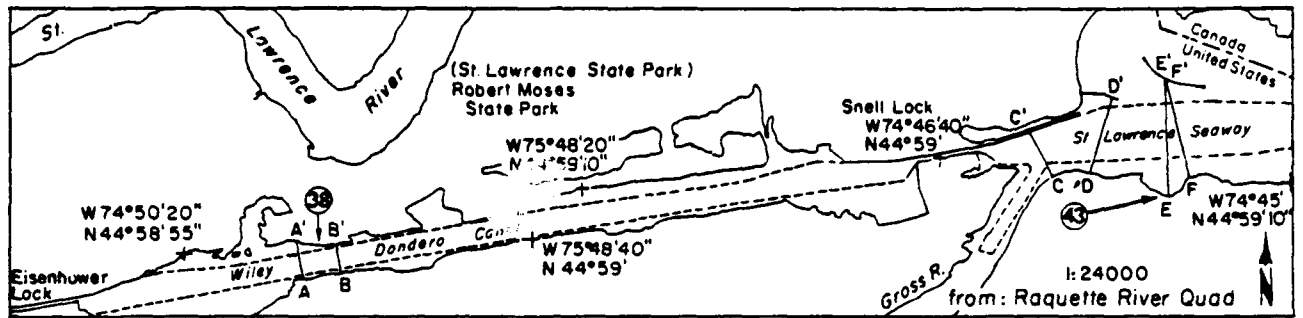
Figure D76. Generalized river cross-sections, sites 38 to 43, St. Lawrence River.

LANDUSE		Bathymetry		Shelf/Drop off		Texture		Vegetation Type		Remarks	
Photo No. _____		Steep (Fig. D76)		X		Gravel and cobbles		X		None	
UPSTREAM CONDITIONS		Residential <input type="checkbox"/> Medium <input type="checkbox"/> Dense <input type="checkbox"/>		Sparse <input type="checkbox"/> Medium <input type="checkbox"/> Dense <input type="checkbox"/>		Commercial		Agricultural		Recreational	
Photo No. _____		Protective Structures		Vegetated Bluff		Slope		Nearshore Conditions		Remarks	
Photo No. _____		B.H. RR Gab Other		X		Slope		Similar		Grass plain in backshore	
DOWNSTREAM CONDITIONS		Protective Structures		Vegetated Bluff		Slope		Nearshore Conditions		Remarks	
Photo No. _____		B.H. RR Gab Other		X		Slope		Similar		Grass-covered bluff looks stable; grassy plain in backshore
