AIRFIELD PAVEMENT EVALUATION

PISCO AND LA JOYA AIR BASES, PERU

AIRFIELD PAVEMENT EVALUATION
OF
PERUVIAN AIR BASES

PREPARED FOR
TACTICAL AIR COMMAND (TAC)

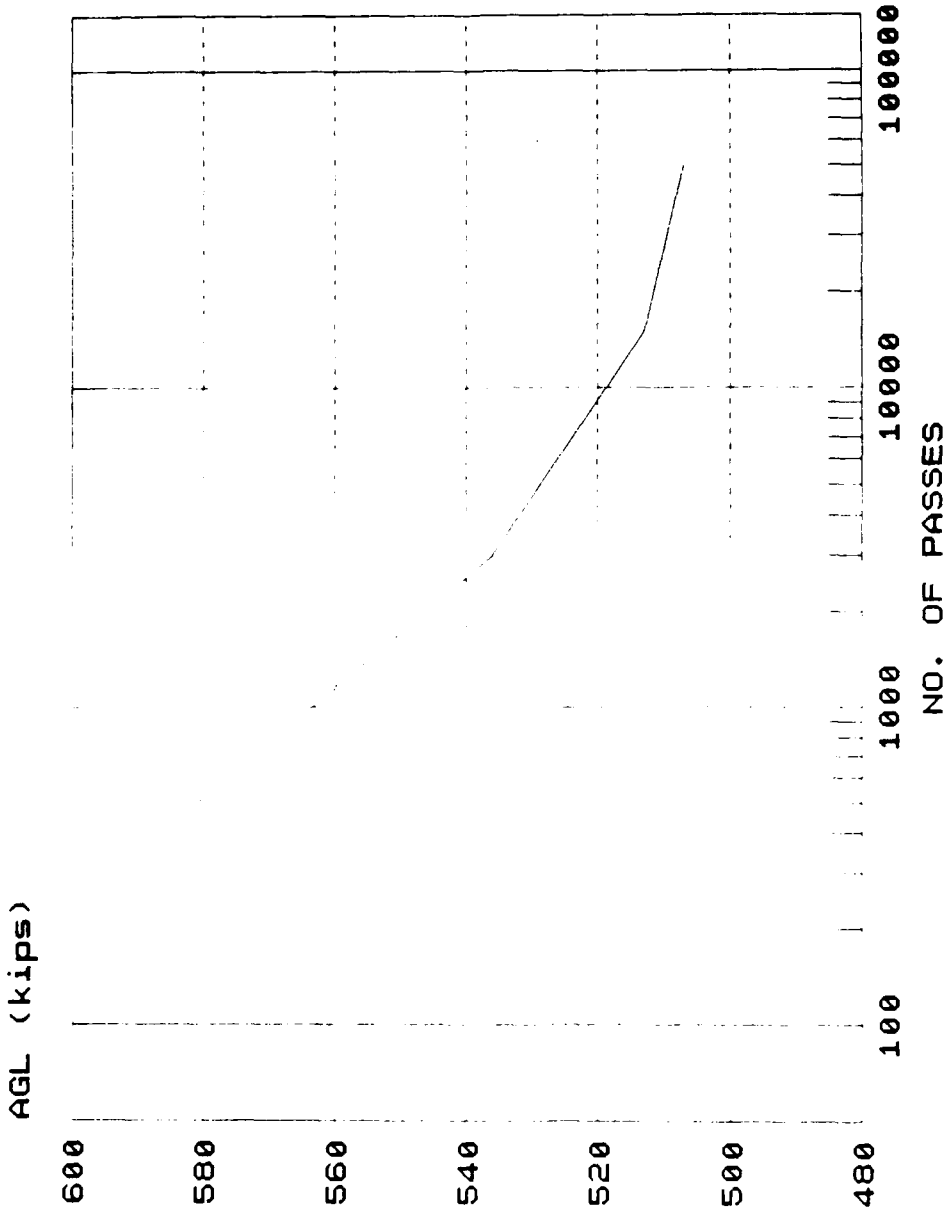
FIGURE 1

Solution: From Appendix F, the Allowable Gross Loads for a C-5 at Pass Intensity Levels I-IV (50,000, 15,000, 3,000, and 500) are 507, 513, 536, and 581 kips, respectively. The weights and passes are plotted on semi-log paper as shown in Figure 1. The completed graph indicates a 550-kip C-5 can make approximately 1,500 passes on Feature T01A before the pavement fails.

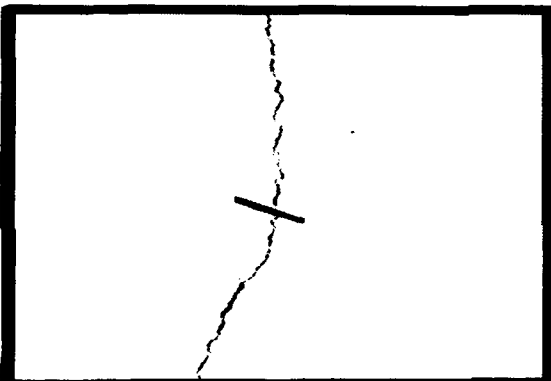
PHOTO 3: Longitudinal, environmental, and load-related cracks limited to the outer 3 paving lanes of the Parallel Taxiway. This is common to both sides, but isolated to the Parallel between Taxiways 4 and 5.

The only obvious distresses on the Parallel Taxiway are some environmentally-related block cracks limited to one paving lane between ladder Taxiways 4 and 5. The only other distresses are the same type of diagonal cracks that were present on the runway. These cracks appear to follow the same pattern and continue along the same geological disturbance path. The recommended maintenance for this type of cracking is to seal the cracks and watch for any further deterioration.
