## Richard B. Russell Dam and Lake

Savannah River, Georgia And South Carolina

# Final Foundation Report Volume 2 of 2

RICHARD B. RUSSELL PROJECT  
SAVANNAH RIVER, GEORGIA AND SOUTH CAROLINA  
FINAL FOUNDATION REPORT  
CONCRETE DAM, EMBANKMENTS, AND POWERHOUSE

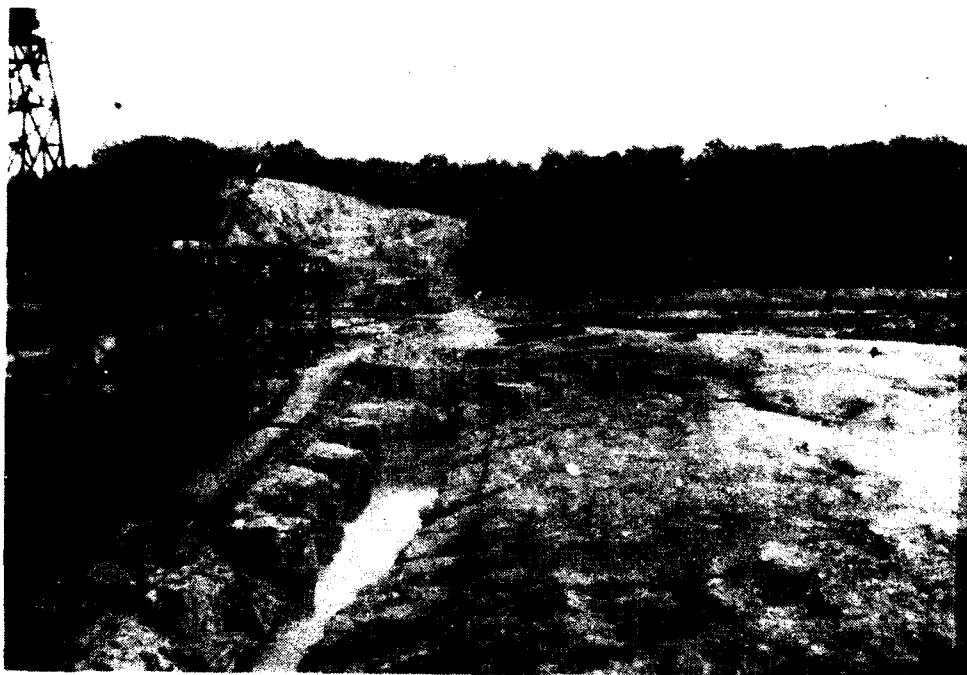
Photo 109 - Power excavation (May 1979)

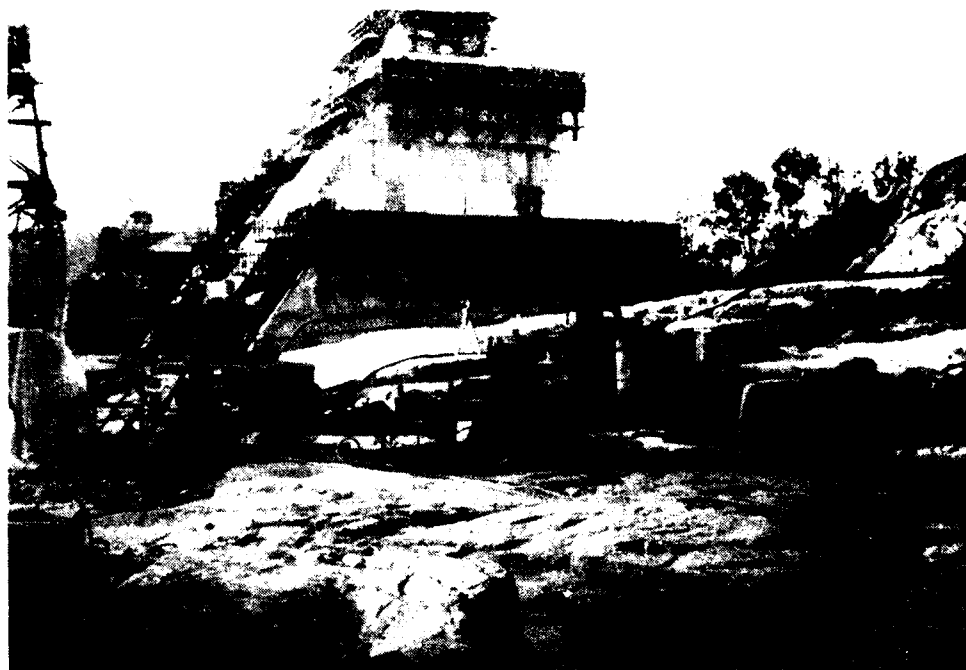
Photo 186 - Grout plant - South Carolina embankment.
