# Embankment Criteria, Performance, and Foundation Report

**Waco Lake  
Bosque River, Texas  
Brazos River and Tributaries, Texas**

January 1990

SUBJECT: Waco Lake, Texas, Embankment Criteria and Performance Report

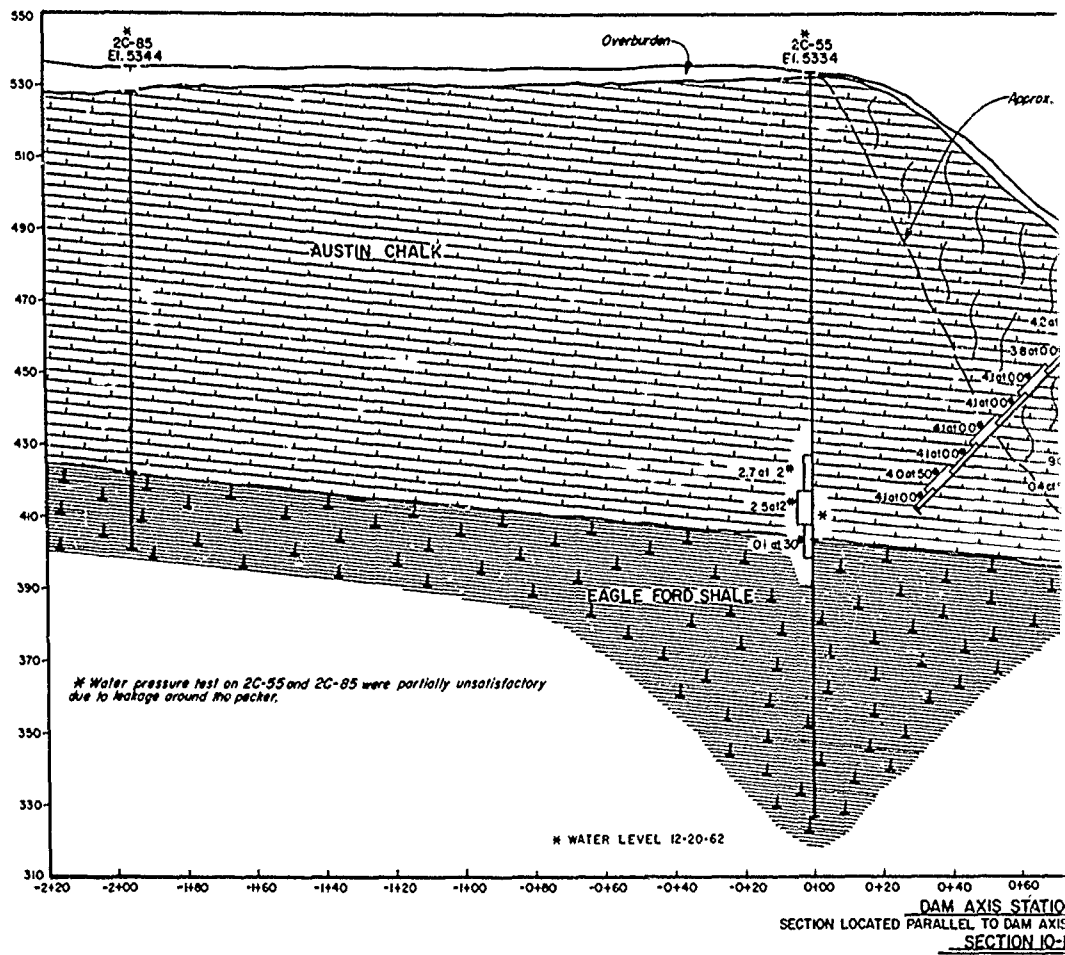
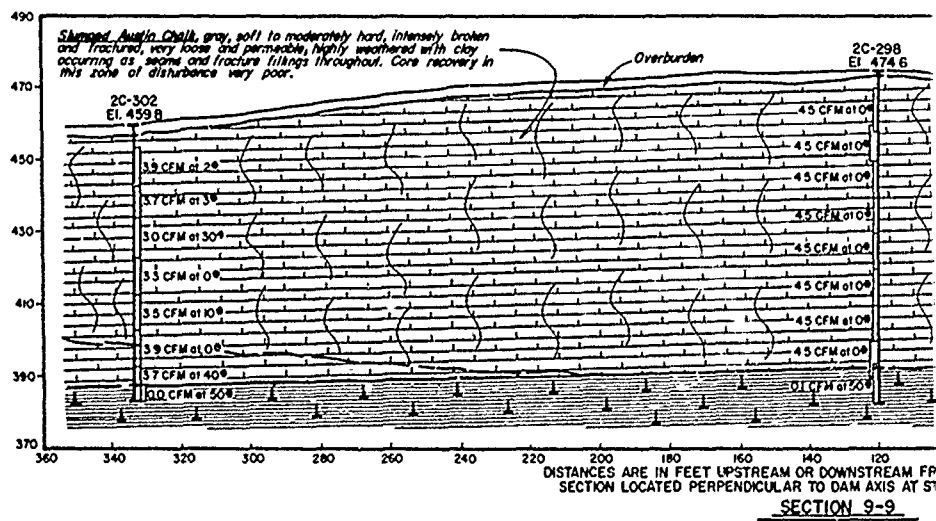
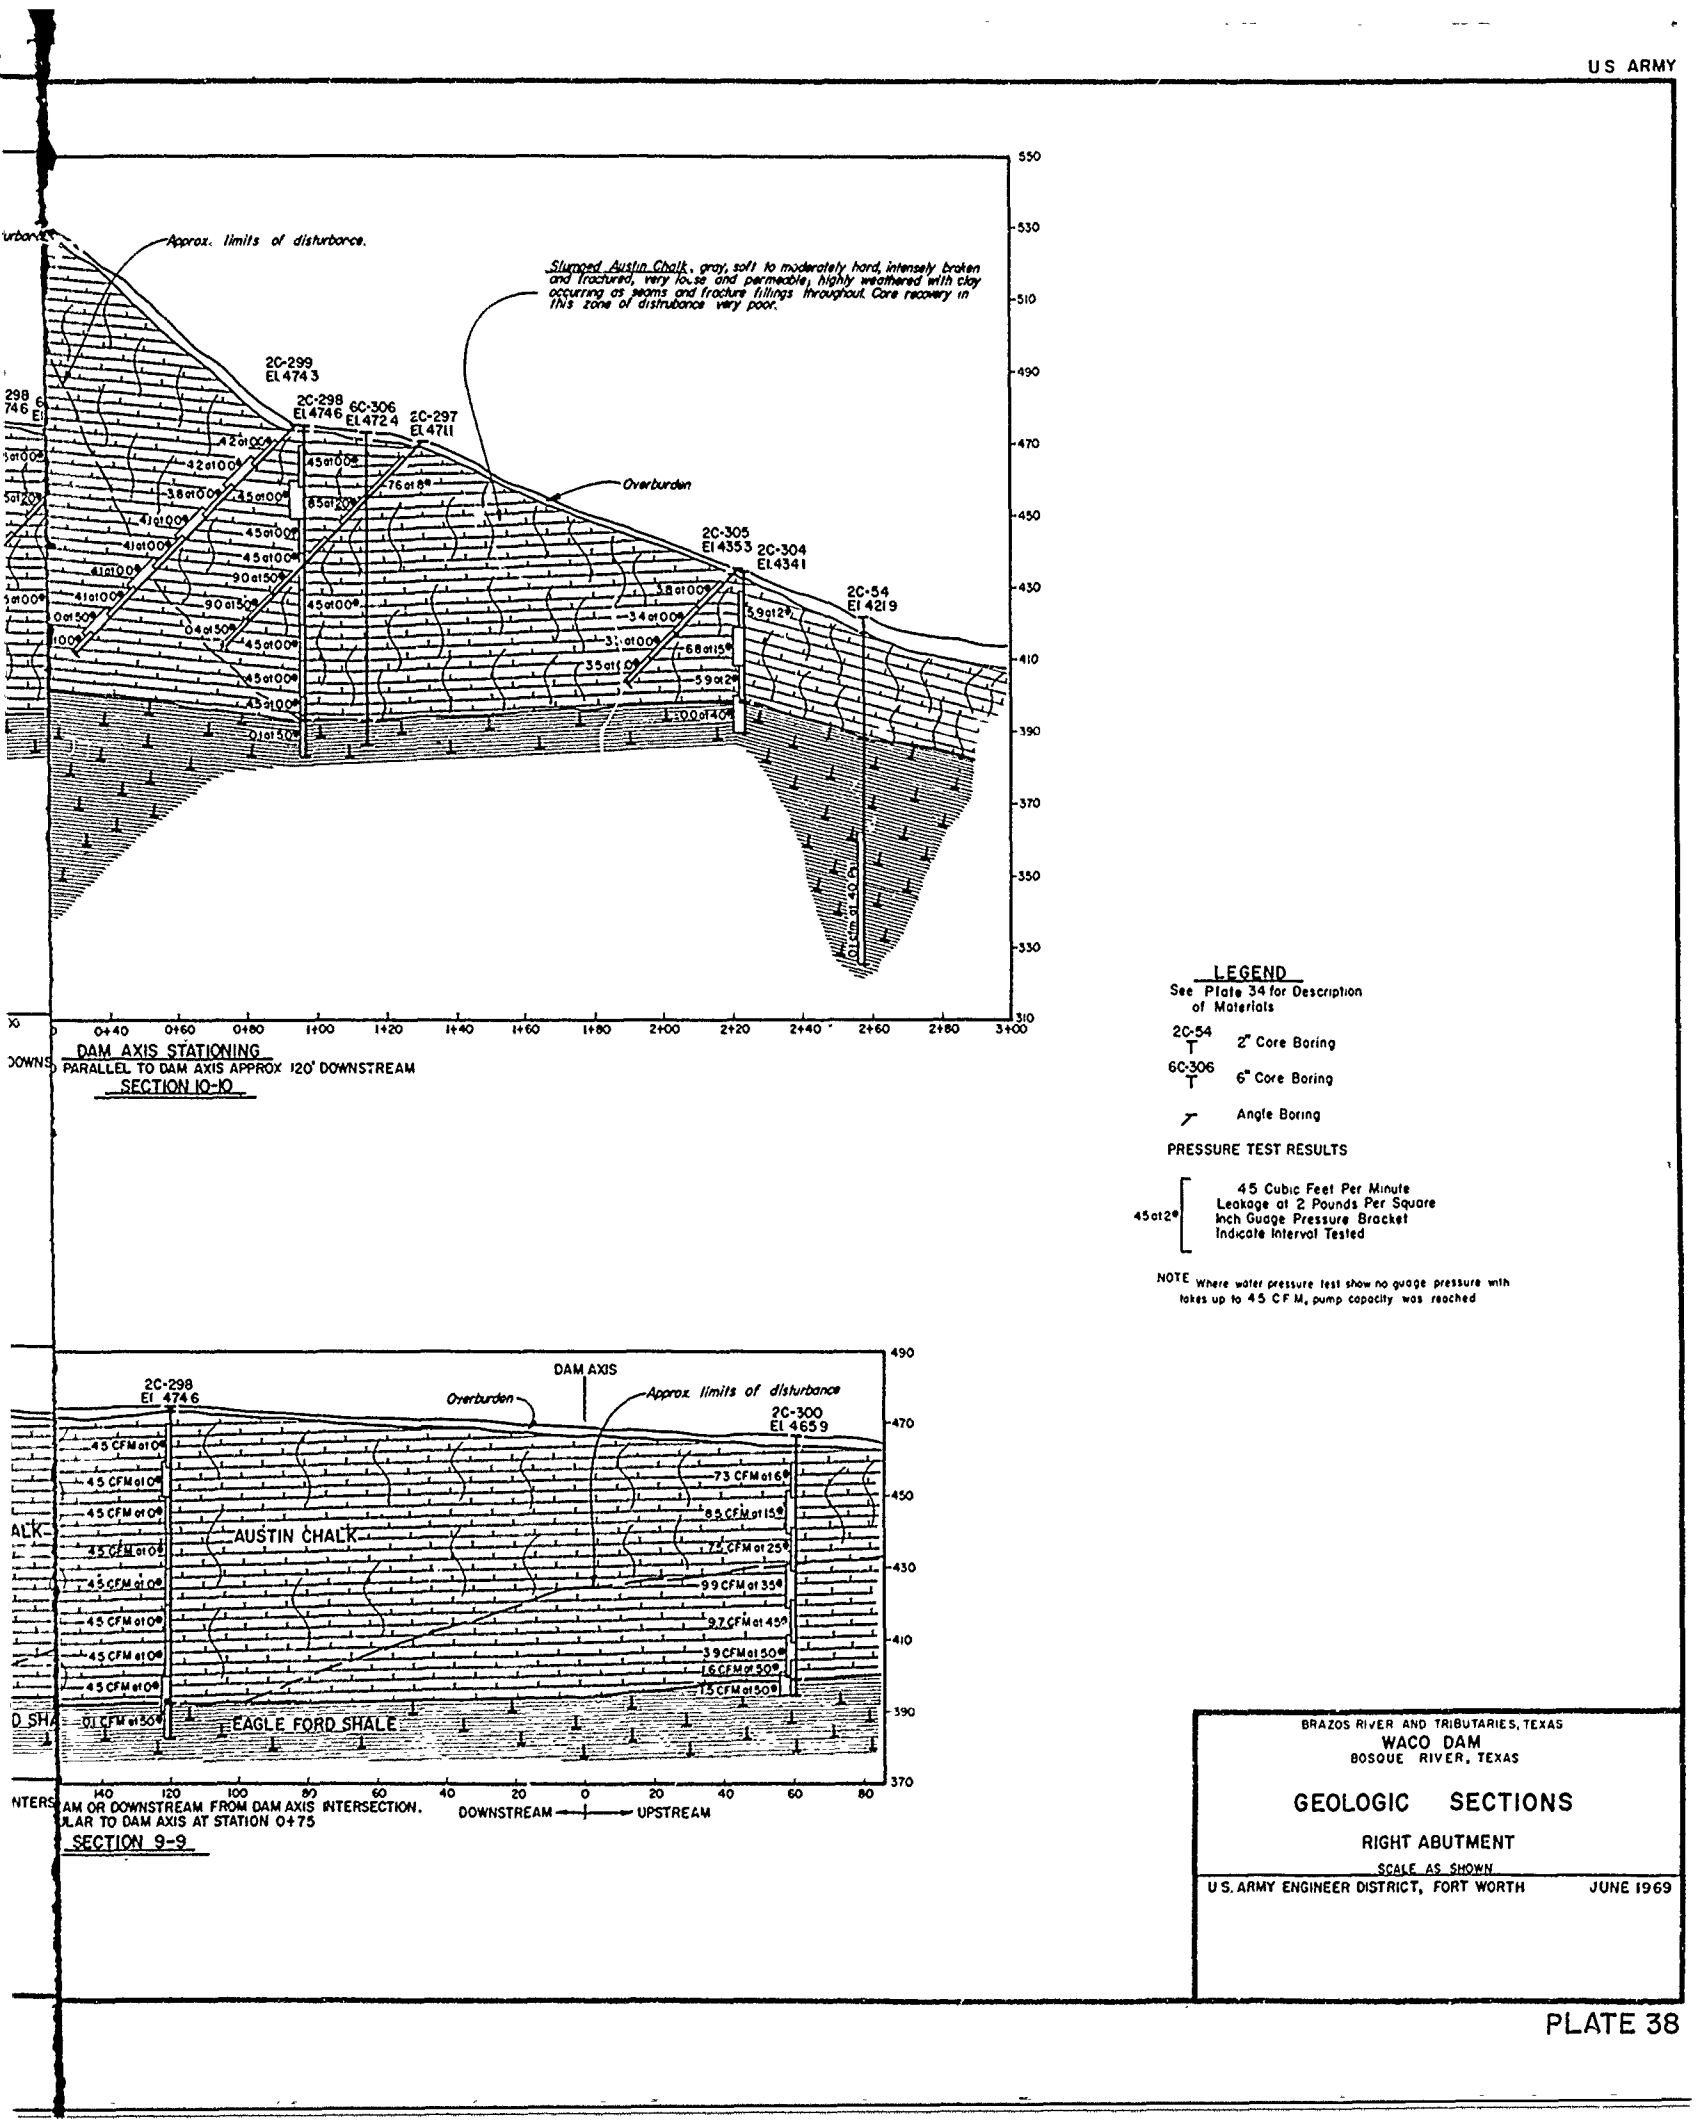
Approx. limits of disturbance.

Slumped Austin Chalk, gray, soft to moderately hard, intensely broken and fractured, very loose and permeable, highly weathered with clay occurring as seams and fracture fillings throughout. Core recovery in this zone of disturbance very poor.

45 at 12" 45 Cubic Feet Per Minute Leakage at 2 Pounds Per Square Inch Gauge Pressure Bracket Indicate Interval Tested

NOTE Where water pressure test show no gauge pressure with leaks up to 45 CFM, pump capacity was reached

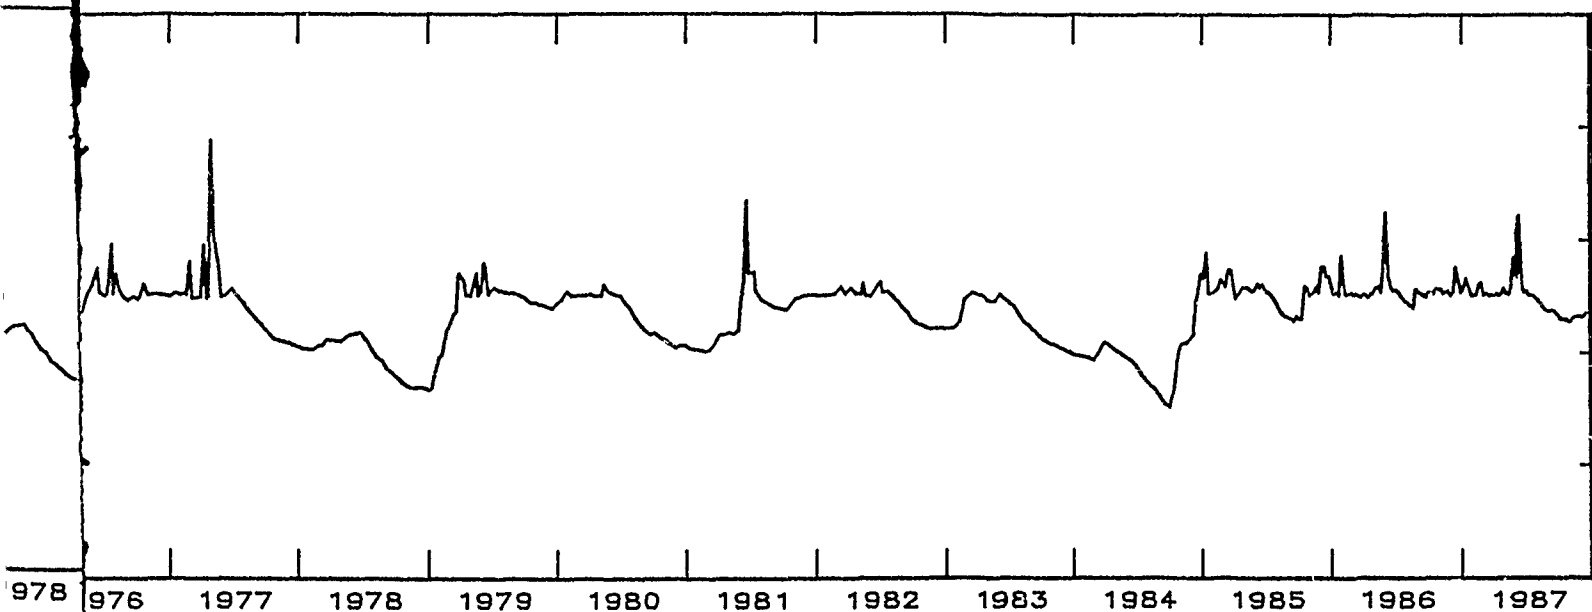
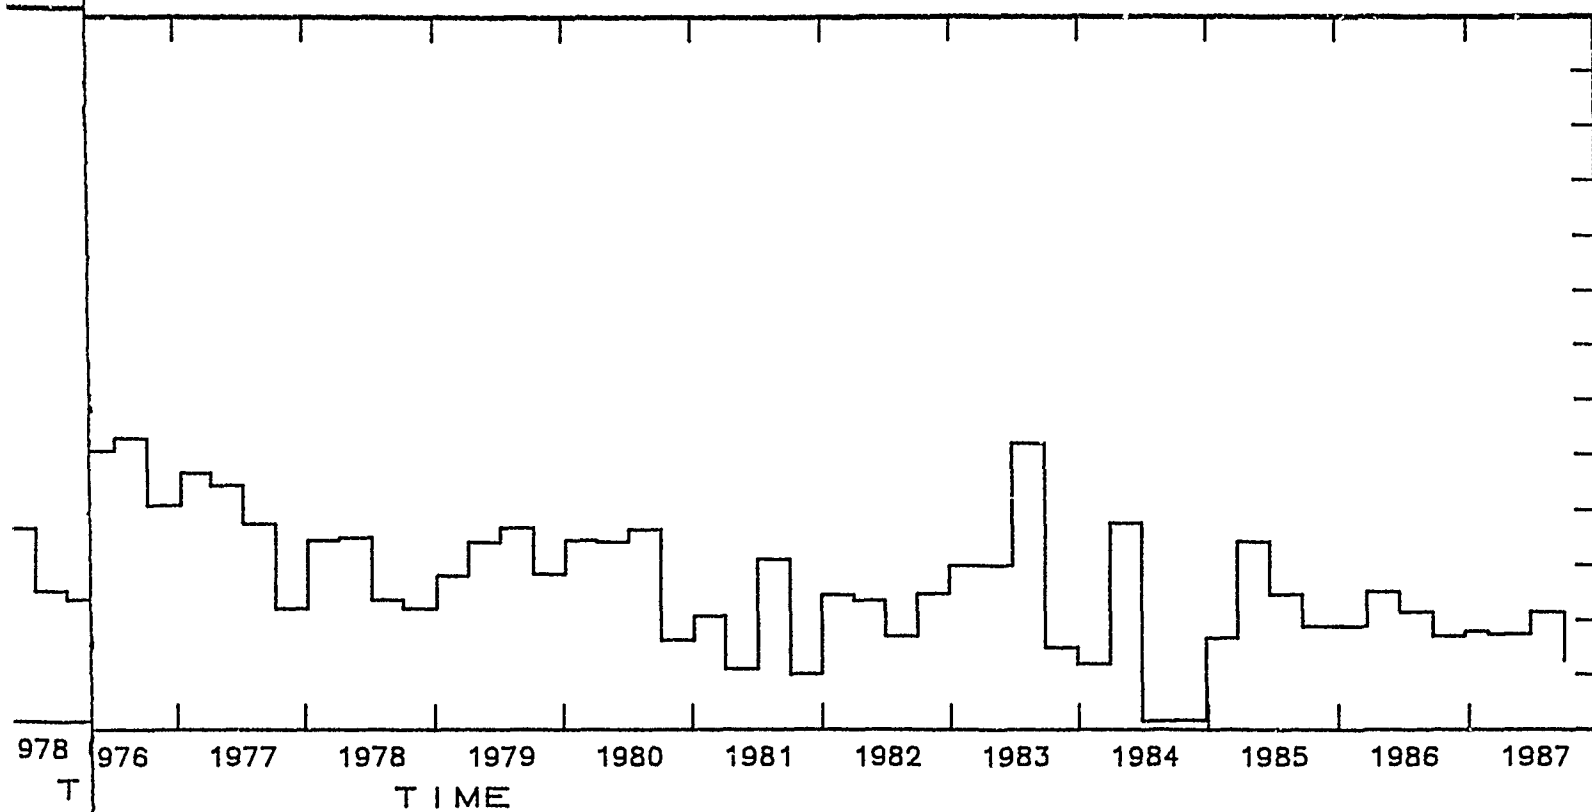
WACO LAKE  
FORT WORTH DISTRICT  
LAKE ELEVATION  
AND  
GALLERY DRAINAGE vs. TIME

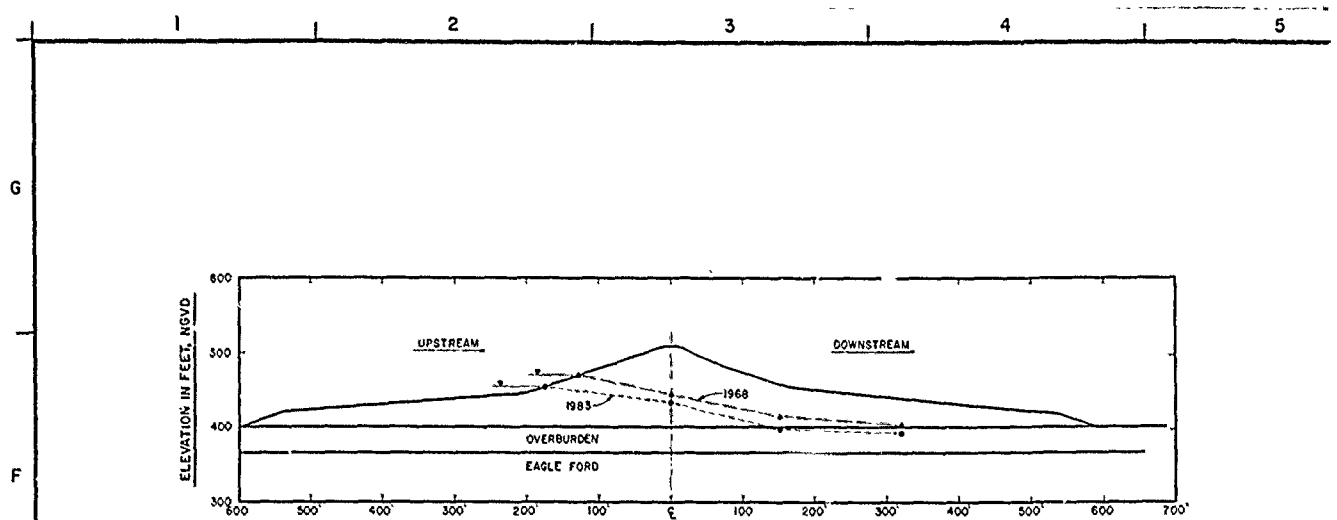
FIGURE 1  
FILL-OVERBURDEN PIEZOMETERS  
STATION 8+00

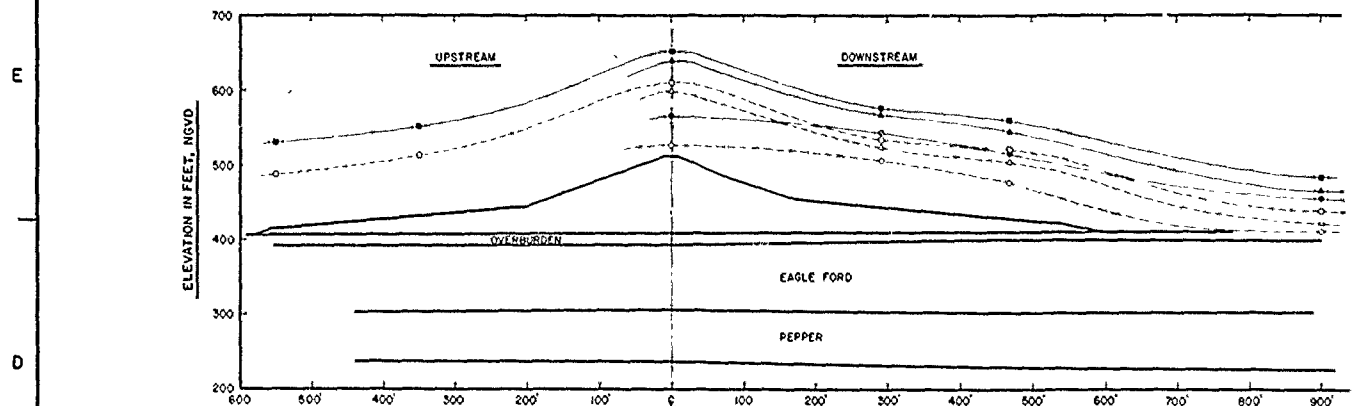
FIGURE 3  
FOUNDATION PIEZOMETERS  
STATION 44+00

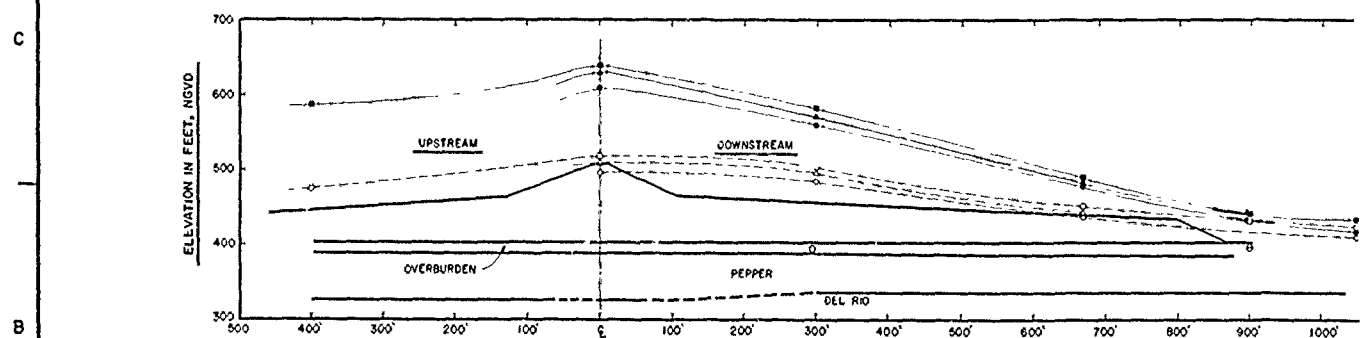
FIGURE 5  
FOUNDATION PIEZOMETERS  
STATION 55+00

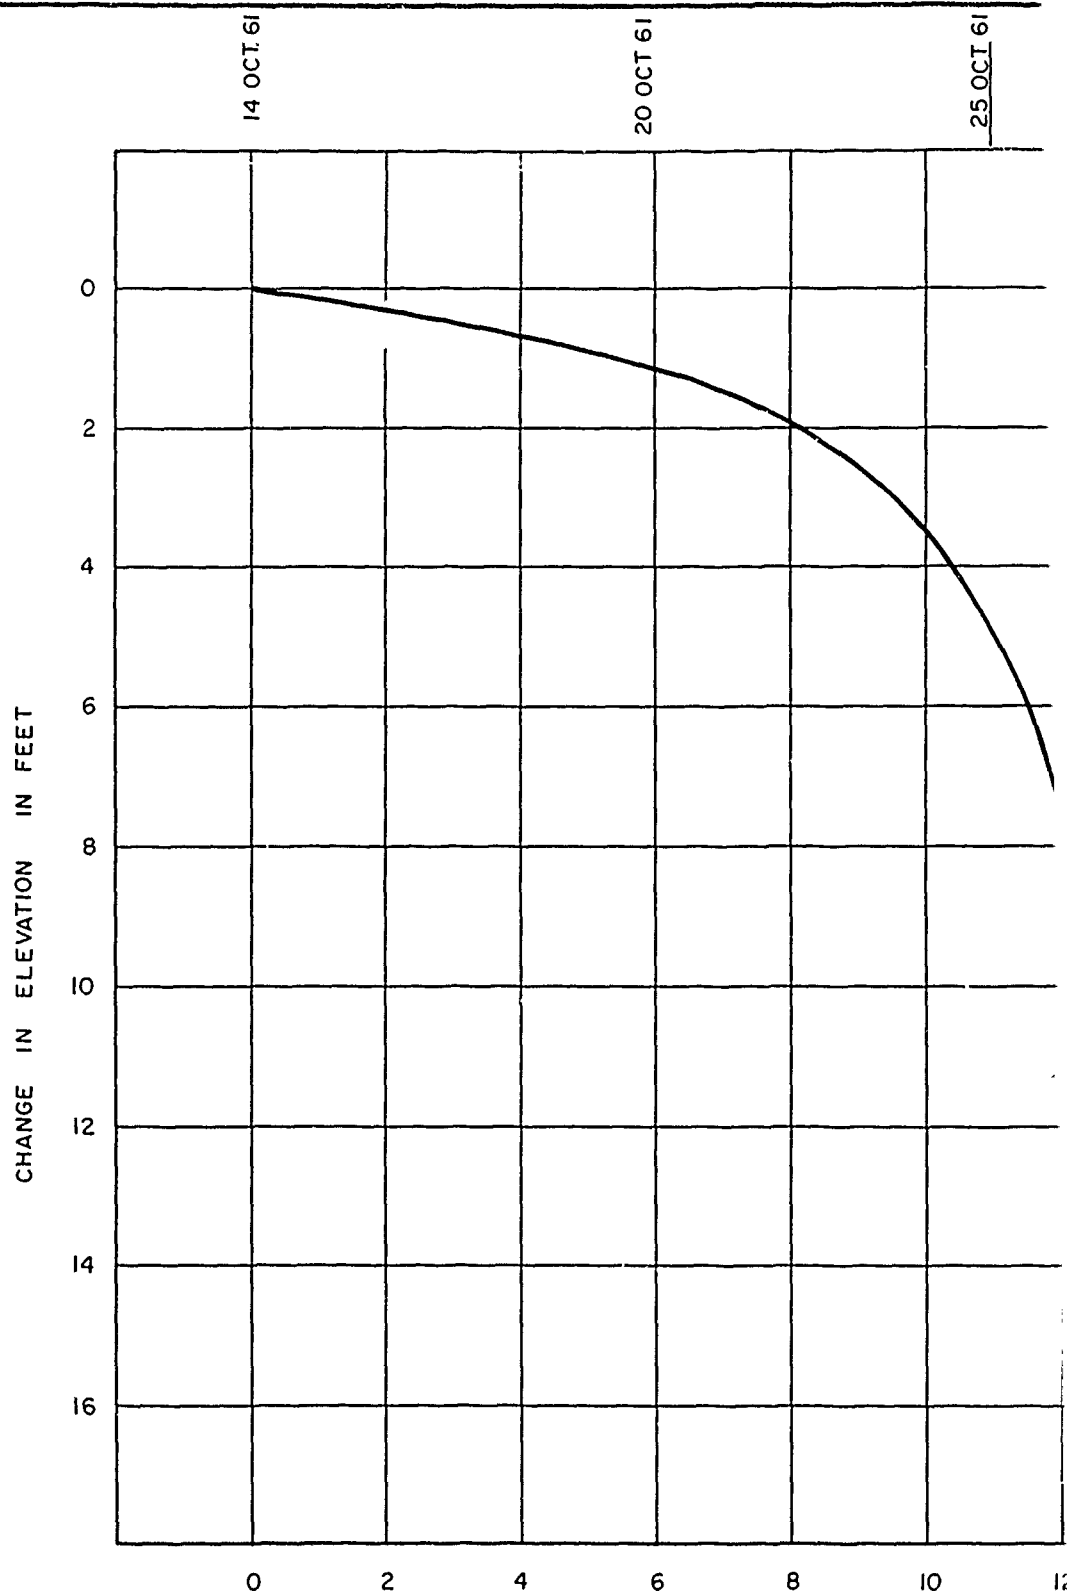
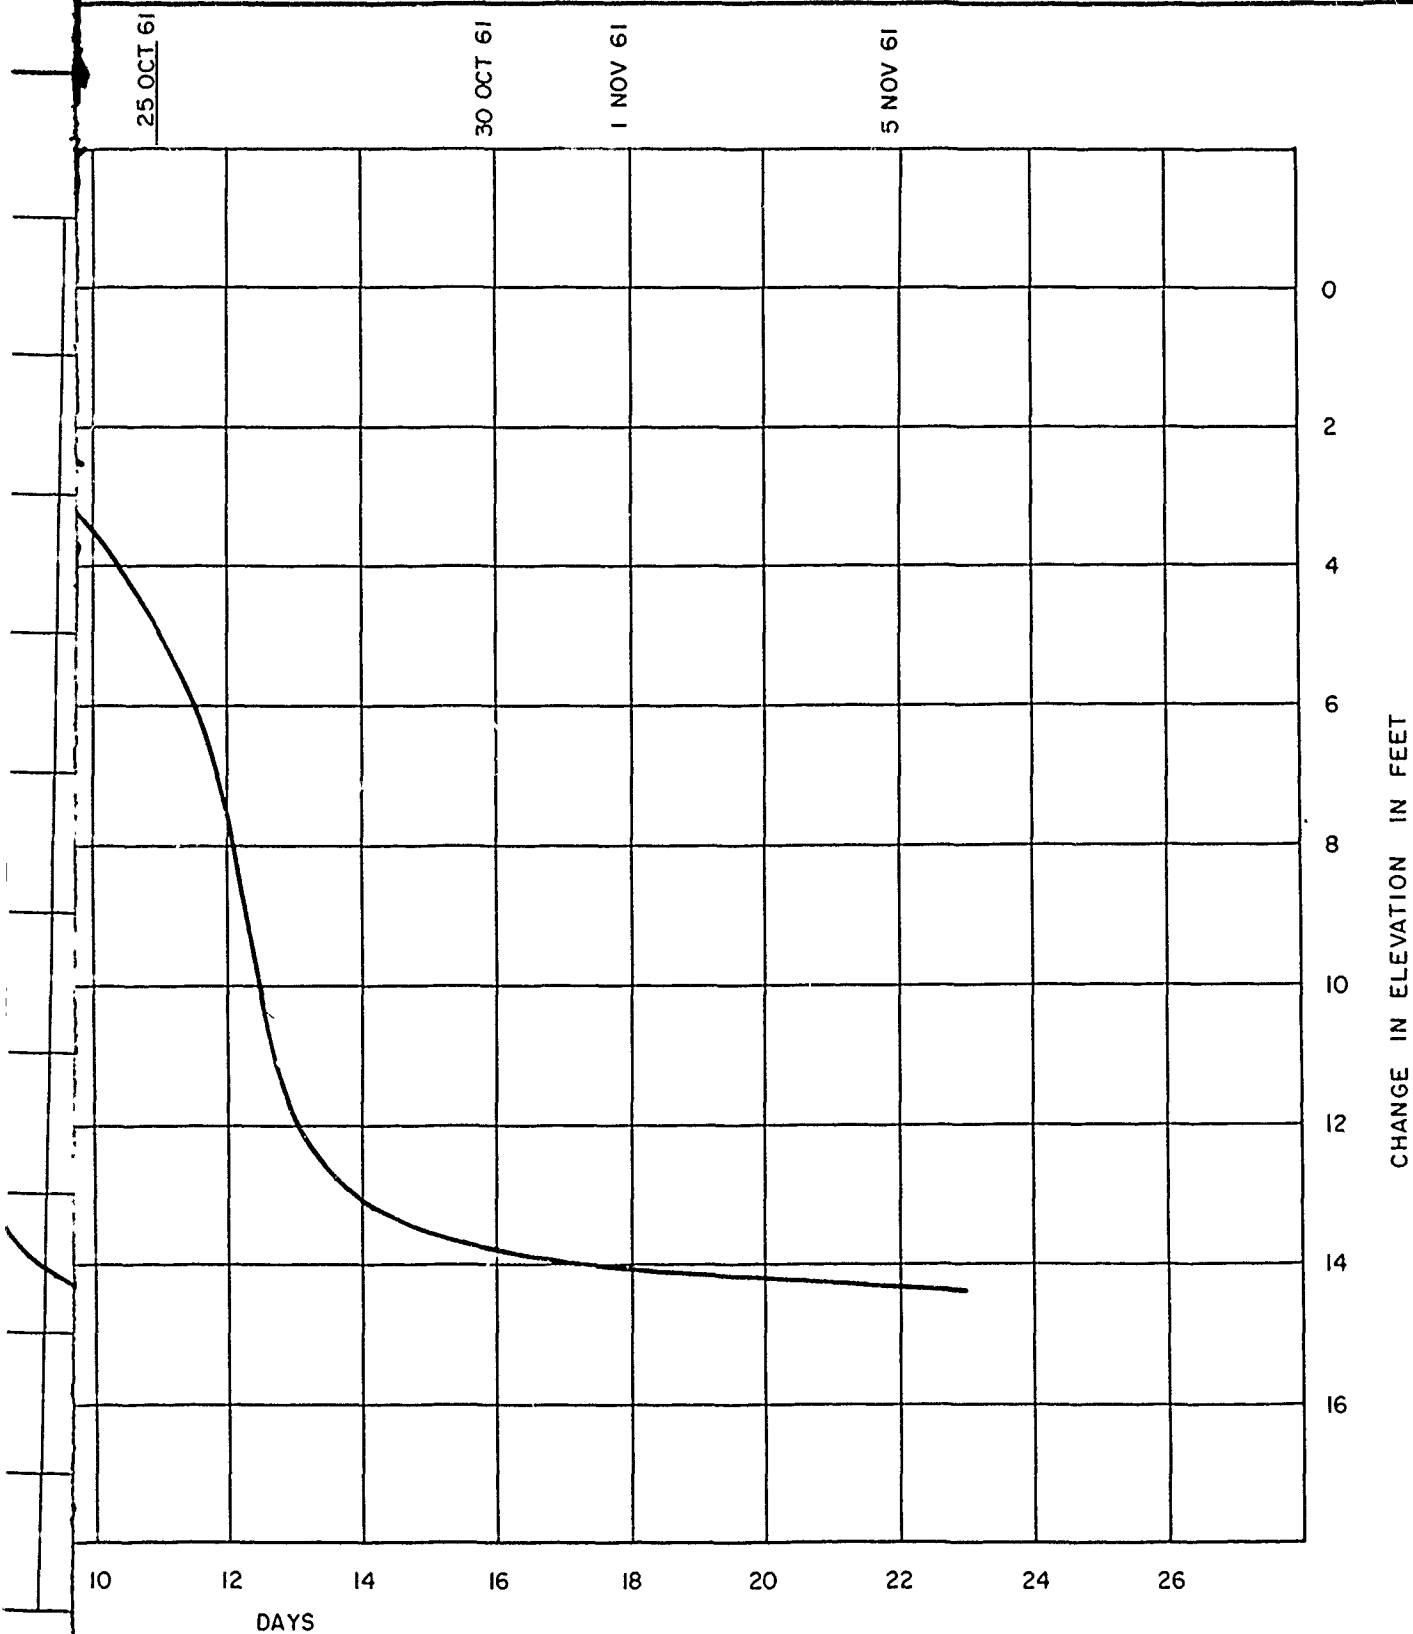
BRAZOS RIVER AND TRIBUTARIES, TEXAS  
WACO DAM  
BOSQUE RIVER, TEXAS  
RATE OF MOVEMENT  
CENTERLINE POINT  
STATION 55+00  
EMBANKMENT  
SCALES AS SHOWN  
U.S. ARMY ENGINEER DISTRICT, FORT WORTH JAN 11

NOTE:  
MOVEMENT PRIOR TO 14 OCTOBER 1961  
WAS NOT MEASURED.

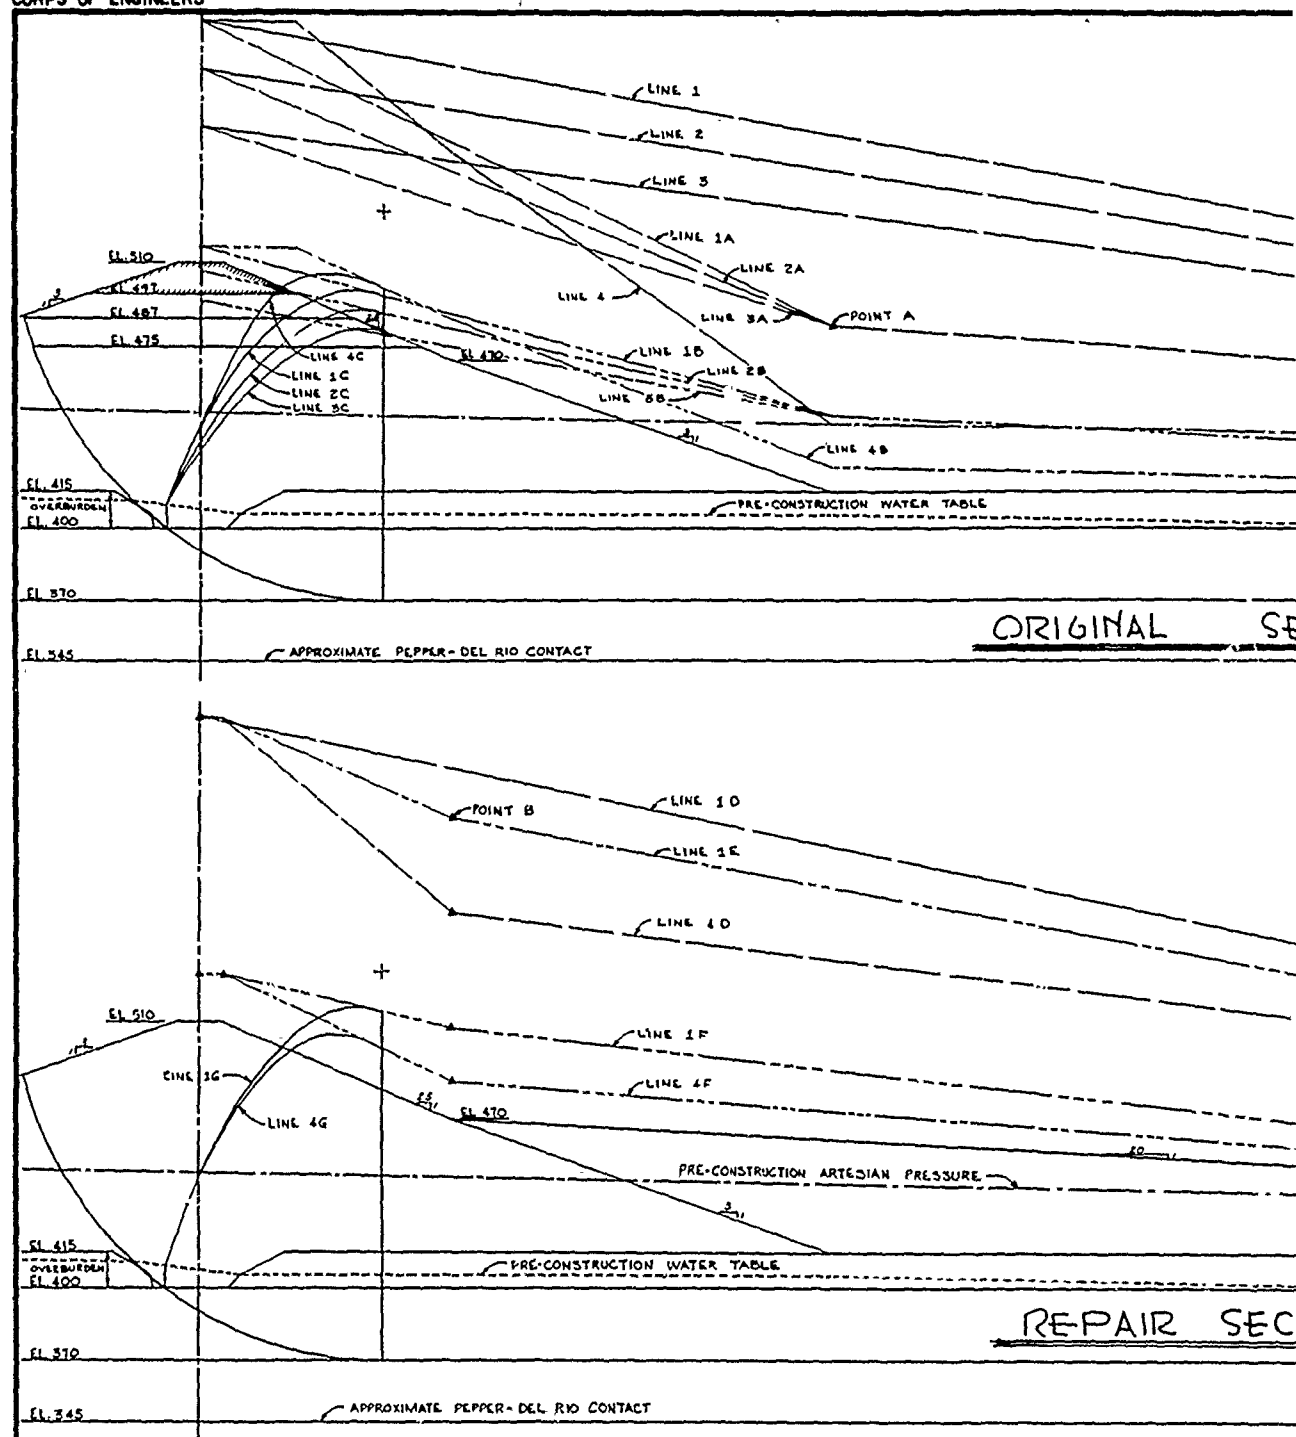
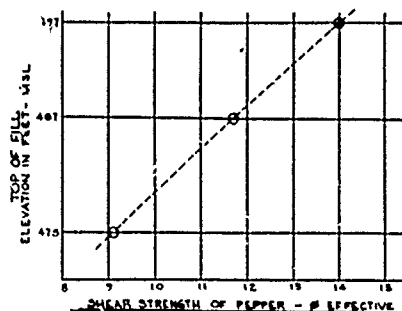
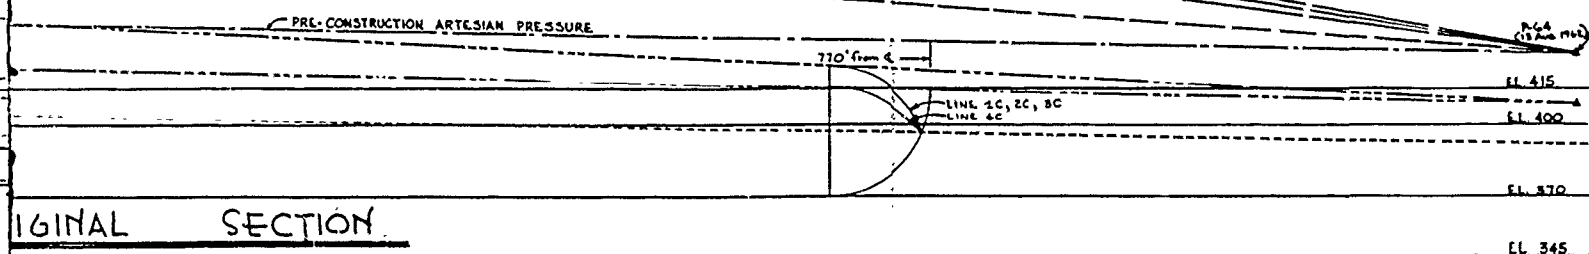
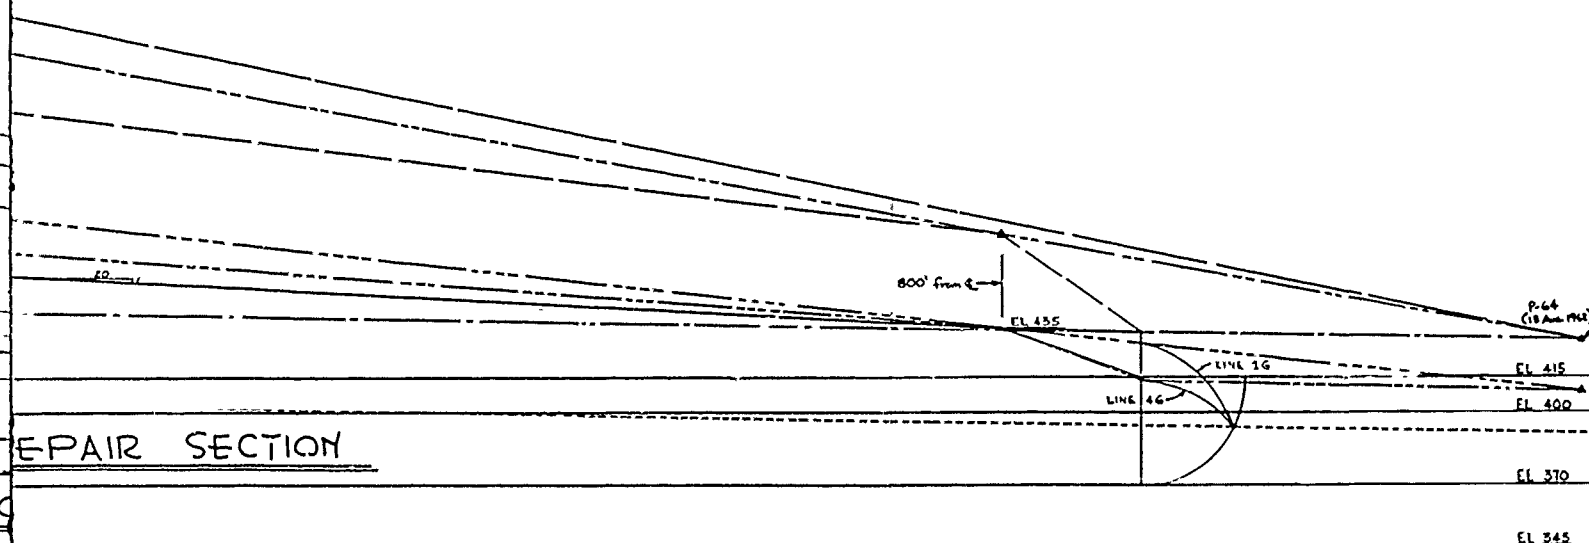
FIGURE 1

1. The slide was analyzed by a simplified procedure for a circular arc plane failure surface to determine the shear strength required for stability ( $sf=1.0$ ). The shear strength thus determined was applied to the repair section using comparable pore pressure assumptions to determine the safety factor.

2. The slide was analyzed for three elevations for the top of fill to show variation of strength required as construction of fill progressed. The results are summarized in Figure 1. The pore pressures used are identified as line series 1, 2, and 3. The repair section was analyzed using only the shear strength determined from the analysis of the slide with the fill at El. 497, and a safety factor = 1.72 was obtained.

3. The slide was analyzed using pore pressure line series 4, and the shear strength in the Pepper shale was determined to be  $\phi$  (effective) = 9.5 degrees. This value was applied to the repair section and a safety factor = 1.37 was obtained.

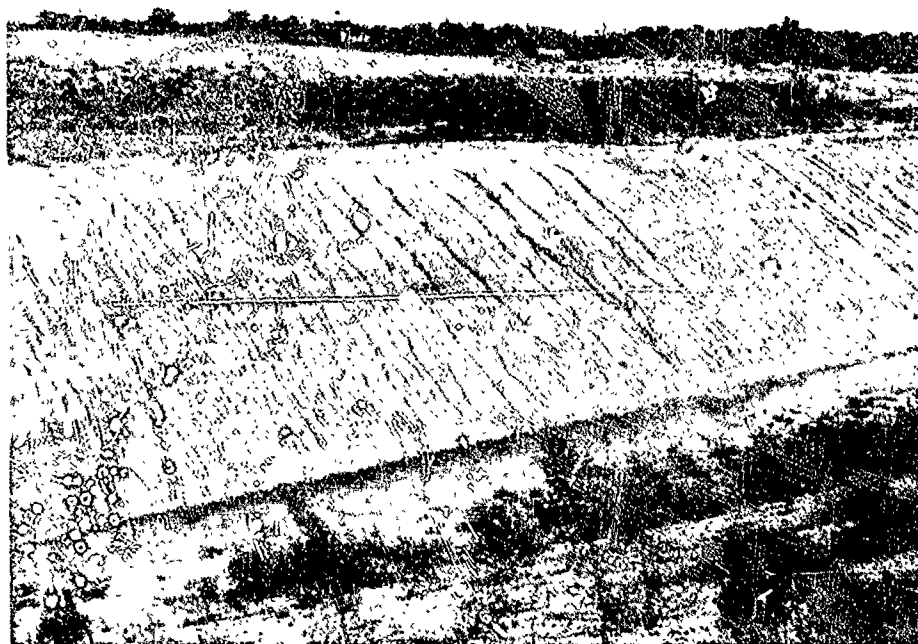
PHOTO 13. Oxidized sandstone seam in the Pepper shale  
in the middle inspection trench 1100 feet  
D/S from dam axis station 55+00.

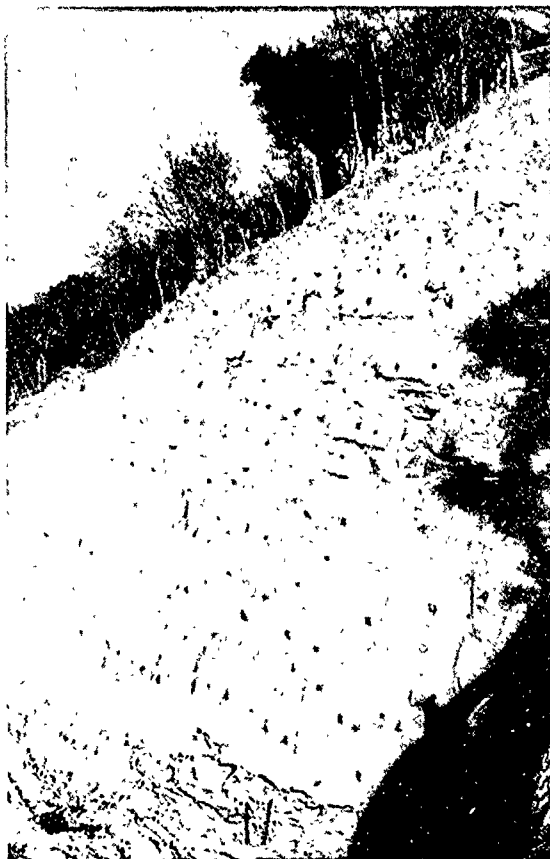
required only scaling and removal of minor overhangs (See Photos 26 and 27. On the side slopes, the loose material and overhangs were removed as much as practical, and the fill tamped in tight with hand equipment. The placement of rock bolts and protective wire mesh undoubtedly restricted the amount of sloughing, and only minor quantities of loose chalk occurred under the mesh. Very little of the mesh stretched or tightened during the time it was in place. All mesh and bolts were removed or cut as the fill was brought up.

PHOTO 26. Austin chalk exposed on the right abutment,  
Feb 64

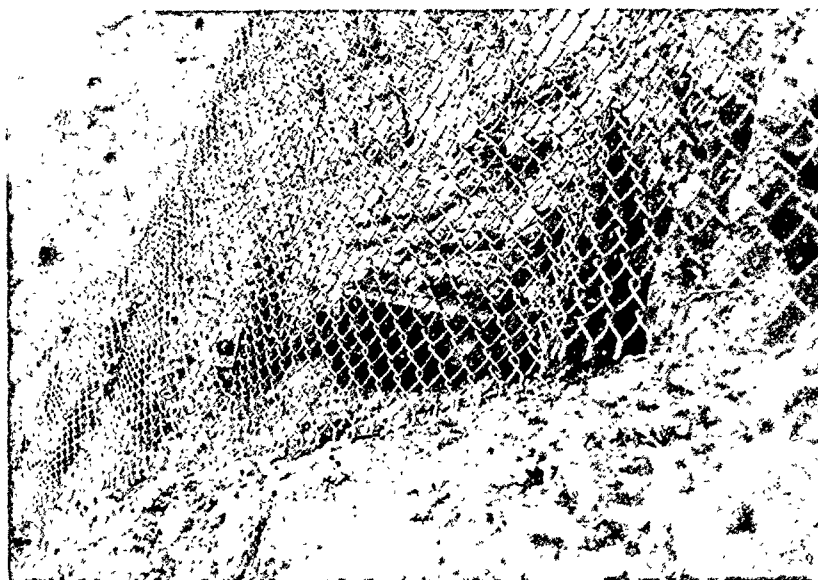
PHOTO 27. Rock bolts and protective wire mesh,  
Feb 64
