WRDC-TR-89-4112

COMPUTER TOMOGRAPHY OF ELECTRONICS

Boeing Aerospace Company  
P. O. Box 3999  
Seattle WA 98124

Interim Report For Period August 1988 - May 1989

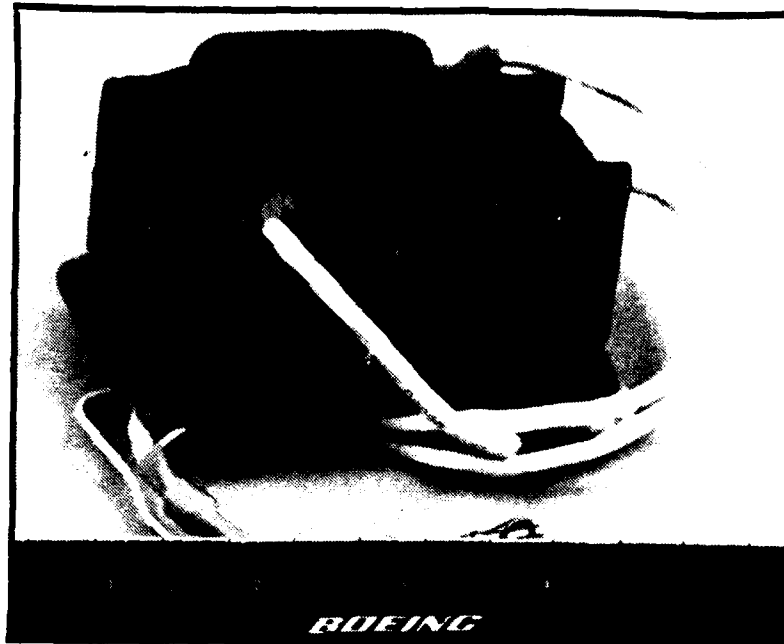
Figure 3.1-1 Steel 'E' core transformer, potted

The 'E' core transformer type in Figure 3.1-1 is shown unpotted in Figure 3.1-2. Scan slices were taken in the orientation as shown by plane A. One area of interest in this slice is to identify the butting of the steel laminations beneath the coil. Misaligned laminations causes decreased efficiency of the transformer and may lead to a reduction in life expectancy of the part.

bands used to hold the laminations together are shown to the upper right and lower left of Figure 3.1-3. The core in Figure 3.1-2 uses only 1 band but the core in Figure 3.1-1 has two.

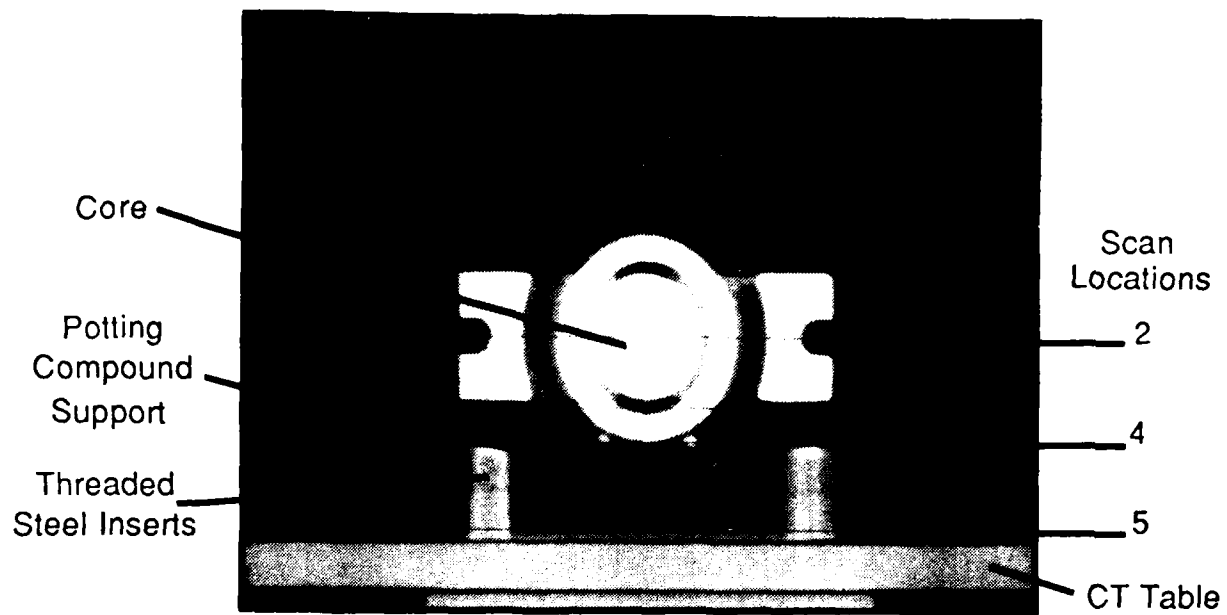
Figure 3.1-7 Digital radiograph of the Figure 3.1-6 transformer from System E

Images of the transformer shown in Figure 3.1-6 were taken on System E. Figure 3.1-7 is a digital radiograph (similar to a standard film X-ray) showing a profile of the component. CT scan slice locations are indicated. The scan taken in location 2, is shown in Figure 3.1-8. The outline of two ferrite 'E' cores facing each other with 26 gauge (0.404 mm diameter) windings in-between is shown. The uneven winding arrangement is of particular interest. Nothing unusual is seen in the alignment of the two ferrite cores. The image does not appear to have the sensitivity to detect micro-cracking in the ferrite. Micro-cracking is of concern, although none is suspected in this unit.

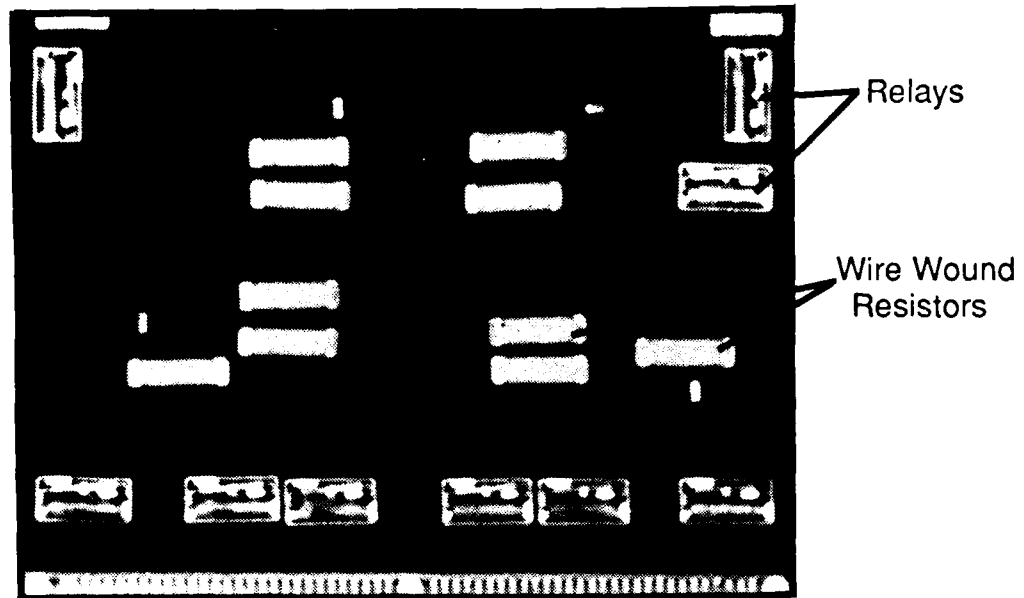
Figure 3.2-4 CT scan of the Figure 3.2-2 circuit board from System A showing the internal structure of the relays

A scan taken a few millimeters above the board is shown in Figure 3.2-4, and reveals information about the internal structure of the relays and precision wound resistors (filled in rectangles). It is conceivable to think that a system with improved resolution would be able to scan a circuit board, identify solder location information and also be able to identify defects in components such as relays without removing them from the board (a costly failure analysis procedure which often results in destroying good parts).

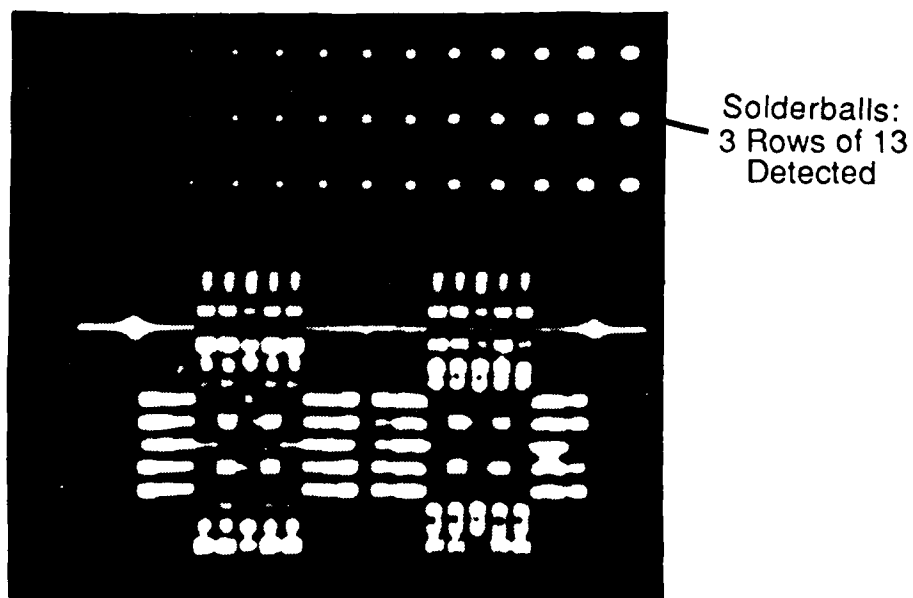
Figure 3.2-7 Laminogram of Figure 3.2-5 board from System B

A laminogram taken on System B (a system primarily designed for CT, but is reconfigured in software for laminography) is shown in Figure 3.2-7. The laminography image shows significant improvement over the Figure 3.2-6 CT image in solder detection including all 13 rows of solder balls, but was unable to

identify voiding and cracking of solder. Using the image analysis capabilities of System B, the top LCC was enlarged in software and is shown in Figure 3.2-8. Note the differences in the amount of solder contained on the pads.

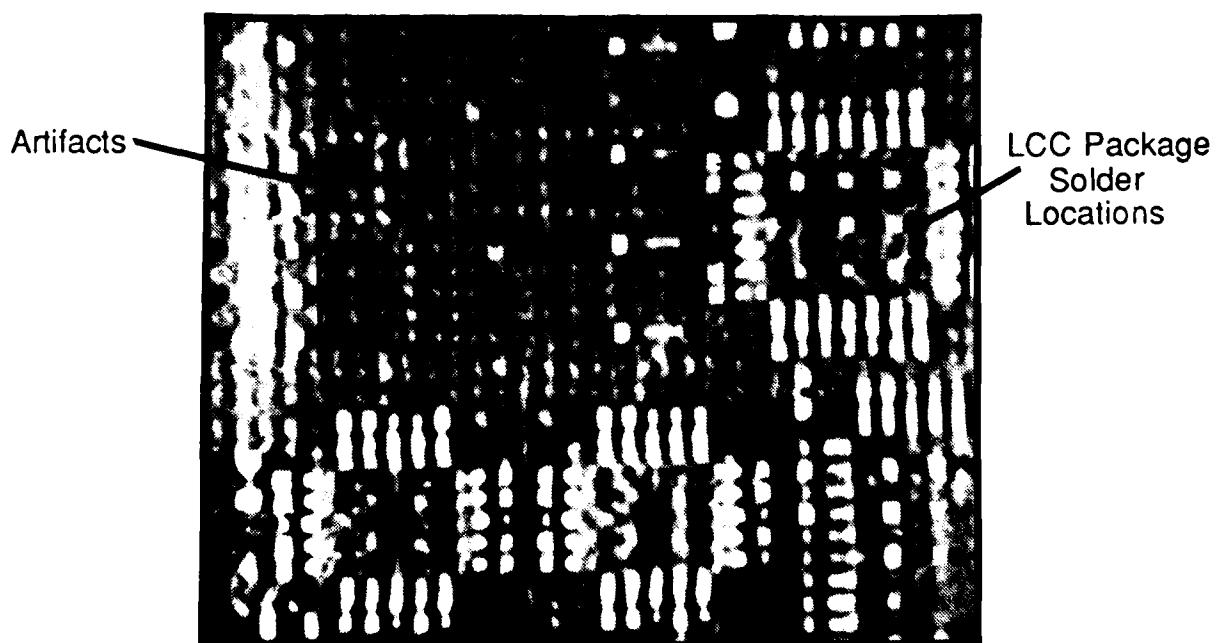
Figure 3.2-13 Laminogram of the rear side of the Figure 3.2-11 board from System B

Moving through the laminographic data set, the rear side of the board is focussed in Figure 3.2-13, indicating the presence of packages to the right and bottom of the view. Although the images show the ability of System B to perform laminography, they fail to identify the areas of interest: namely defects in the solder.

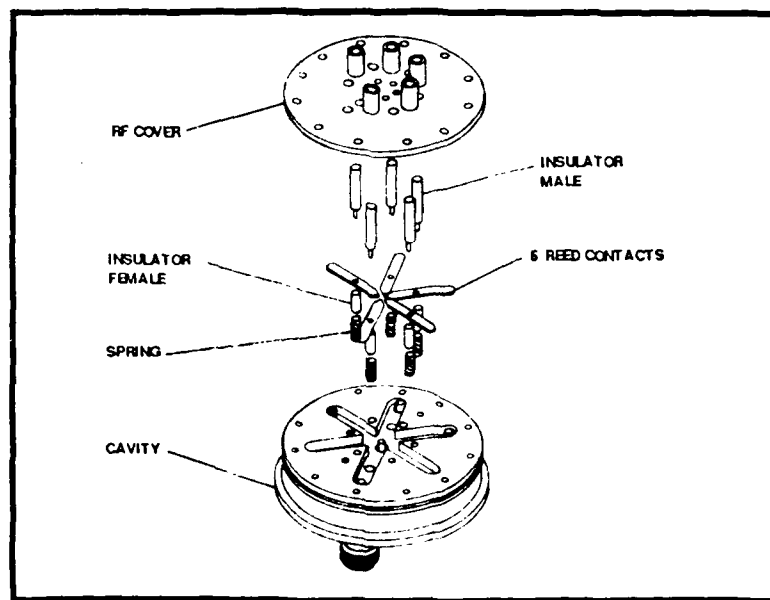
Figure 3.3-9 Exploded view of the multi-pole RF relay; note 5 reed contacts are used

Figure 3.3-9 is an exploded view drawing of the relay. A scan taken on System E, shown in Figure 3.3-10, shows 4 good contacts and one missing (the relay has 5 good contacts, as seen in Figure 3.3-9). Figure 3.3-11 identifies the defective contact, which might be difficult to determine using destructive analysis due to the contact size and orientation within the stainless steel enclosure.

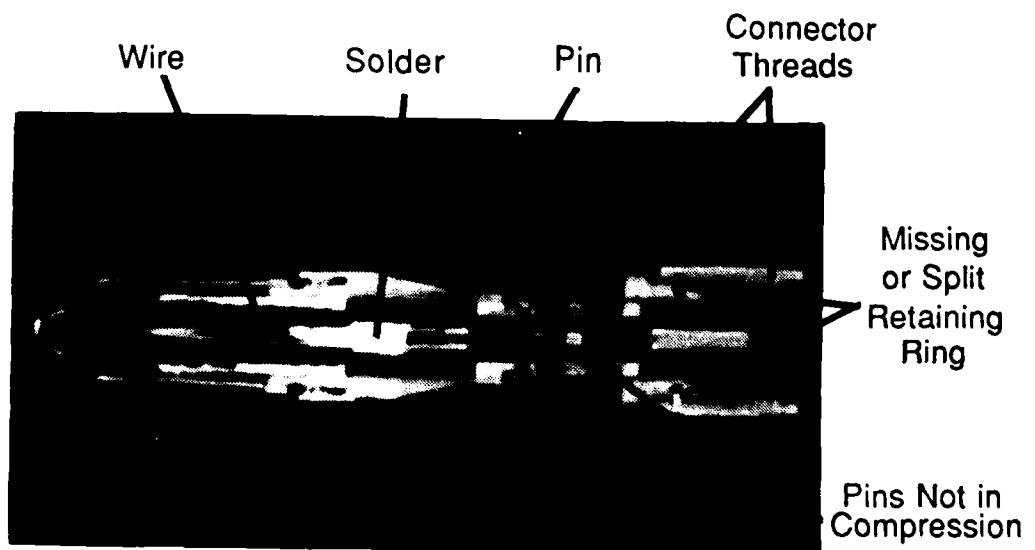
Figure 3.4-2 CT axial image of the Figure 3.4-1 connector from System B

Current inspection methods for the connector involve lot sampling. This is a costly sectioning process whereby the connector is mounted in an acrylic potting compound, sectioned with a saw, and polished. This same analysis sectioning was performed nondestructively using System B where an axial slice was taken across the connector and is shown in Figure 3.4-2.

Reproduction has reduced the visibility of detail that was present on the original display monitor. The steel shell did not prevent the system from obtaining remarkable detail of several internal structures. In the center is the pin where individual strands of the center wire can be identified to the left. Direct center is an

indication of the amount of solder connecting the wire to the pin. Details of the connector threads can be seen (above and below) on both the large and small terminal connections. A gap to the right of the pin (not observable in this photo) between the dielectrics of Parts A and B indicate that the Teflon is not being compressed. Other features such as hermetic rubber rings and retaining rings are also clearly shown.

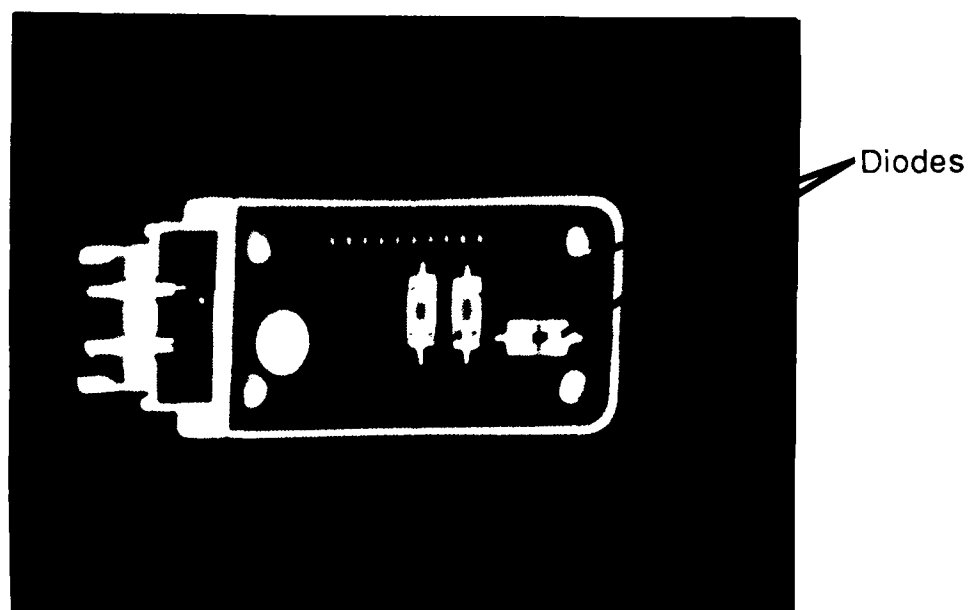
Figure 3.5-4 CT image at scan plane #5 of Figure 3.5-2 from System E

The image reveals density variations in the inlet structure and mechanical or welding voids near the base of the sensor left of center. Figure 3.5-4 is a scan taken in location #5 in Figure 3.5-2 and identifies what appears to be 3 diodes (2 vertical, 1 horizontal). Figure 3.3-5 shows a contrast adjustment from Figure 3.3-4 which reveals the hollow connector pin, the structure supporting the pins, and a 5-pin component socket. Figure 3.5-6 shows a scan taken in location #7 which clearly identifies 9 nuts supporting the circuit board arrangement.
