Aircraft Structures Technical Memorandum 515

FLUTTER INVESTIGATIONS ON A TRANSAVIA  
PL12/T-400 AIRCRAFT (U)

A. GOLDMAN, C.D. RIDER and P. PIPERIAS

JULY 1989

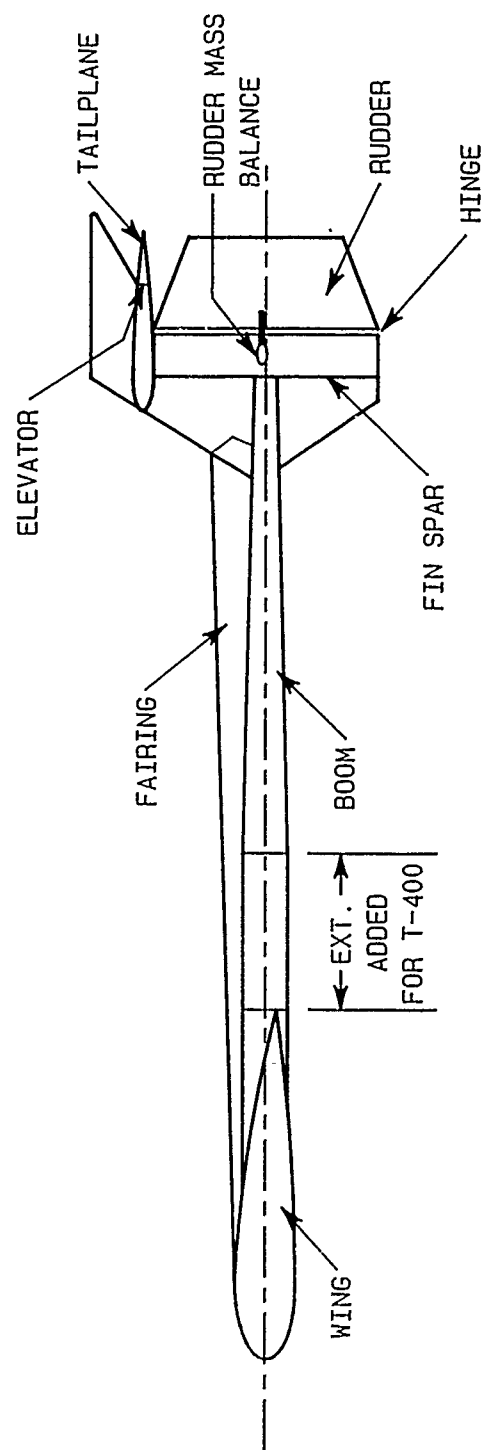
FIG 1. LAYOUT OF WING-BOOM-TAIL OF T-400

Figure 1 shows the layout of the tail boom of the T-400 aircraft. The T-400 aircraft was first flown in 1984 and flutter clearance testing was completed that year (Ref. 1). During the flutter clearance programme, the aircraft was flown up to a speed of 160 knots and shown to be free from flutter, using what were considered at the time to be adequate means of excitation in flight.

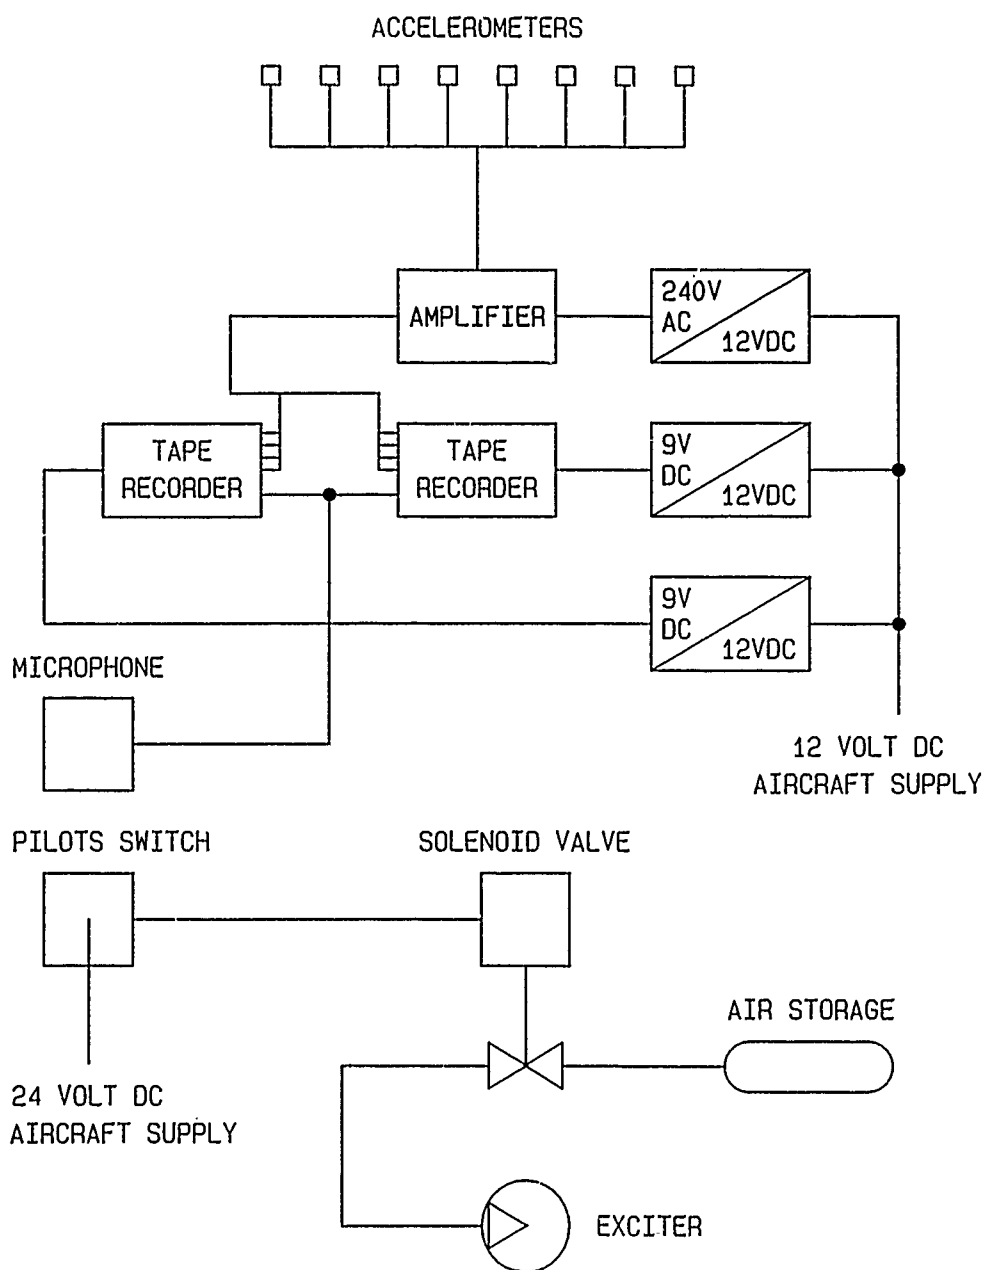
FIG 2. BLOCK DIAGRAM OF FLIGHT TEST INSTRUMENTATION

Figure 2 shows a block diagram of the instrumentation.

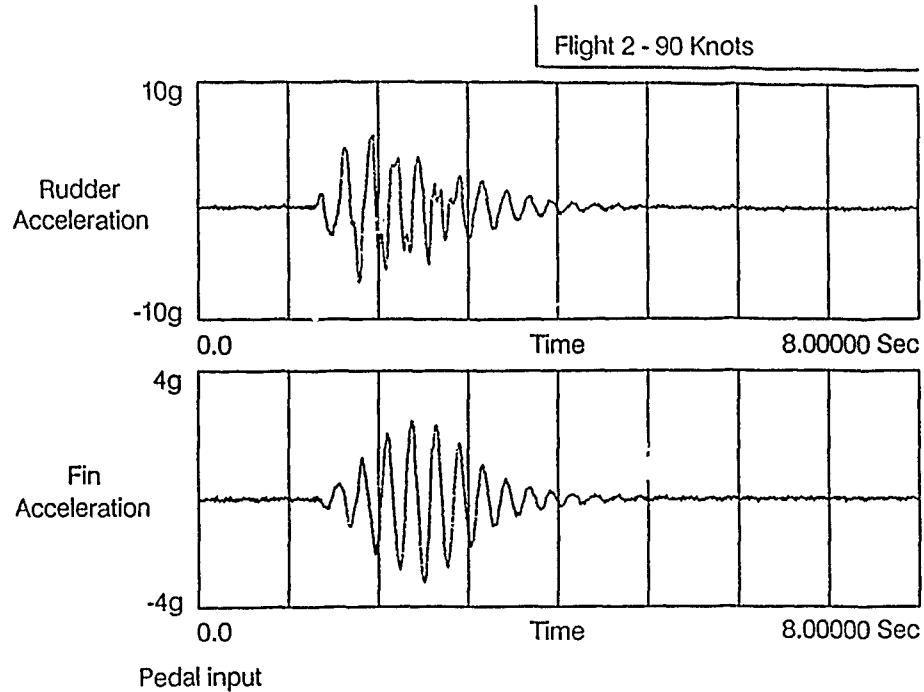
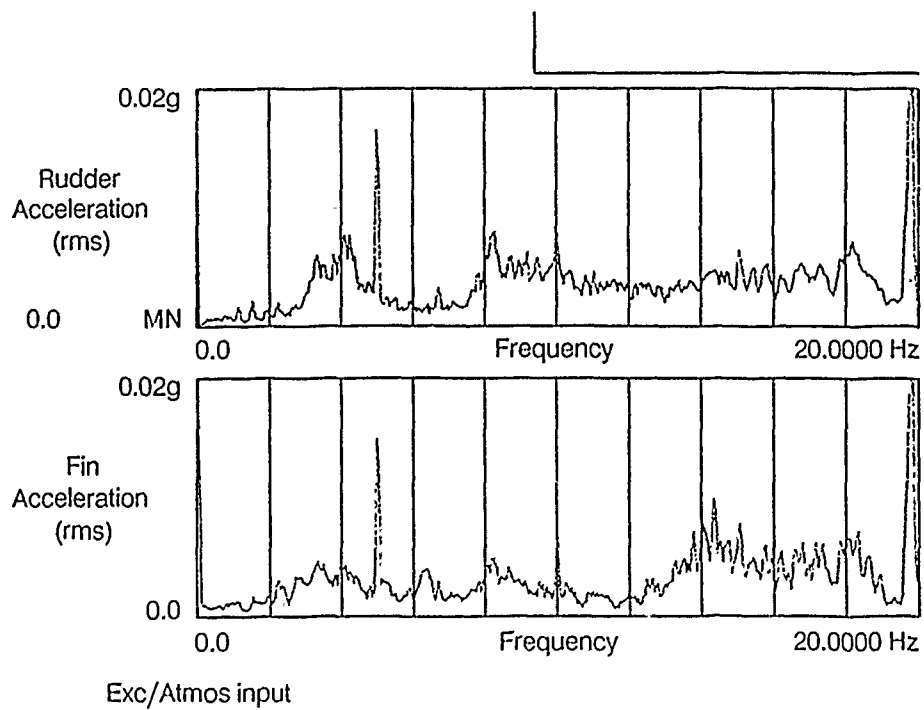
FIG 8a. FLIGHT 2 - 90 KNOTS

Following the fitting of adequate mass balance to the rudder, it will be seen from Figures 7 to 11 that it was not possible to excite this mode of flutter with rudder oscillations up to 800 mm in amplitude. These amplitudes, of course, are in absolute terms and include the fin motion.

Figure 7 to 15 also show the results of FFT frequency analysis of the fin/rudder and tailplane/elevator combinations. The elevator and tailplane locations were included to ensure that no problems had been introduced in the vertical plane by the addition of the rudder mass balance system.

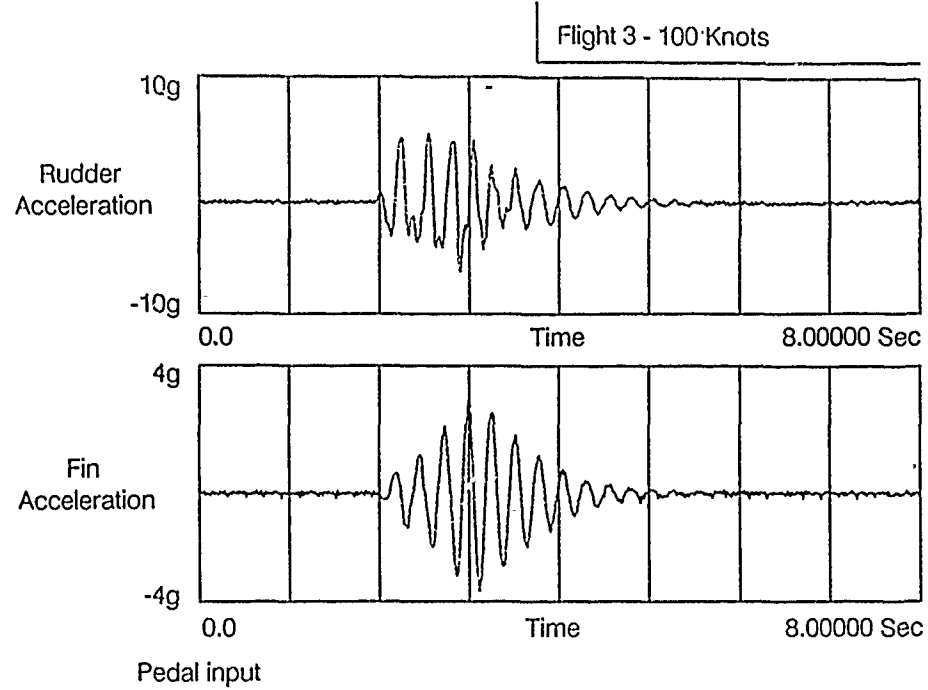
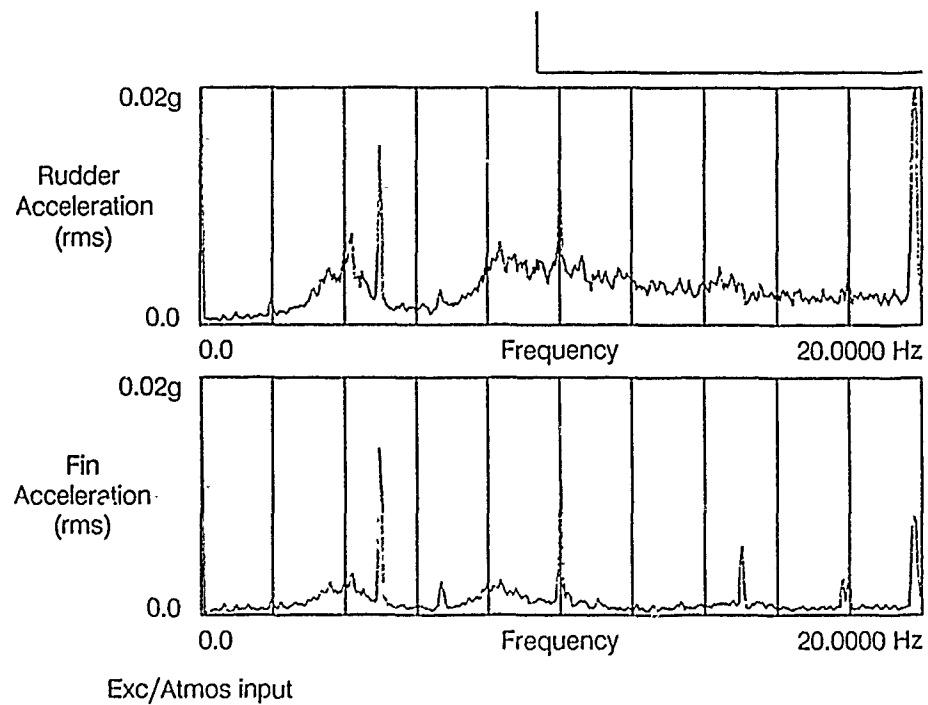
FIG 9a. FLIGHT 3 - 100 KNOTS

On flight 3 the tape recorder installed to record tailplane and elevator response failed to operate. The problem was corrected for all subsequent flights, and the indications from analysis of the data from flight 2 were such that it was not considered necessary to repeat that test point.
