MTL TR 90-30

METALLURGICAL ANALYSIS OF LEAKING TRAY PACKS

KUAN S. LEI
GEO-CENTERS, INC.
NEWTON, MA

May 1990

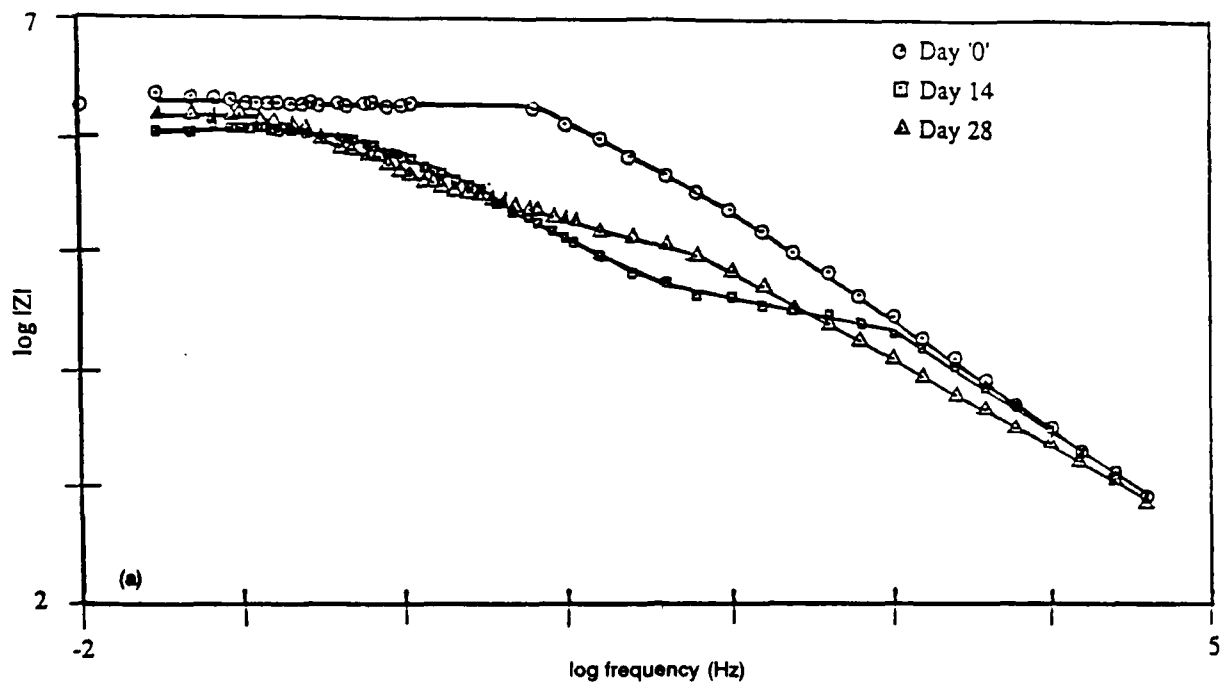
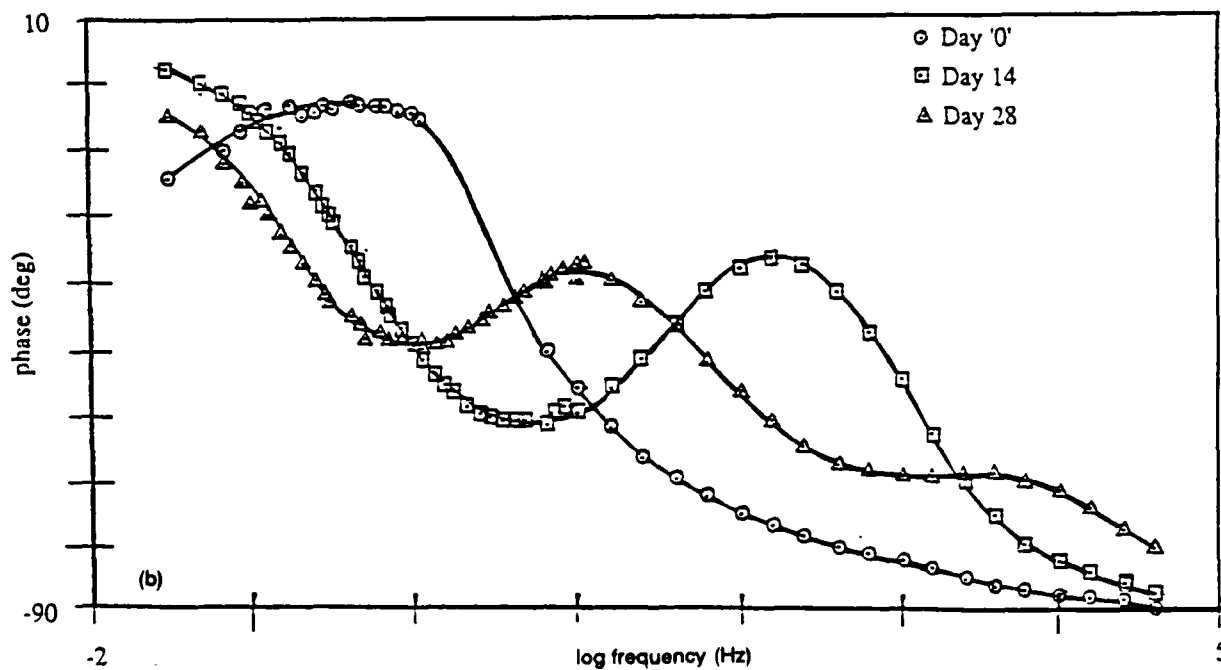
Figure 12. Bode plots for (a) magnitude and (b) phase angle for HGW coating tested in 3.5% NaCl for 0, 14 and 28 days exposure.

Figure 12 contains Bode plots, (a) $\log |Z|$ versus \log frequency and (b) θ phase angle (deg) versus \log frequency, which compare the behavior of the new HGW coating exposed to 3.5% NaCl solution for 14 and 28 days. The polarization resistance, determined by extrapolation from the linear region at low frequencies to the $\log |Z|$ axis intercept, (see Figure 12a) remains relatively unchanged from 0 to after 14 and 28 days of exposure. However, the phase angle plot (see Figure 12b) shows significant differences in behavior as a function of exposure time. The new peak after 14 days indicates another phenomena is occurring, differing from the initial one of penetration of the solution into the coating. This probably represents corrosion at the metal/coating interface.

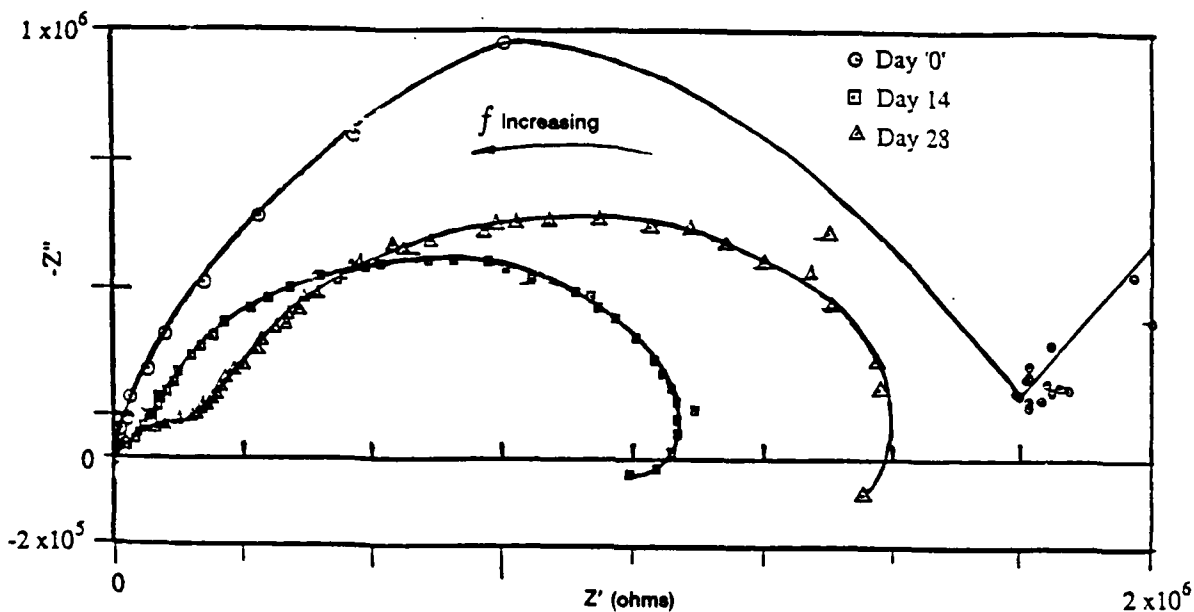
Figure 13. Nyquist plot for the same HGW coating, as shown in Figure 12.

Figure 13 contains Nyquist plots for the same coating exposed for 0, 14, and 28 days to 3.5% NaCl solution. The response curve after one day of exposure is a relatively large semi-circle. The impedance behavior after 14 and 28 days shows that the high frequency intercept of the curves with the Z' -axis is the same, but the response curves become smaller semi-circles (decreasing in area with increased exposure time) with the center of the semi-circle lying along the Z' -axis. An estimate of the polarization resistance may be made from the intersection of the low frequency end of the semi-circle with the Z' -axis. Thus, the polarization resistance decreases with increasing exposure time.

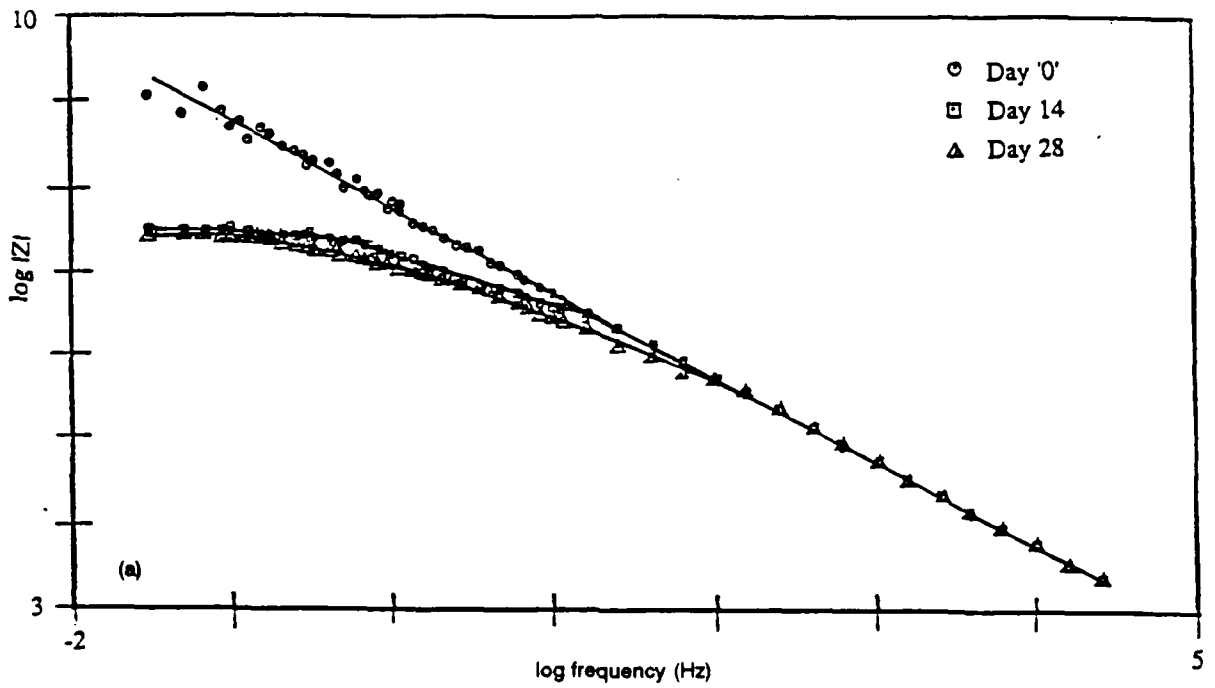
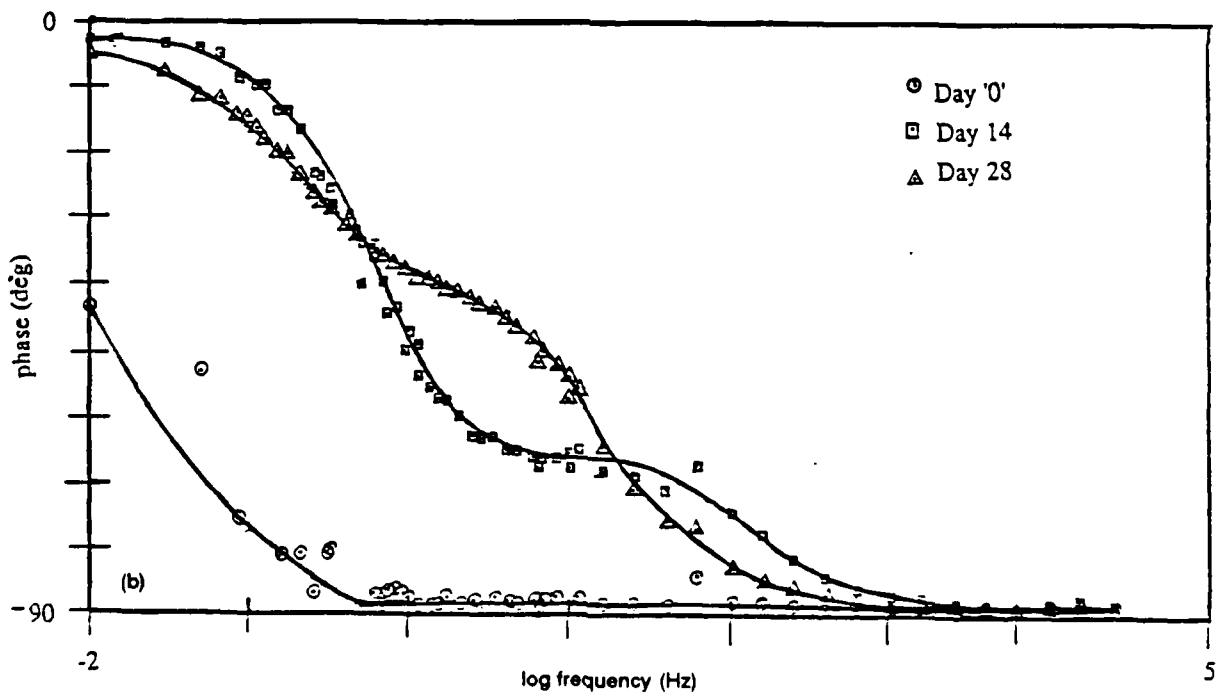
Figure 14. Bode plots for (a) magnitude and (b) phase angle for the current coating system tested in 3.5 % NaCl for 0, 14 and 28 day exposures.

Similar AC impedance measurements in 3.5% NaCl solution were made on the current coating system. Bode and Nyquist plots for this system are contained in Figures 14a, 14b, and 15, respectively; generally, the impedance behavior of the multilayer system is qualitatively similar to that of the new high gloss (HGW) coating. Nevertheless, there are some discrete differences which are discernable from the plot of polarization resistance as a function of exposure time, as shown in Figure 16. The presently used coating system has a much higher initial polarization resistance (R_p) than the HGW coating (1×10^{10} ohms cm^2 versus 6.3×10^9 ohms cm^2), but as the coating system is exposed to 3.5% NaCl solution, R_p decreases with exposure time and levels off to 6.3×10^7 ohms cm^2 . Although some coating degradation has occurred, R_p after 28 days of exposure remains significantly above the critical value¹ of 10^6 ohms cm^2 , below which corrosion of the tin-free steel occurs. The R_p of the HGW coating is consistently much lower and even approaches the critical value of 10^6 ohms cm^2 after exposure time of 28 days.
