NASA Technical Memorandum 102681  
USAAVSCOM Technical Report 90-B-003

# Behavior of Composite/Metal Aircraft Structural Elements and Components Under Crash Type Loads--What Are They Telling Us?

Huey D. Carden, Richard L. Boitnott, and  
Edwin L. Fasanella

May 1990

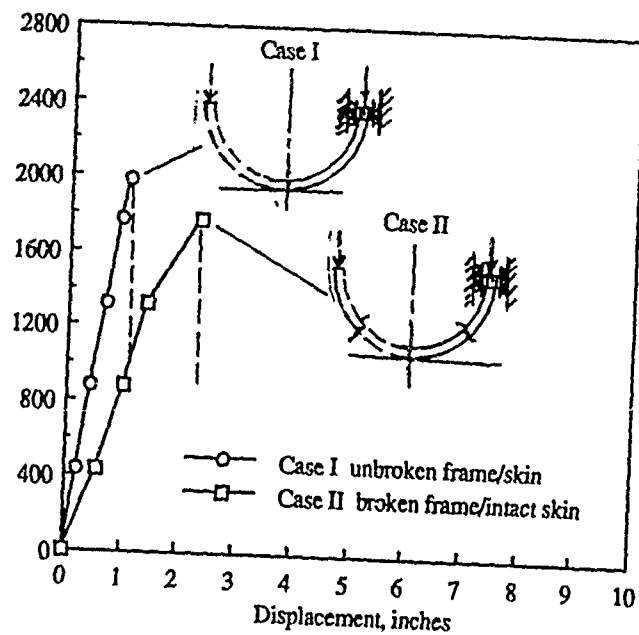
(a) Load-displacement.

**Static analytical studies.** To demonstrate analytically the apparent behavior of the frames under load (exclusive of the local buckling which actually initiated the failure in the static case), two DYCAST finite-element models were constructed. For ease of analysis, a typical I-section was modeled from the specimens described in the "Single Frame Studies" section. The frame was loaded at the top and a simulated ground plane (ground contact springs) resisted the vertical movement of the frame during load application. Only half the frame was modeled using thirty-four (34) I-section beam elements with boundary conditions imposed at the bottom node of the model to account for the symmetrical situation. The top node was constrained to allow only vertical displacement thus simulating the effect of a very stiff floor across the frame diameter. The static load was slowly increased until an input failure strain for the material (0.0086) was exceeded at the point of loading and failure was indicated. The curve labeled *unbroken frame, case I*, in figure 12(a) is the load-deflection plot for this case I.

A second DYCAST model, *broken frame, case II*, was also run wherein the bottom point of the frame was modeled with two short skin segments to represent the different boundary condition following the initial failure of the frame. This condition will be discussed further relative to the composite subfloor test with the skinned subfloor specimen. The curve in figure 12(a) labeled *case II* is the load-deflection response for this frame loading case. Essentially, the frame load increases along the *case I* curve to the point of initial failure at the bottom of the frame. After the frame fractures the boundary changes to one considerably weakened--down to the bending stiffness of the skin alone at that location. The load then drops to the lower curve, *case II*, which represents the stiffness of the section with the weakened boundary on the bottom end of the frame. The load continues to increase along the *case II* curve until secondary failures at some other location on the frame circumference occur.

Furthermore, a comparison of the analytical cases (figure 12(a)) with the actual static load-deflection of the Z-section (figure 11(b)) indicates very similar load-deflection behavior patterns as discussed above. Although the Z-frame had no skin, if the ends jam together (as they did in several cases), the boundary is effectively between the skin stiffened case and a guided boundary. Thus, the predicted maximum moment location in the simple beam-frame model at about 50 degrees (See figure 12(b)) agrees well with the 54 and 58 degree failure locations in the experiment with the Z-section frame.

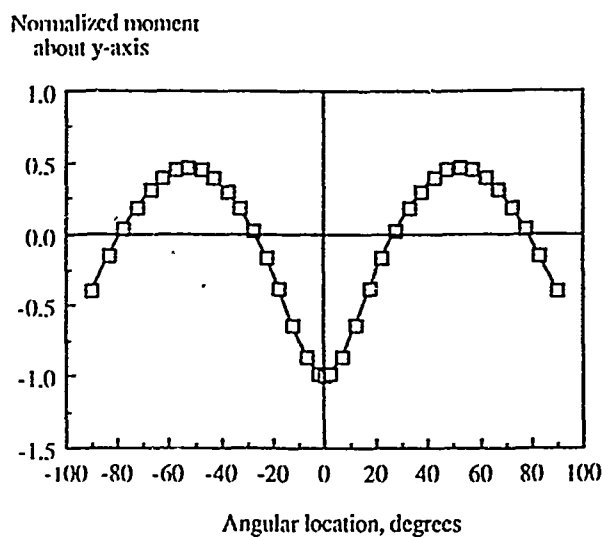
(b) Case I---Normalized moment (Prior to failure).

An examination of the normalized distribution of the bending moment on the frame shown in figure 12(b) provides insight and a better understanding of the failure/behavior. Maximum moments are indicated (just prior to failure) to be at the 0 degree location and between  $\pm 50$ -60 degrees from the bottom contact area. The locations correlate well with the failure locations in the experiment with the Z-frame.

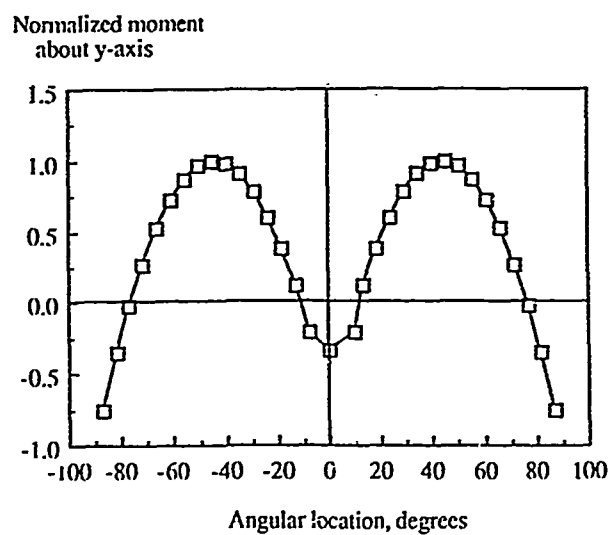
(c) Case II---Normalized moment (Broken frame-intact skin).

Normalized bending moment distribution on the broken frame is presented in Figure 12(c). As may be noted, the distribution is quite similar to the initial model results in figure 12(b). The failure location is at the maximum bending moment location predicted to be about  $\pm 45$  degrees which is somewhat lower than the same location shown in the initial model of the unbroken frame. The agreement between the predicted behavior by the two models, however, is still considered good. The effect of diameter on the moment distribution of the frame was assessed with a model having a 75 inch diameter (twice the initial diameter). The distribution was identical to the smaller diameter results, however, the loads producing the moments differed between the two models (as expected). Moment in terms of geometry and load for a point loaded ring<sup>28</sup> shows that the maximum moment will occur at the same angle for different values of diameter.

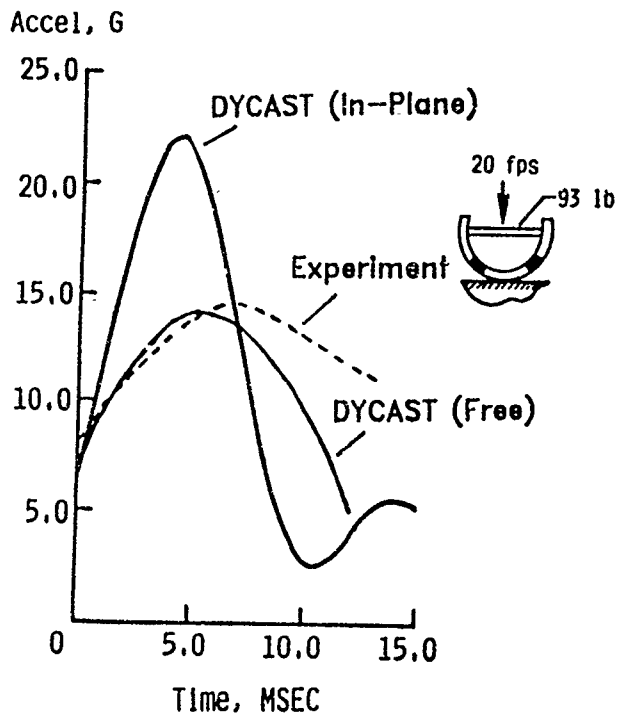
(c) Experimental and analytical accelerations.

**Dynamics analytical studies.** Experimental and analytical model results for the composite Z-frame subjected to a 20 ft/s impact are shown in Figure 13(c). The first 15 milliseconds of the experimental acceleration of the floor and analytical predictions are shown. In one analysis, in-plane deformations were constrained to the plane of the frame whereas in the other, the frame was free to twist and bend out-of-plane. As noted in the figure, agreement between the "free" model and the experiment is good for the initial peak load. Later the agreement is less because the backstop and clear fence in the experiment, which was not modeled, began to provide support to the twisting and bending frame. The in-plane model results are about 60% higher when compared to the experiment and the free model results. Such results emphasize the importance of knowing and modeling the experimental boundary conditions to understand the dynamic and static behavior of structures under crash loadings. Unfortunately, mixed boundary conditions often exist or occur in the experiment.

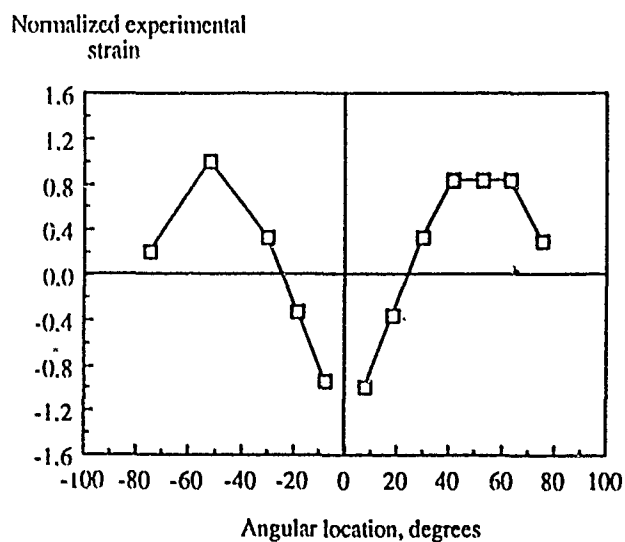
(c) Normalized circumferential strain distribution.

**Dynamic tests.** A photograph of a skeleton subfloor after an impact test onto a concrete surface at 20 feet per second is shown in Figure 15. In the dynamic test of the skeleton subfloor, fractures were produced at notches in the frames (Figure 15(a)). The locations, shown in figure 15(b), were also near the point of impact (about 11 degrees because of the splice plate) and at three other locations up the circumference of the frames (55 degrees and 78 degrees) totalling 15 fractures for all three frames. The impact energy exceeded the energy absorbed by the local fractures and the floor bottomed out during the impact. The normalized circumferential strain distribution measured on the flange of the front frame during the dynamic test just before first failure is shown in Figure 15(c). A comparison of the measured distribution to the predicted moment distribution of Figure 12(b) and (c) shows essentially identical shape between the single frame and skeleton frame distributions. Maximum values at 0 degrees and at approximately 50 to 55 degrees for the experiment agree well with the analytically predicted locations on the frame.

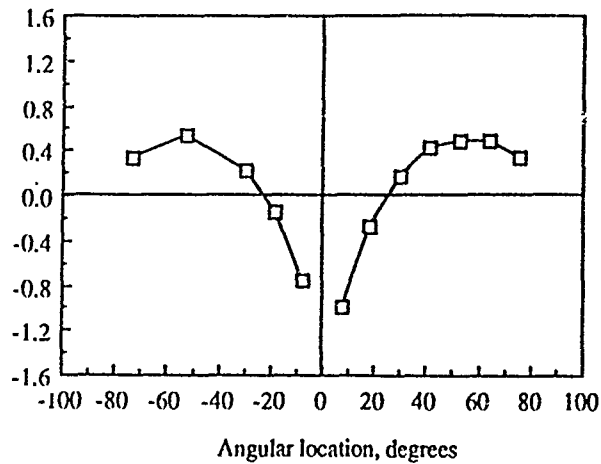
(c) Normalized circumferential strain distribution.

Impact results for the subfloor with skin after an impact of 20 feet per second are shown in Figure 16. A photograph of the subfloor specimen after the test is shown in Figure 16(a). Points of failure of the frames in this specimen are indicated in figure 16(b). Again the points of failure are at or near the impact point (within 12 degrees) and circumferentially at about 56 degrees up both sides of the frame on the middle and back frame and 45, 12 and 22.5 degrees on the front frame. It was observed that the subfloor impacted first on the front area which possibly explains the 12 and 22.5 degree fractures being different from the other locations. Again all three frames were involved in the failures. Some delamination of the frames from the skin was evident but the skin remained intact. Normalized strain distribution (just prior to first failure) measured on the skin at the location of the front frame during the dynamic test showed essentially identical shape as the single frame and skeleton frame distributions. As was the case for the skeleton subfloor maximums at 0 degrees and at approximately 50 to 55 degrees for the experiment agree well with the analytically predicted locations on the frame.

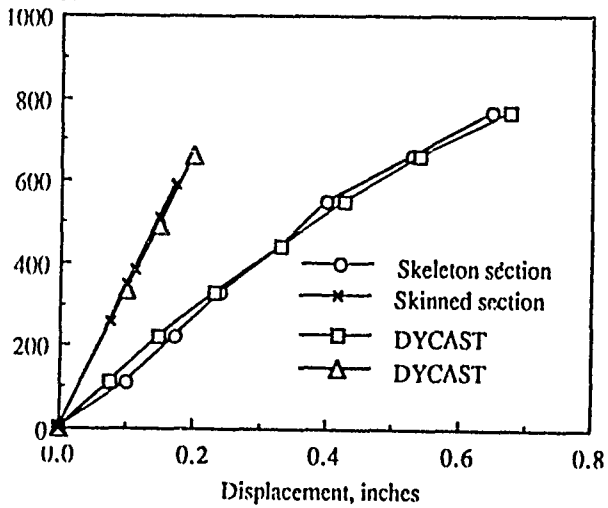
Figure 17. - Comparison of experimental and analytical stiffness of composite skeleton and skinned subfloors.

Analytical studies.—The contribution of the skin to the stiffness of the section with the nonsymmetrical frames is illustrated in figure 17. Static load-deflection data for the unskinned subfloor and the skinned subfloor along with the DYCAST predictions are shown in the figure. It can be noted that the subfloor stiffness (with skin) is approximately three times the stiffness of the skeleton subfloor, thus the skin's contribution to the structure is to maintain in-plane deflections of the non-symmetrical Z-section and prevent any substantial twisting of the frames. Out-of-plane bending and twist were allowed in the skeleton subfloor predictions.
