MTL TR 90-44

# **FAILURE ANALYSIS OF A MAIN ROTOR PITCH HORN BOLT LOCATED ON THE AH-1 COBRA HELICOPTER**

VICTOR K. CHAMPAGNE, Jr.  
MATERIALS TESTING AND EVALUATION BRANCH

September 1990

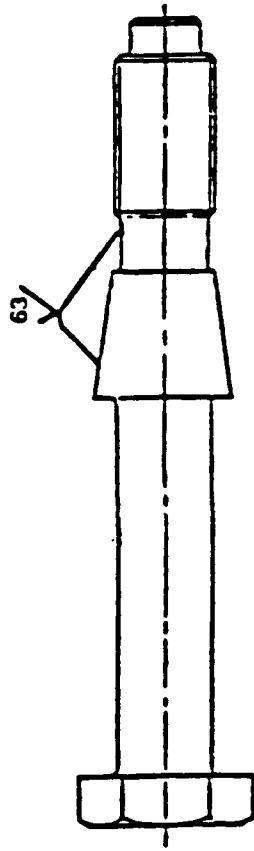
Figure 13. Schematic of bolt design. Surface finish is specified as 125 microinches, except the two areas indicated where the finish is 63 microinches.

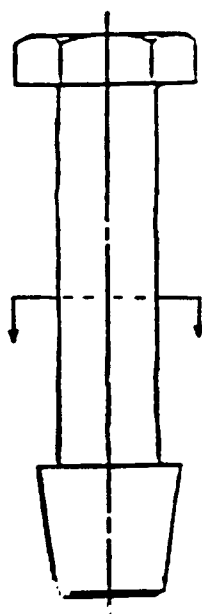
The engineering drawing of the pitch horn bolt specified a minimum tensile strength range of 180 to 200 ksi which converted to an approximate hardness level of Rc 39-43. Macrohardness measurements were taken on transverse cross sections of the bolt above the conical region, as shown schematically in Figures 15 and 16. The results of this test did not reveal evidence of any regions that displayed unusually higher or lower degrees of hardness, which may occur if the material had been locally heated. The average value of all the measurements taken did show that the material was hardened to the upper limit of the acceptable range (refer to Table 3).

Figure 15. Indicates the area where the bolt was sectioned for hardness testing.
