**US Army Corps  
of Engineers**

USACERL Technical Report M-91/02

October 1990

# **Exterior Insulation and Finish Systems (EIFS) on U.S. Army Facilities: Lessons Learned**

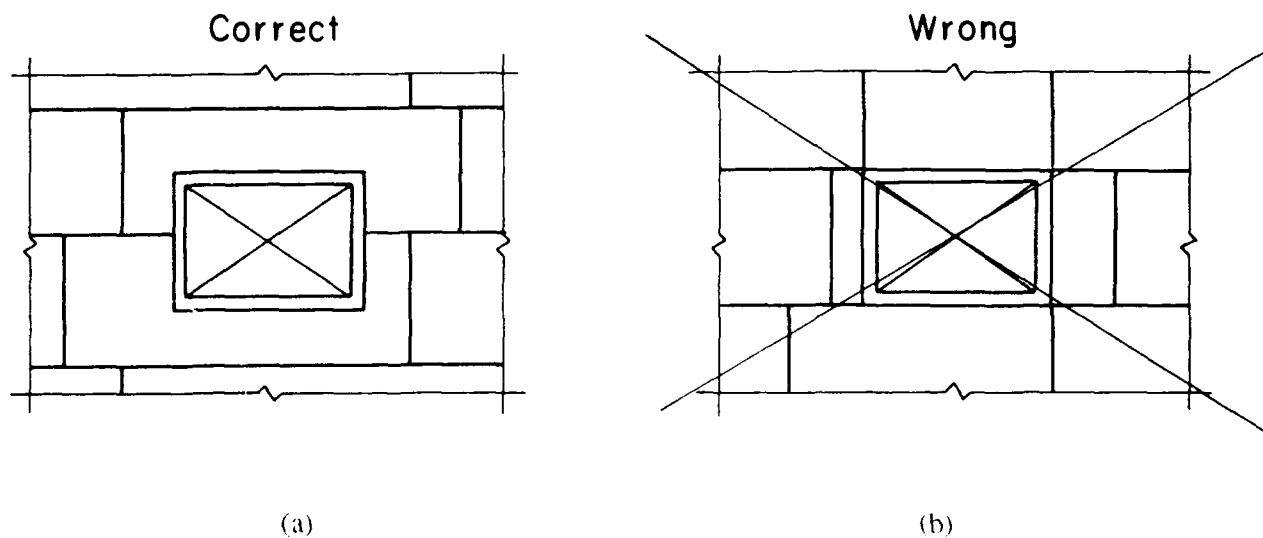
**Figure 23.** Insulation boards at window penetrations, placed (a) properly, (b) improperly. (This information was printed with the permission of Dryvit Systems, Inc., One Energy Way, P.O. Box 1014, West Warwick, RI 02893.)

Most of the cracking in EIFS due to these common causes could be prevented. To lessen the occurrence of corner-initiated cracking, most manufacturers now require that diagonal pieces of reinforcing fabric be placed at the corners of windows and doors (Figure 22). Also, the insulation boards should be placed so that the vertical edges of the board do not line up with the vertical edges of the window, door, or other such wall penetrations (Figure 23).

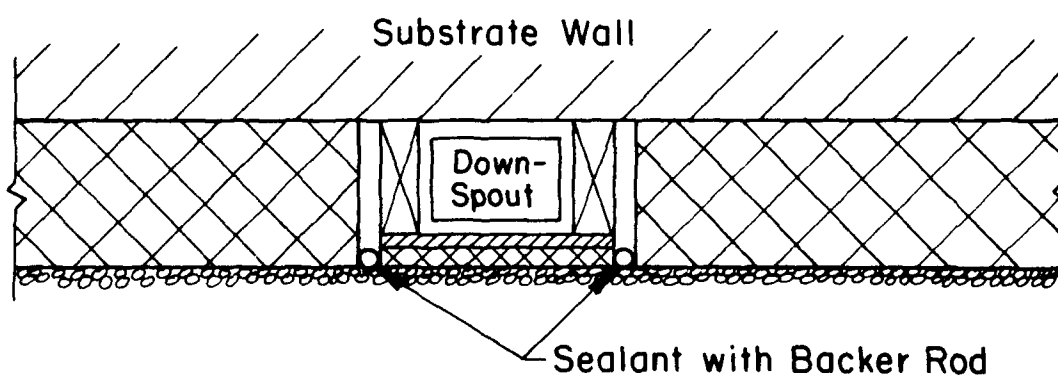
Figure 27. System detailing needed to bridge underlying downspout.

Careful attention should be paid to the treatment of gutters and downspouts in the building design. Downspouts should not be concealed. If this is not possible, the bridge section must be isolated from the adjacent wall (Figure 27) and the downspout itself. The bridge section must not be adhesively attached to the downspout. The system and the downspout must be free to move independently of each other. Any existing installations with these conditions present will need to alter the system to conform to the above recommendations. Leaking, damaged, or missing gutters and downspouts must be repaired or replaced to reduce the possibility of water infiltration into the EIFS.
