Multiple-Purpose Project  
Little Blue River Basin  
East Fork Little Blue River  
Missouri

# Blue Springs Lake

## Operation and Maintenance Manual

# Construction Foundation Report

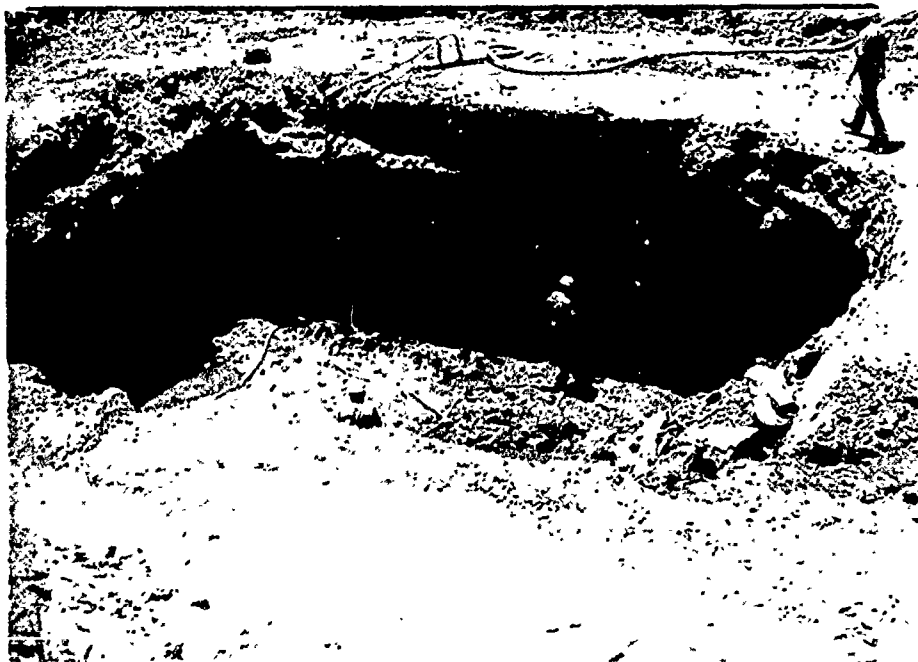
17. Blue Springs Lake, 7 May 1983, Neg. No. 117.  
Outlet/Sewer excavation. Applying RC500 protective  
coating to east side wall. Looking upstream.

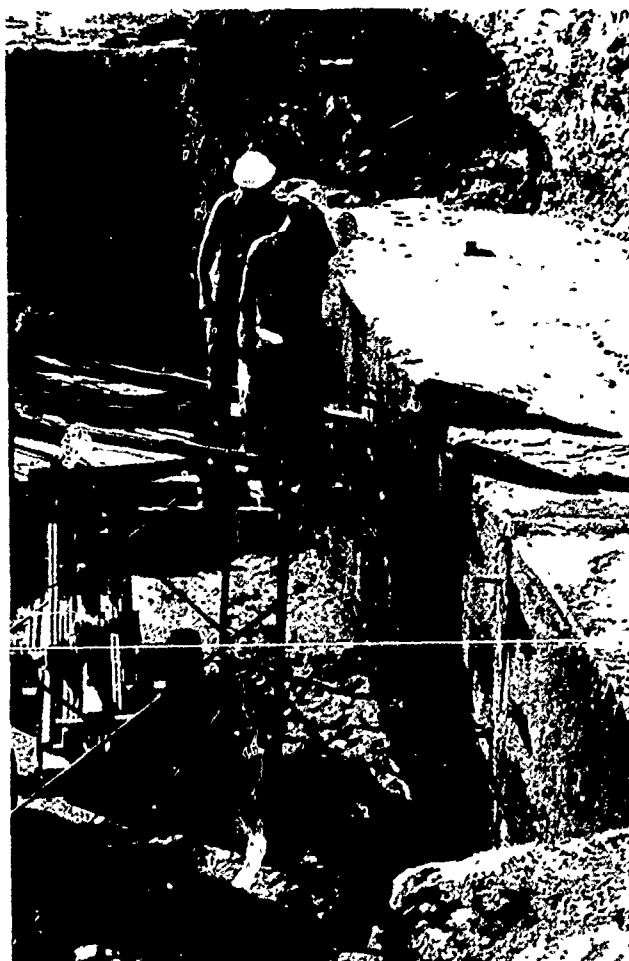
(a) During design investigations, significant stress release fracturing was found to exist low in both abutments in the Pleasanton Zone C. Fracturing was most intense in the left abutment where near vertical fractures were spaced as close as 2 inches or less. They were generally tight and disappeared with depth normally at bedding planes. There was concern that

21. Blue Springs Lake,  
7 July 1983,  
Neg. No. 139.  
Tower excavation.  
Detail showing high  
angle joints in  
Pleasanton "C" shale,  
station 47+65.

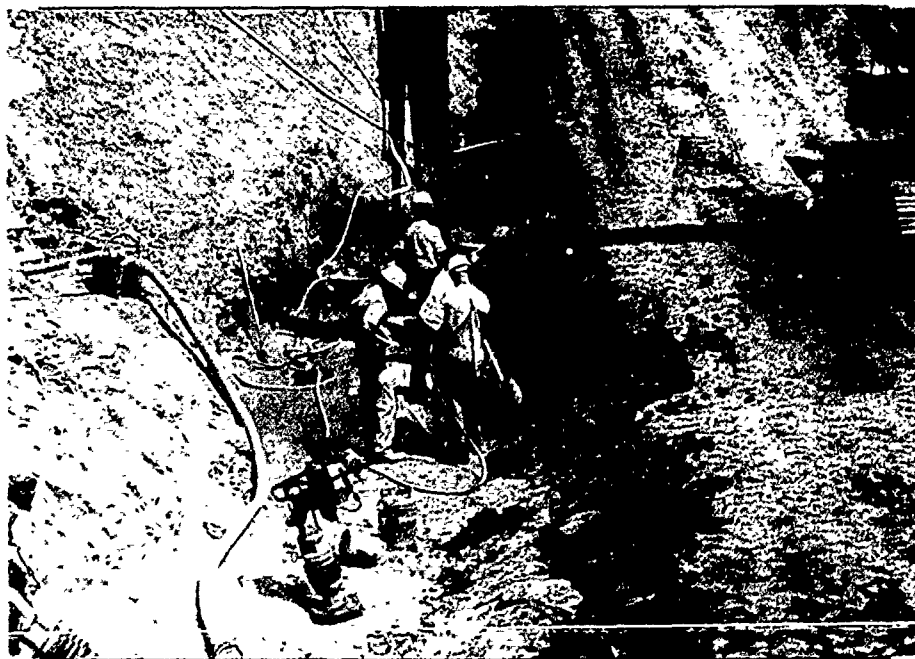
33. Blue Springs Lake, 12 August 1983, Neg. No. 182.  
Left abutment cutoff trench, bottom of trench.  
From station 96+75 to station 97+00.

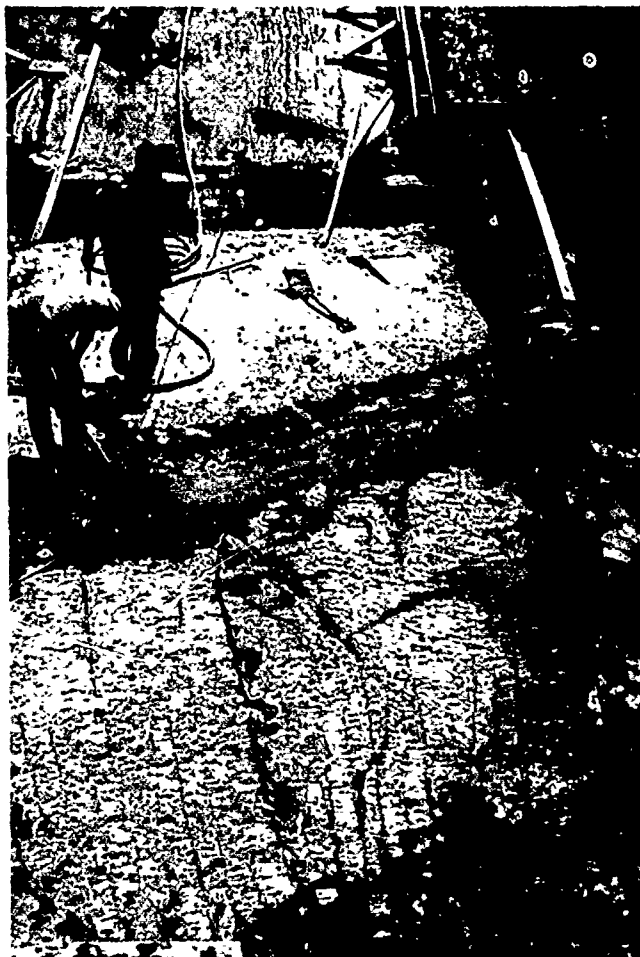
58. Blue Springs Lake,  
30 July 1984,  
Neg. No. 307.  
Joint zone in outlet  
works at station  
53+25, looking east.

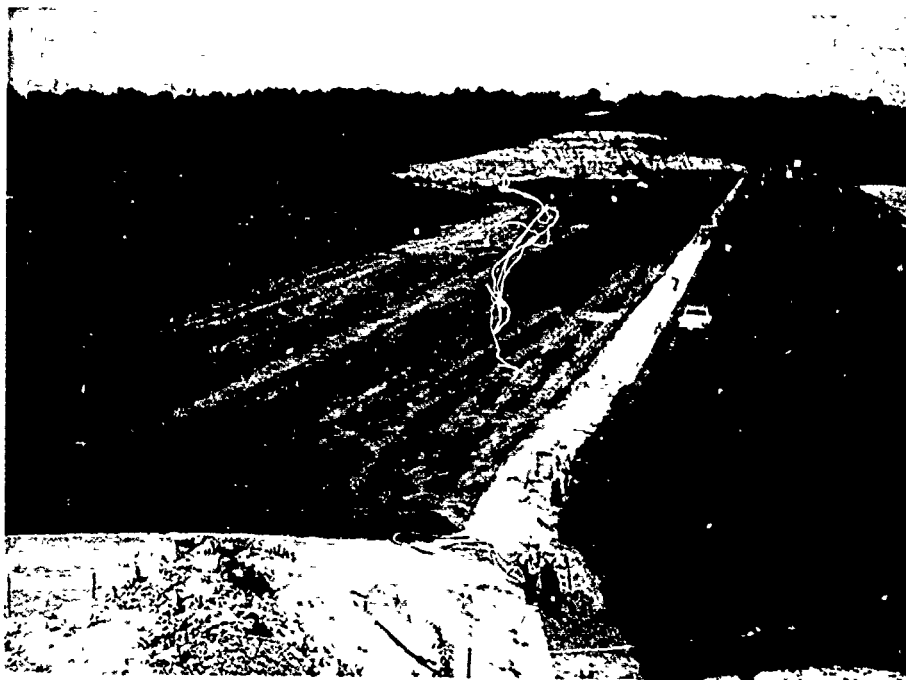
76. Blue Springs Lake, 20 May 1985, Neg. No. 440.  
Left abutment cutoff trench. From station 98+00  
looking downstream. View of floor after cement  
sand slurry. Note results of line drilling on face  
of Pleasanton "B" Sandstone.

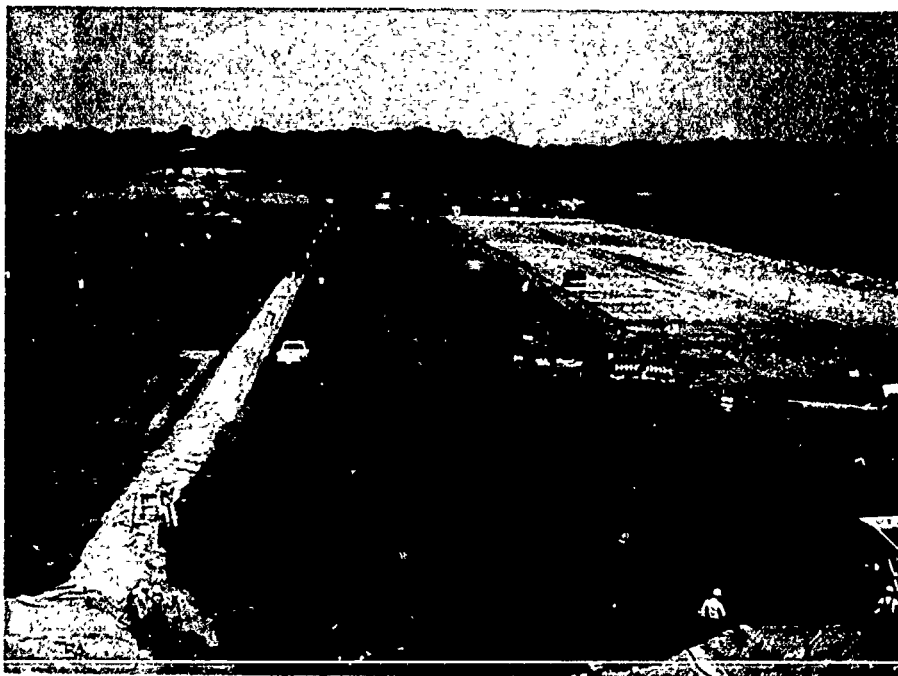
77. Blue Springs Lake, 21 May 1985, Neg. No. 441.  
From left abutment station 99+00, looking east.

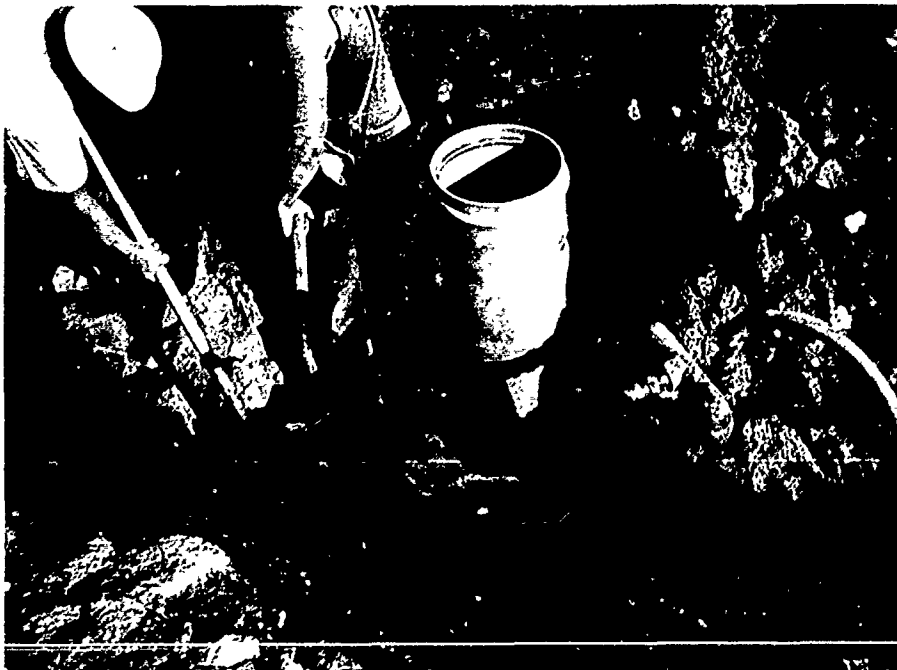
97. Blue Springs Lake, 12 August 1985, Neg. No. 536.  
Right abutment upstream sand drain at station 76+30.

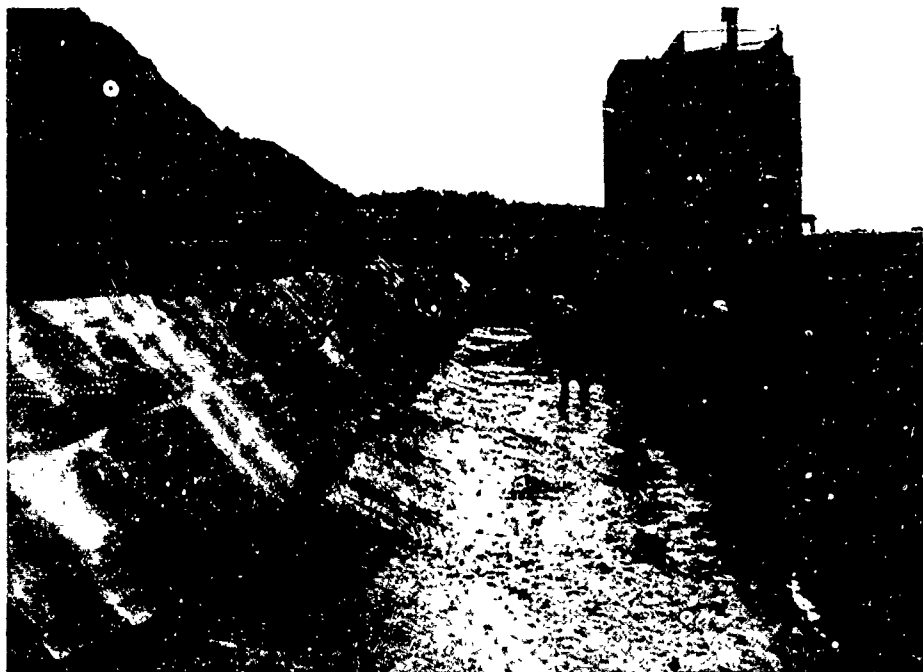
110. Blue Springs Lake, 17 April 1986, Neg. No. 608.  
Right abutment. From station 74+70 on center  
line of dam, looking upstream. View of Pleasanton  
"C" Zone.

111. Blue Springs Lake, 17 April 1986, Neg. No. 609.  
Right abutment. See Photo No. 110 for details.
