REPAIR, EVALUATION, MAINTENANCE, AND  
REHABILITATION RESEARCH PROGRAM

TECHNICAL REPORT REMR-CO-15

FIELD EVALUATION OF PORT EVERGLADES,  
FLORIDA, REHABILITATION OF SOUTH JETTY  
BY VOID SEALING

October 1990

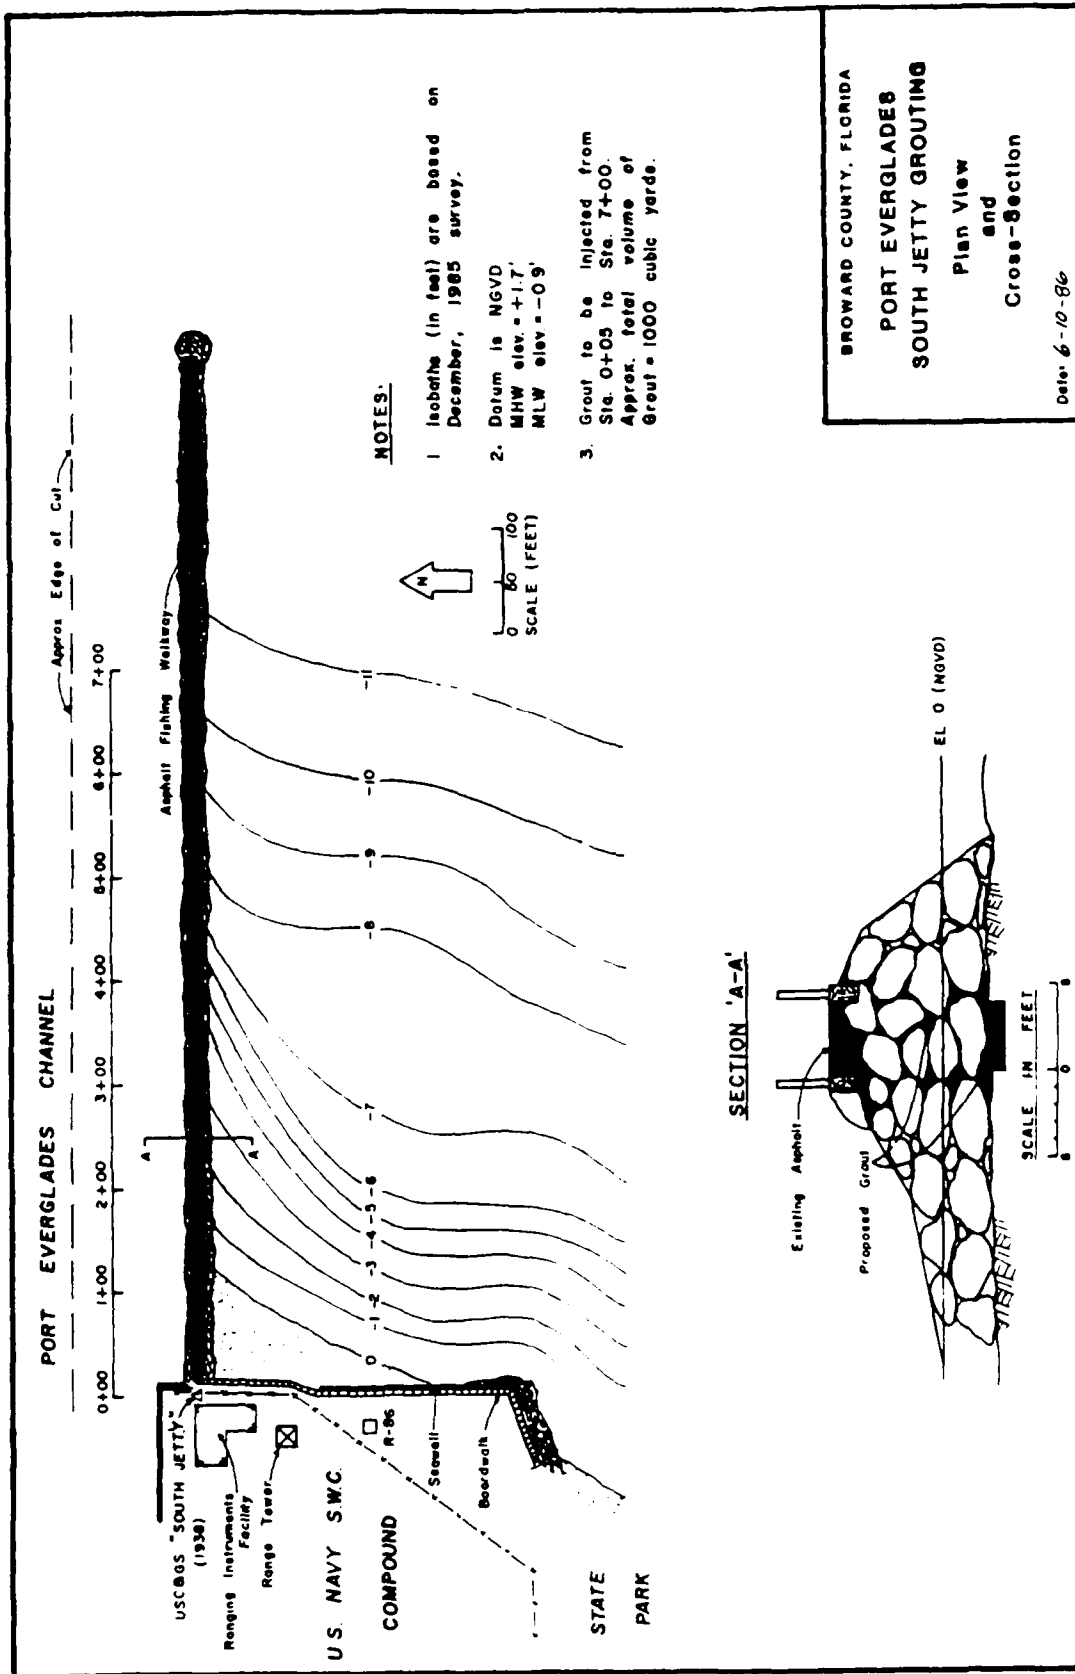
Figure 6. Plan view and cross section, Port Everglades, Florida, south jetty rehabilitation project (after BCEQCB, op. cit.)

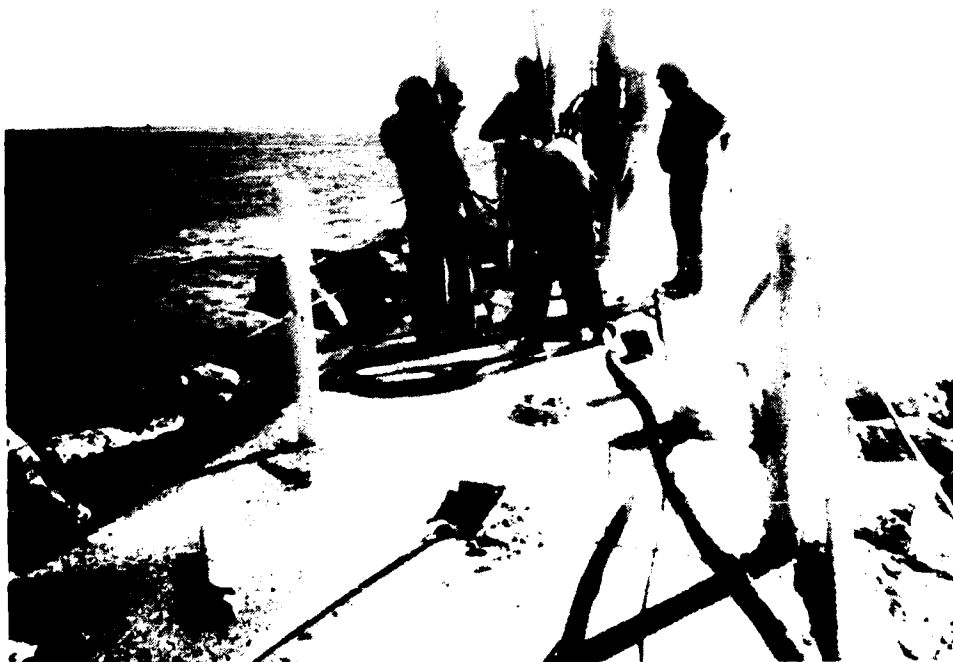
Figure 9. Placing sealant into south jetty at entrance to Port Everglades, Florida

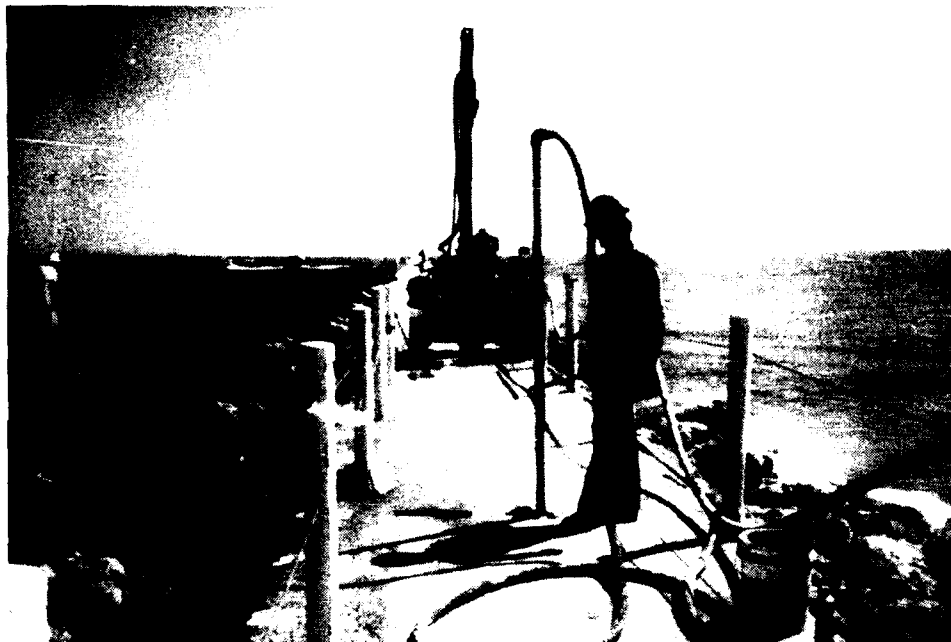
Figure 10. Monitoring sealant level in south jetty  
at entrance to Port Everglades, Florida

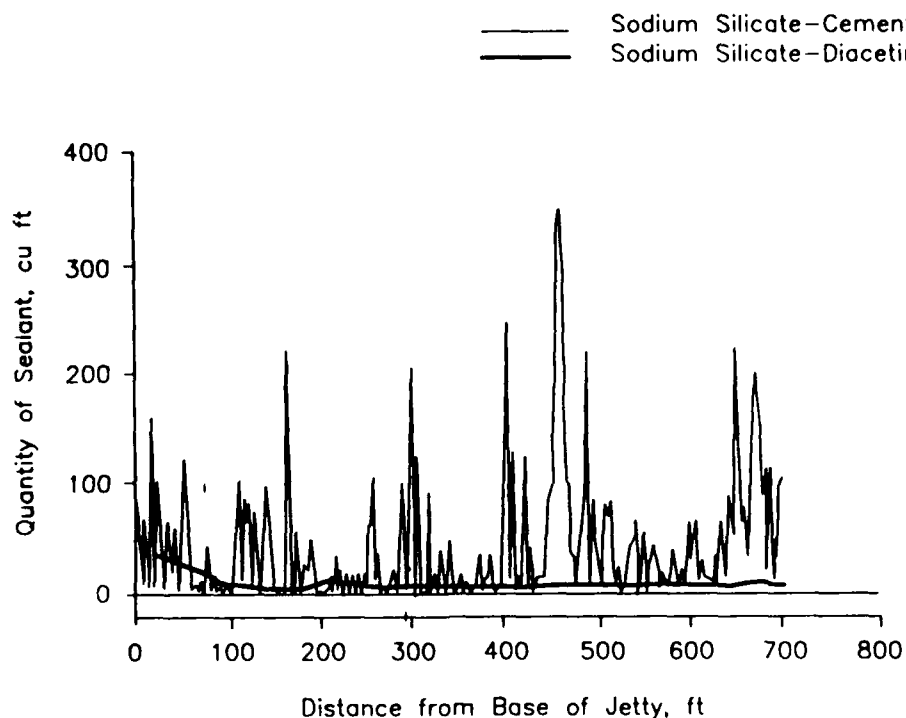
Figure 14. Quantities of sodium silicate-cement and sodium silicate-diacetin sealants placed into south jetty at entrance to Port Everglades, Florida
