TECHNICAL REPORT HL-90-19

# A STUDY OF VEGETATION ON REVETMENTS SACRAMENTO RIVER BANK PROTECTION PROJECT

## PHASE 1

### LITERATURE REVIEW AND PILOT STUDY

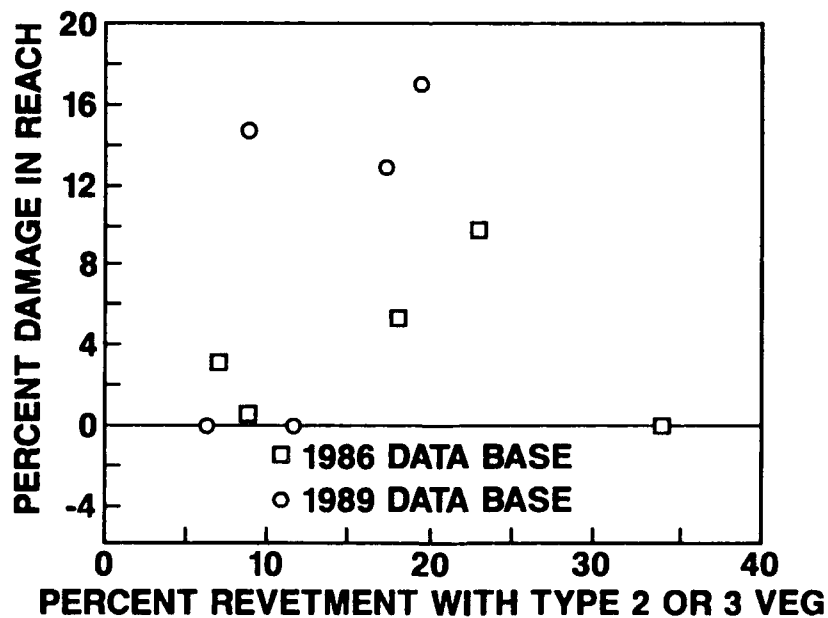
Results obtained from cross-tabulation analyses of the two data bases are compared in Table 18. The 1989 data base includes more damage and more types of damage situations, although it does not provide any information about structure performance under a given set of hydraulic conditions. Aside from 84.6 to 85.4L, the PL-99 data base emphasizes damage to relatively new rock riprap sites on convex bank. The 1989 data base records damage to old cobble sites that was not recorded in PL-99 files. Many of these sites are located on concave bend exits or convex bend entrances. Both data bases revealed that older revetments were more likely to support woody vegetation (Figure 28). Both also indicated no relationship between the amount of vegetation and the amount of damage in a WET subreach (Figure 29).

Figure 29. Damage and vegetation rates by WET subreach

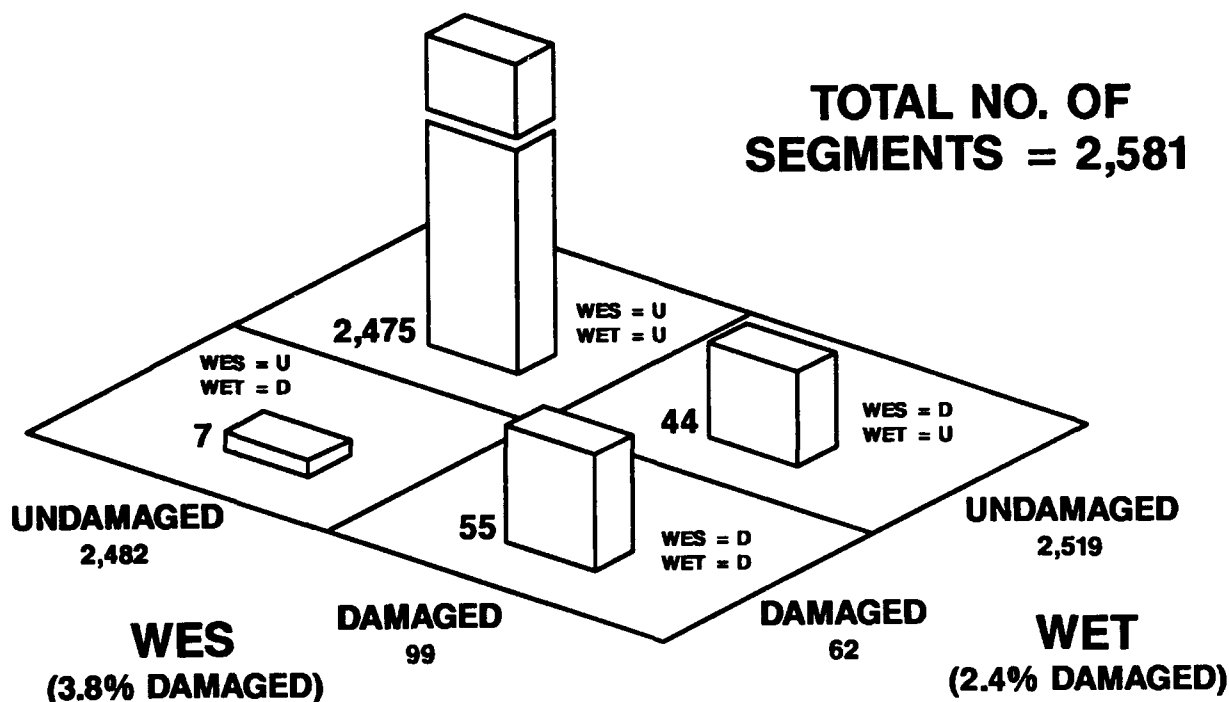
on the WET field notes from April 1989. Comparison of the two damage tallies is provided in Figure 30. Essentially all of the WET damage was included in the WES September inspection results, and 44 additional 100-ft segments were also identified as damaged. The seven segments classified as damaged by WET but undamaged by WES were due primarily to subjective differences.

Figure 30. Comparison of WES and WET revetment damage tallies for pilot study reach, Sacramento River. Of the 99 100-ft segments classified as damaged by WES investigators in September 1989, 55 were also classified as damaged on WET field notes from April 1989. The remaining 44 were not shown as damaged on WET notes
